**DEPARTMENT OF WATER RESOURCES**

*Re: Water Use Complaint for Papoose Creek*

## **PAPOOSE CREEK FIELD INSPECTION OF DEMERSE SITE**

Prepared by Steve Lester, IDWR Western Region  
October 31, 2000

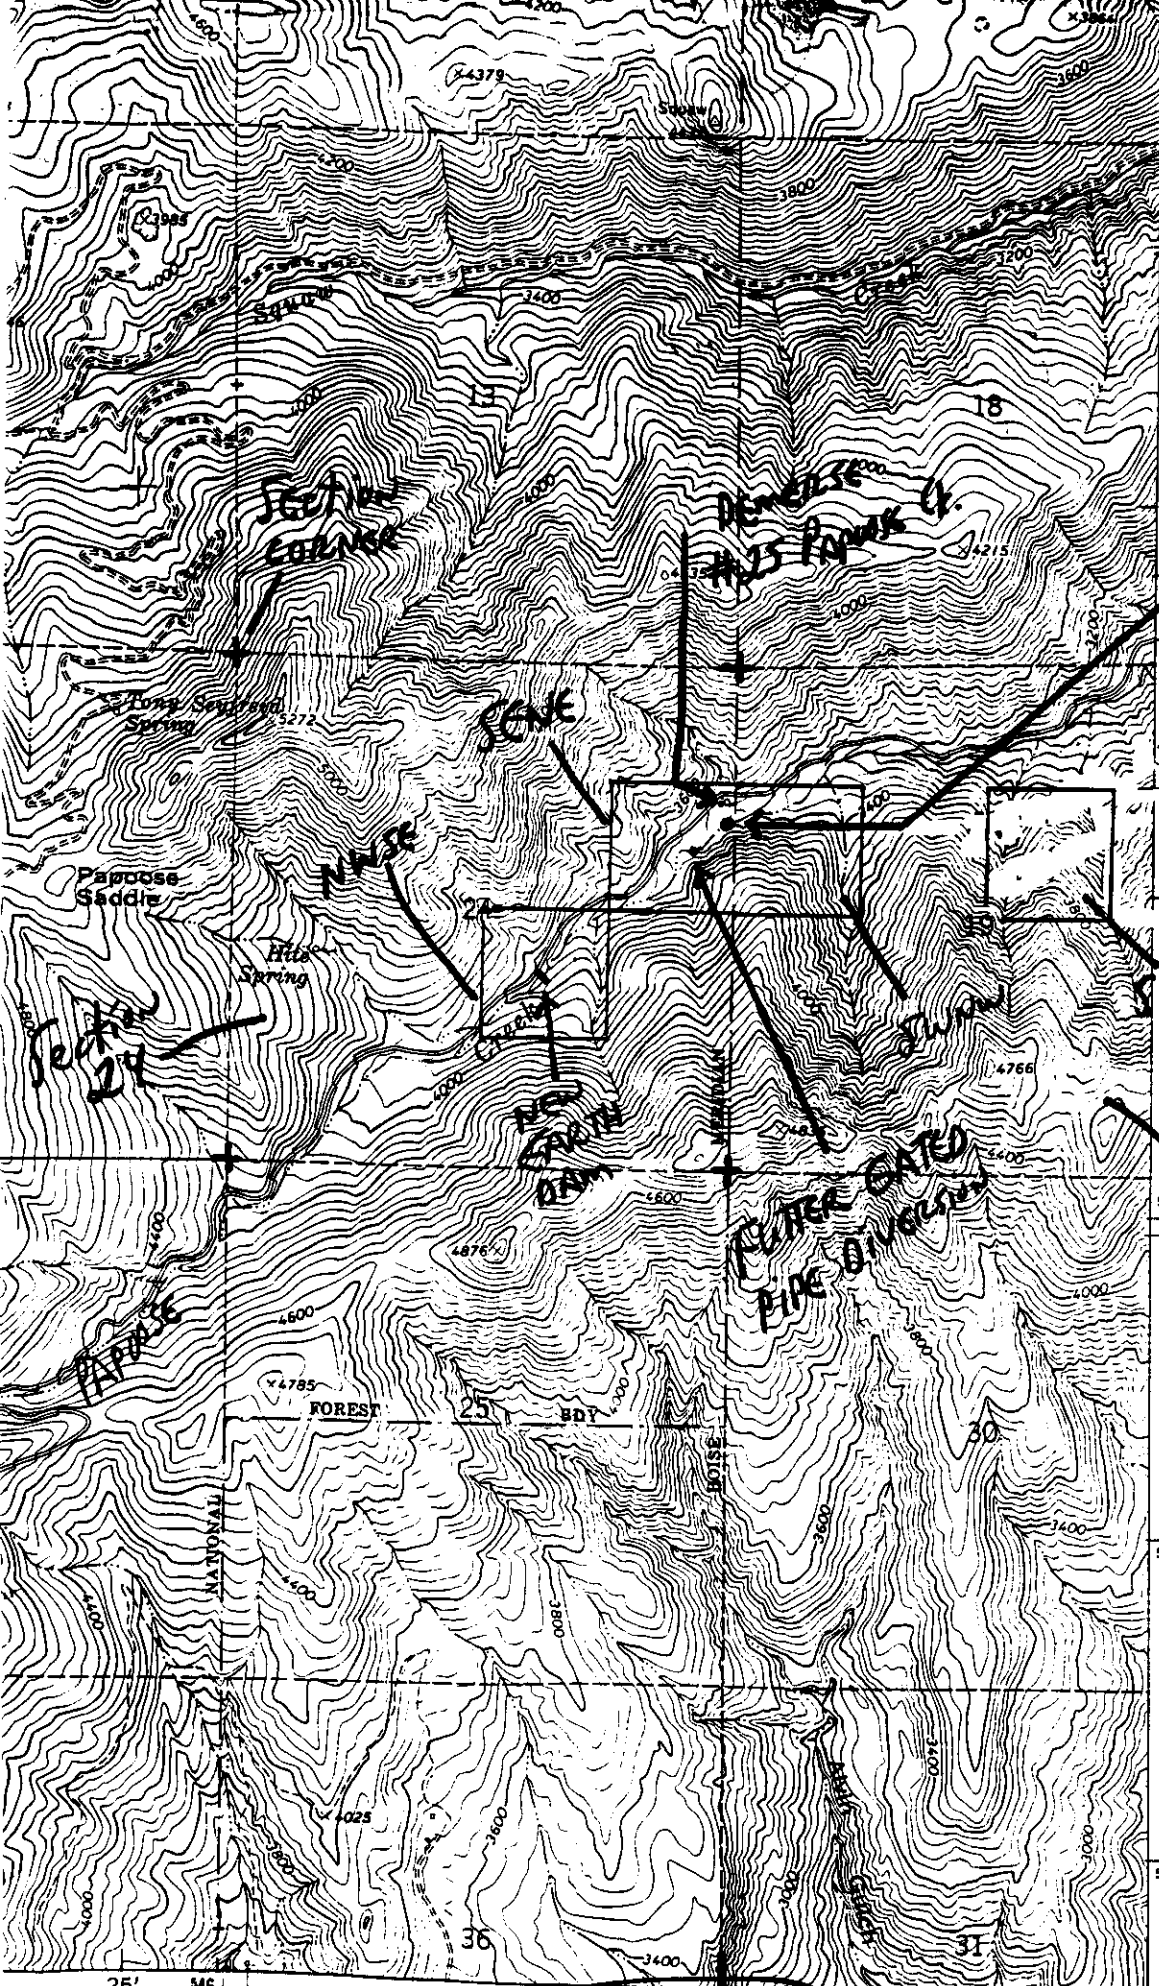
1. A large earth and rock dam straddled Papoose Creek in NWSE S. 24. Flow passed through the dam via a 3' culvert. No diversion of water occurred from or near the dam. The dam appeared to be a partially completed road grade of questionable stability. A spillway or other bypass was not found. The dam did not appear to be built to store water.

2. Futter had a 4" gated pipe at the head of his field above Demerse's place.
3. The creek had a modest flow at the dam and along the border of Futter's field above Demerse's place. As I walked the creek along Futter's field, the flow gradually diminished and finally stopped (sank?) just upstream from the Demerse diversion.

Site visit  
10/27/00 - gl

DEMERSE pump  
ON CREEK in  
SENE Sec 24

DEMERSE house  
#25 POPOSE Ck. Rel  
to junction with  
Squaw Ck = 2.0 miles

#25 to Lupton dam on  
CREEK = .4 mile
