IN THE DISTRICT COURT OF THE FIFTH JUDICIAL DISTRICT OF THE STATE OF  
IDAHO, IN AND FOR THE COUNTY OF TWIN FALLS

In Re SRBA Case No. 39576 ) AFFIDAVIT OF DAVE SUNDBERG  
SUBCASE No. 43-10356 )

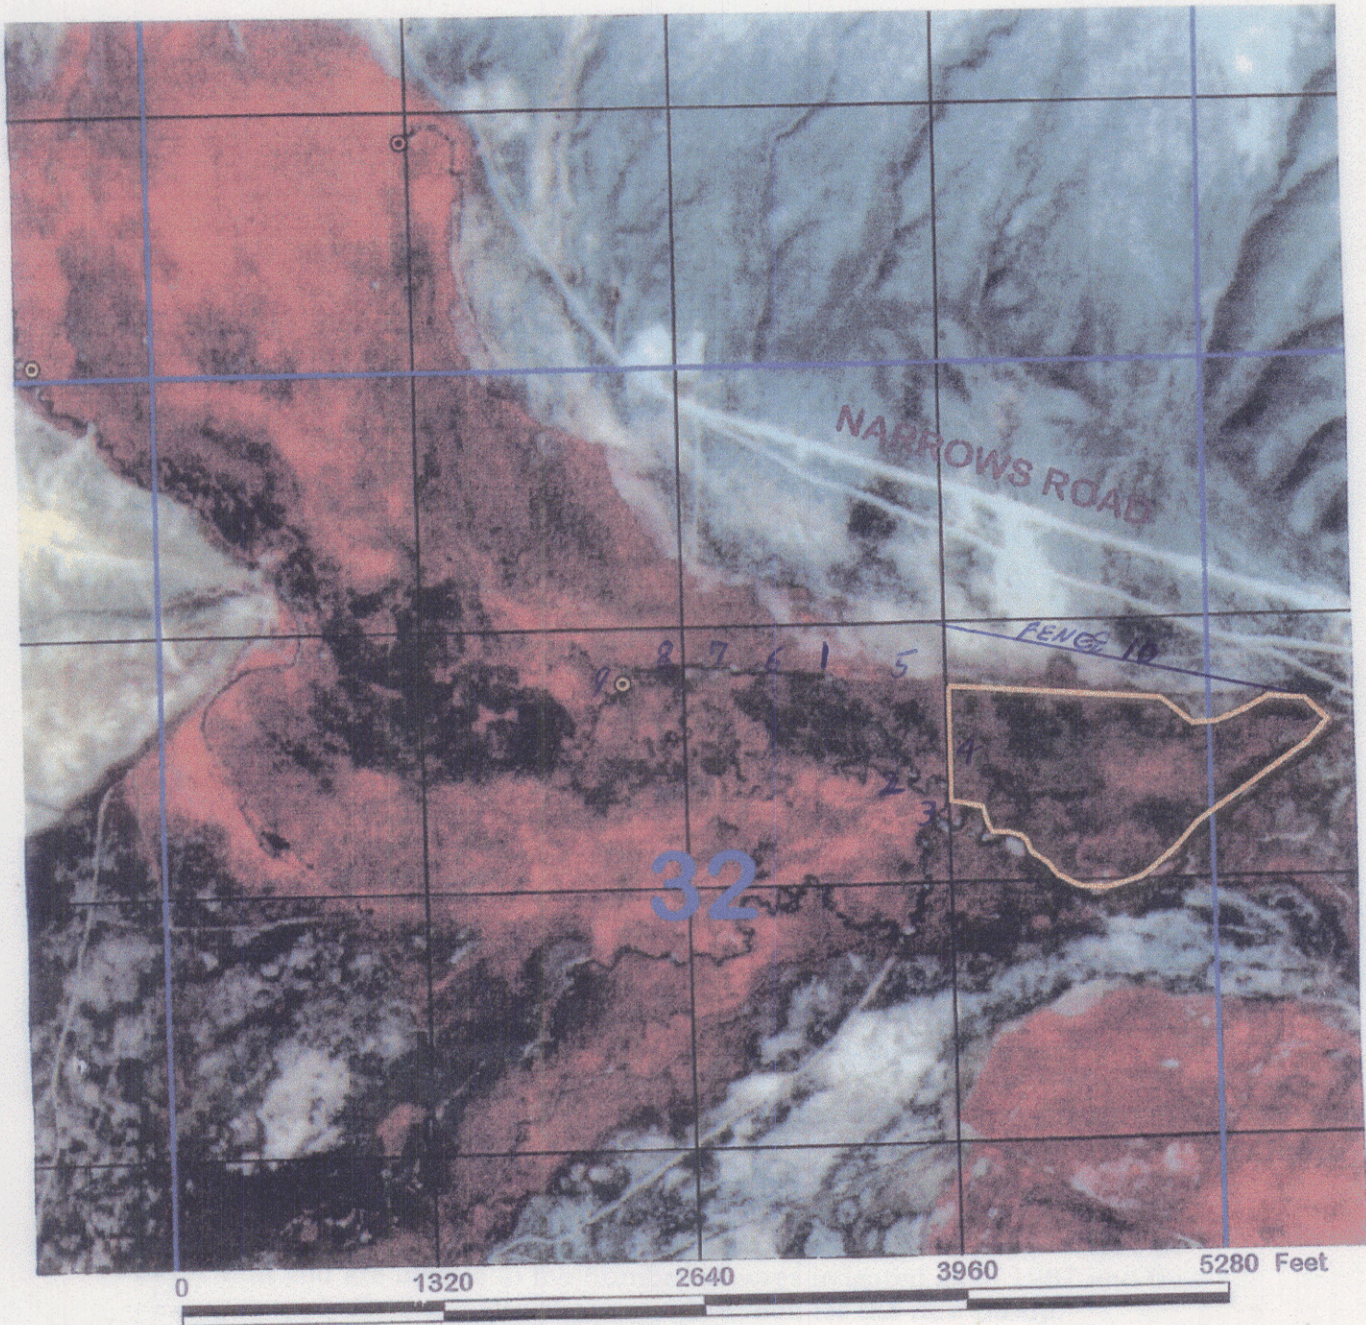
RECOMMENDED PLACE OF USE

5. I have labeled the points from which the Photographs were taken on an aerial photo which Roscoe provided for this purpose. The photographs are also labeled with the same numbers.

irrigating new ground on the North side of the Place of Use, up to the line which I have labeled "Fence" on the Aerial Photo. This group of photographs was taken from Point #4 on the West fence looking Southeastward across the field. The area which they claim they have ceased to irrigate is covered with tall rye grass and big sagebrush.

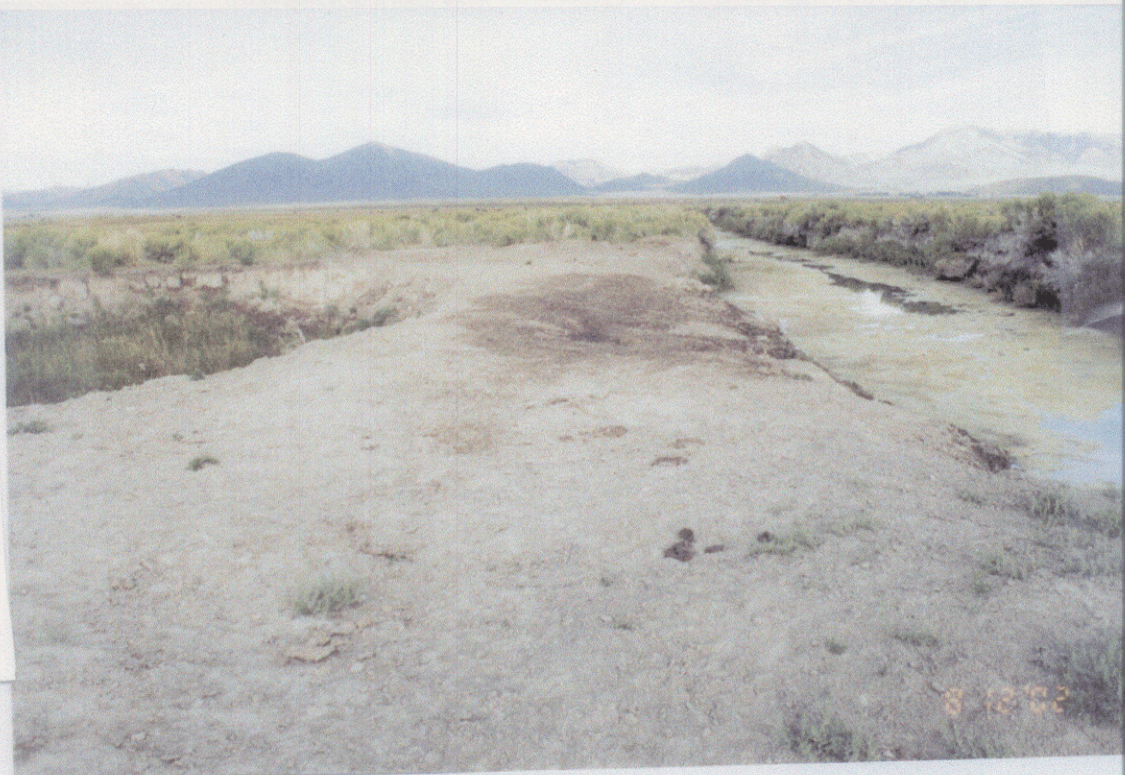
POINT #1  
EARTHEN DAM  
LOOKING WEST

6. Number 1 was taken from the earthen dam from which Joneses attempt to run water towards their property.
7. #2 shows where the natural channel of Almo Creek runs together with the channel of the

20. As can be seen by the photographs of the earthen dam, there is no way to release the water except by removing the dam.

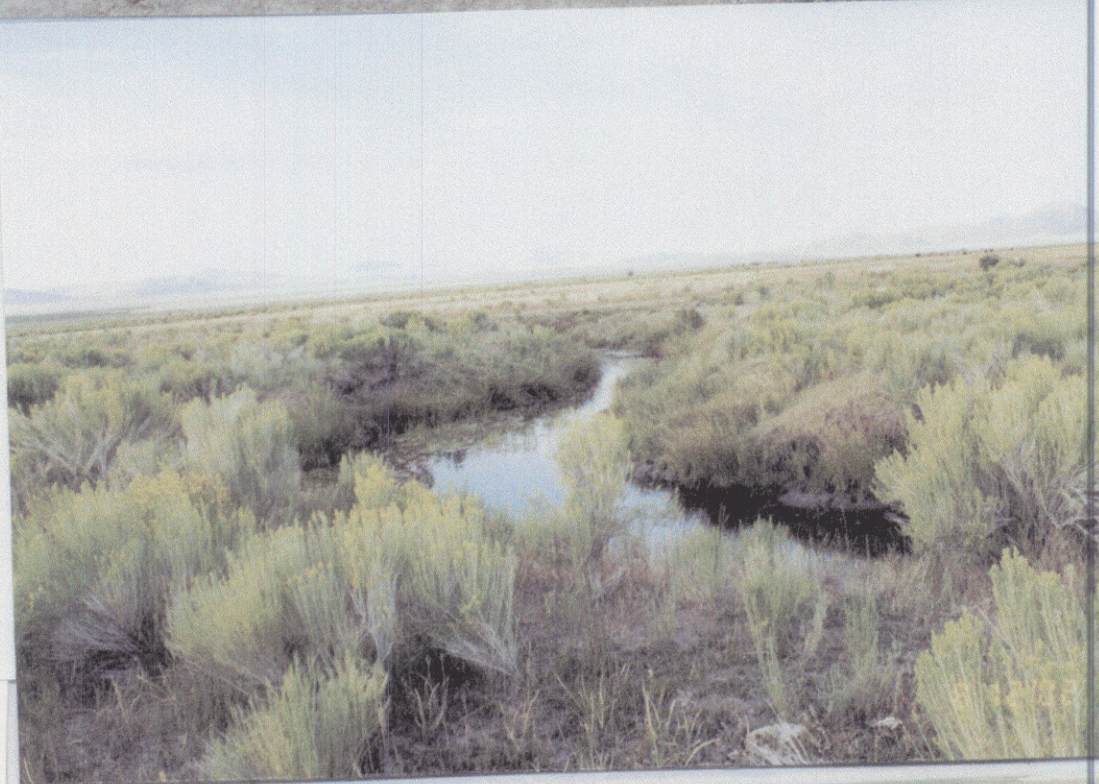
POINT #2  
JUNCTION OF  
ALMO CREEKBED  
AND SPRING

stream which is being diverted by the earthen dam. This is about 250 yards Southeast of #1.

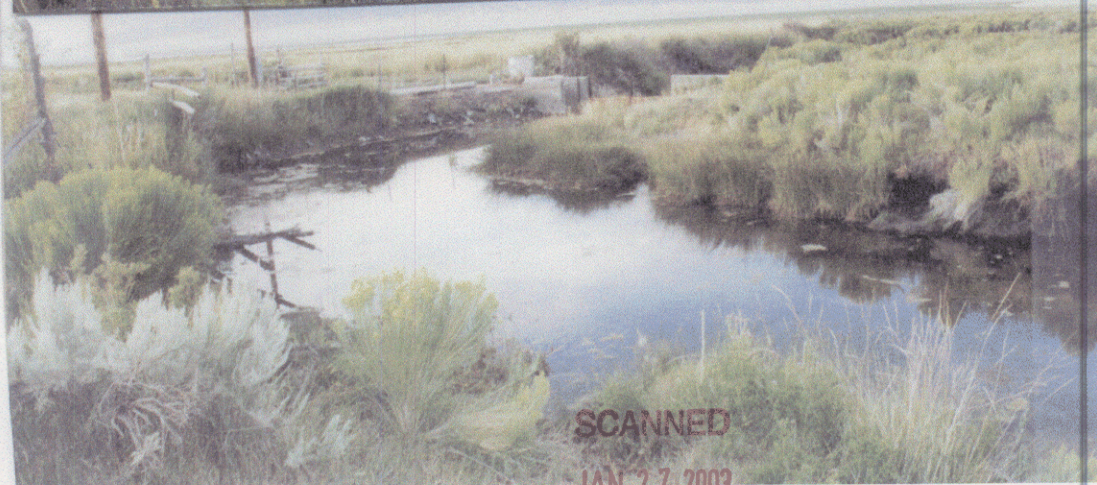
POINT #3  
CREEK BY  
PUMP, JUNCTION OF  
ALMO CREEK AND  
RAFT RIVER

8. #3 shows the concrete structure and pond at the pump site where the water was diverted into Jones'es sprinkler system. In August there was no water being diverted by the pump. It was merely being impounded so that it filled the channel towards the earthen dam and also the channel of Almo Creek, as shown in #2.

16. Still at Point #3, at 4:47 I turned around and tried to show that the measuring weir in the ditch by the pump has a hole washed under it so that the water which came down the ditch last Summer was probably not all measured.

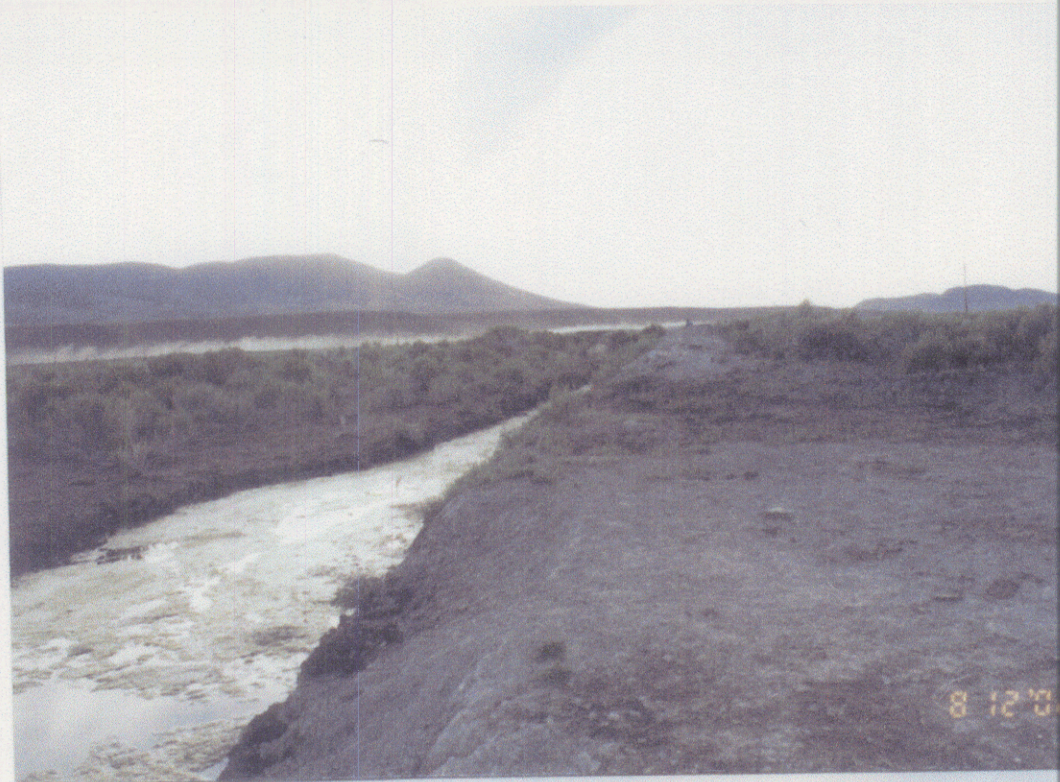
POINT #1  
EARTHEN DAM  
LOOKING ~~WEST~~  
EAST

9. The next photo was taken from Point #1, the earthen dam looking Eastward.

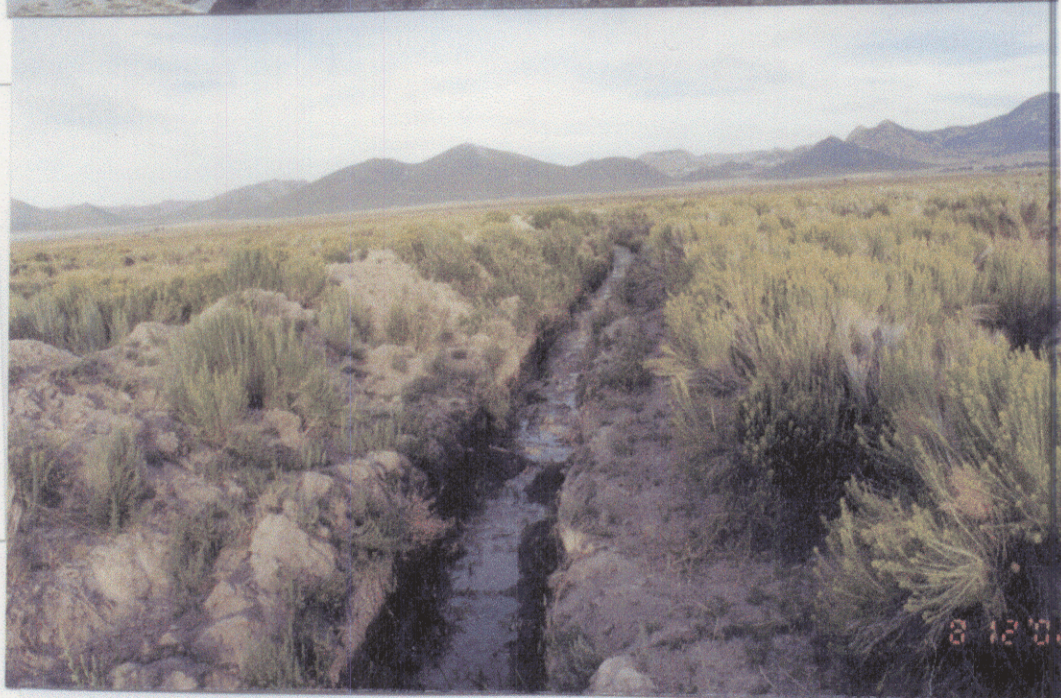
POINT #5  
RIPPLE IN DITCH  
WEST OF JONES

10. The next photo was taken from Point #5, near Jones'es fence, looking towards the Earthen Dam, showing that some water was reaching Jones'es fence. This water ran down the ditch part way to the pump site, to about Point #4, but all sank before it reached the pump site.

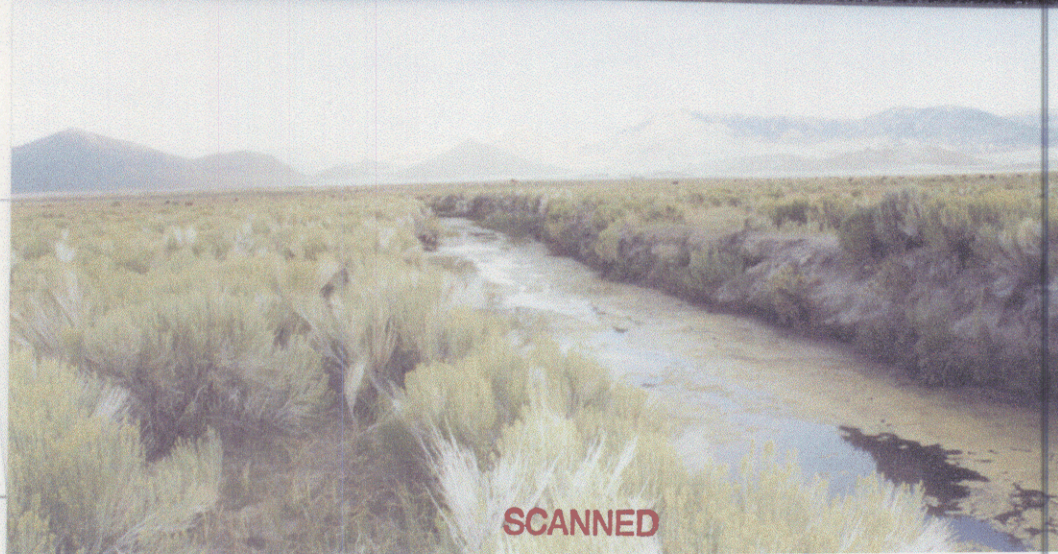
POINT #6  
WEST OF  
EARTHEN DAM

11. The next photo shows the pond created by the earthen dam, about 100 yards West of the Dam at point #6.

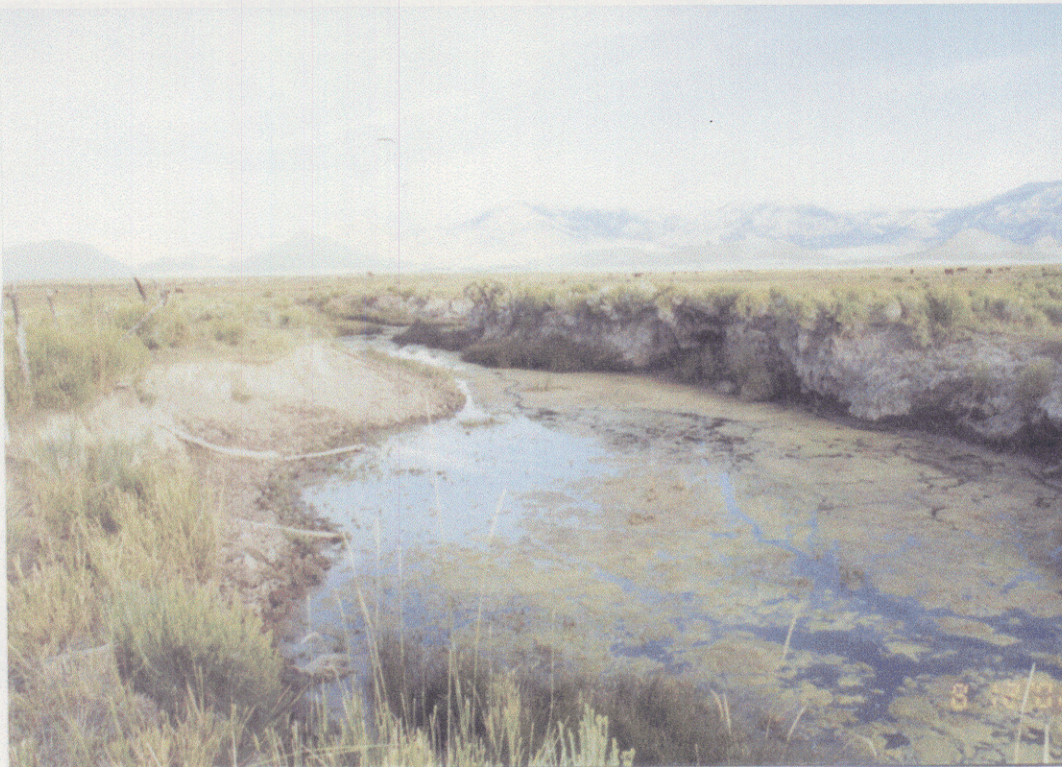
POINT #7  
WEST OF  
EARTHEN DAM

12. The next photo shows the pond about 220 yards West of the Earthen Dam . This Photo was taken from Point #7.

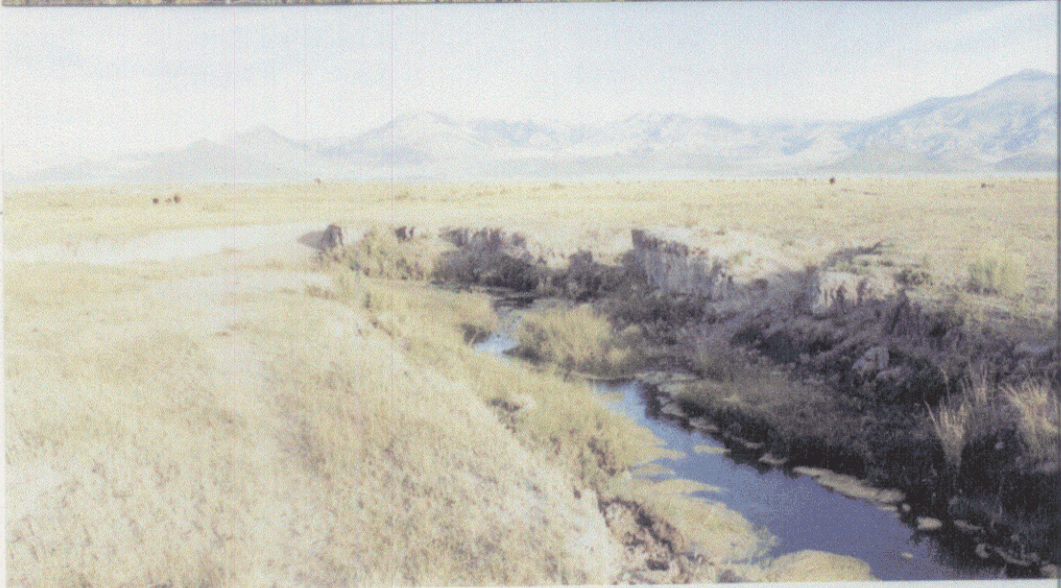
POINT #8  
WEST OF  
EARTHEN DAM

13. The next photo shows the pond about 3/16ths of a mile West of the Earthen Dam at Point #8, showing the Western end of the pond. Where the pond appears to turn toward the South is very near the measuring device at Point #9. Water springs up in potholes in the area near the measuring device slightly to the Northwest. There is another large spring about 1/2 mile North at the foot of Jim Sage Mountain and somewhat wet areas in between, which are possibly seepage from the mountain.

pond appears to be the same type of soil, it looks quite obvious that a considerable amount of water is sinking because of this impoundment. This water would all go to Raft River if it were released.
