**29-00274E**

**Field Exam: 8/13/02**

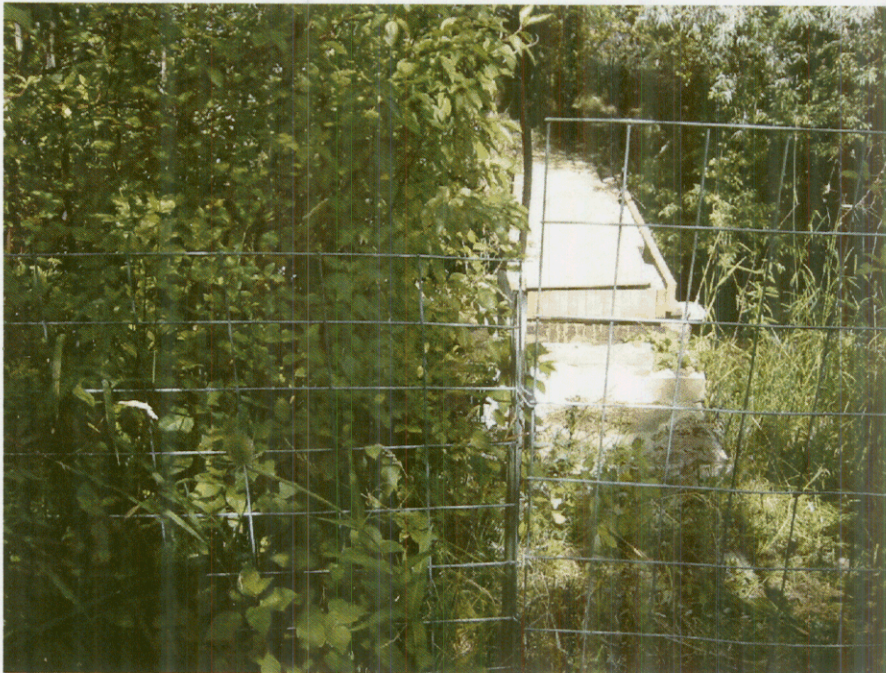
**POD**

Looking East at bridge over creek. Water is diverted just North of the bridge (csaxton).

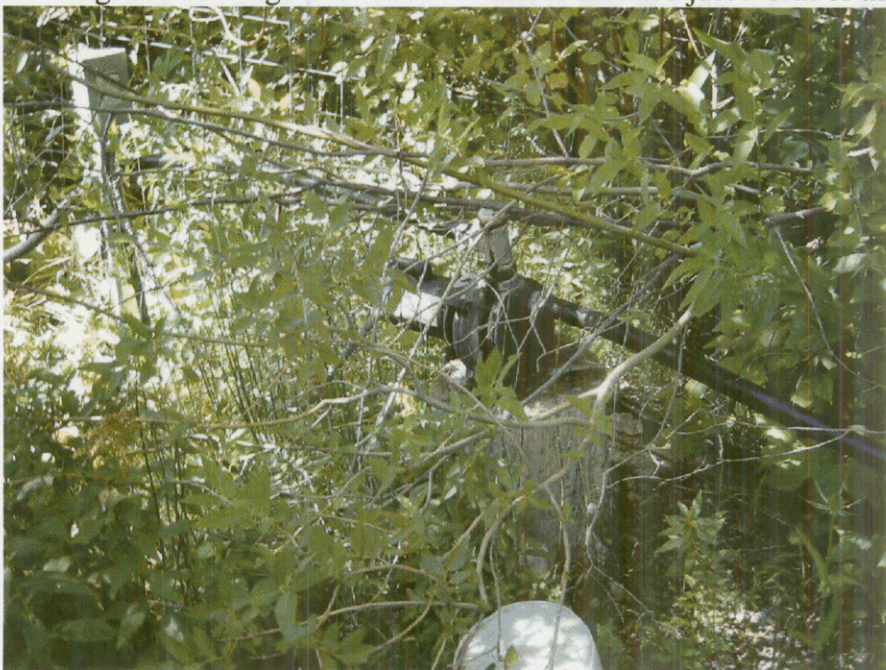
Looking North at Pump used to divert water to claimed POU. Mink Creek to the Right of the picture. Black ABS line is the intake line (csaxton)

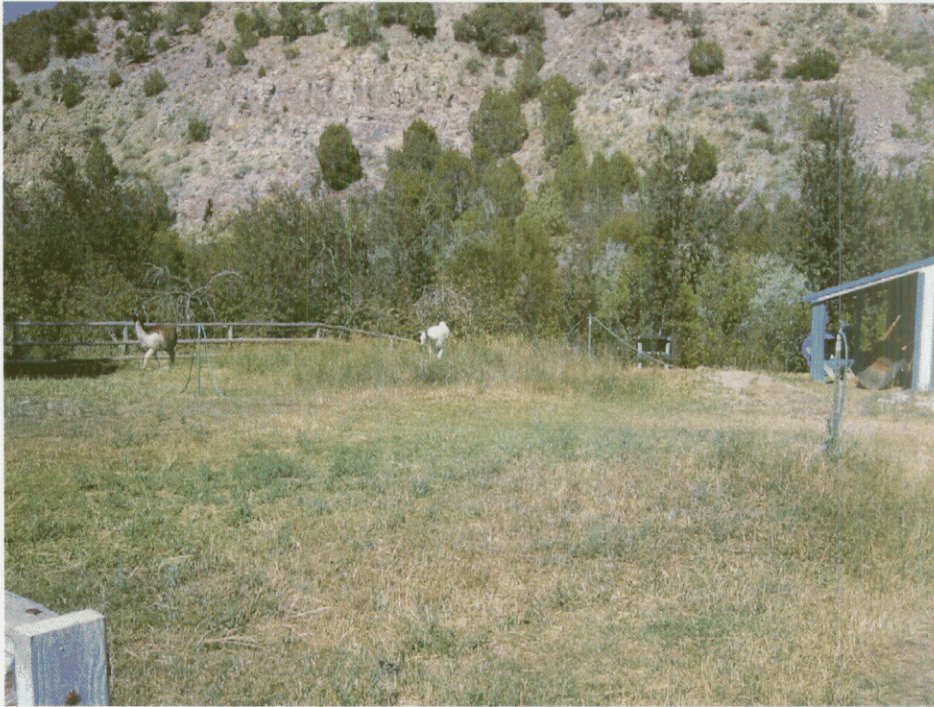
**POU**

Looking East at claimed POU. Creek at the base of the hill in the background of the picture (csaxton).
