**29-00276D**

**Field Exam: 9/17/02**

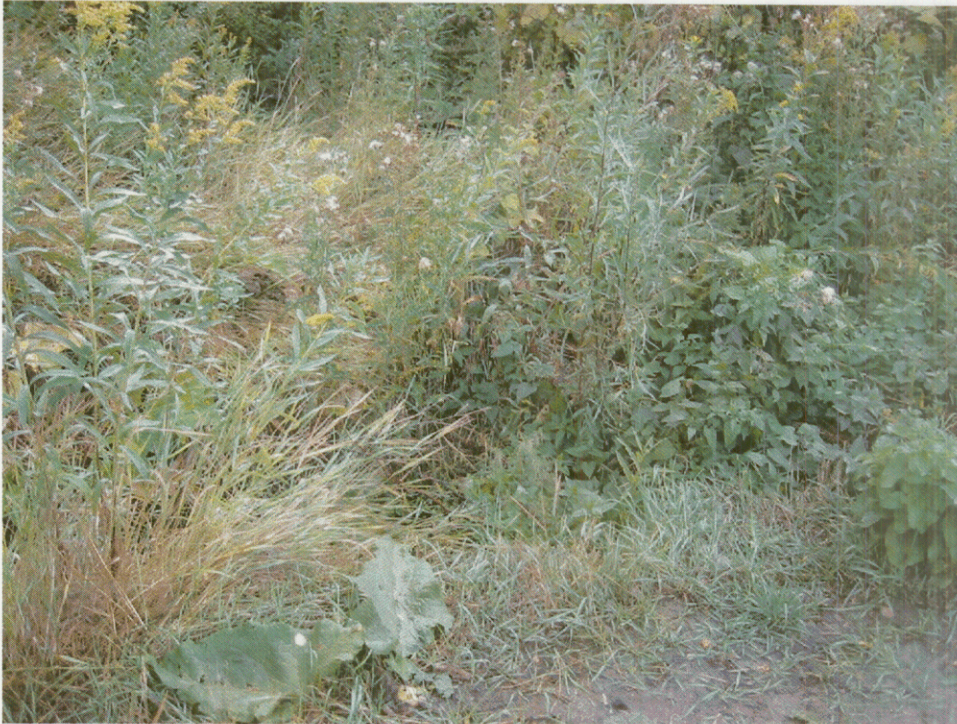
**POD**

Looking at point where pump is placed when in place. Mink Creek to left of picture. POU behind me in picture. Ditch seen in the middle of picture (csaxton).

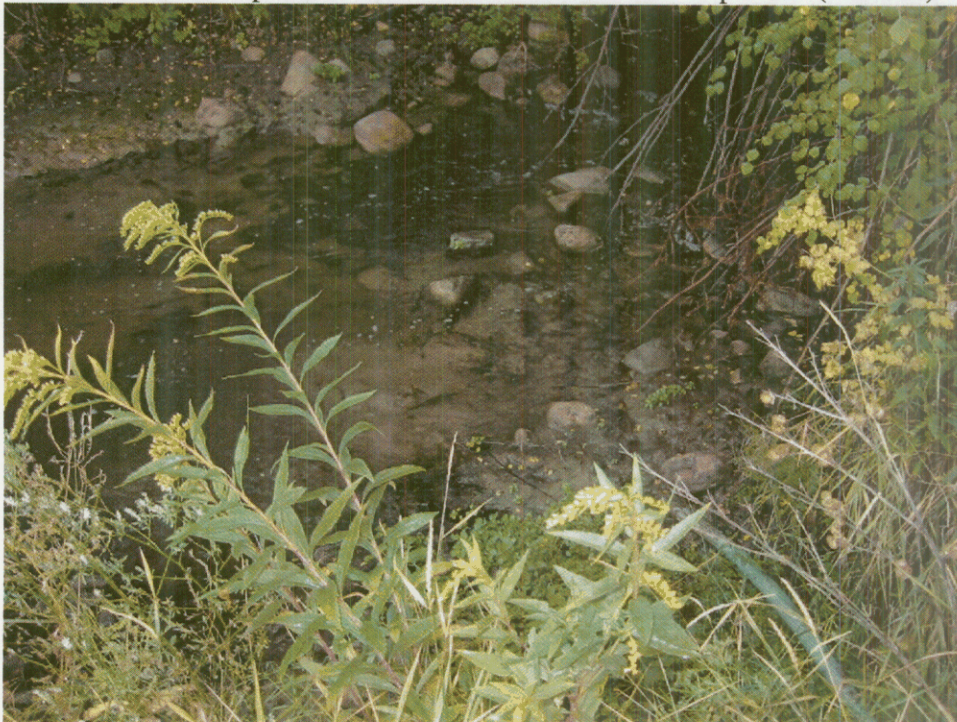
Looking East at POD. Claimed POU behind me in picture (csaxton).

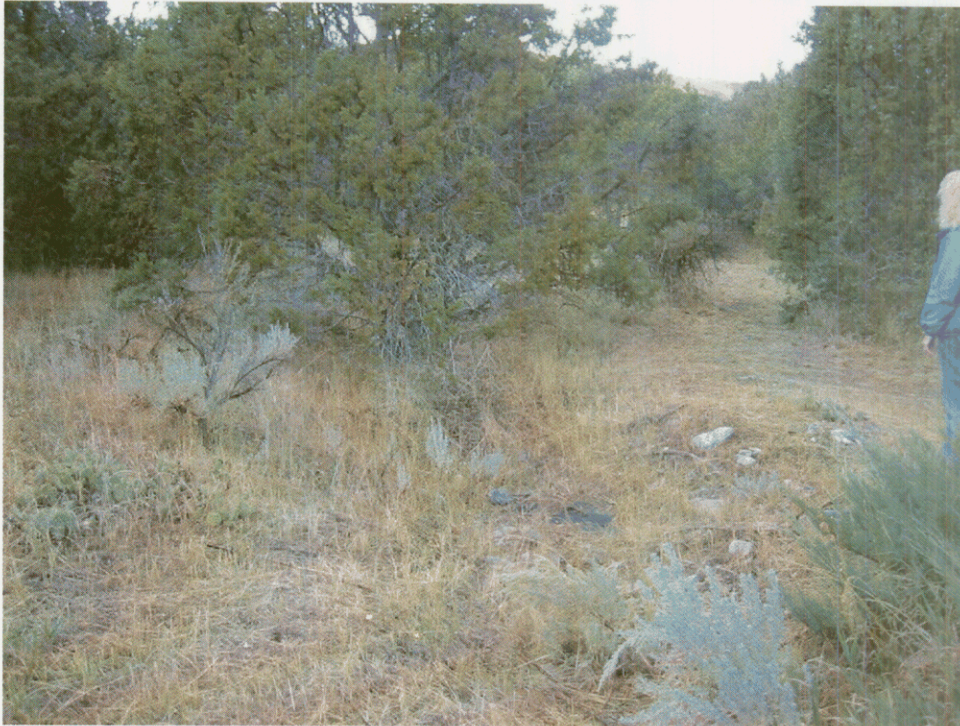
**Ditch**

Looking West at drainage ditch coming from above the property. Could be historical ditch (csaxton).

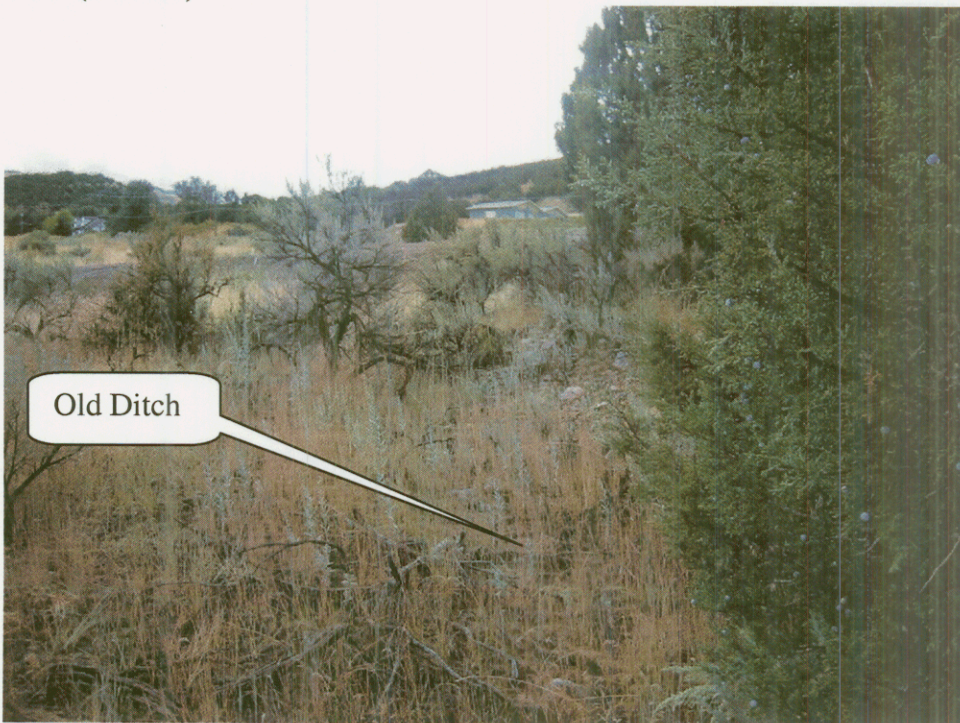
Looking south at historical ditch that could have irrigated the claimed POU (csaxton).

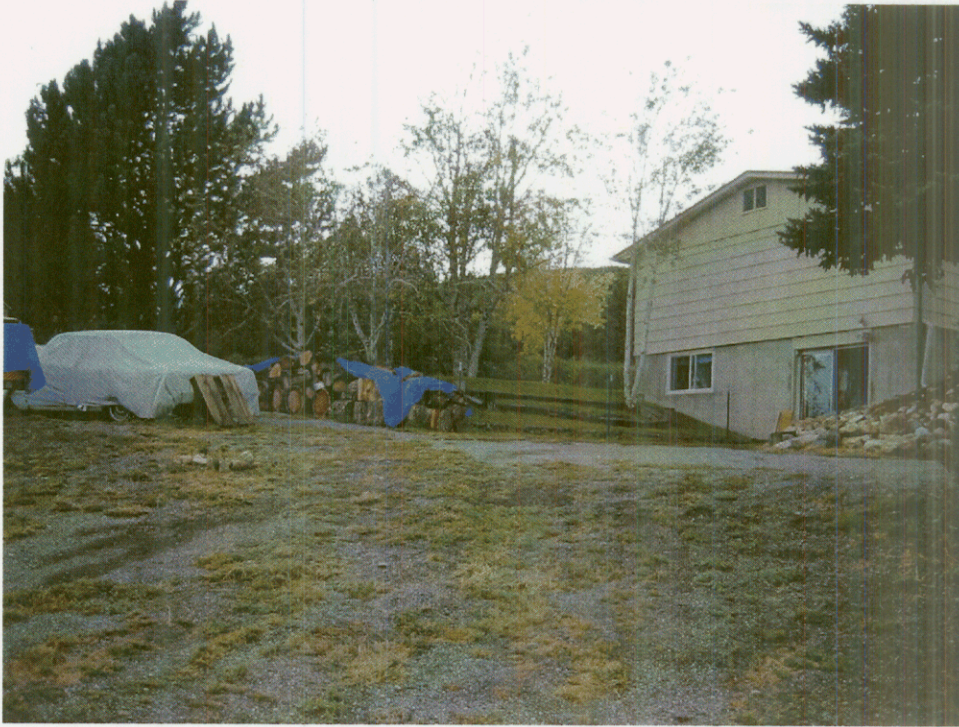
**POU**

Looking West at claimed POU. Irrigation occurs around lawn according to claimant (csaxton).
