**WR: 29-00285H, 302, 306**

**FE: 3/4/03**

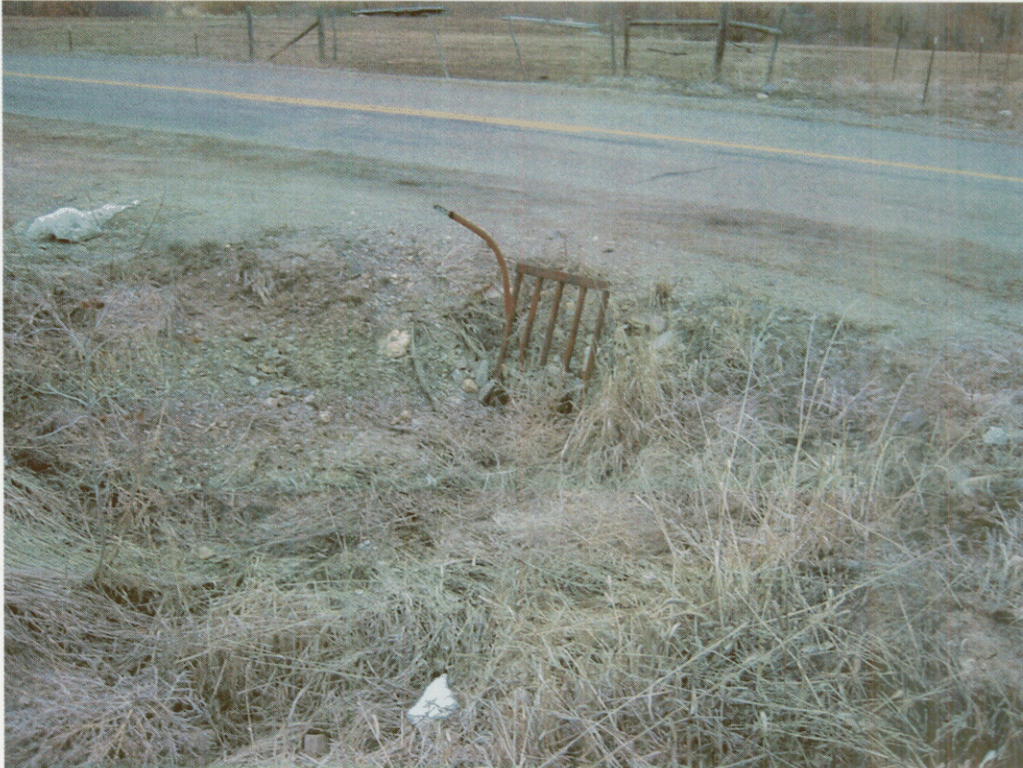
Looking NE at a culver that runs under Rapid Creek road. I am standing on Mr. Morrison's property and George Chandlers property can be seen in the background. Mr. Morrison says he taps into George Chandlers system and runs a line through the culvert. No system was in place at time of the field exam. This culver is used to convey water from the gulch at the north of Mr. Morrison's property to Rapid Creek.

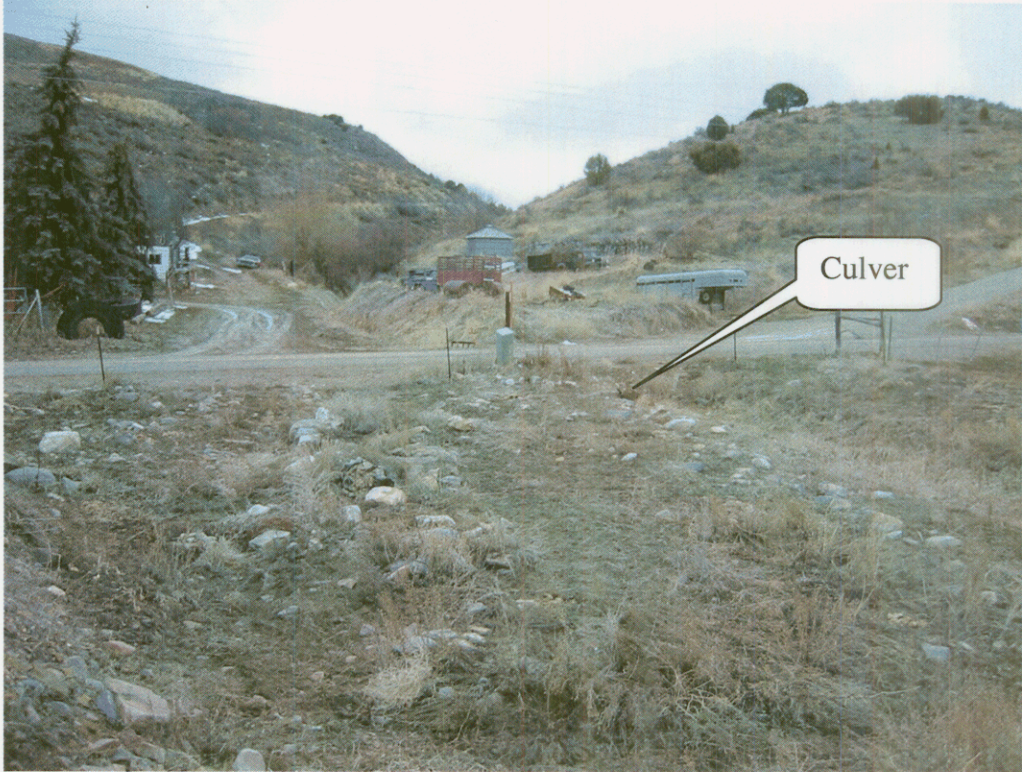
Looking West at the gulch where Mr. Morrison gets his spring water to irrigate his ground to the Left of the picture. Standing on George Chandlers property.

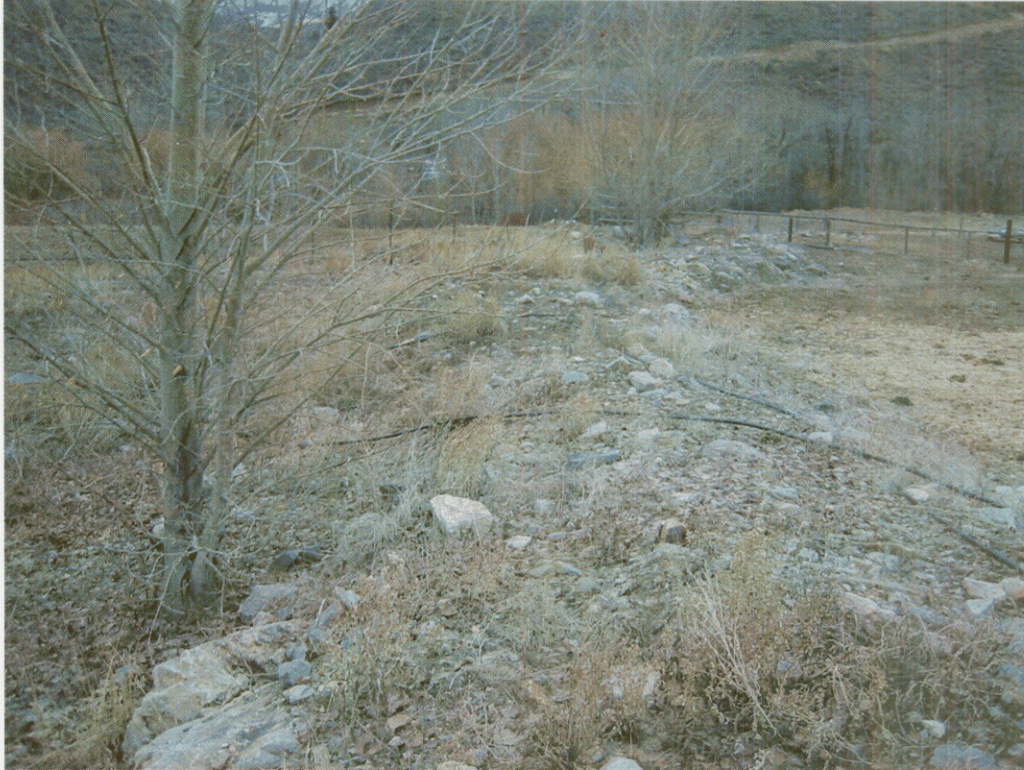
Looking East at George Chandlers property. Mr. Morrison says that this black pipe seen in the picture is used to run through the culvert to convey water to his property.
