**29-00443I**

**Field Exam 10/02/01**

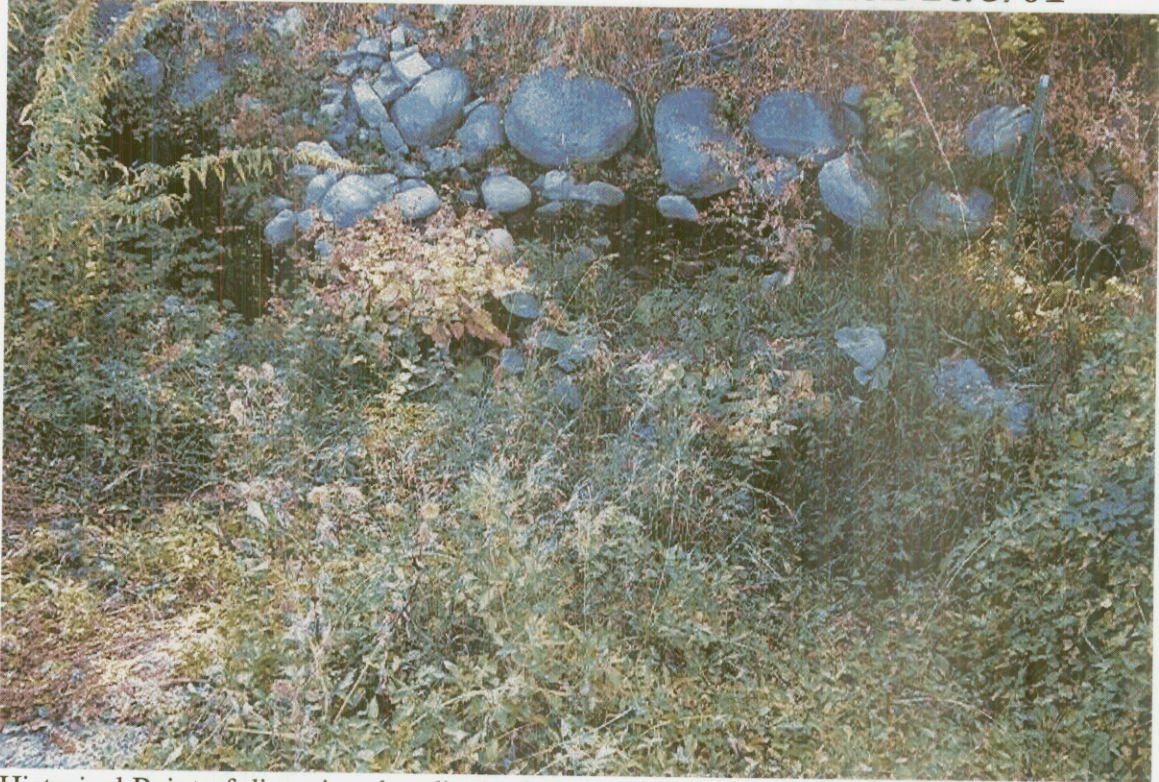
## **Historical Ditch**

Historical Point of diversion that diverted water to the ditch that carried water to the north side of the North Fork of Pocatello Creek.

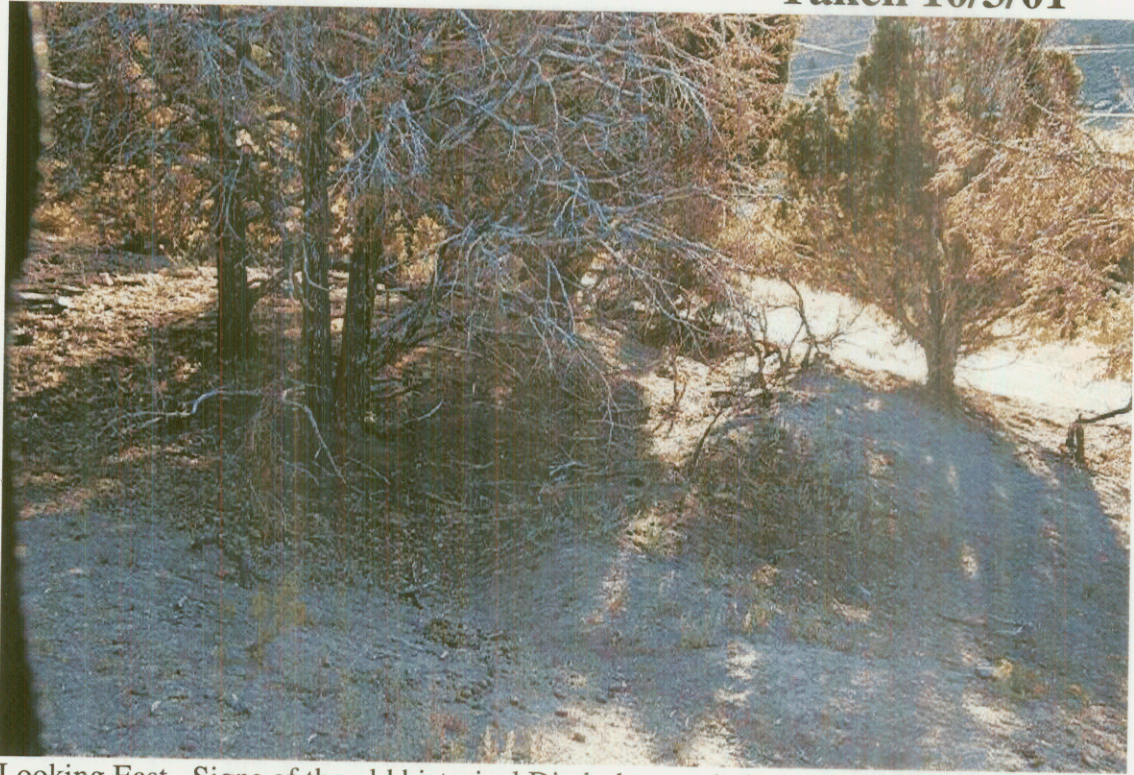
## Historical Ditch

Looking East. Signs of the old historical Ditch that carried water to the north side of Pocatello creek to flood irrigate down to as far as Angelo Trayis' place.

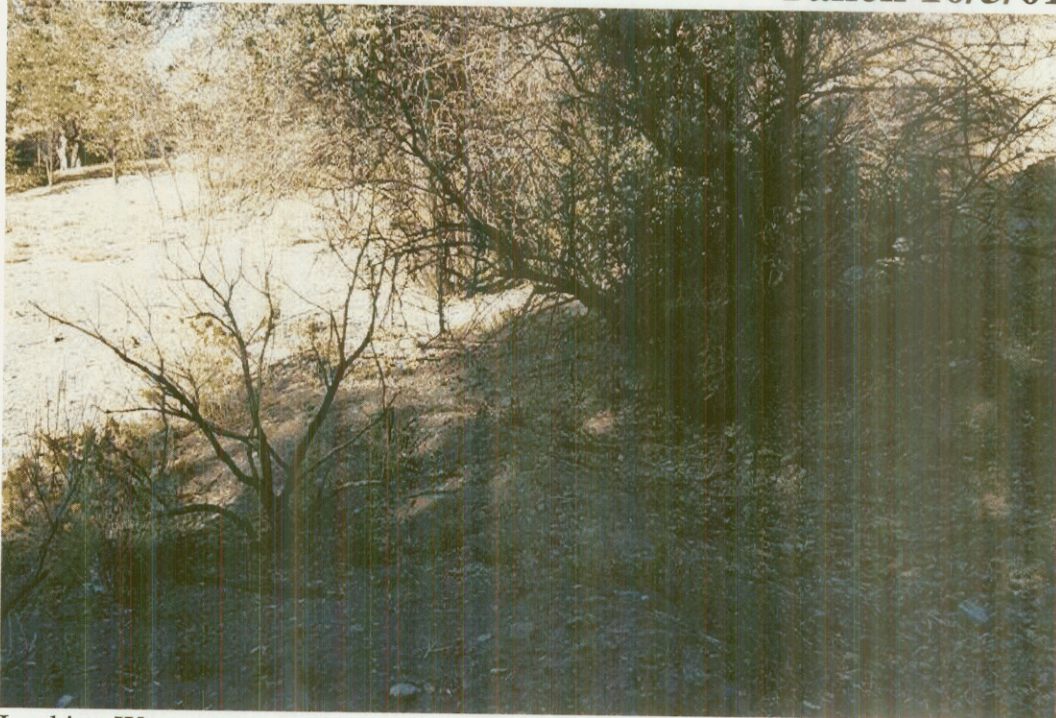
## Historical Ditch

Looking West

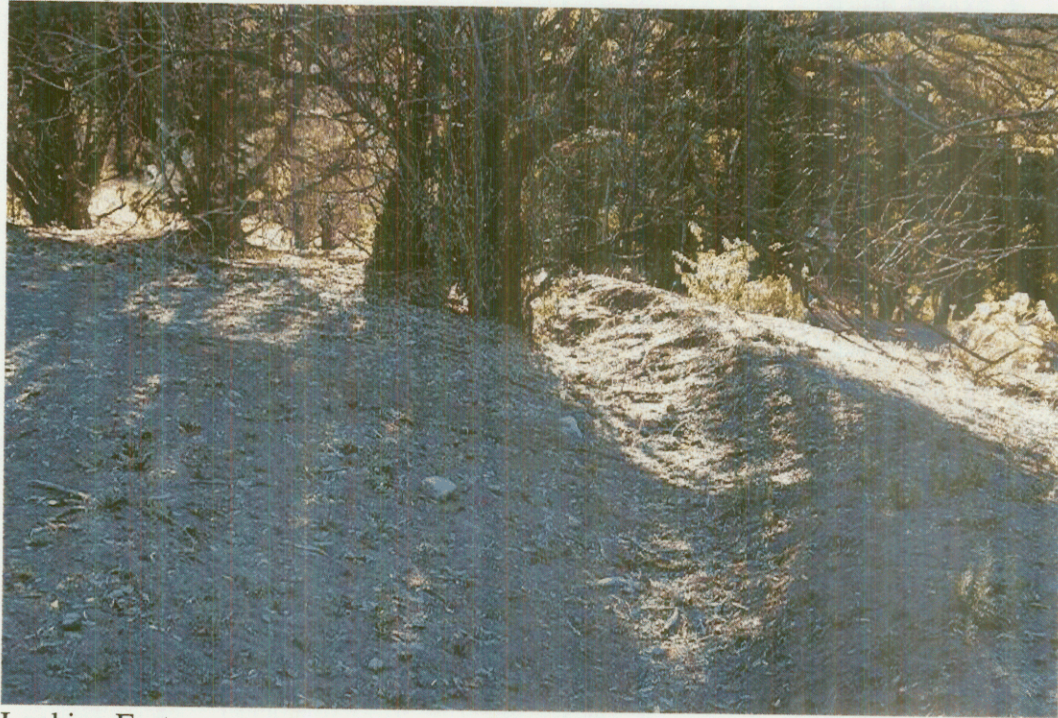
Looking East

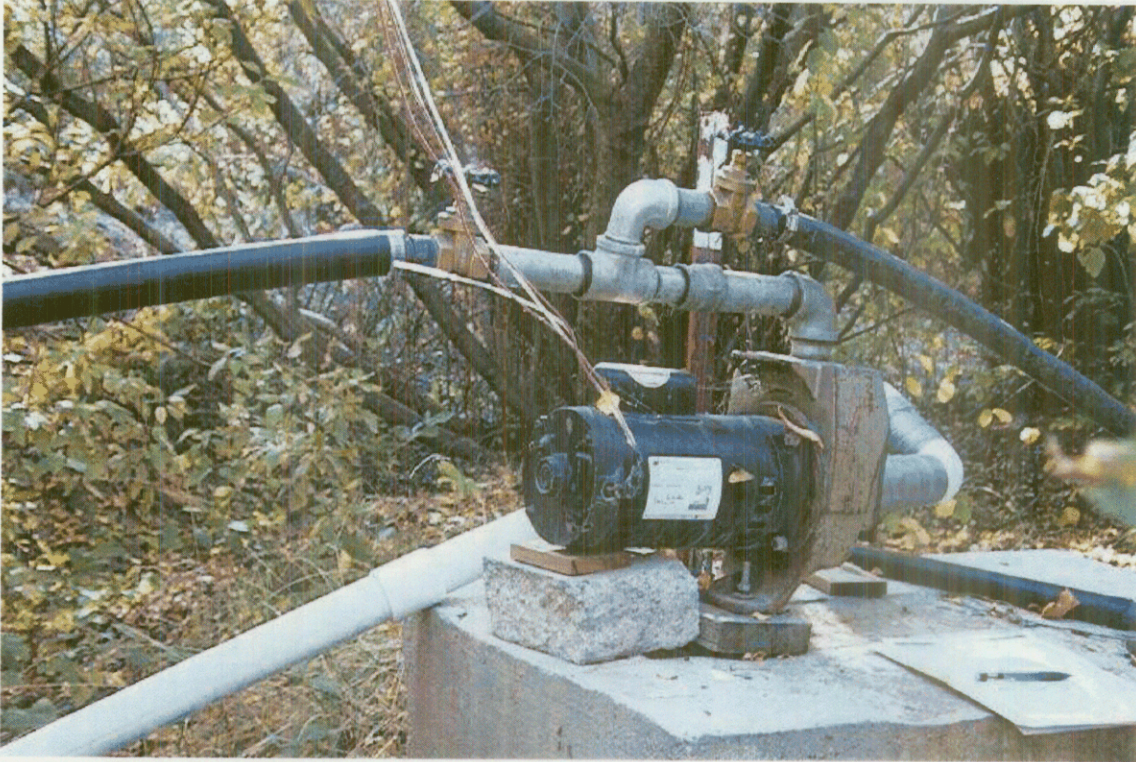
**POD**

Looking West. Pocatello creek to the Left of the picture (csaxton 10/25/01).

Pump information:

Centurion – Self Priming

Part: 186016-02

HP: 2

Volts: 230

Amps: SF 11.5

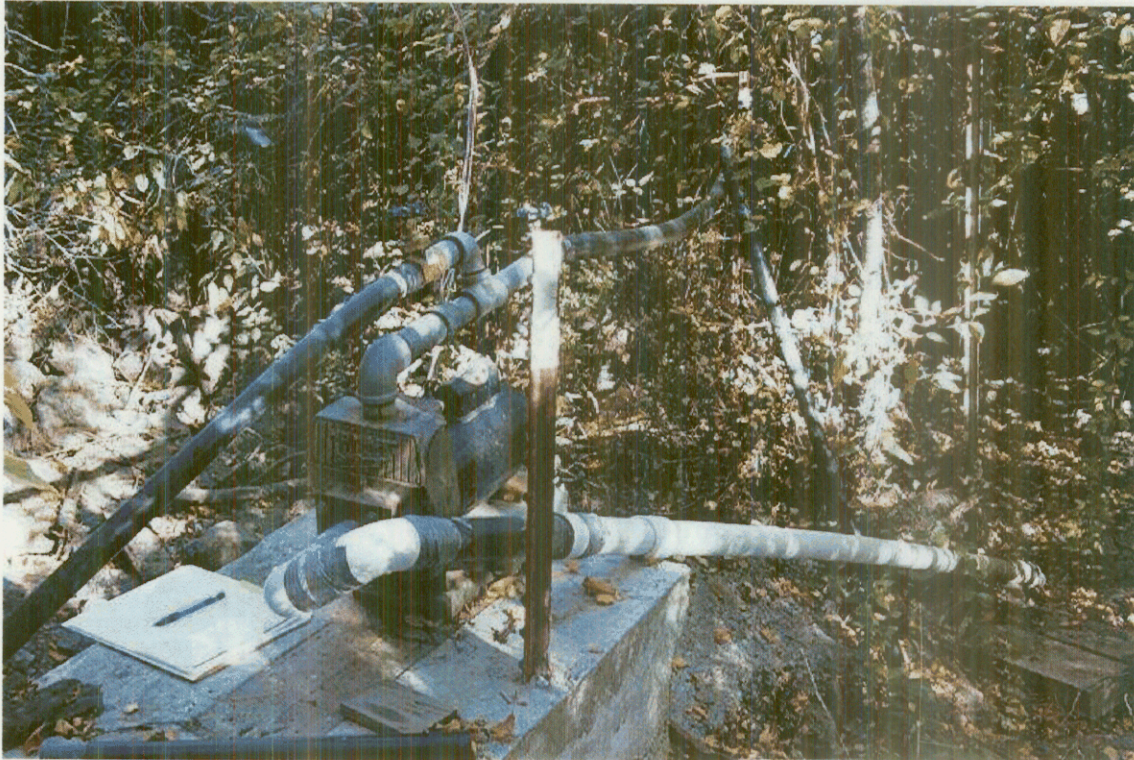
**POD**

Looking North into Pocatello Creek (csaxton 10/25/01).

Pump information:

Centurion – Self Priming

Part: 186016-02

HP: 2

Volts: 230

Amps: SF 11.5

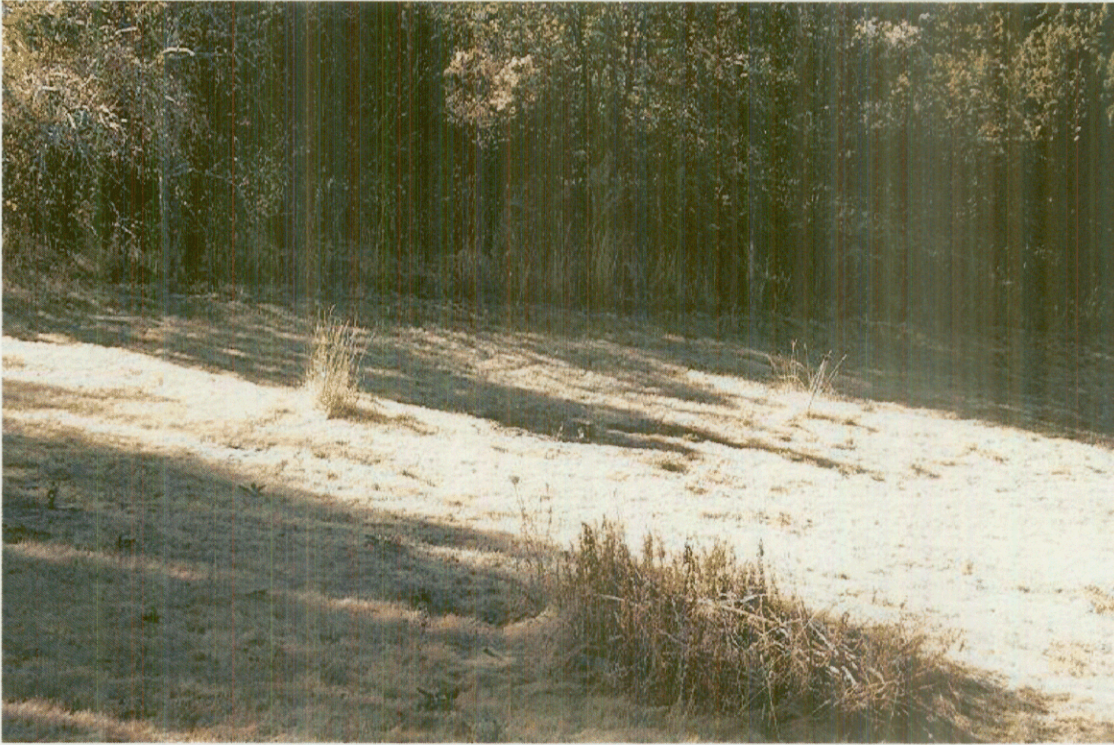
**POU**

Looking South. Picture shows a small area that is normally irrigated when there is water in the creek (csaxton 10/25/01).

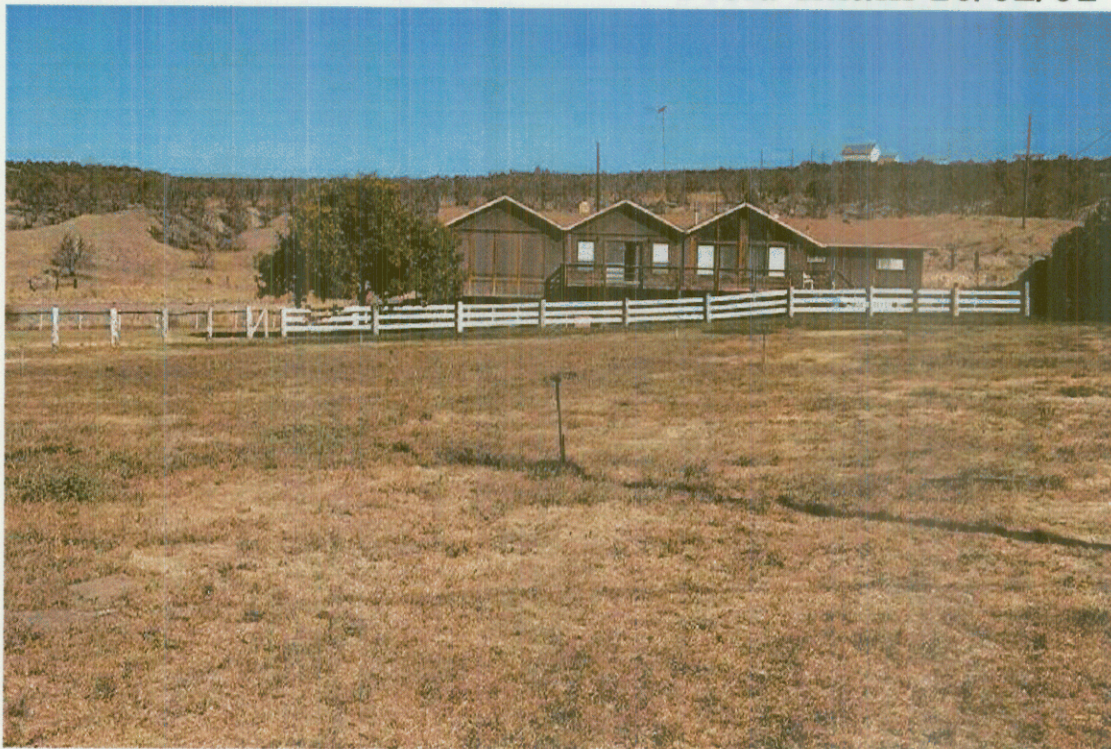
**POU**

Looking North. Claimants home in back ground. Lawn area around claimants home is irrigated from domestic well. Field is the main portion of POU irrigated from Pocatello Creek (csaxton 10/25/01).
