**29-00448H**

**Ditch**

**Field Exam 5/6/03**

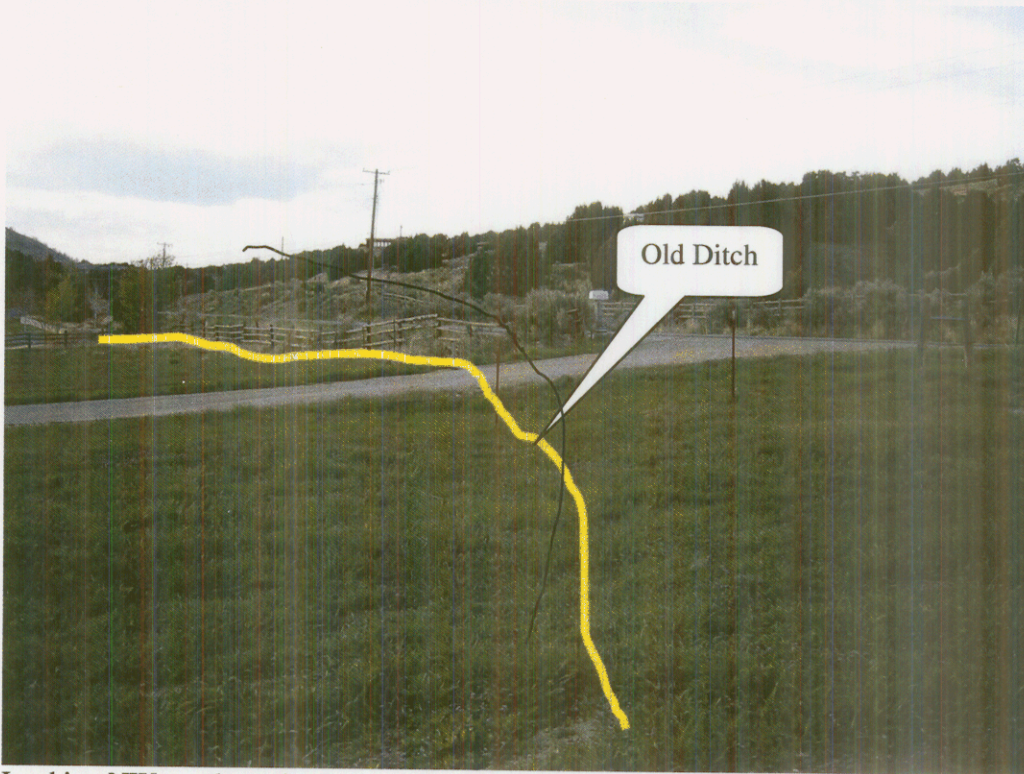
Looking NW at where the claimant states the historic path of the conveyance ditch ran (csaxton).

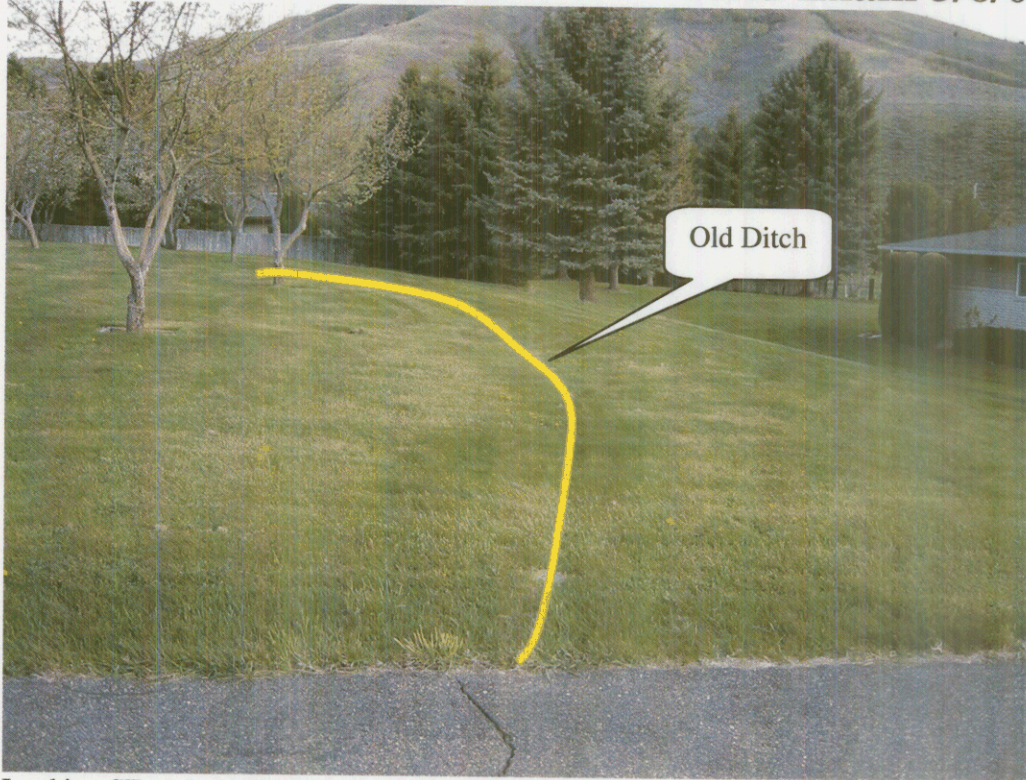
Looking SE at the path of an historic ditch that runs across the claimed POU (csaxton).

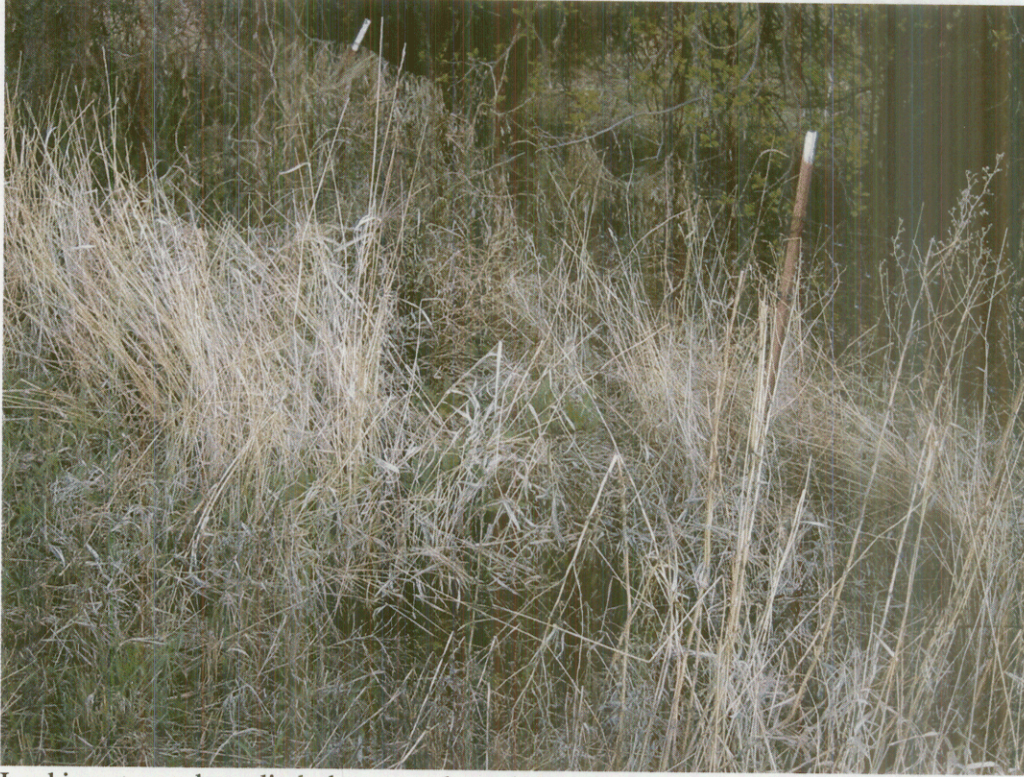
Looking at a un-kept ditch that runs along the south side of the claimants property (csaxton).

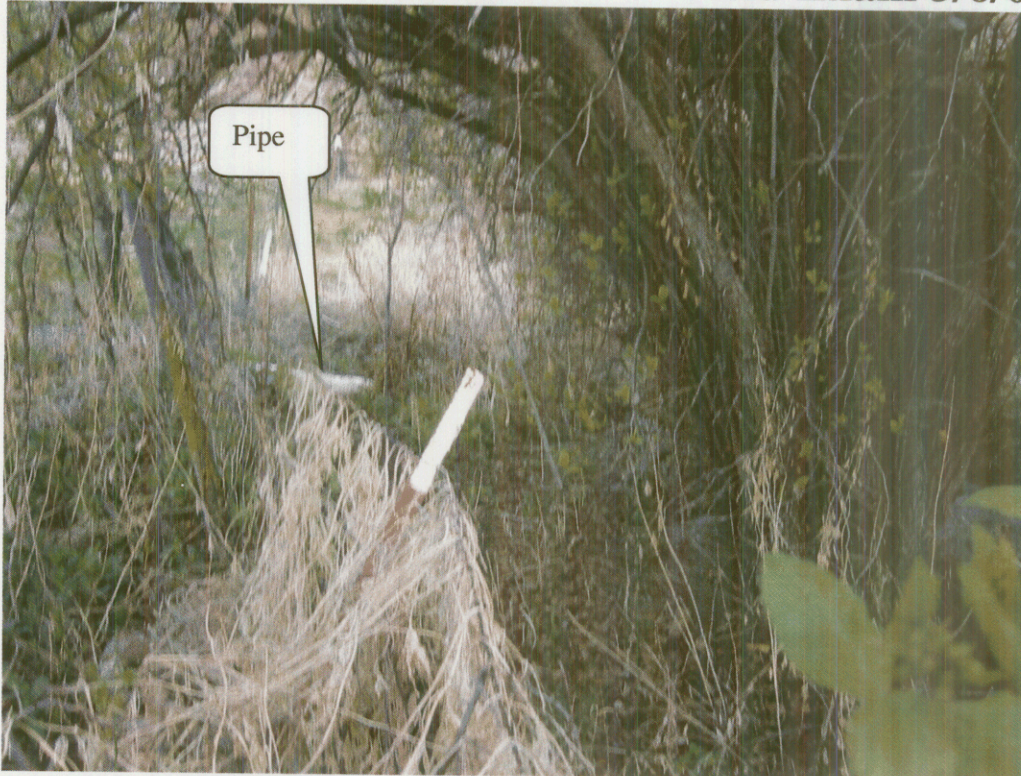
Looking East. This picture shows a pipe that would divert water between Casper and West property to feed into a ditch that is located about where I am standing when I took this picture. (csaxton).

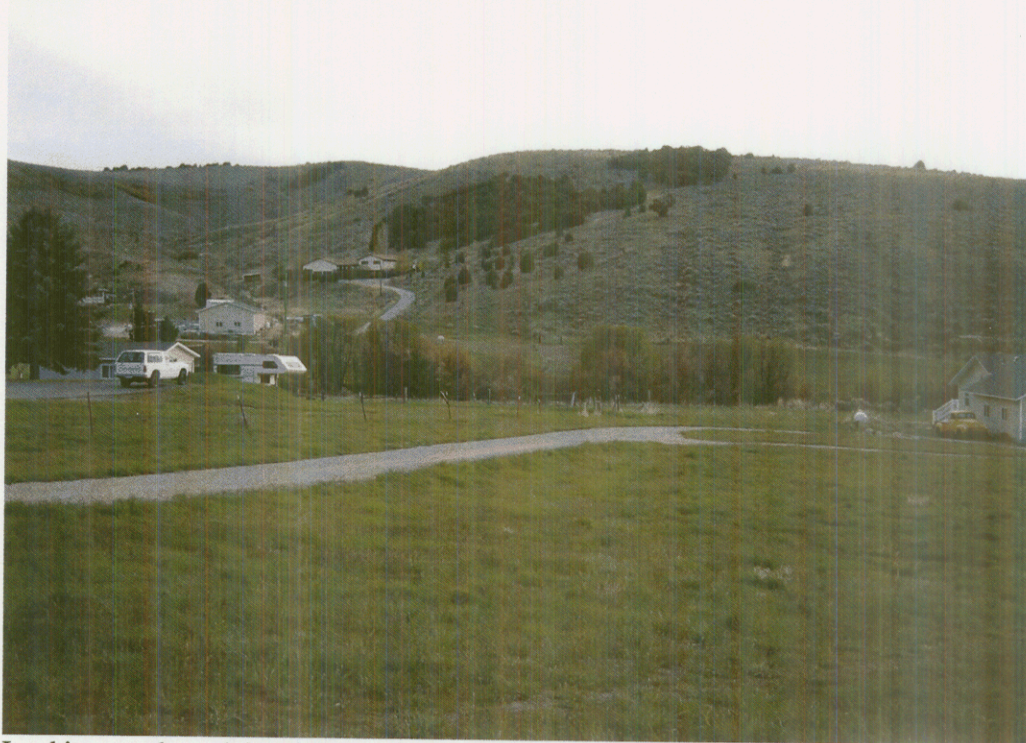
Looking south at claimed POU. Claimed POU is on both sides of the driveway running through the middle of the picture (csaxton).
