**29-00494L**

**Ditches**

**Field Exam 8/7/01**

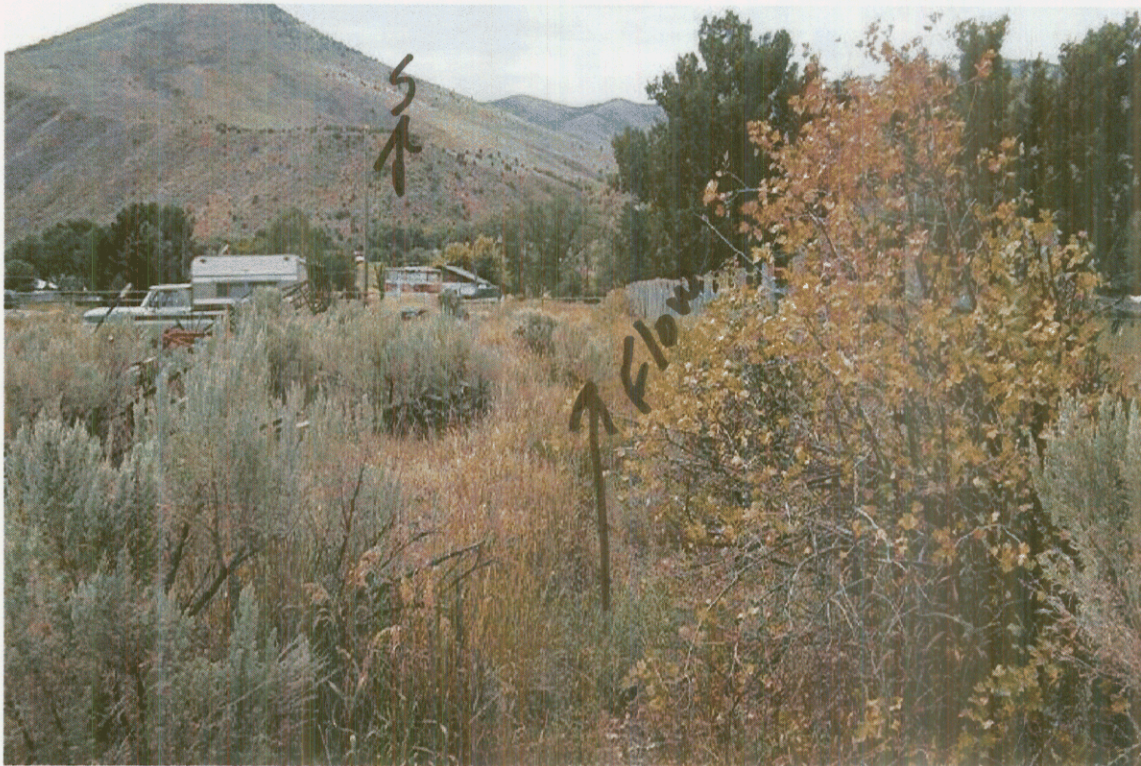
Looking South. Terrell Creek flows South along the West side of the claimants property. I15 behind me in picture. Place of use to the Left of the Picture. (csaxton 8/8/01).

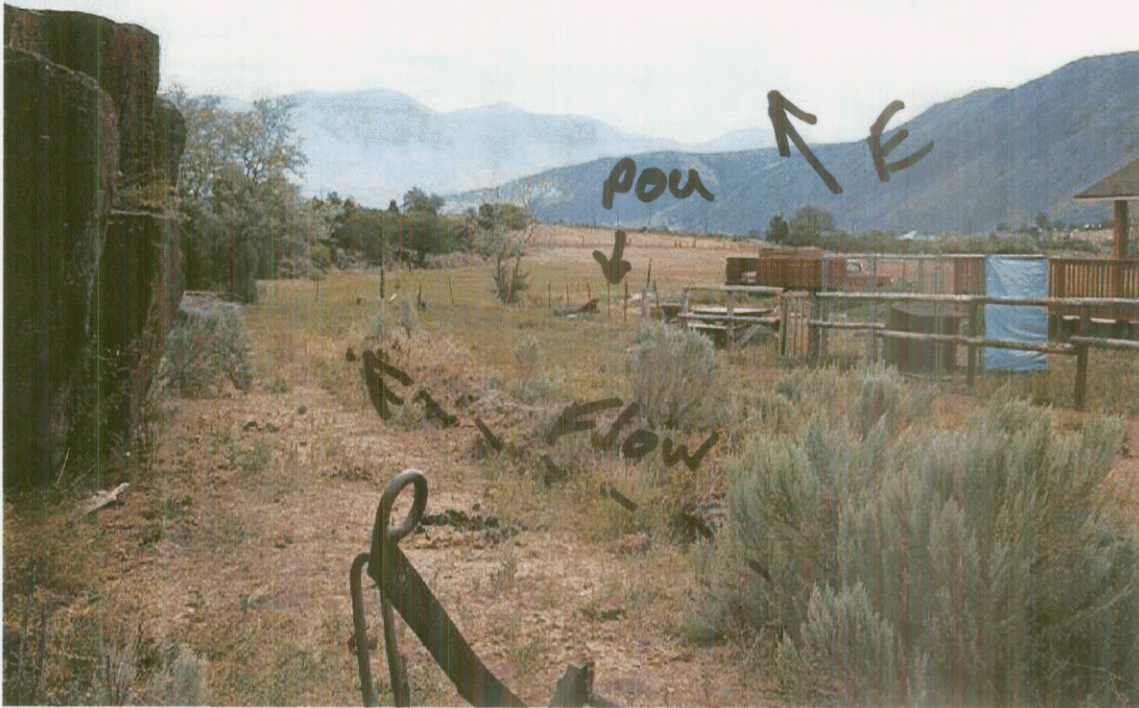
Looking East. Picture shows ditch that runs on the north side of the claimants property. POU in background. (csaxton 8/8/01).

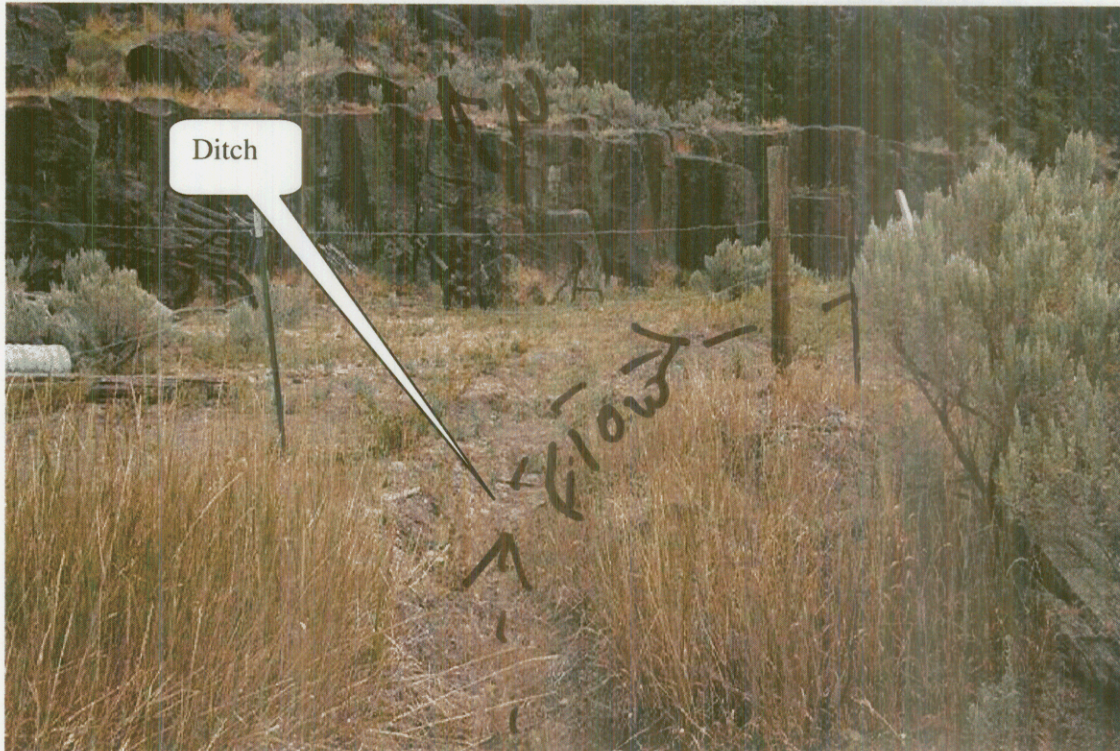
Looking NE. Picture shows ditch that connects claimant ditch on North side of property and historical ditch on West side of claimant property. (csaxton 8/8/01).

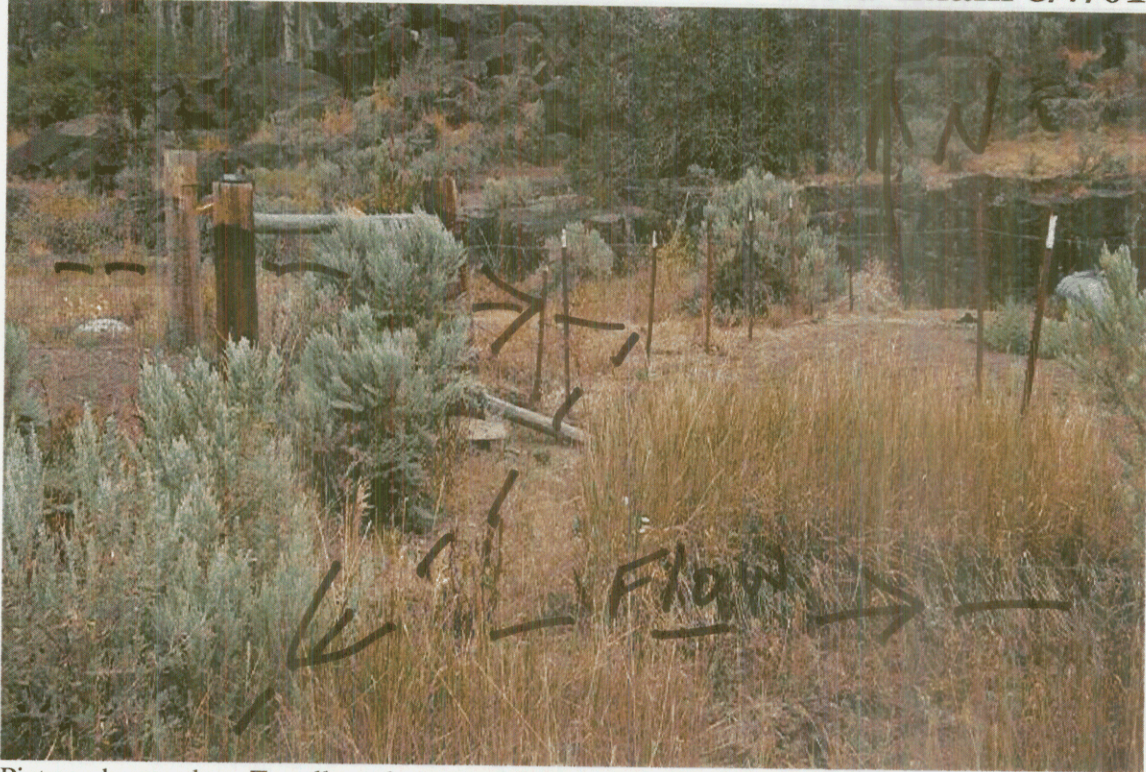
Picture shows where Terrell creek enters claimants property from the West and can be diverted either East or South (csaxton 8/8/01).
