# Water Right 29-556

## Willard and Elizabeth Cheirrett

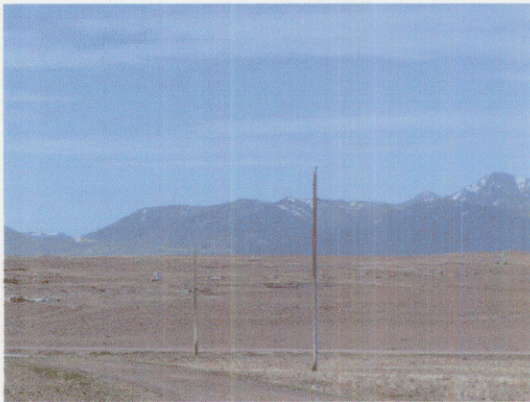
Photo 1. Looking westerly at the NENE of section 27.

Photo 1 above was taken from the Cheirrett home looking westerly to the NENE of section 27. Will installed the first pivot in the NE quarter in 1996 and the second pivot in the NW quarter in 1998, both within section 27, township 8 south, range 40 east.

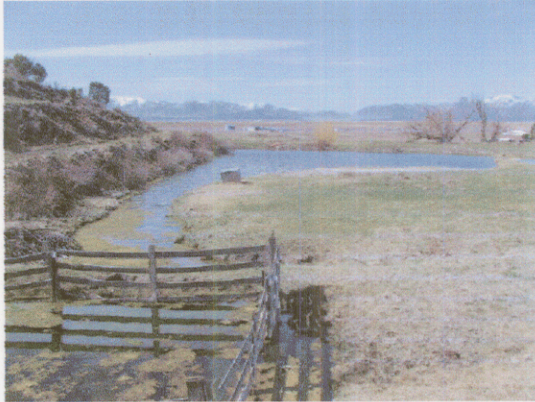
Photo 2. Where the spring surfaces on the Cheirrett property. Looking west from the canal bank.

Photo 2 is looking westerly from the Farms Land & Irrigation Company canal bank where the spring surfaces on the Cheirrett property. The spring is enclosed within the fenced area and gravity flows into the first pond through an 8" pipe at the east end of the pond. Photo 2 also shows the Farms Land & Irrigation Company Canal running along the hillside.

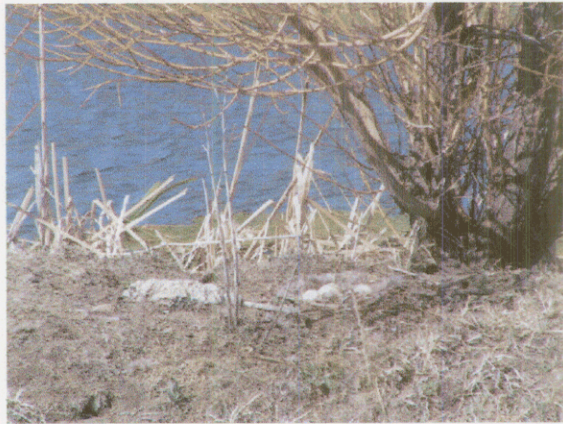
Photo 3. Canadian Geese nest.

Photo 3 is looking westerly from the west bank of the first pond to the island located in the center of the second pond. Which is situated southwest of the first pond. At the time of my visit a pair of Canadian Geese were nesting on the island. Beside the Canadian Geese there was evidence of other birds and a herd of elk.

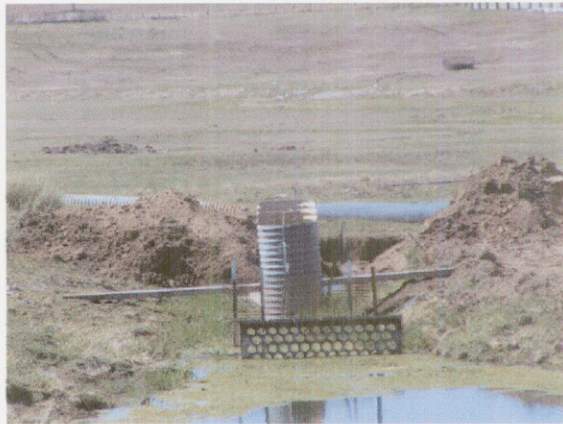
Photo 4. Looking south at screens and pipe to pivot from second pond.

Photo 4 is looking southward at the south end of the second pond at the screens for the pipe to the pivots. The diversion point from the pond is located in the NWNW of section 26 as decreed in the Bancroft-Lund Decree.

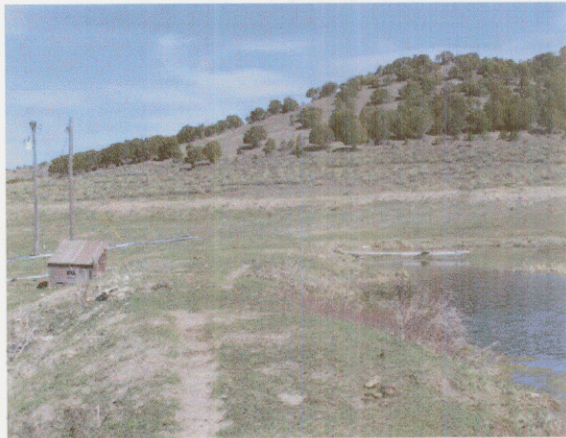
Photo 5. Looking north at 15 hp pump to the risers.

Photo 5 was shot standing between the two ponds looking north. The small building houses the 15 hp pump that withdraws water from the pond in a 6" pipe to a mainline. The 1987/88 NAPP photography shows approximately 60 irrigated acres in the SWSW of section 23 and the SESE of section 22.

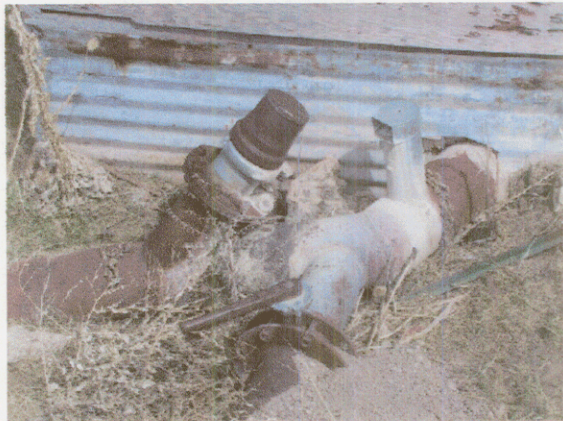
Photo 6. Looking north. Close-up of the pipes out of the 15 hp pump.

Photo 6 is a close-up of the pipe as it exits the small building west of the pond. The system includes a way to drain the system and flood irrigates the land in the NWNW of section 26 behind the Cheirrett home as shown in photo 6.

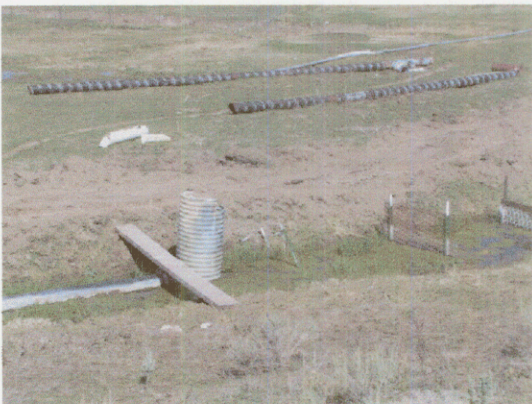
Photo 7. Looking north at southwest corner of the second pond.

Photo 7 was taken from the Farmers Land & Irrigation Bank looking in a northwesterly direction. Inside the culvert is a valve to the pipe.

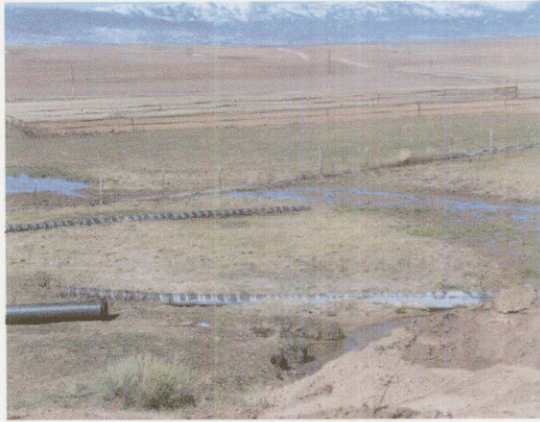
Photo 8. Looking northwesterly at spring seepage.

Photo 8 was also taken while walking along the canal banks and looking in a northwesterly direction. The spring water just beyond the second pond was flooding out onto the land in the NWNW of section 27.

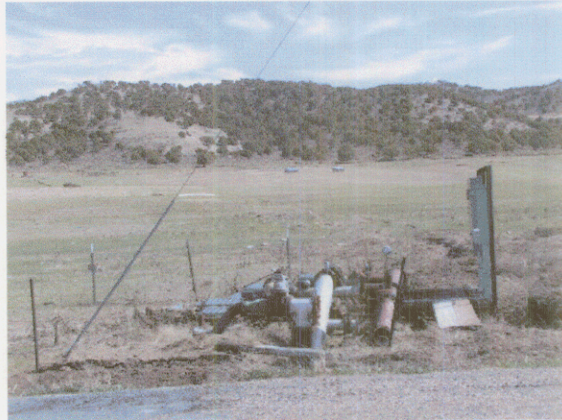
Photo 9. Looking east at the pipe before they go under Ivins Road.

Photo 9 was taken from Ivins Road looking east towards the head of the east pipe section and the Farms Land and Irrigation Company. Just below the hill to the left of the photo is a vertical culvert that allows the Cheirretts to add canal water to the pivots on the Westside of Ivins Road. The 40 hp motor pumps the water under the road to the pivots. The Cheirrett's own a total of 610 acres that is irrigated with this spring and canal shares.
