**29-00604A**

**POD**

**Field Exam: 8/27/02**

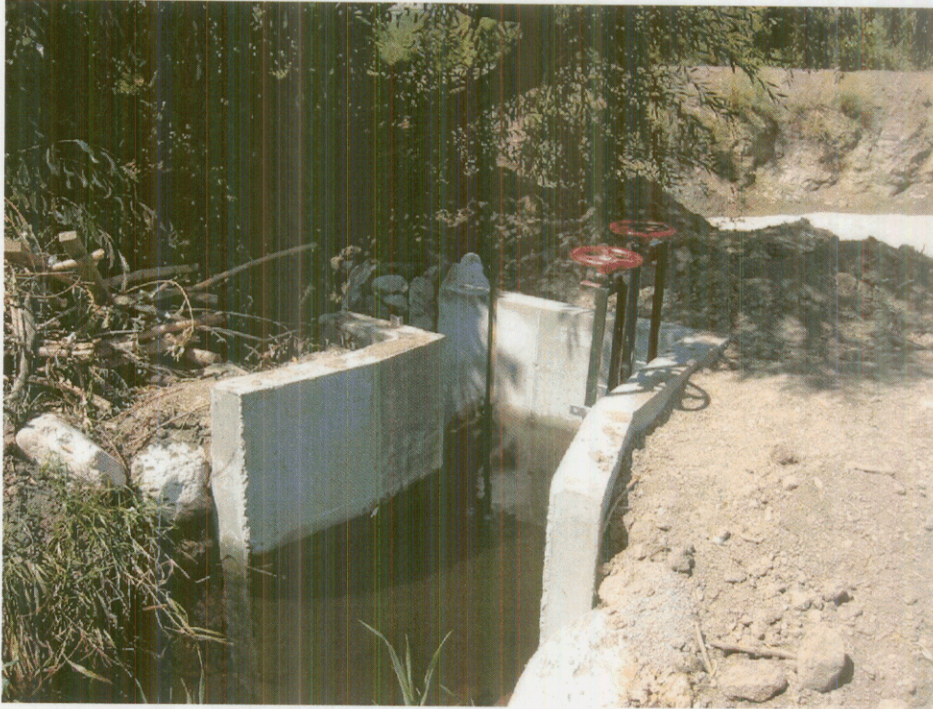
Looking NW at POD for all Indian Creek rights with a POU south of W Portneuf RD. (csaxton).

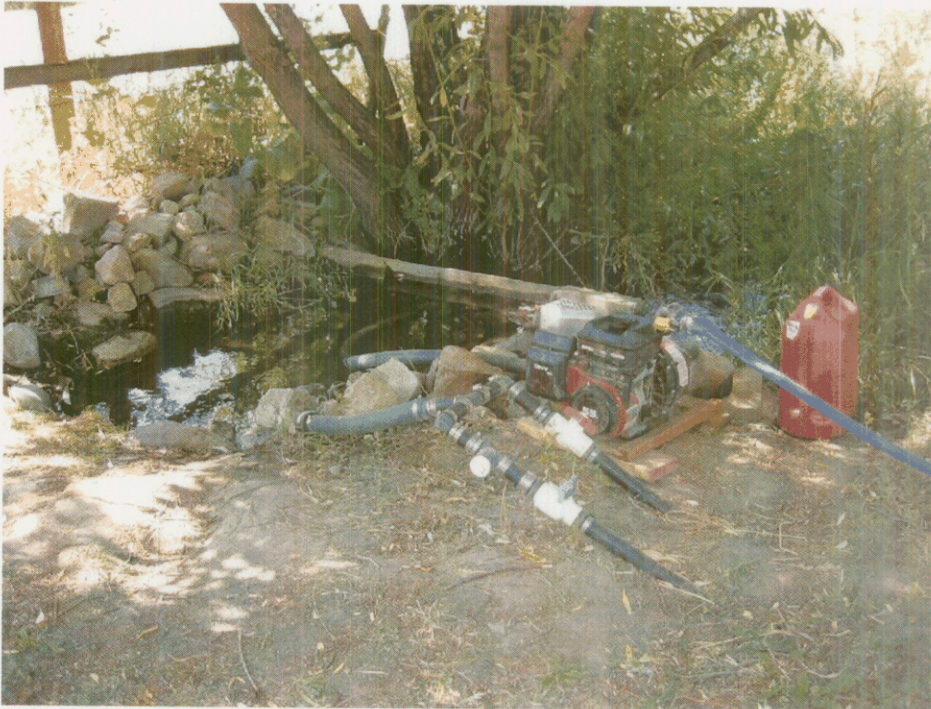
Pump that diverts water from the ditch system. Not an actual POD since it is diverting from a ditch (csaxton).

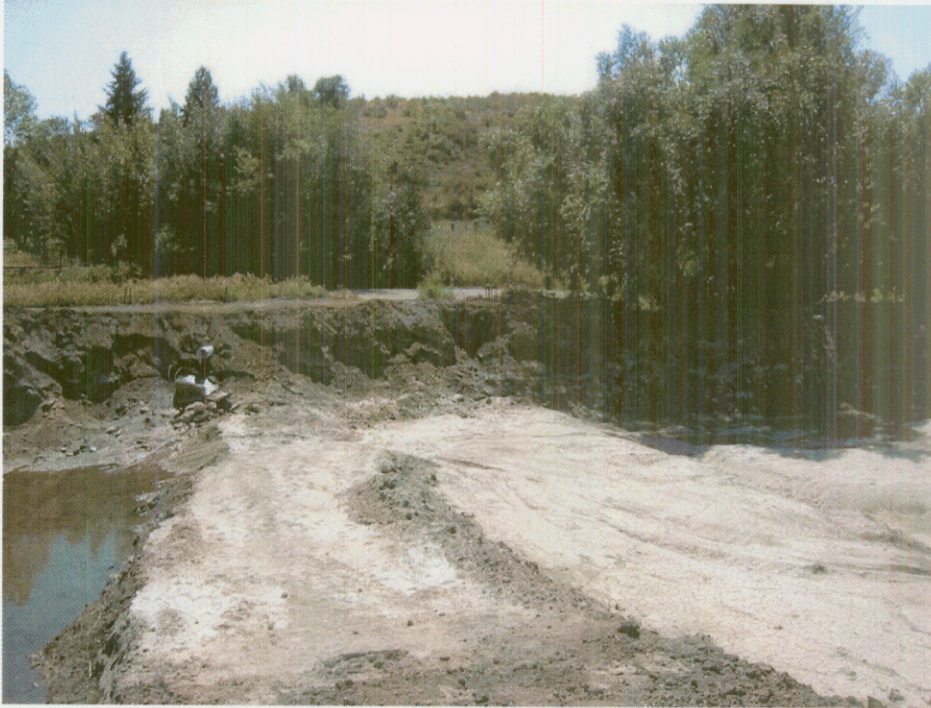
Looking South at pond. Indian Ck flows underneath the W. Portneuf RD into a headgate that can be used to divert water East, West, or into the pond (csaxton).

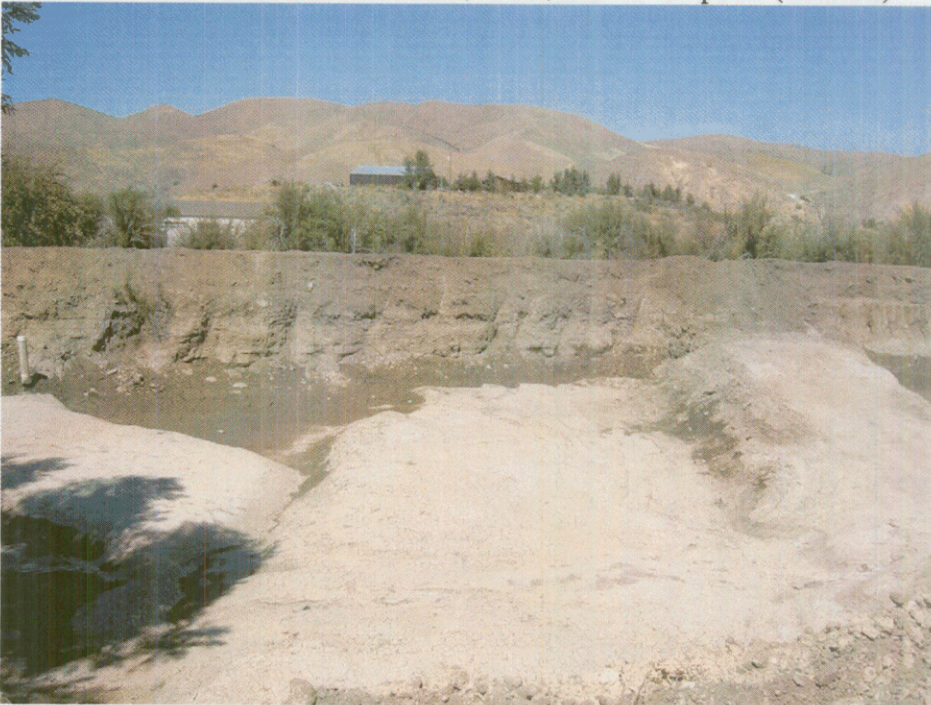
Looking North at pond. Claimed POU contains orchard and the top of the trees can be seen in this picture just above the bank of the pond (csaxton).

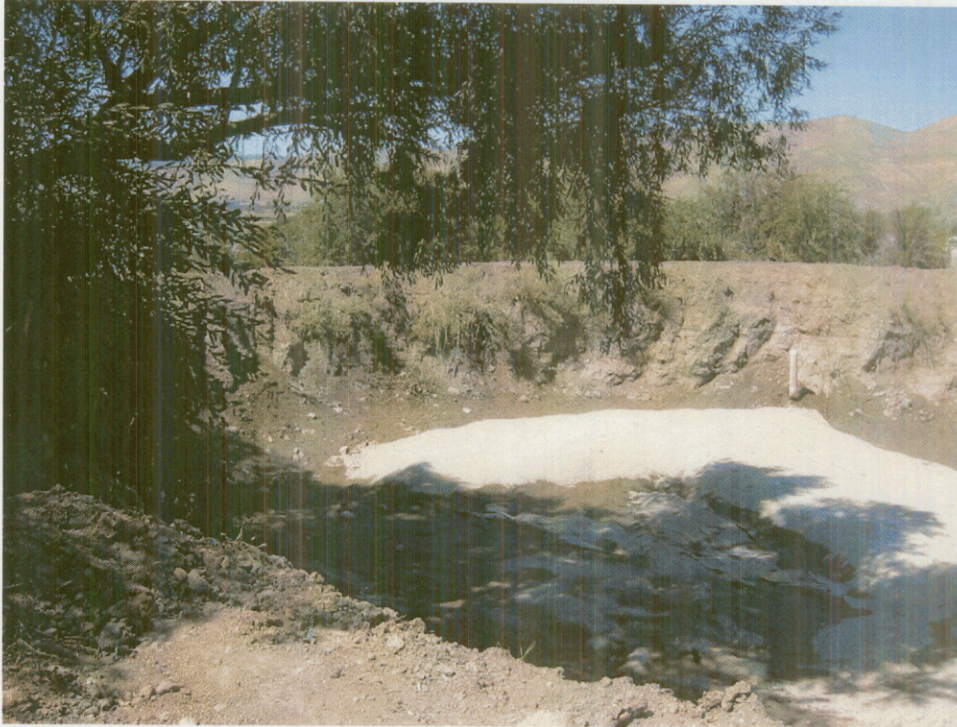
Looking NW at pond (csaxton).

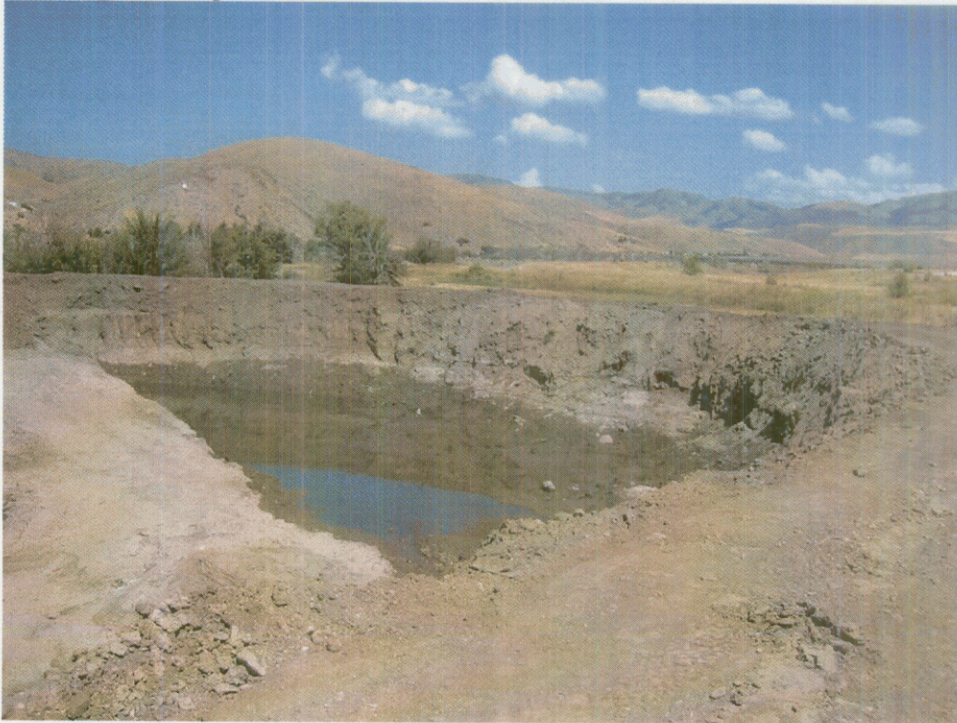
Looking NE at pond (csaxton).

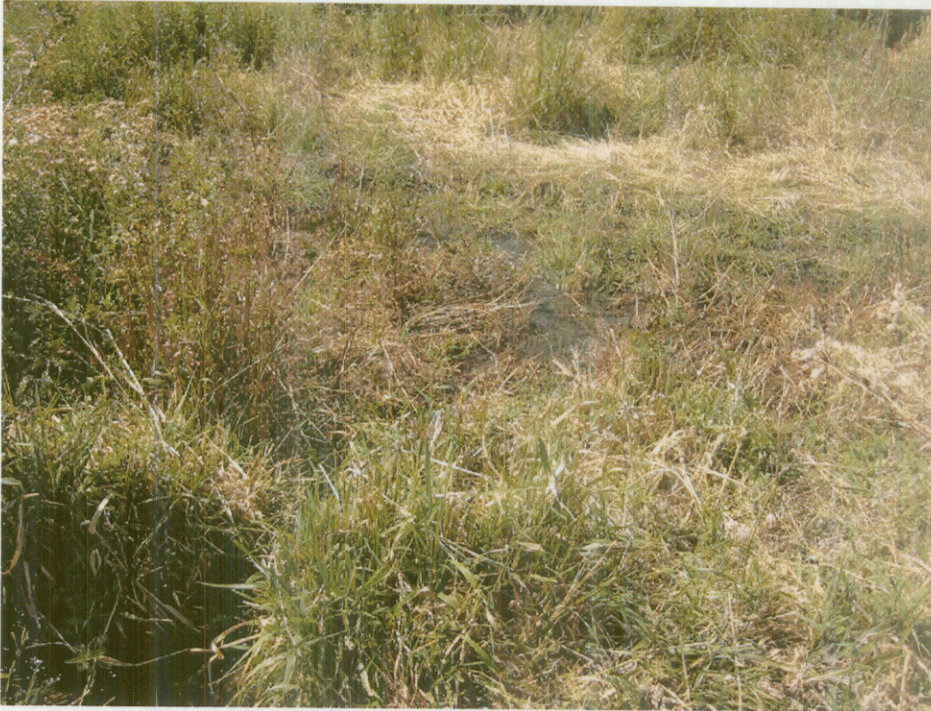
Looking at flood irrigation system to the West of the claimants home. This water runs in a northerly direction along the west side of the property.

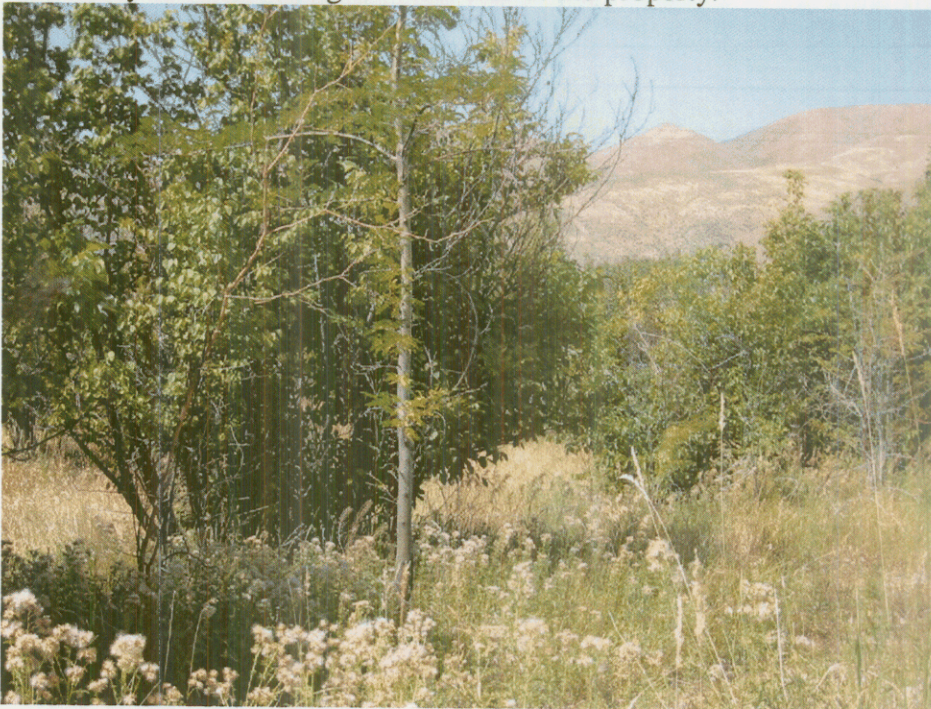
Looking North at Orchard that is part of the claimed POU (csaxton)

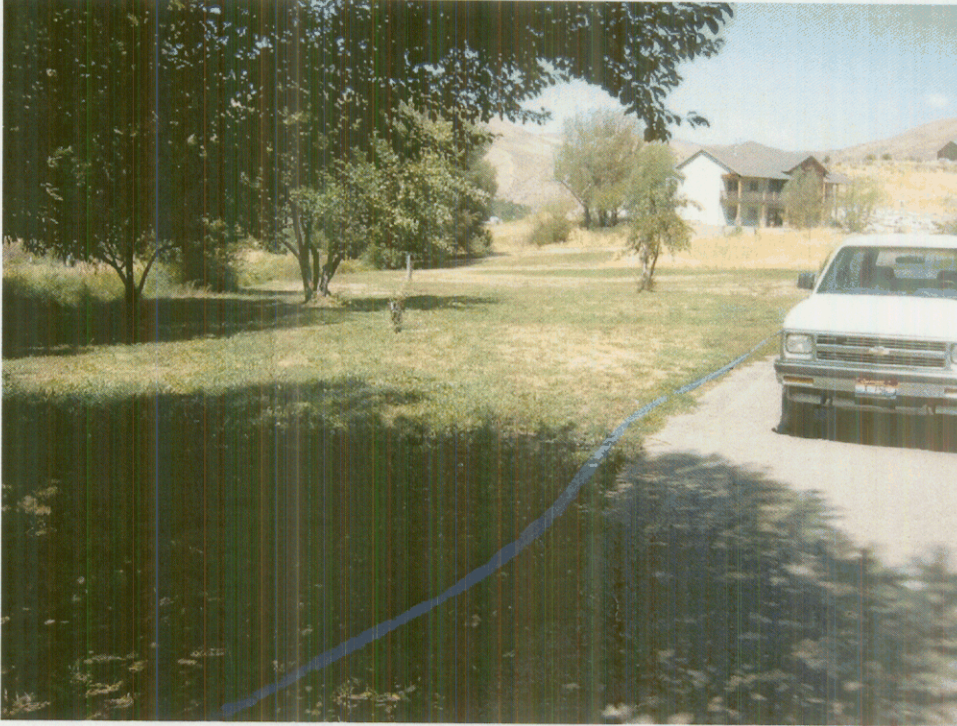
Looking North at claimed POU. Claimants home in background.

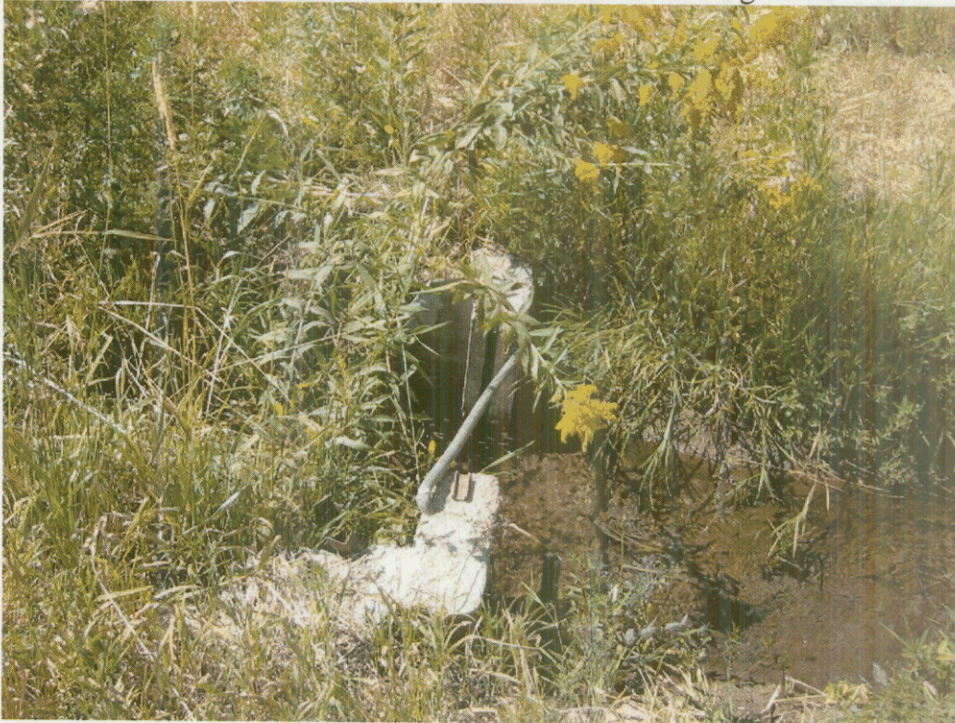
Looking at a headgate in the ditch to divert water to claimed POU (csaxton)

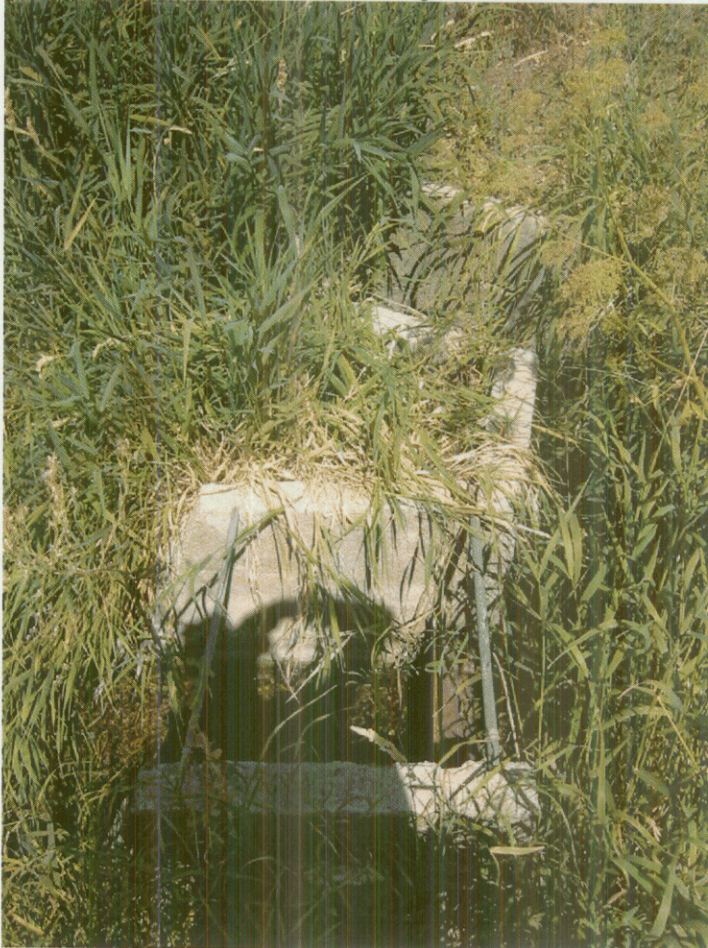
Looking North at headgate in main ditch used to split the water into two directions. The top of the picture shows the split that diverts water to the west side of the claimed POU (csaxton)
