**29-00606A**

**POD**

**Field Exam: 8/27/02**

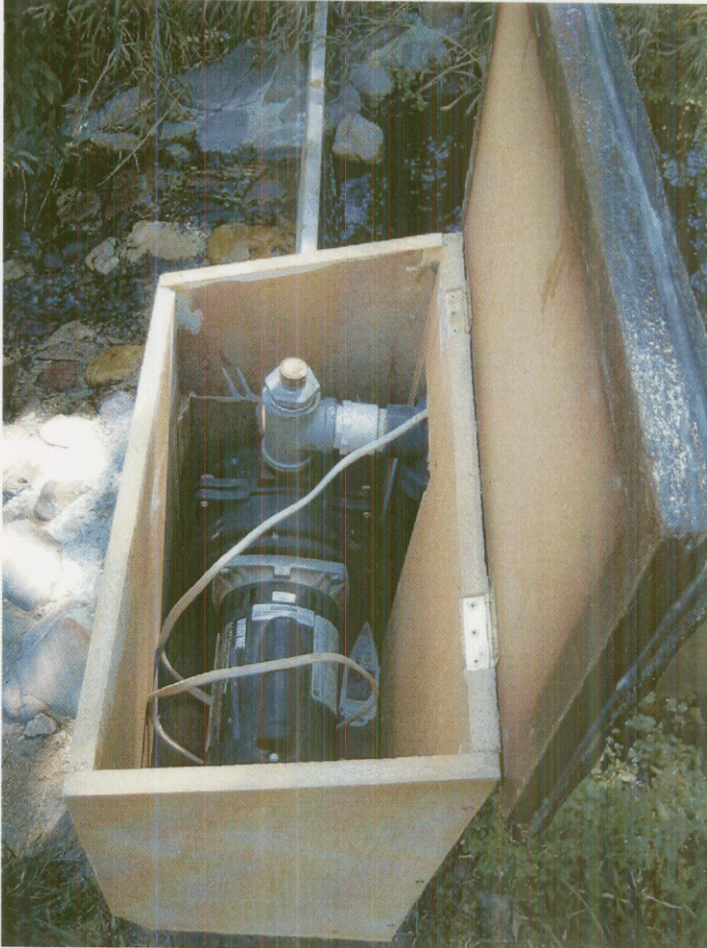
Current POD hooked into sprinkler system. This POD and sprinkler system installed 3 or 4 yrs ago when Leo Dean inherited the property from his mother. Previous method of irrigation was flood irrigation from upstream. Must recommend historical POD (csaxton).

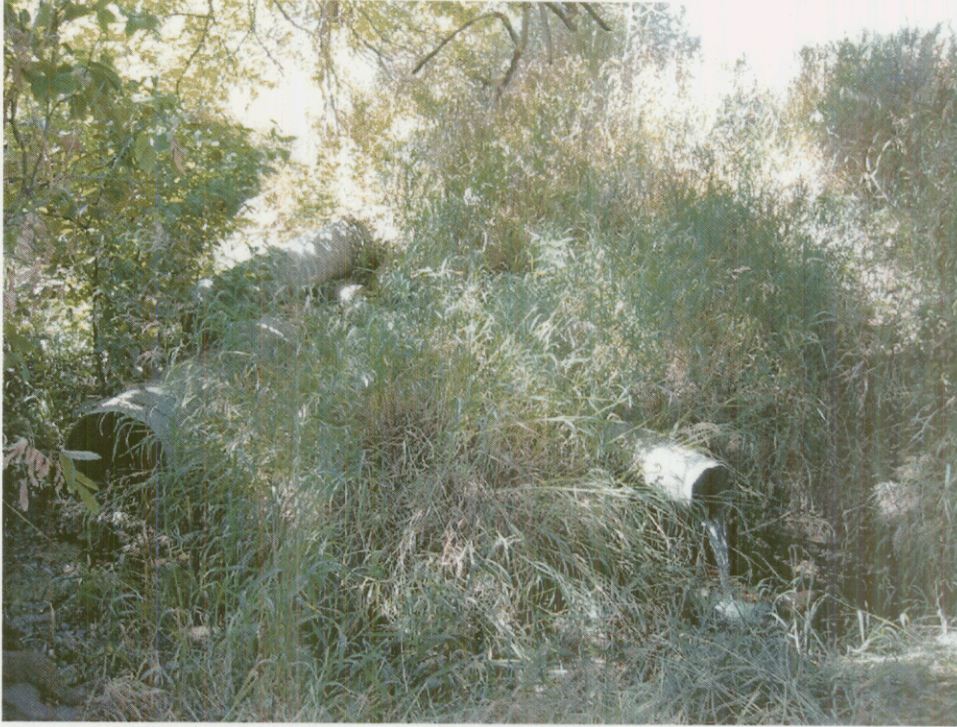
Looking South at flood irrigation POD (csaxton).

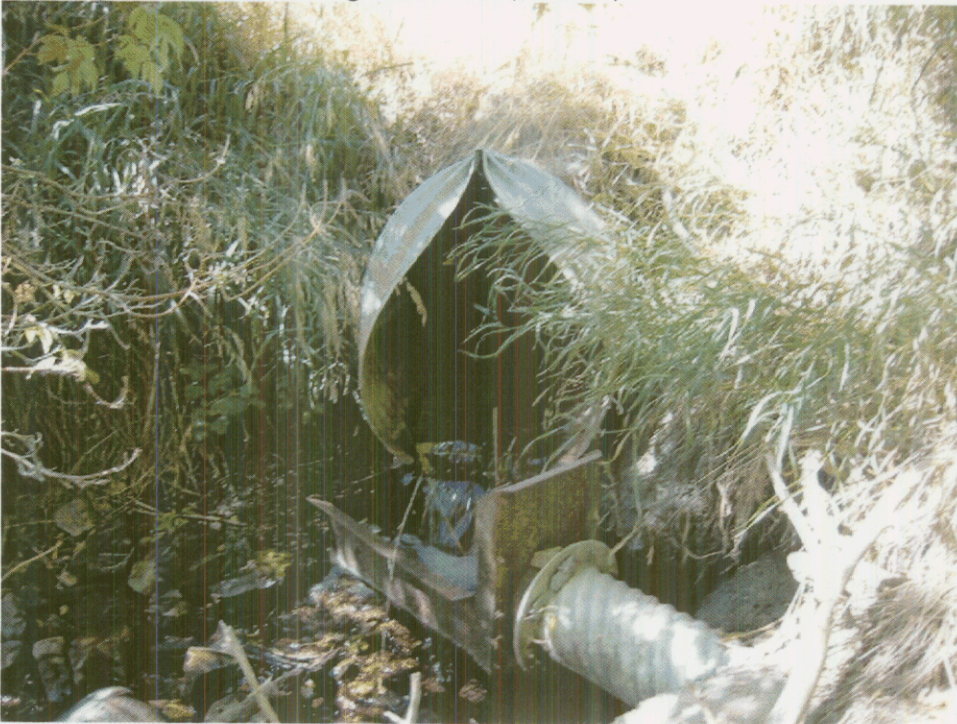
Looking at flood irrigation POD (csaxton).

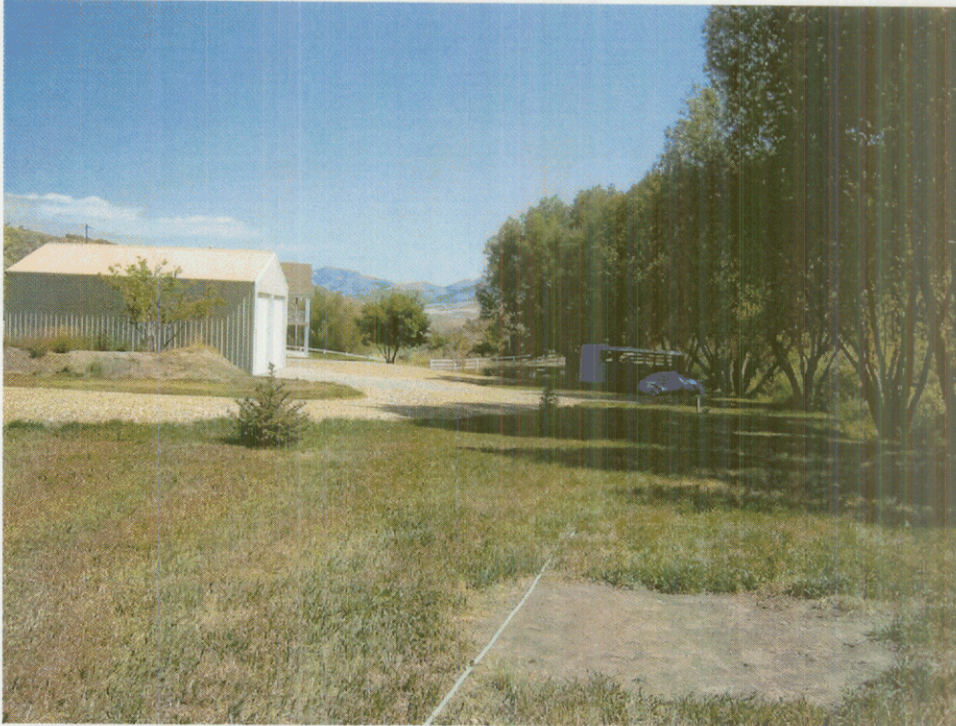
Looking North at claimed POU. Note irrigation line in Picture (csaxton).

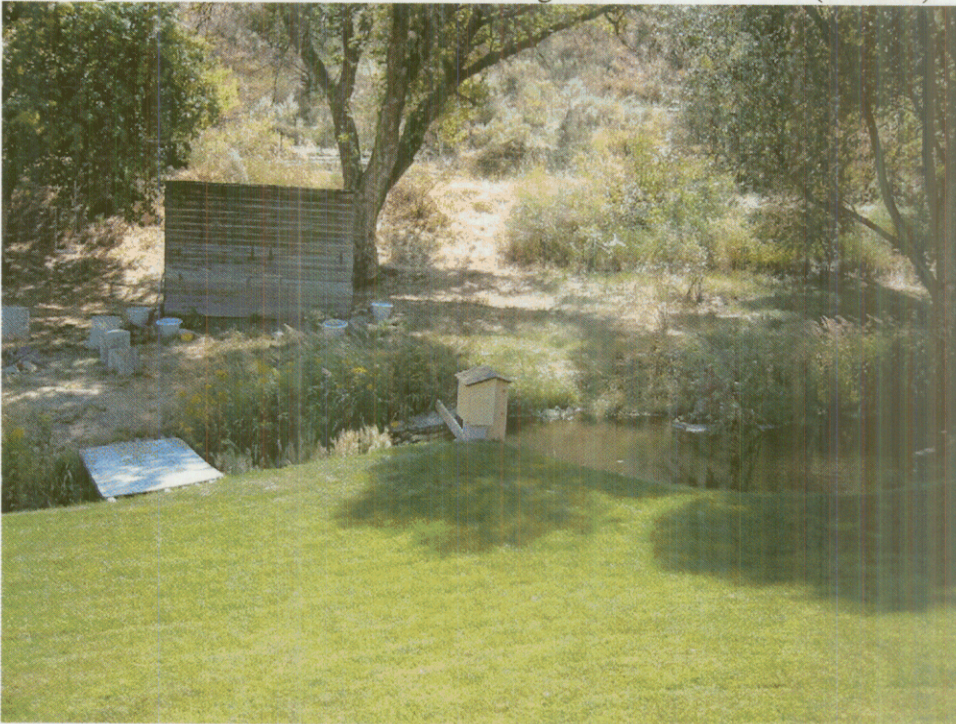
Looking E at claimed POU. Mink Creek shown in the picture (csaxton).

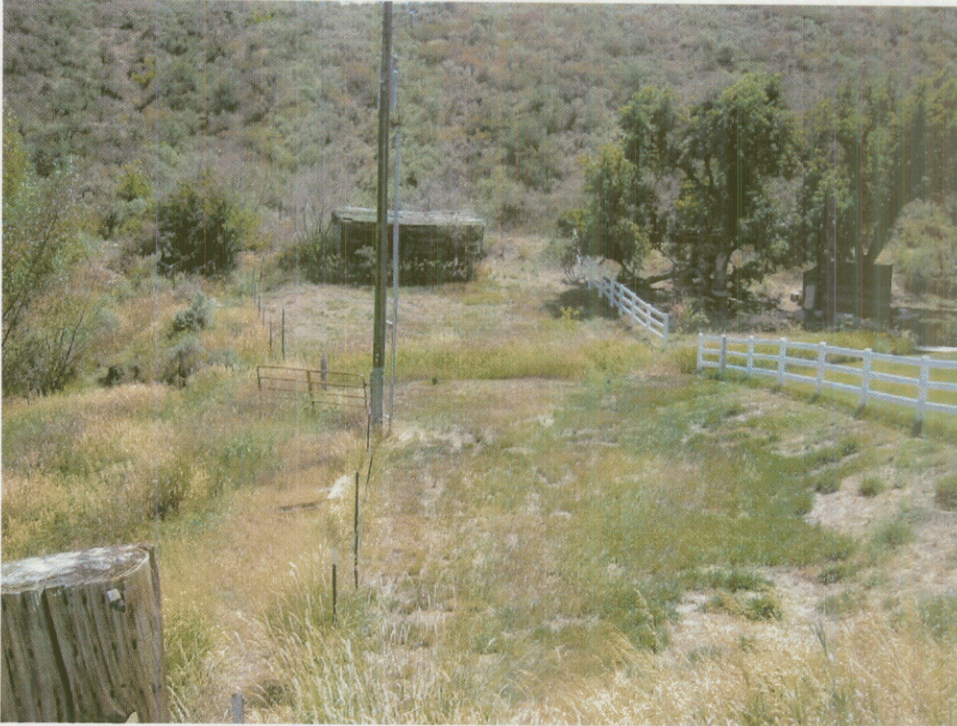
Looking East at claimed POU. Home to the right of picture. Non-irr field to the left (csaxton)

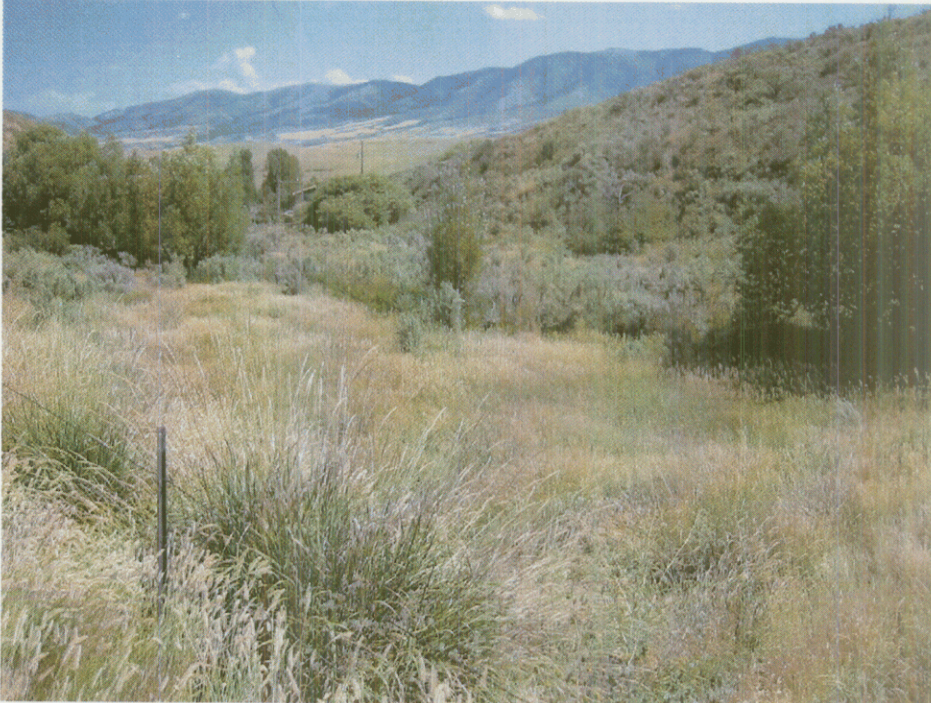
Looking North at claimed POU. No signs of recent irrigation (csaxton).
