STATE OF IDAHO  
DEPARTMENT OF WATER RESOURCES  
Staff Analysis Sheet For  
SRBA Claim Verification Field Report

A51-00113  
A51-02061

FILE NO(S). A51-00113, A51-02061

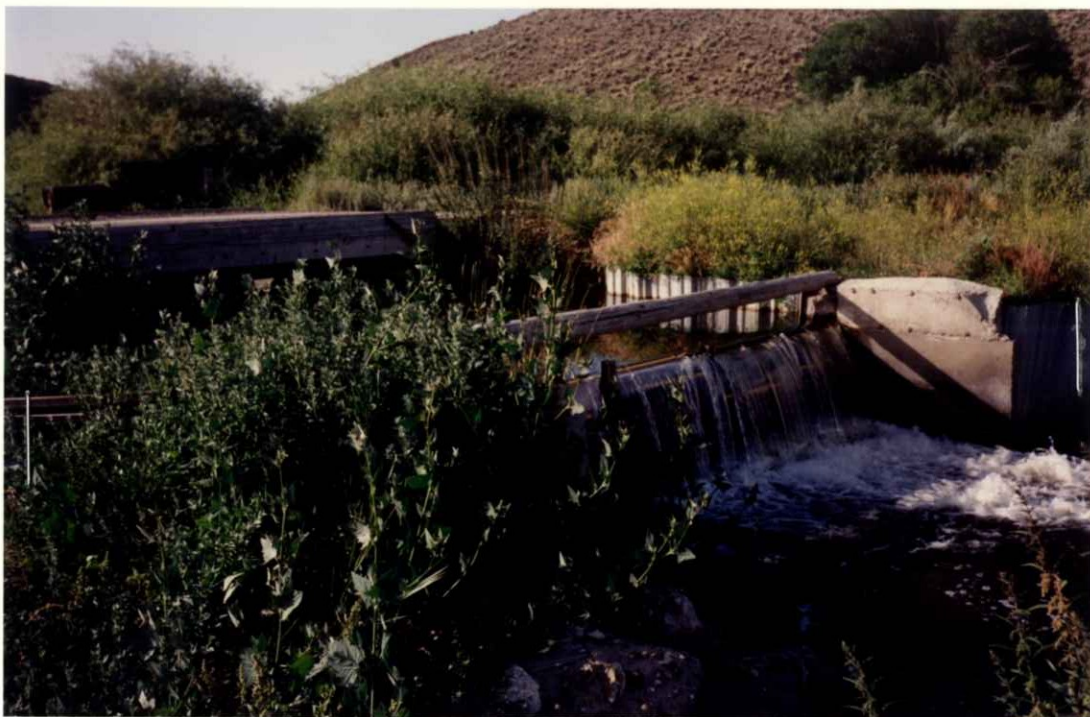
POD #1  
Located in  
SWSW, S23,  
T11S, R9E

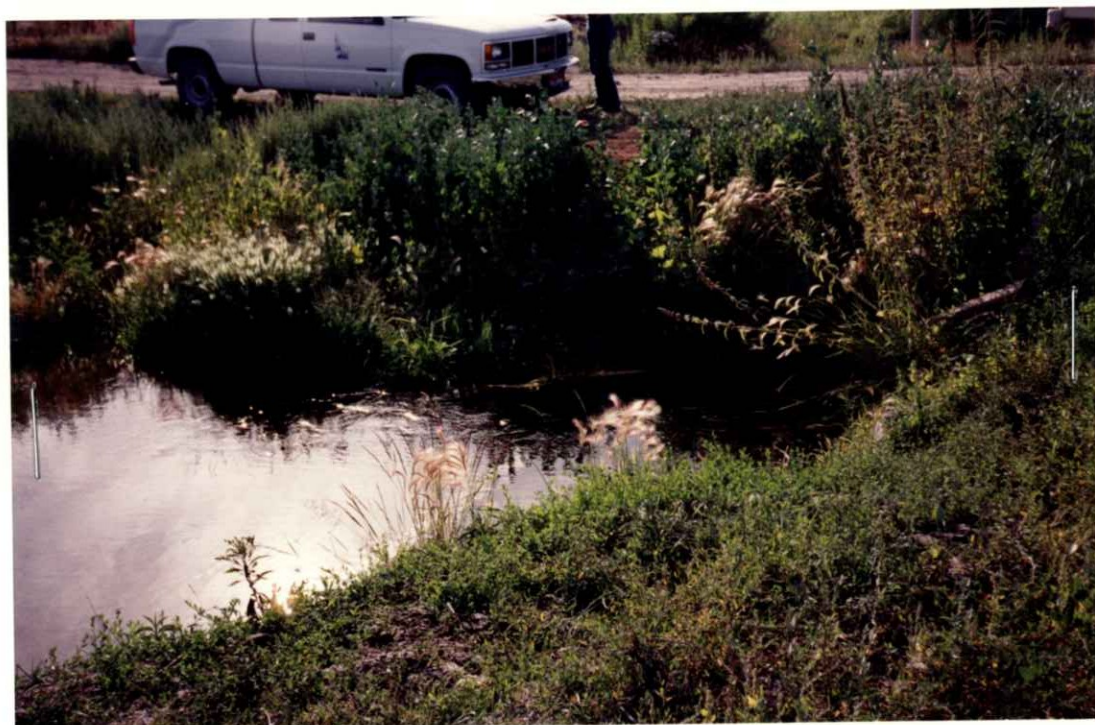
Ditch  
from above  
POD to  
Place of  
use.

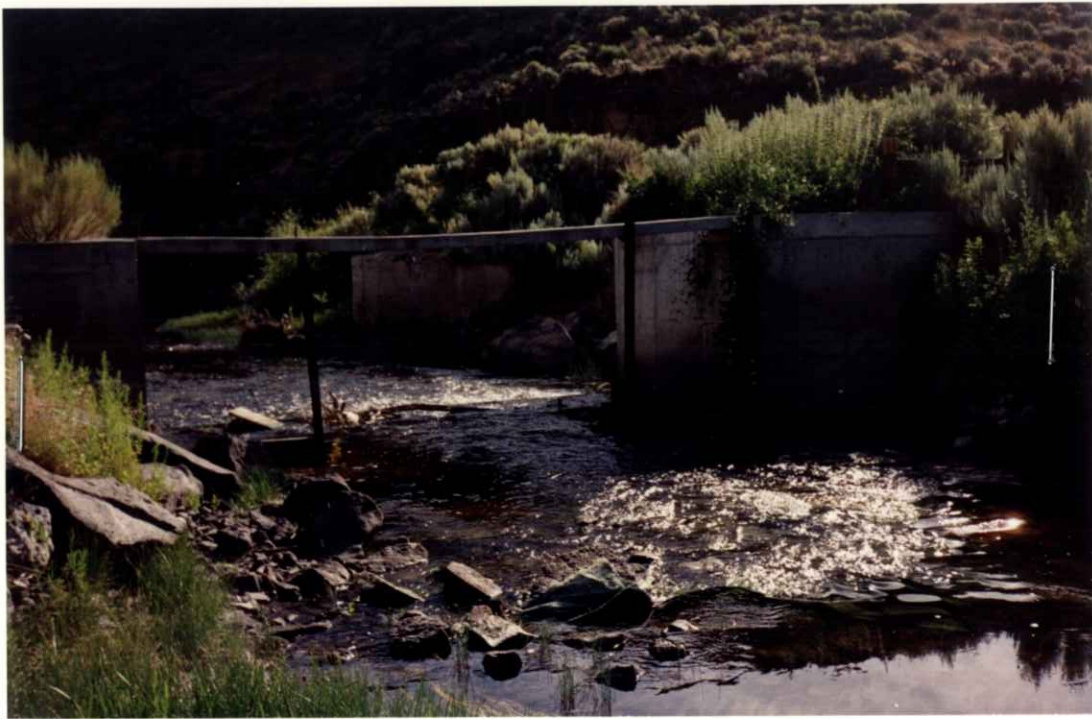
POD #2  
photo taken  
standing by  
creek looking  
upstream.

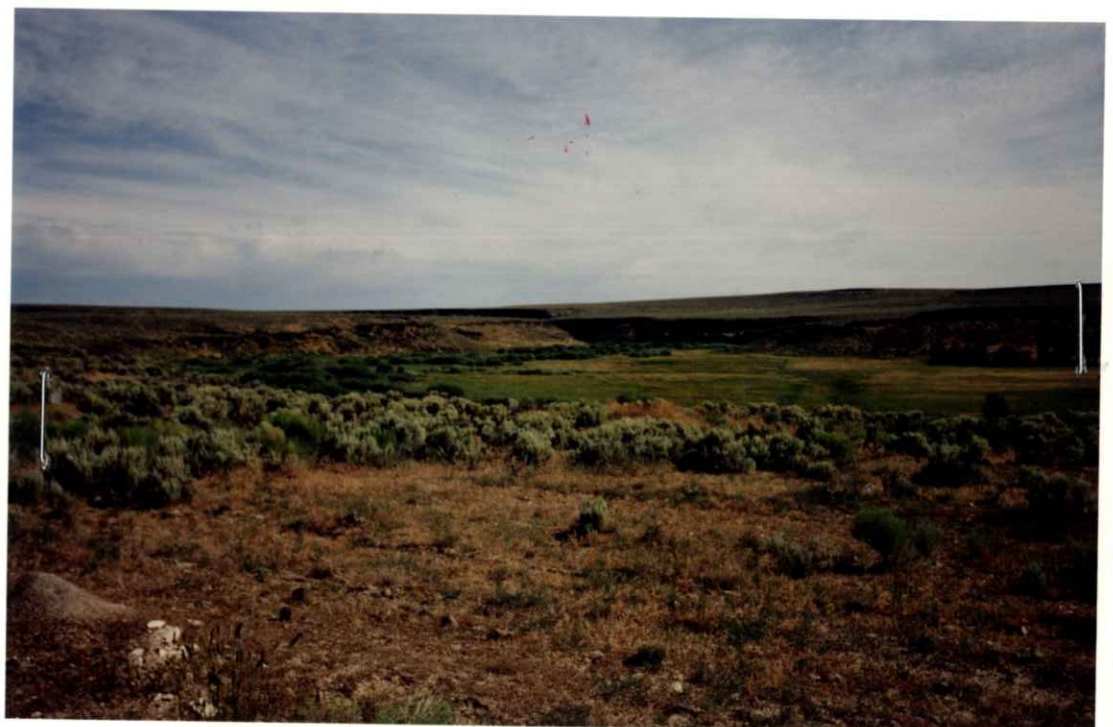
Place of  
use -

Pictures  
taken from  
north to  
northeast -  
see pg. 4  
also

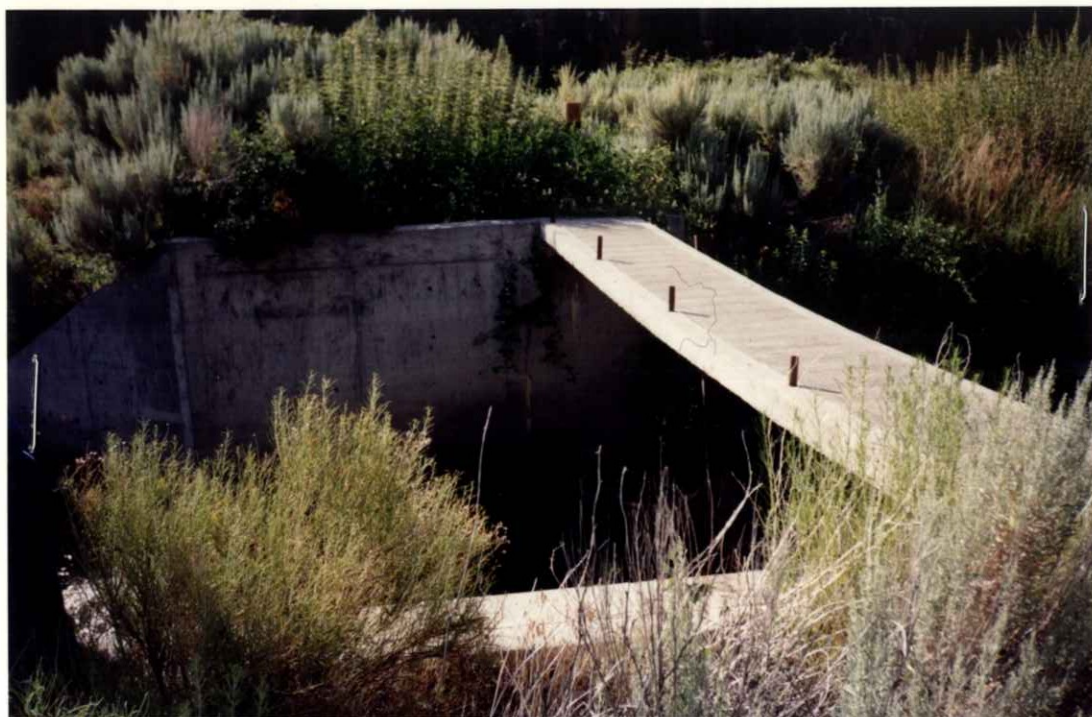
POD #2  
Located in  
SE NW, S26,  
T11S, R9E  
cement stand-  
Flume had  
been washed  
out.

pld  
flume  
washed  
3 yrs ago -  
will be  
rebuilt

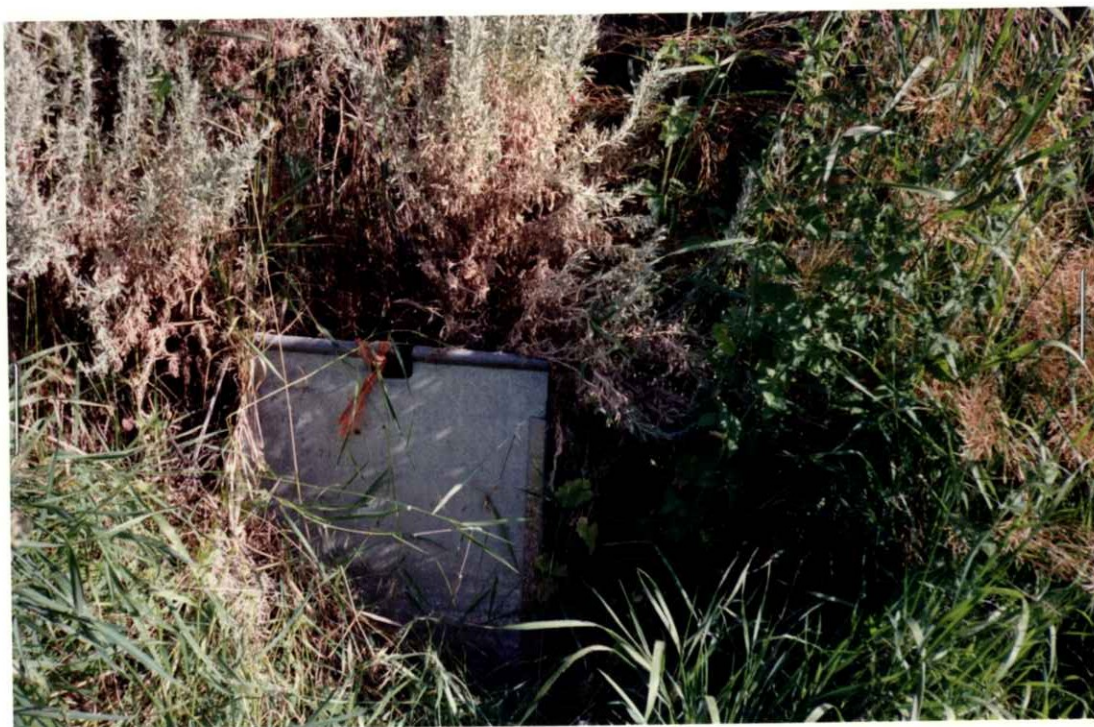
Headgate to  
Ditch from  
POD #2

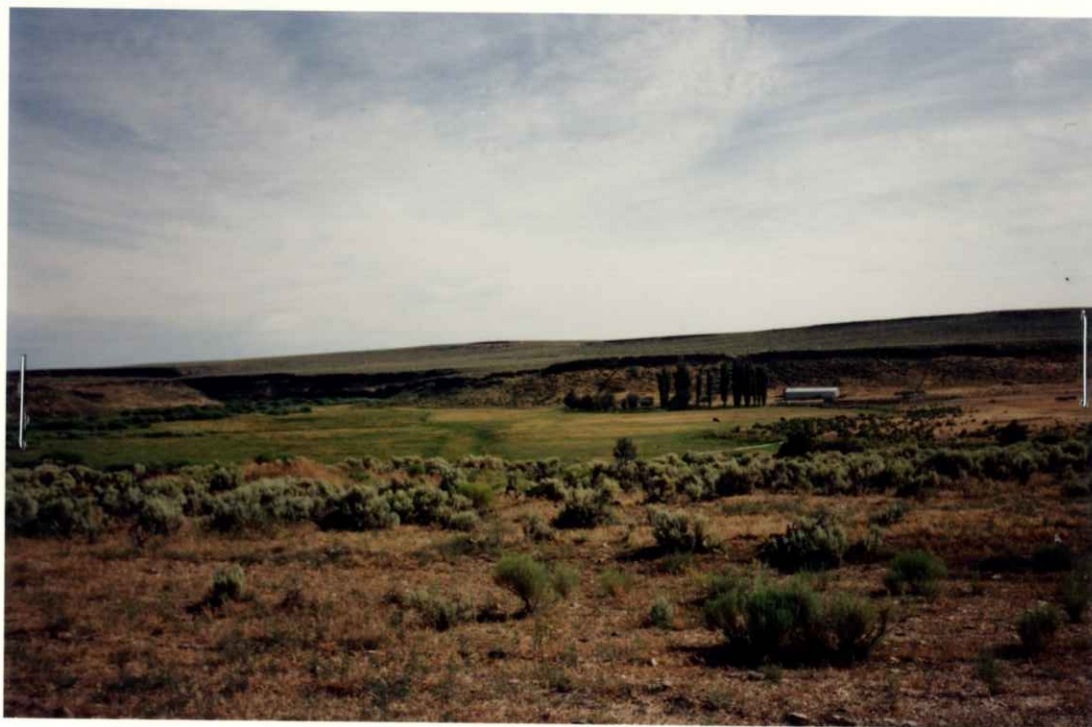
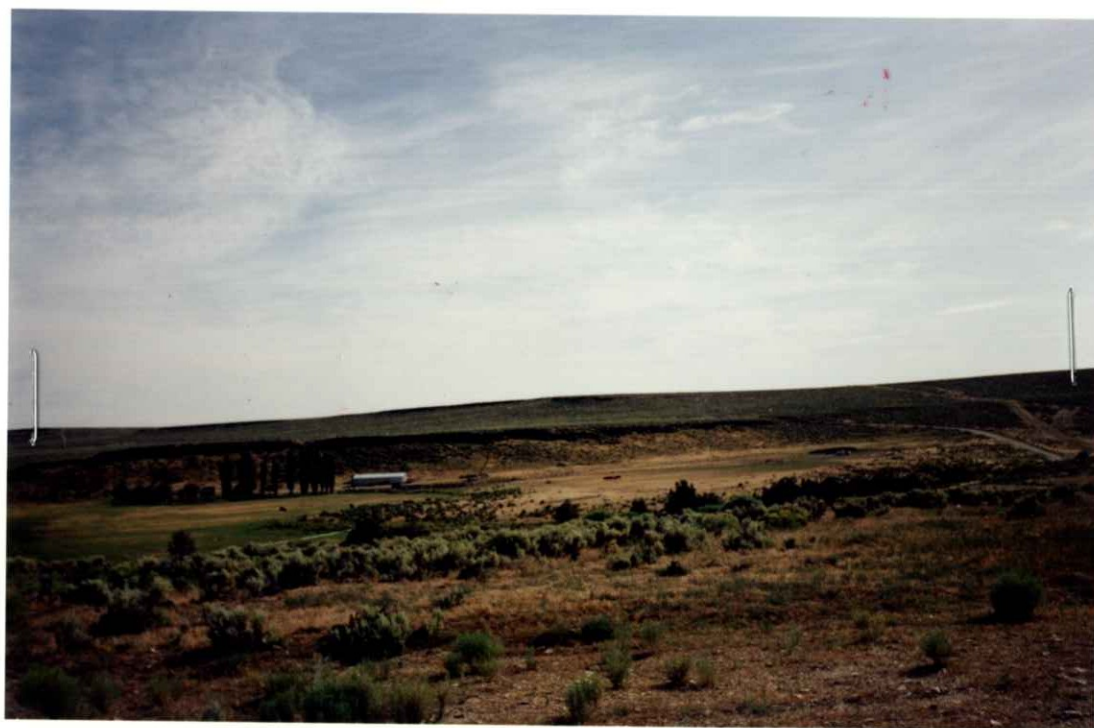
Place of Use — taken looking north to  
northeast. See pg. 3 also
