A29-4418

Narrative by Cindy Bird

August 1, 2002

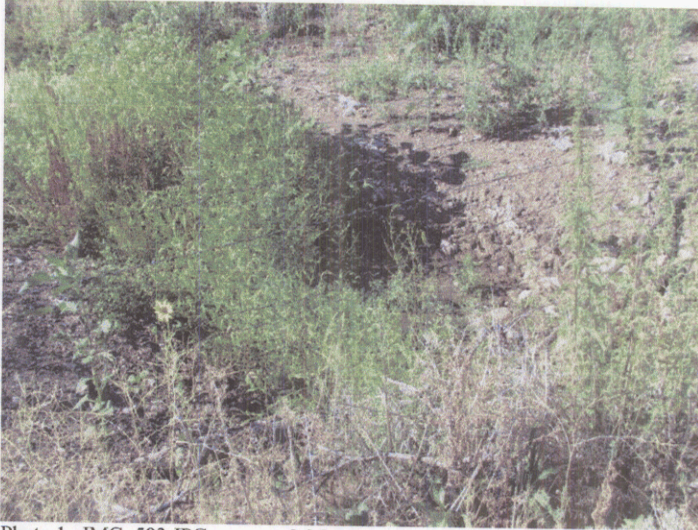
Photo 1. IMG\_583.JPG

July 29, 2002 DeMar Gilbert accompanied me during the field exam. Photo 1 was taken looking south at the point of diversion from Dry Creek. The ditch was overgrown by did has a little water in it.

Ditch at POD.

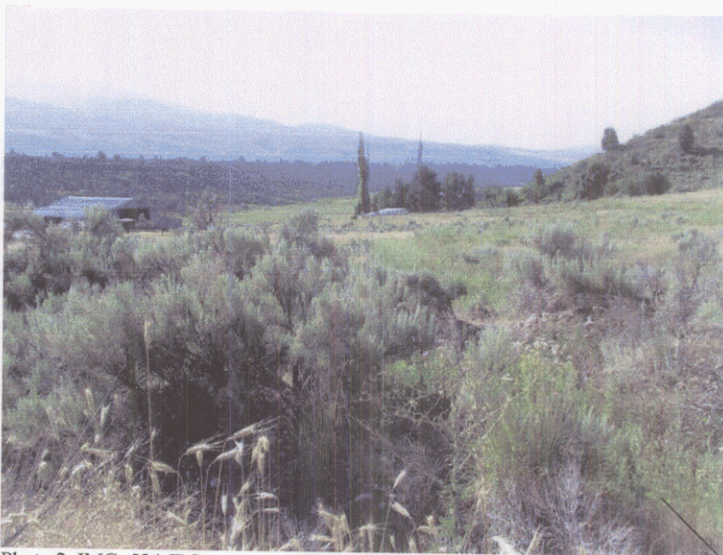
Photo 2. IMG\_584.JPG

Photo 2 was taken looking in a southeasterly direction with the POD in the foreground and the POU in the background. The POD is a 8" concrete pipe in the creek.

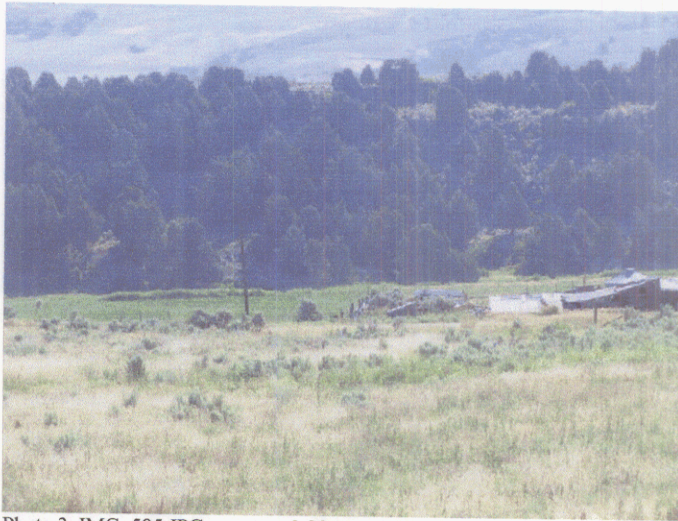
Photo 3. IMG\_585.JPG

Photo 3 was taken looking easterly at the POU. The irrigated POU is on both sides of the road in section 9 & 10. The water is diverted to the property east of the road through the culvert shown in photo 4. Dry creek hasn't had a lot of water in recent years so many of the ditches are overgrown.
