**29-07154**

**POD**

**FIELD EXAM: 7-30-02**

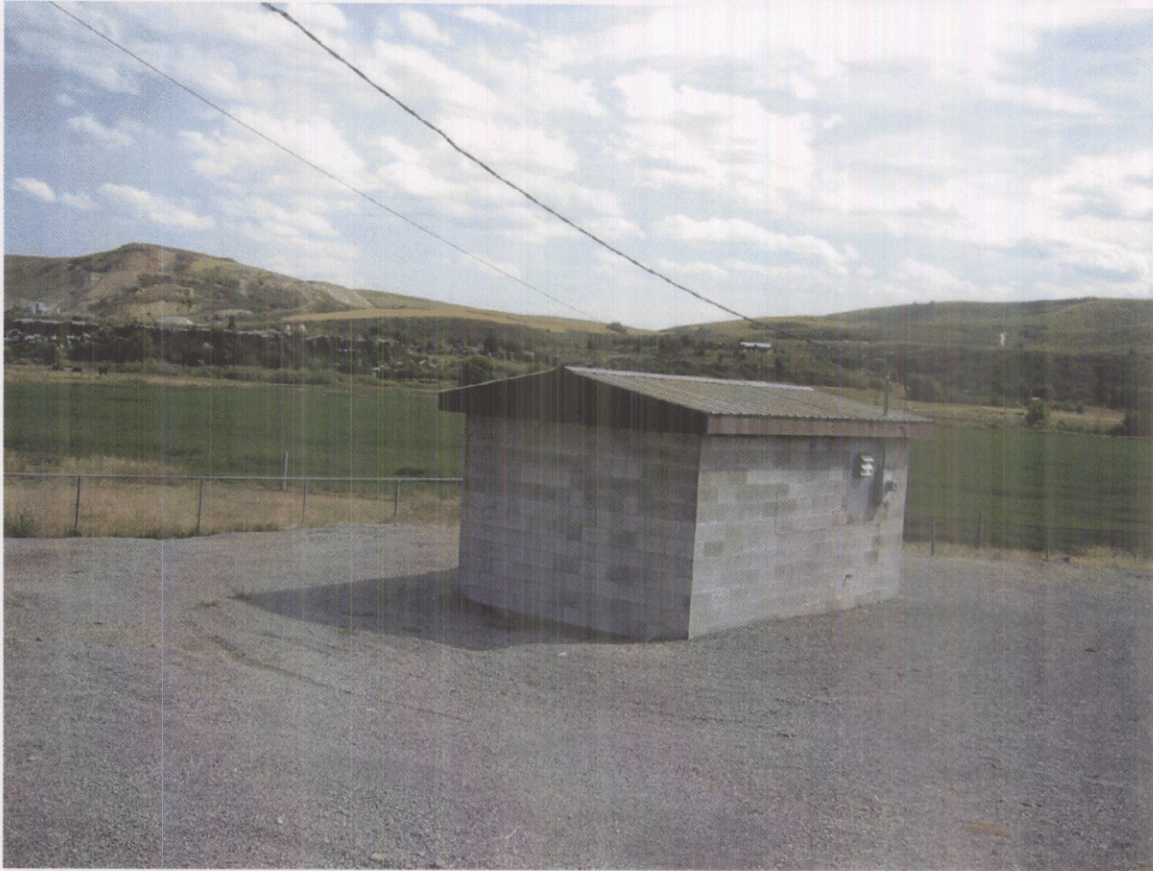
Looking SW at Point of Diversion pump house. Licensing field exam seems to indicate that well is outside of pump house. However, FE doesn't confirm this. No signs of well in surrounding area. Must be inside structure (csaxton 8/7/02).
