**STATE OF IDAHO**  
**DEPARTMENT OF WATER RESOURCES**  
**RECORD OF INSPECTION OF DAM**

Name of Dam: Stewart Ranch Dam  
Name of Owner: Stewart Brothers

Stream: Tr-Crow Creek  
Location: SWSE, sec 15, T10S, R45E

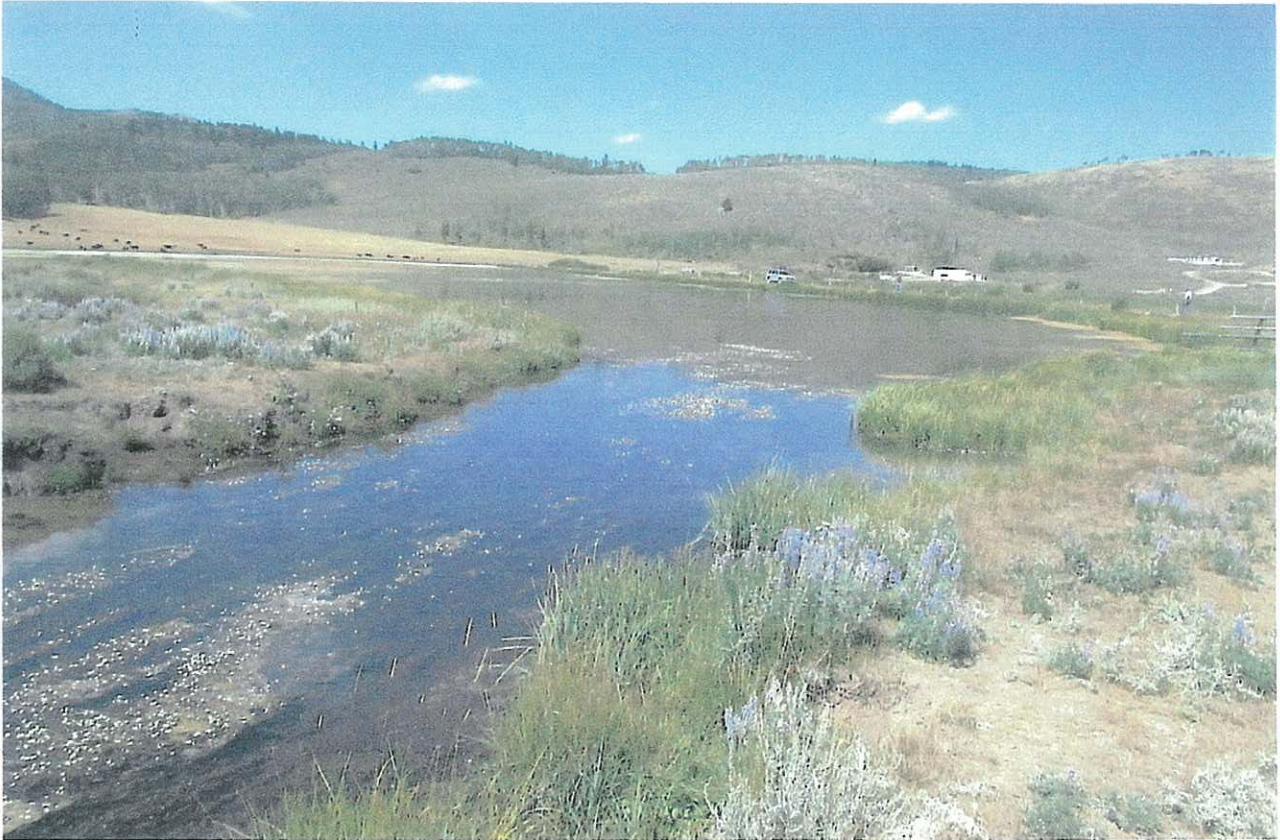
**Spillway entrance.**

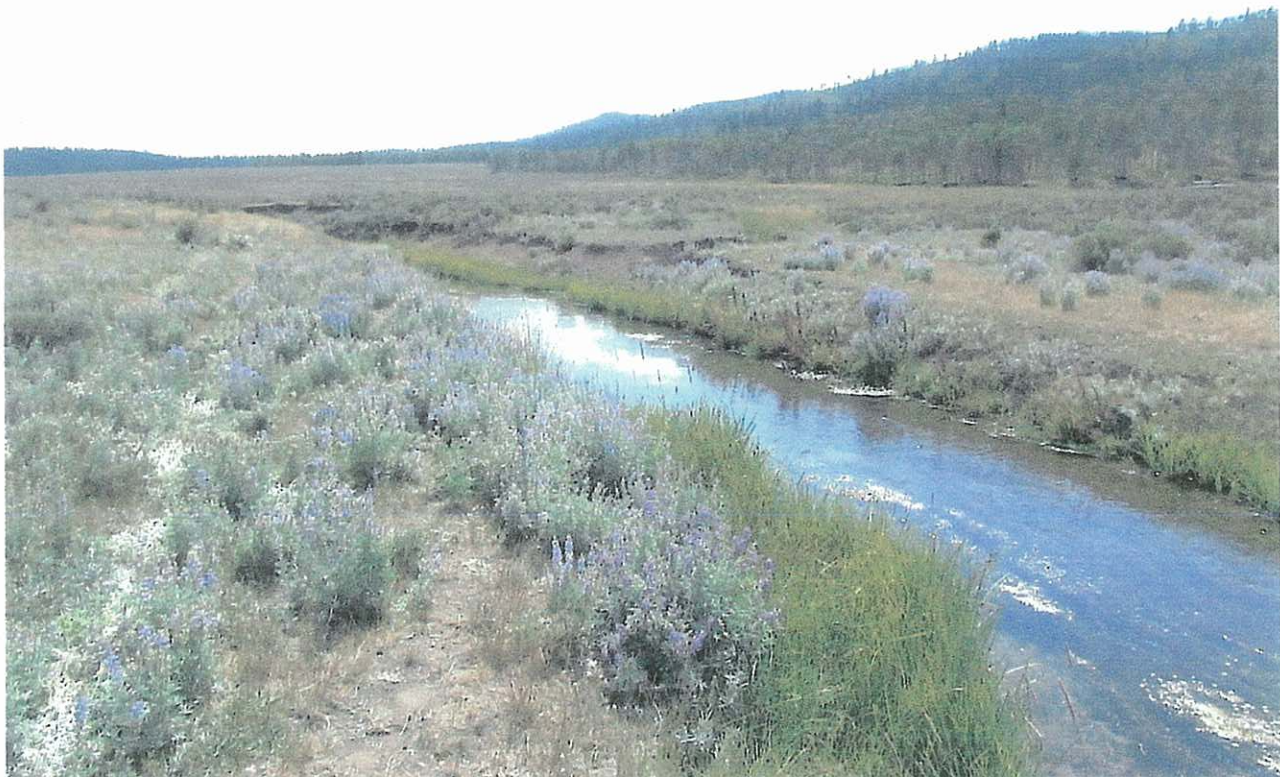
**Spillway channel.**

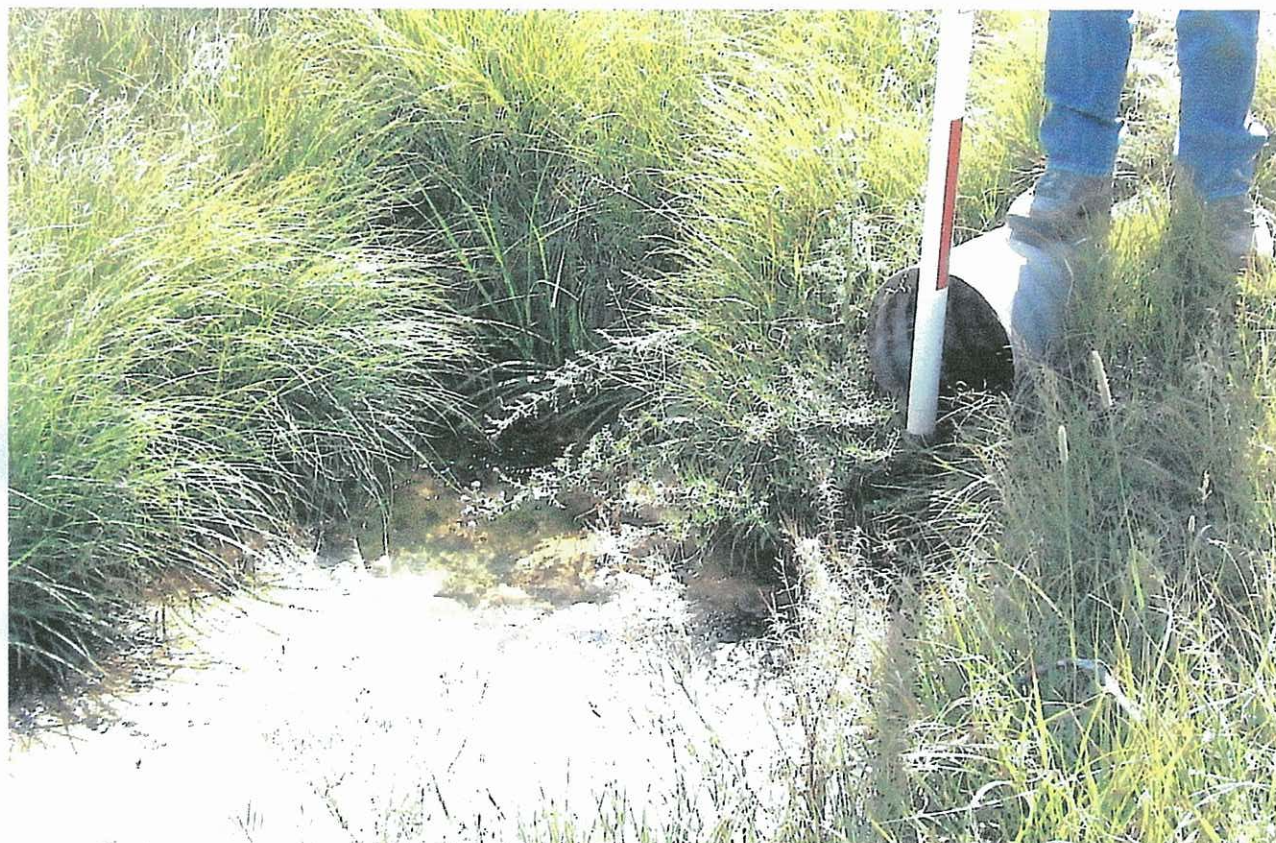
| | TOE AREA | DOWNSTREAM SLOPE | ABUTMENTS | OTHER |
|---|---|---|---|---|
| Flowing water (Est. G.P.M.) | 30 gpm by right outlet | none | none | |

**Right side outlet and spring.**

- Continue to control tall and woody growth on all parts of the emankment and downstream toe
- Control burrowing animals and repair exsisting holes with compacted soil.
- Monitor seepage near right side outlet.

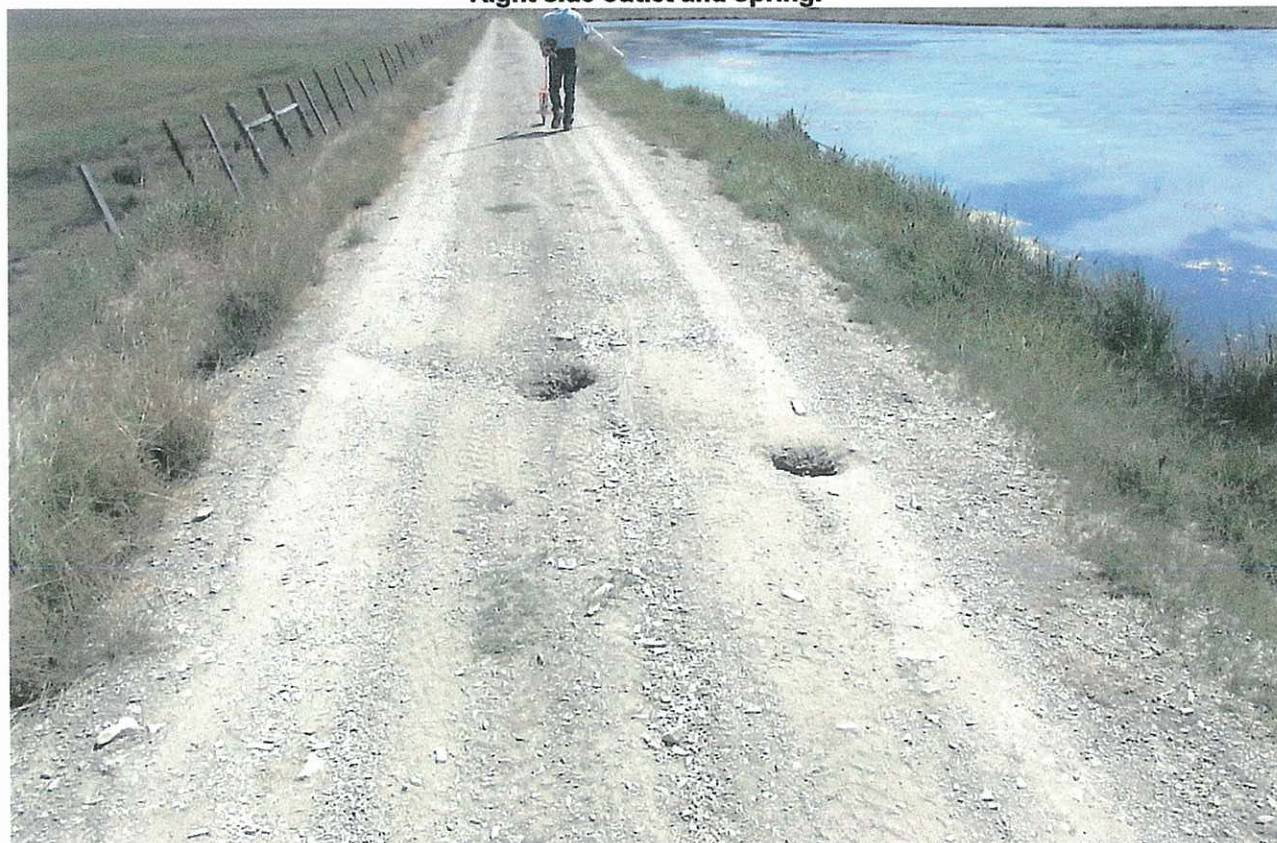
| | UPSTREAM SLOPE | CREST | DOWNSTREAM SLOPE | TOE AREA |
|---|---|---|---|---|
| ANIMAL BURROWS | a couple | several large burrows | several large and some small burrows | |

**Holes in crest.**

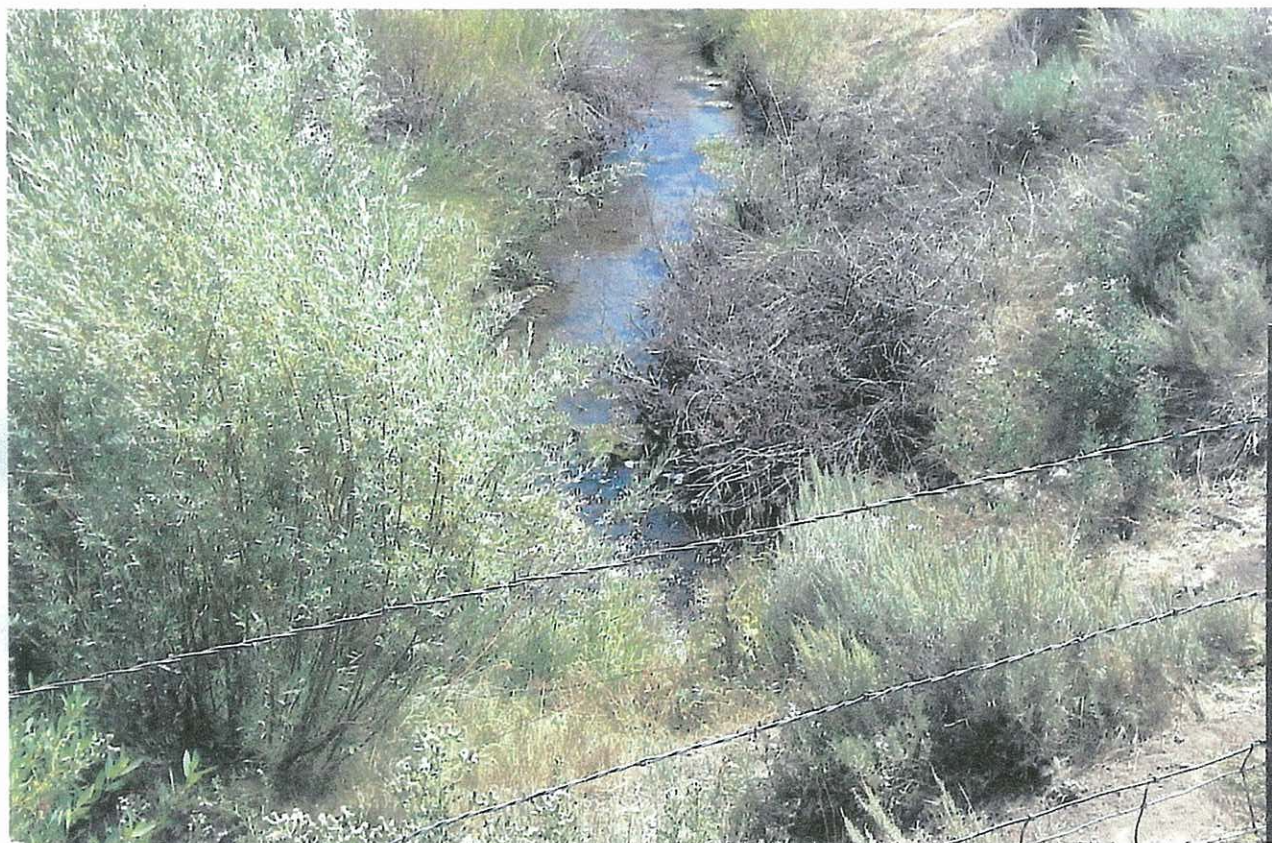
**Left side outlet.**

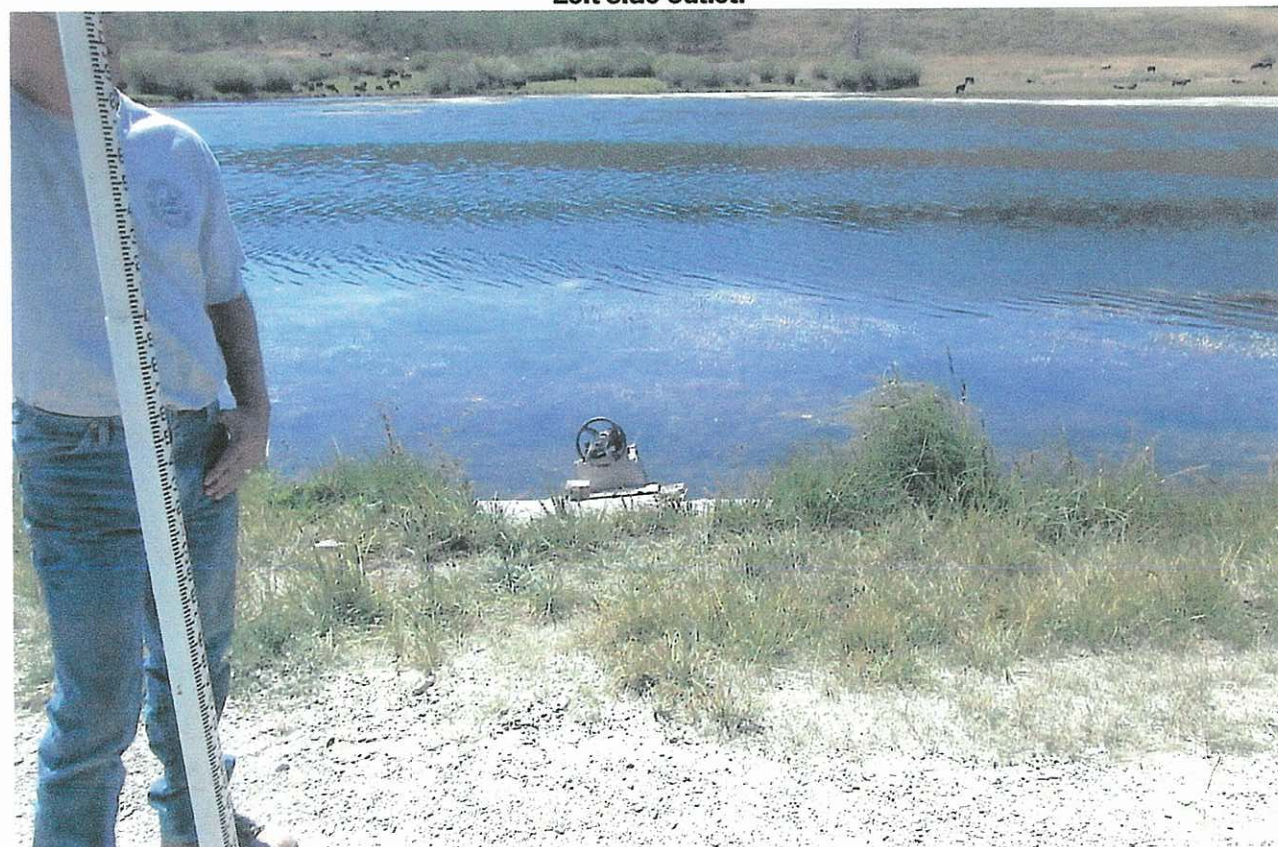
**Right side outlet control.**

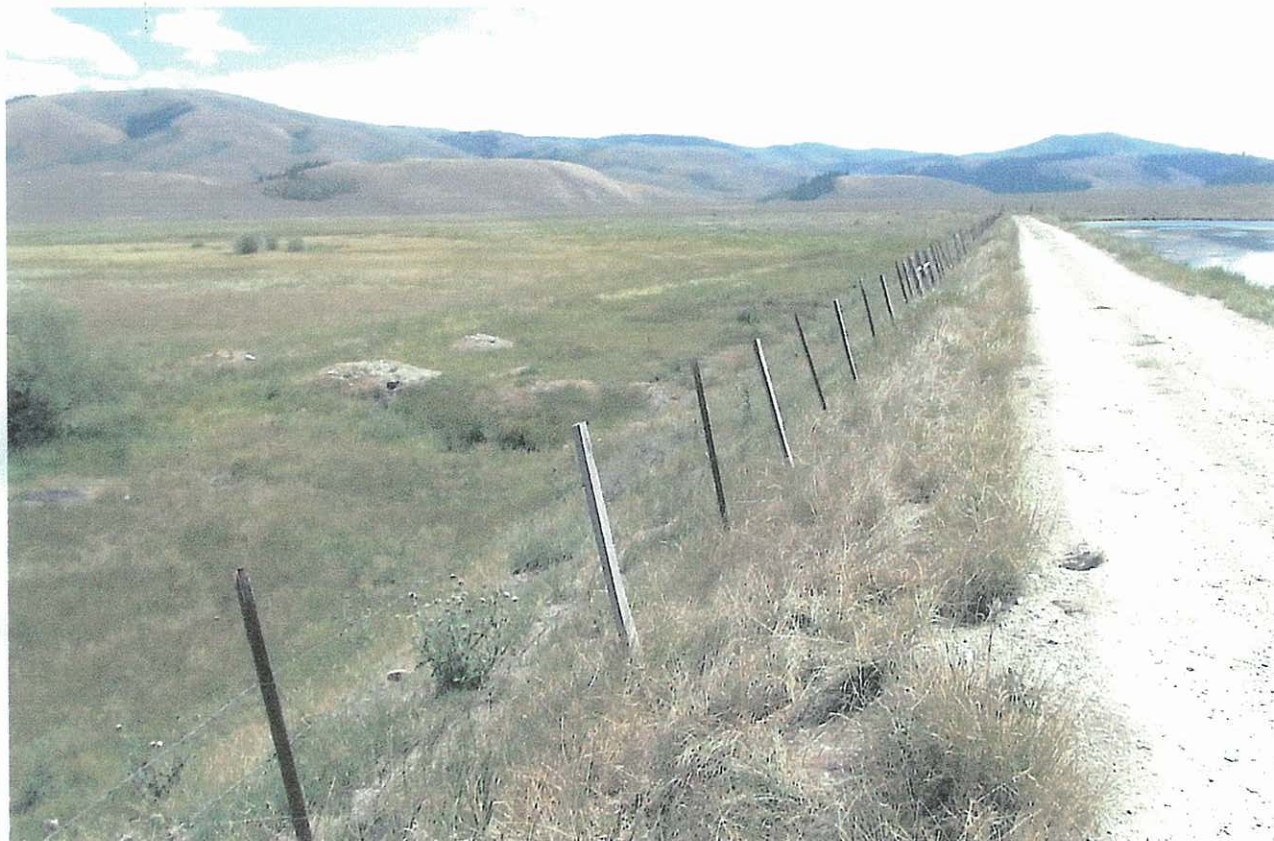
**Right side downstream slope.**

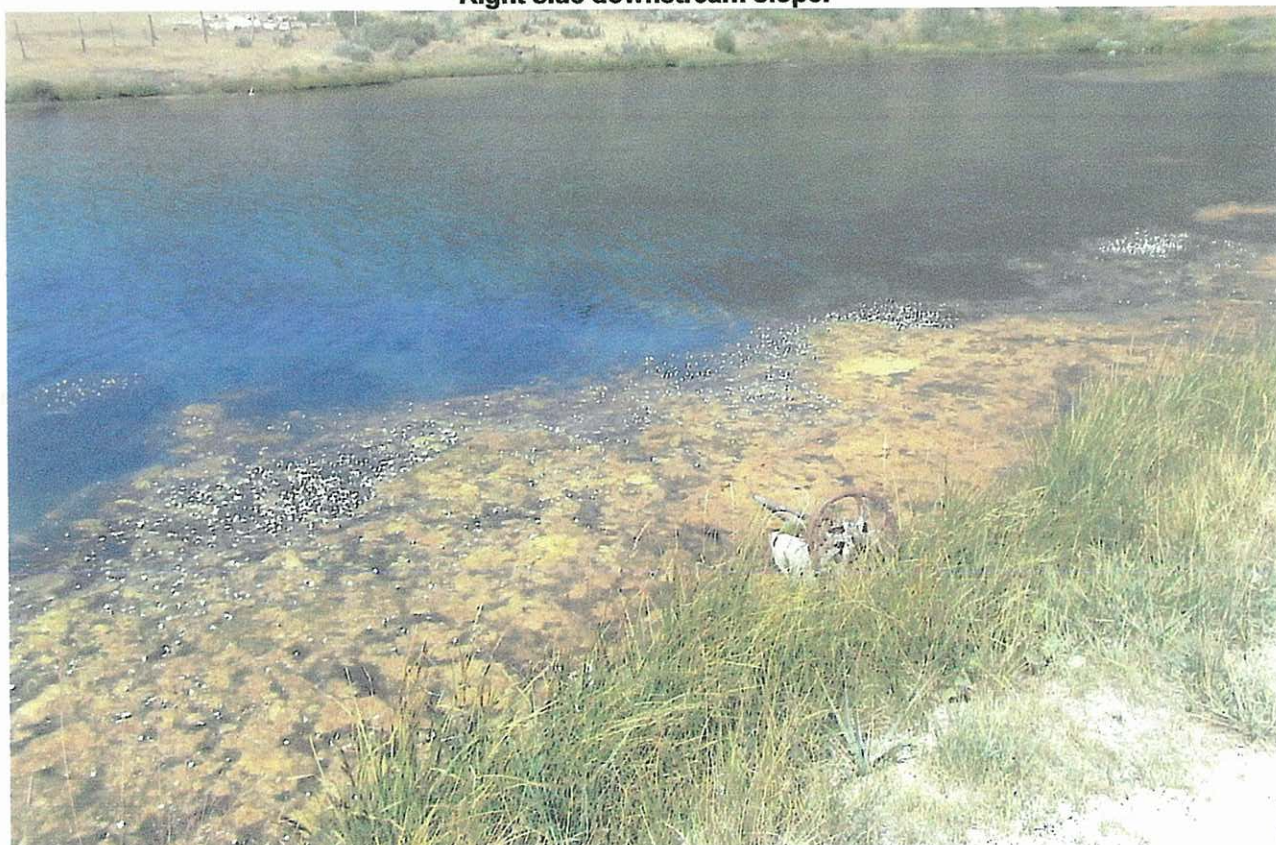
**Left side outlet control.**

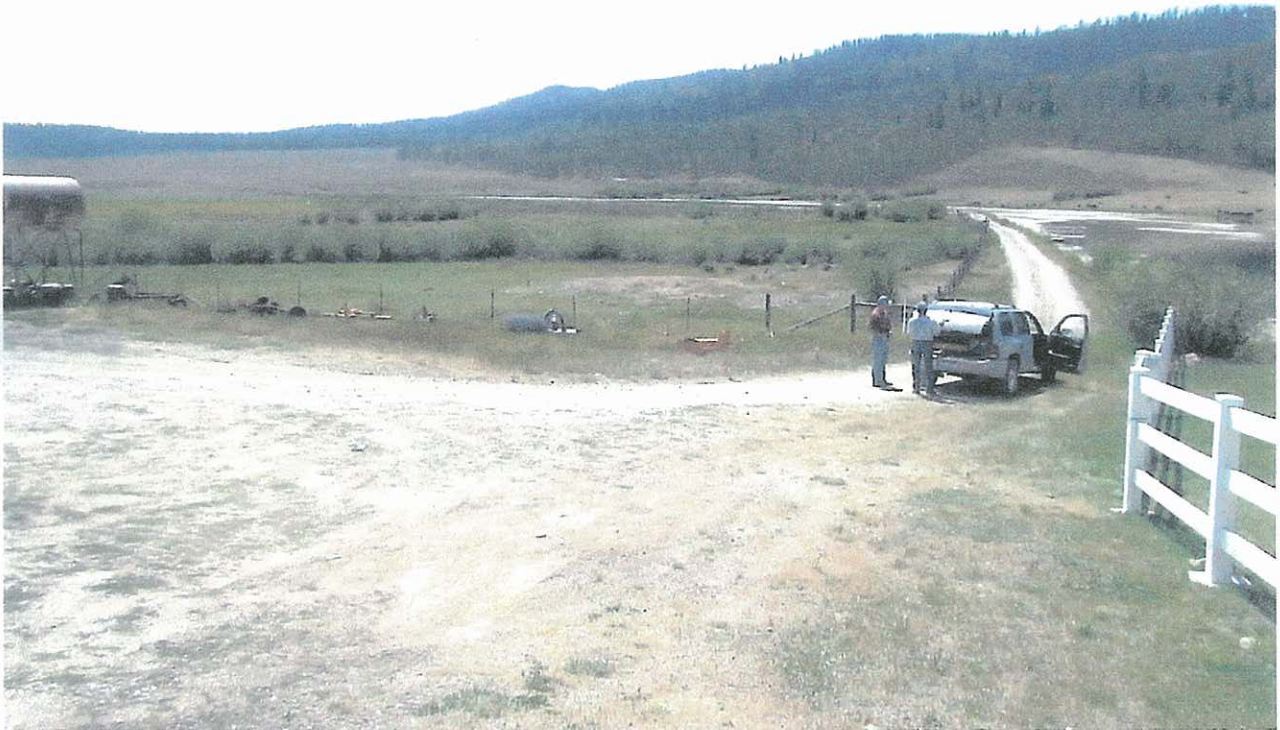
**Dam crest and downstream slope from the left side by the spring that supplies the water for the reservoir.**

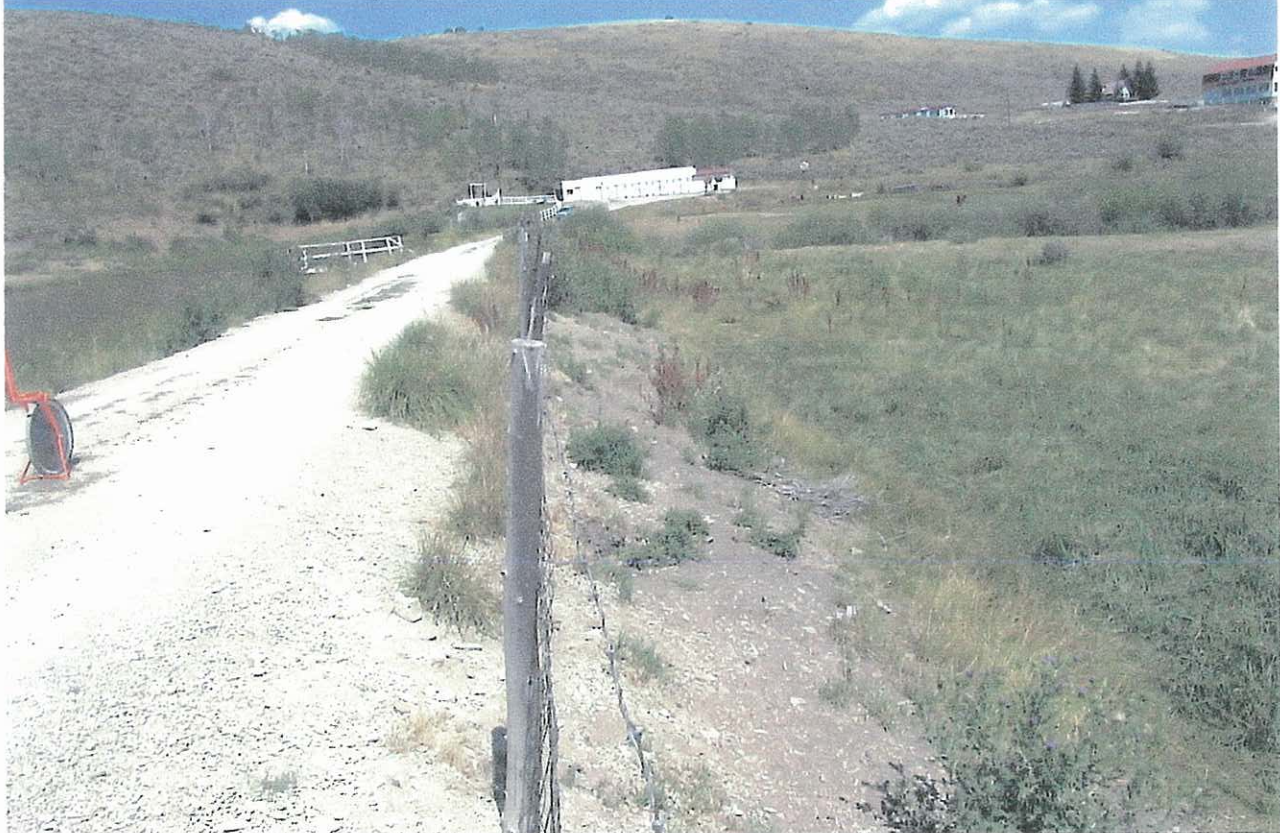
**Left side downstream slope.**
