SAGE WILLOW PNC.  
A33-02133

Photo taken: 14 Nov 95 ABR

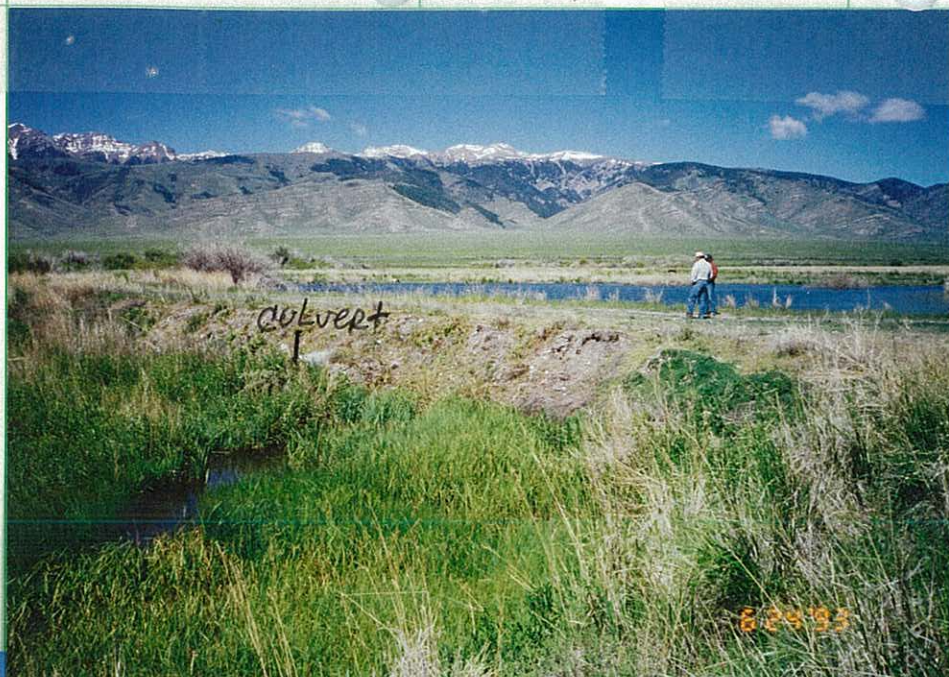
①

POND #1  
-View From Downstream  
SIDE OF DAM.  
NOTE Culvert which  
spills WATER  
to RIVER.

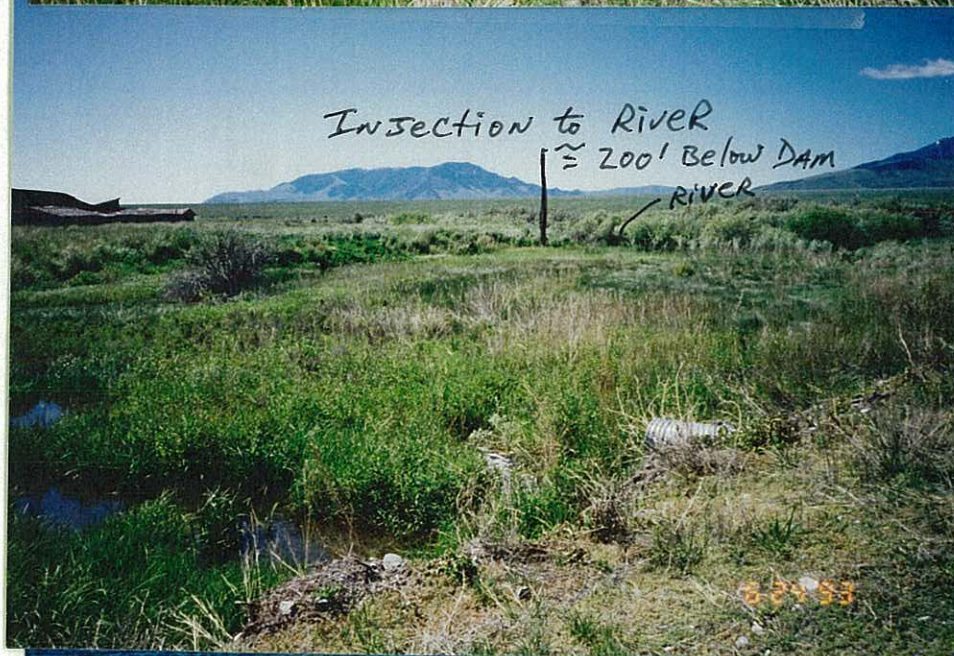
② Looking Southwest  
From DAM of POND  
① to point where water  
enters RIVER

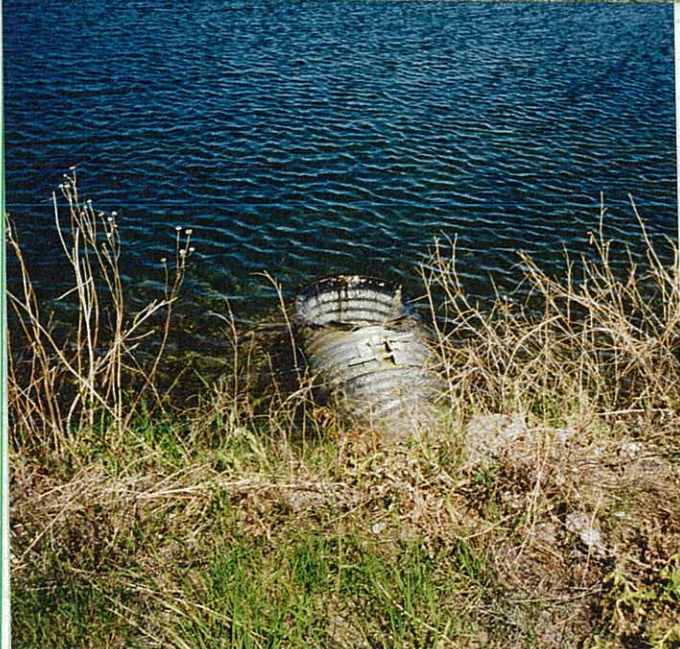
③ Corrugated stand pipe in  
POND 1, LEADS to horizontal  
DISCHARGE pipe.

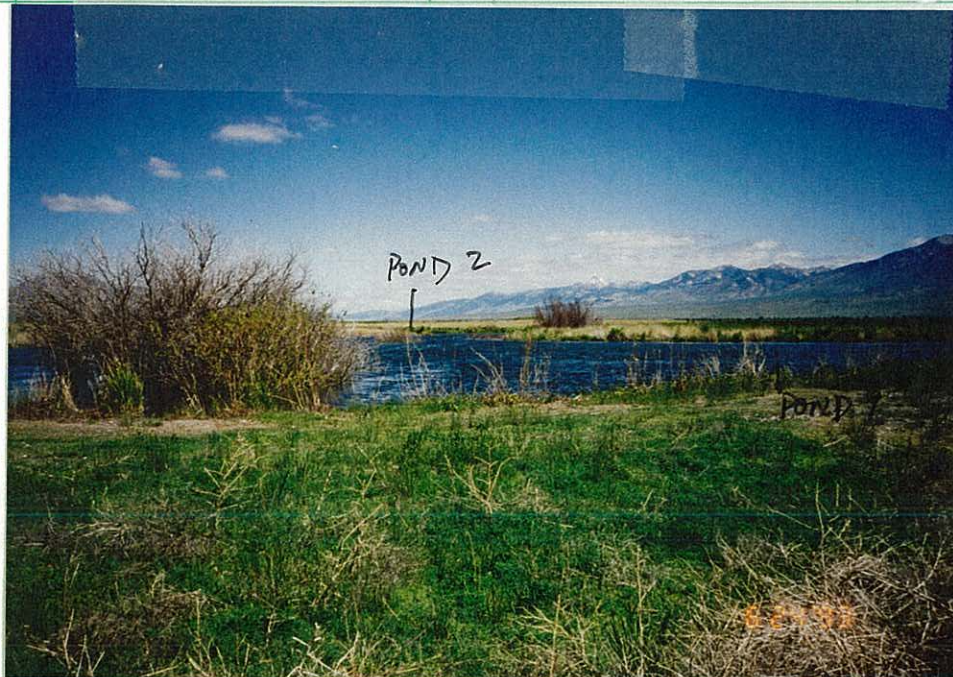
④ View of Pond 1  
From Southwest  
corner of Dam  
Near Bank of Little  
Lost R.

Pond 2 in  
Background

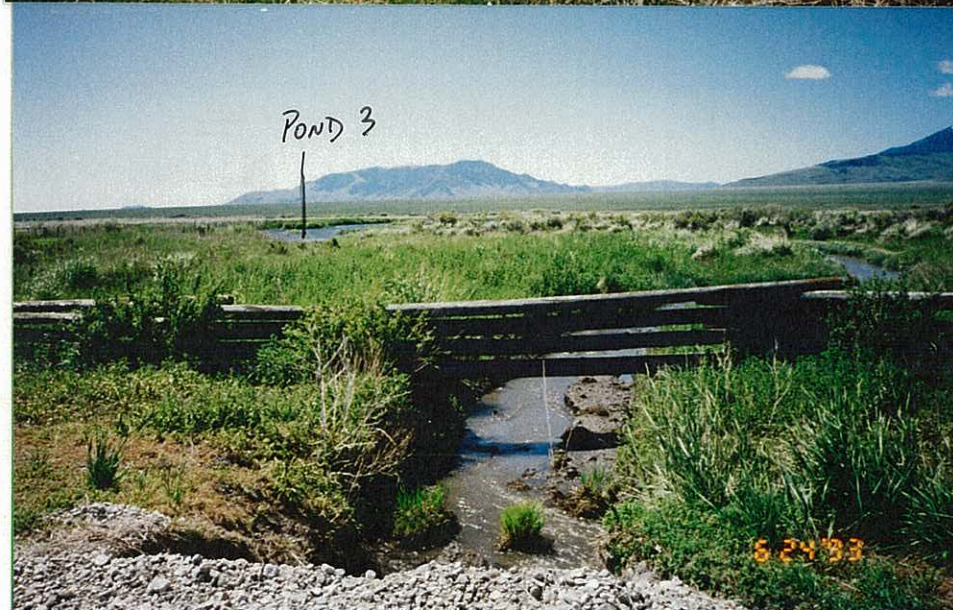
⑤ Inflow to  
Ponds 1-3  
& Pond 3 in  
Background.

View is From  
Road looking South

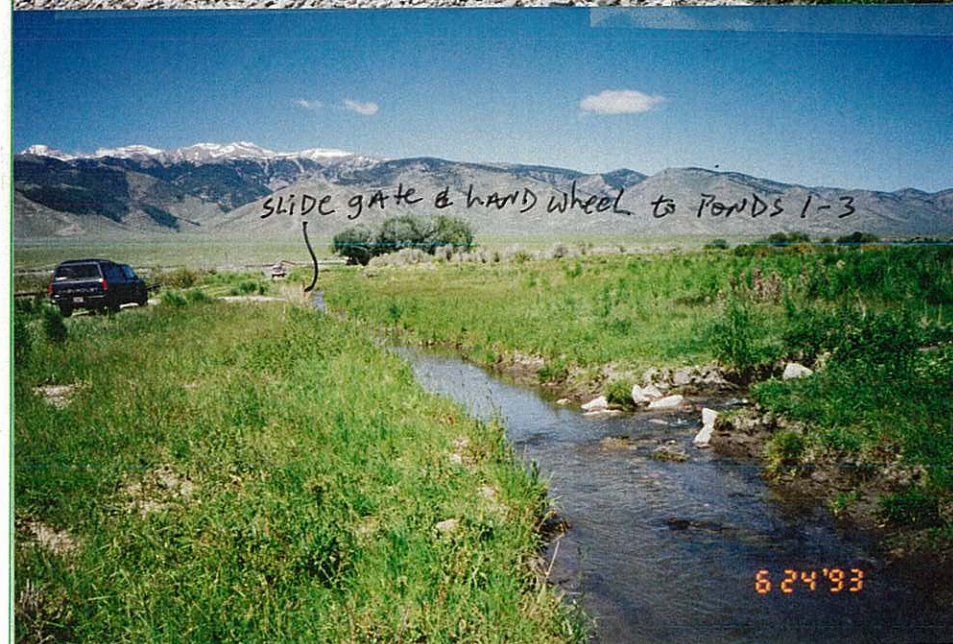
⑥ Ditch Along Road  
which runs east-west  
to Ponds 1-3, and  
Ponds 5-8.

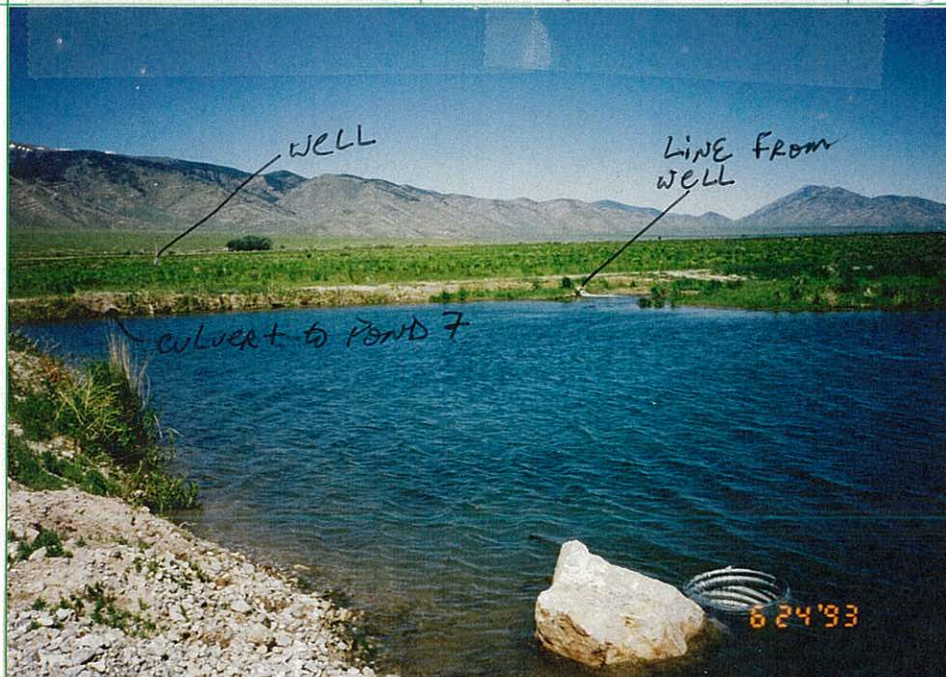
(7) View of Pond 5 From DAM. W/ WELL Discharging Water to Pond, Culvert to Pond 7, AND Sluiceway Spilling Water to Pond 6.

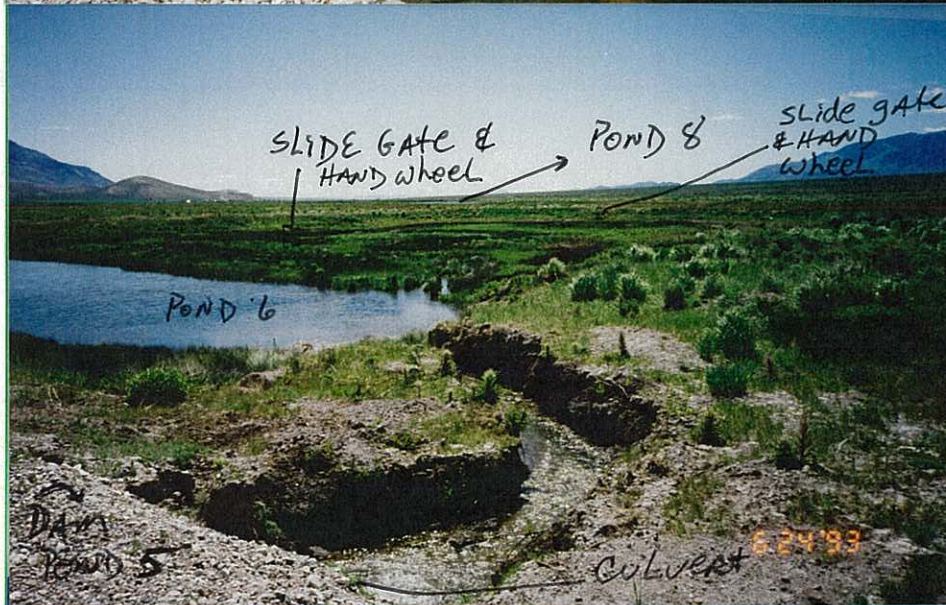
(8) Looking South From DAM ON POND 5; POND 6 in ~~at~~ FOREGROUND & POND 8 in BACKGROUND.

NOTE: Culvert connecting POND 5 to 6 & SLIDE GATES in POND.

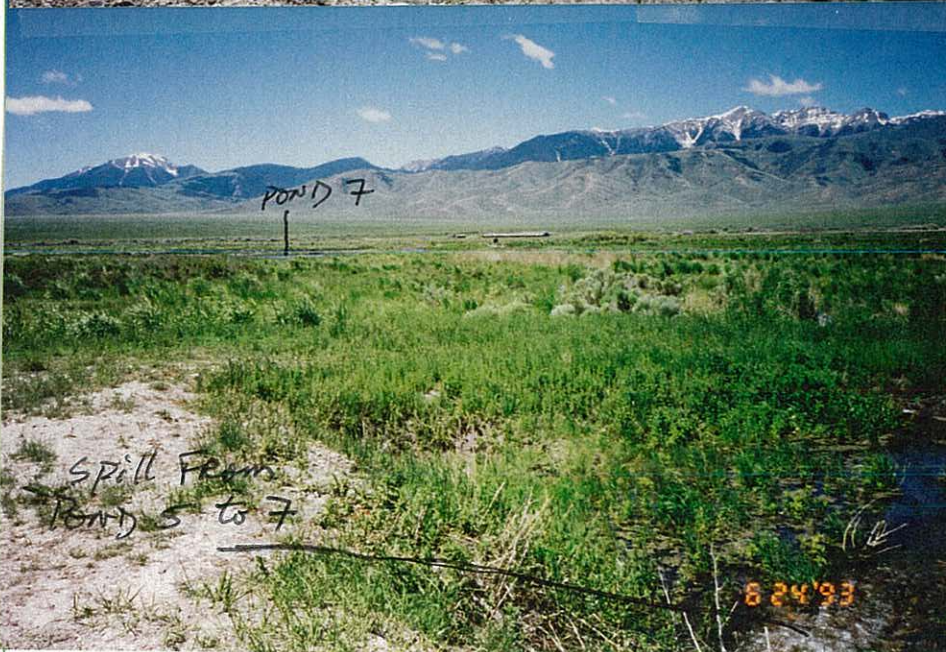
(9) Looking Southwest From POND 5; POND 7 in BACKGROUND. Flow From POND 5 to POND 7 in FOREGROUND.

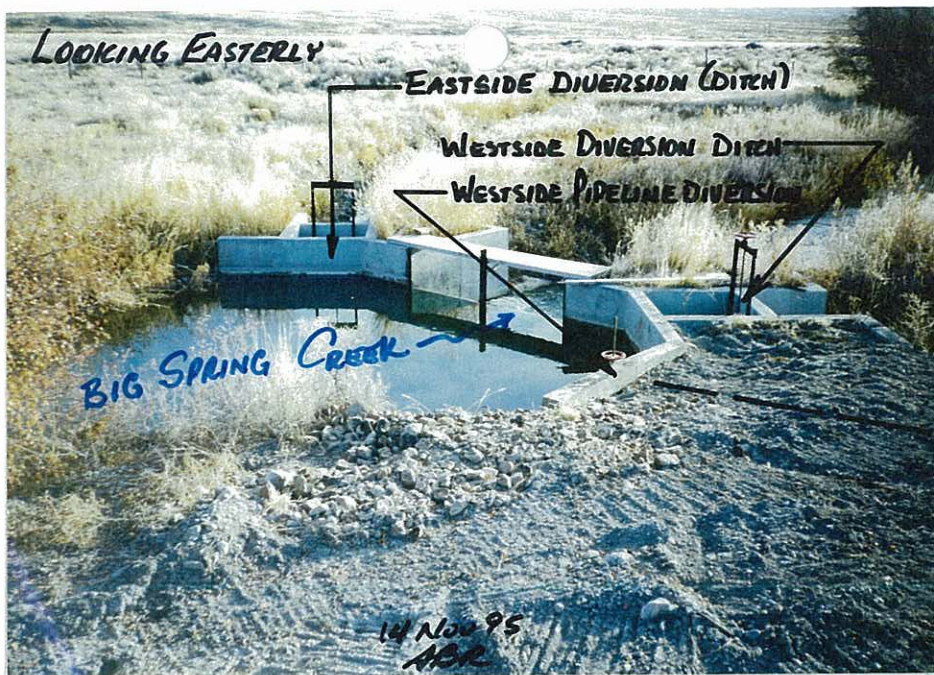
Photo 1. Big Spring Creek

DIVERSION. NOTE THE THREE DIVERSIONS.

THE PIPELINE DIVERSION WAS INSTALLED ABOUT AUGUST 1995. DELIVERS WATER DIRECTLY TO THE POND SHOWN IN PHOTOS 4, 5 & 6.

THIS POINT OF DIVERSION IS LOCATED AT: SENWISW SEC. 5 T. 7N., R. 28E.

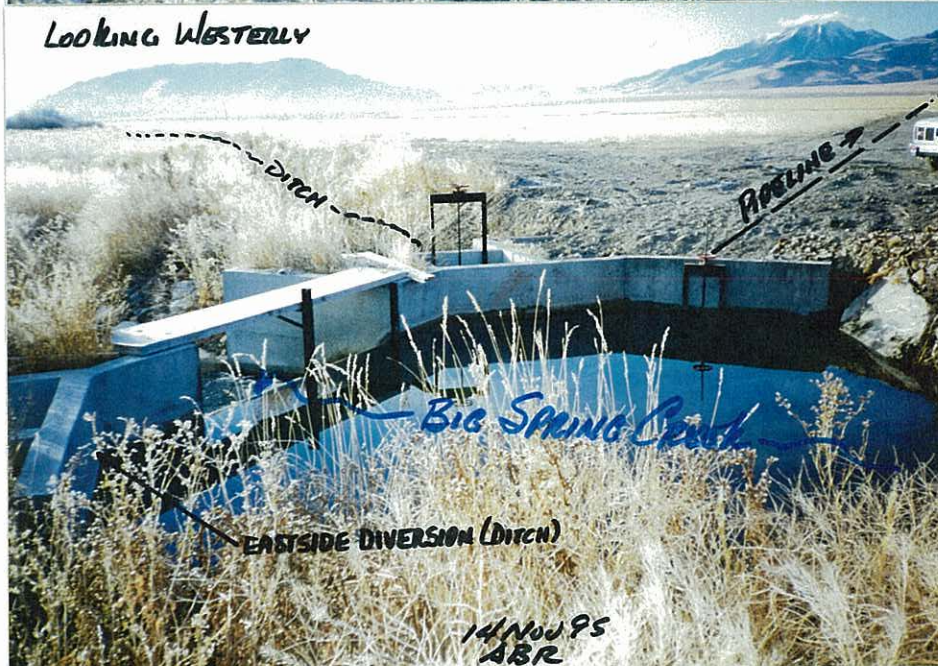
Photo 2. A WESTERLY VIEW OF THE THREE DIVERSIONS IN Photo 1.

NOTE THE BURIED PIPELINE TRACE. THERE ARE NO OUTLETS OR DIVERSIONS FROM THIS PIPELINE.

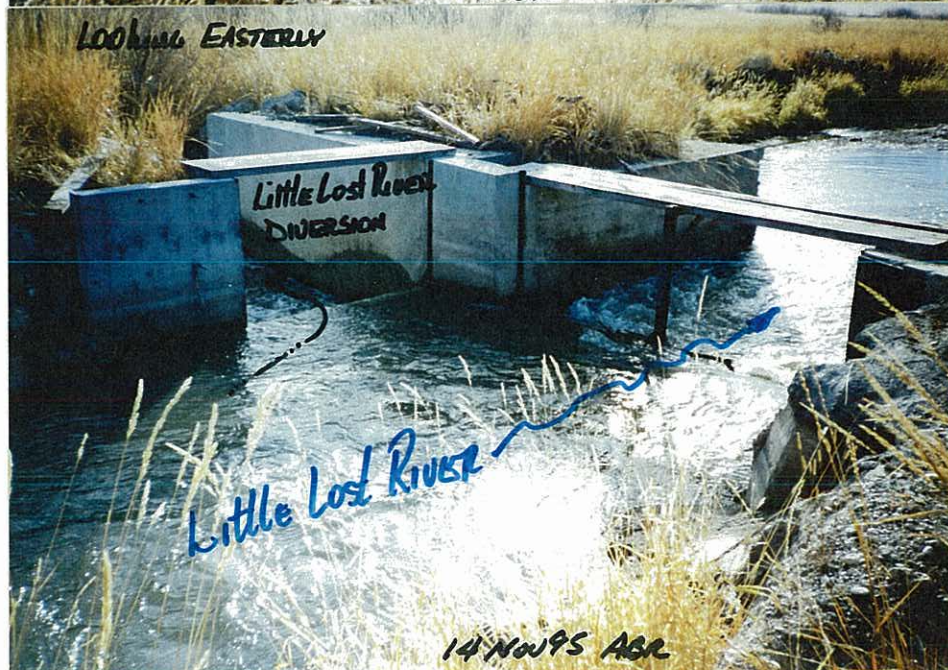
Photo 3. Little Lost River DIVERSION FOR WINTER USE. CONVEYANCE TO THE PLACE OF USE IS BY OPEN DITCH.

THIS POINT OF DIVERSION IS LOCATED AT: NESW 1/4 SEC. 12 T. 7N., R. 27E.

LOOKING NORTHERLY

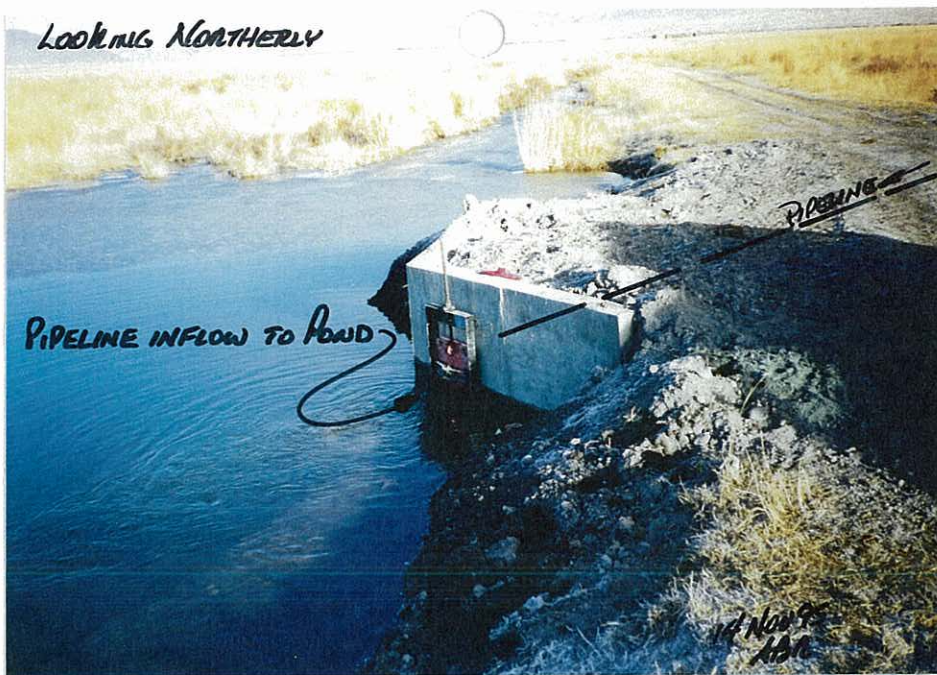
Photo 4. Shows THE BIG SPRING CREEK PIPELINE DISCHARGE TO THE POND AT: SEENSW SEC. 7 T. 9N., R. 2BE.

LOOKING SOUTHWESTERLY

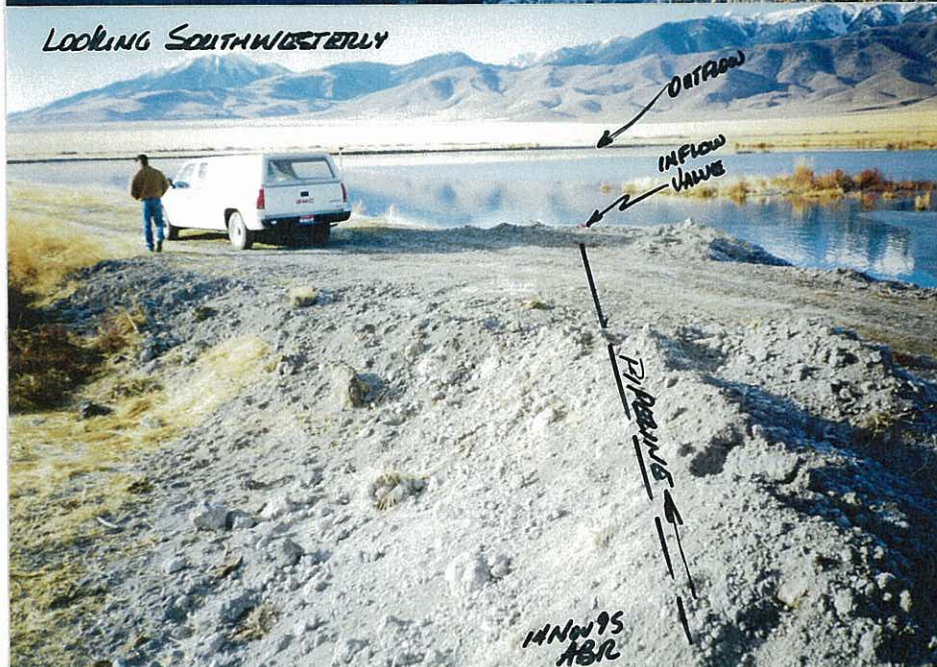
Photo 5. Shows PIPELINE DISCHARGE TO THE POND AND APPROX. LOCATION (IN RELATION TO) OF POND DISCHARGE

LOOKING NORTHEASTERLY

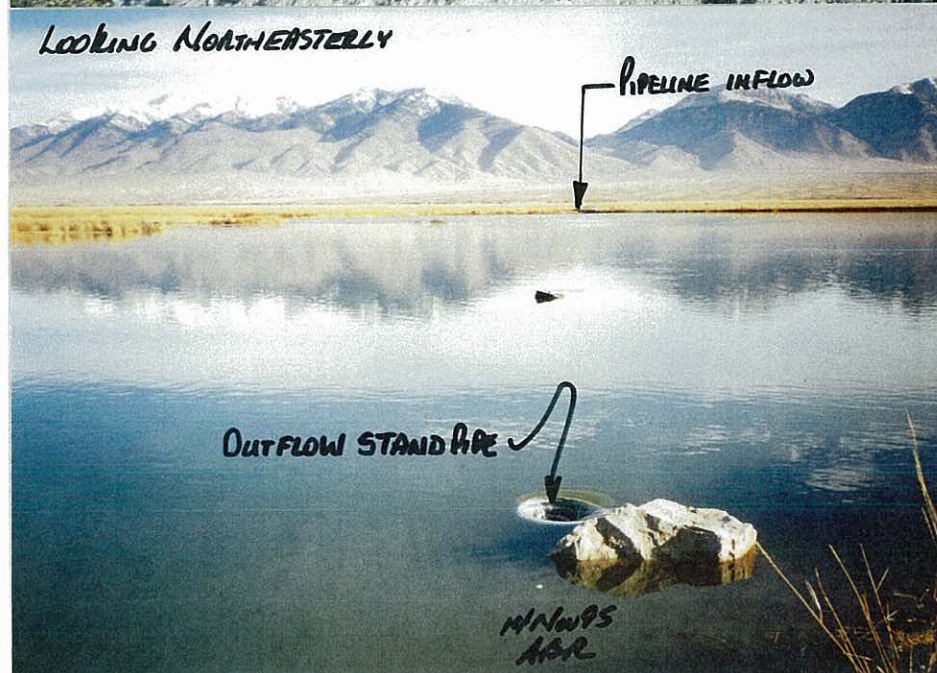
Photo 6. Looking NORTHEASTERLY ACROSS THE POND. SHOWS INLET AND OUTFLOW STANDPIPE.
