Notes from meeting with Patrick Murphy, and Daryl and Pat Hull  
Site visit date: May 1, 2009  
Agent: Monica Van Bussum

Applicable water rights: 75-4126, 75-10603, 75-14531

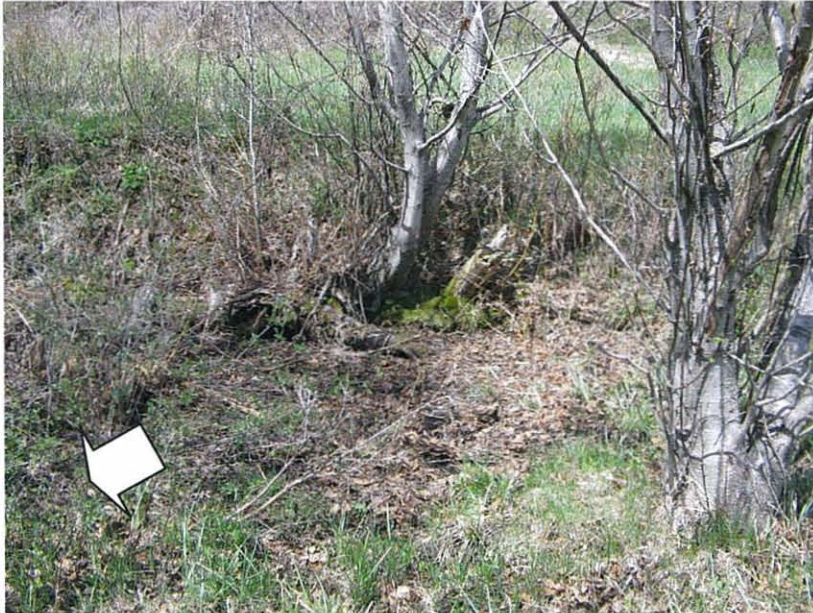
A look at vegetation just upstream of the spring headwaters. While headwaters are not visible, arrow points in general direction of headwaters.

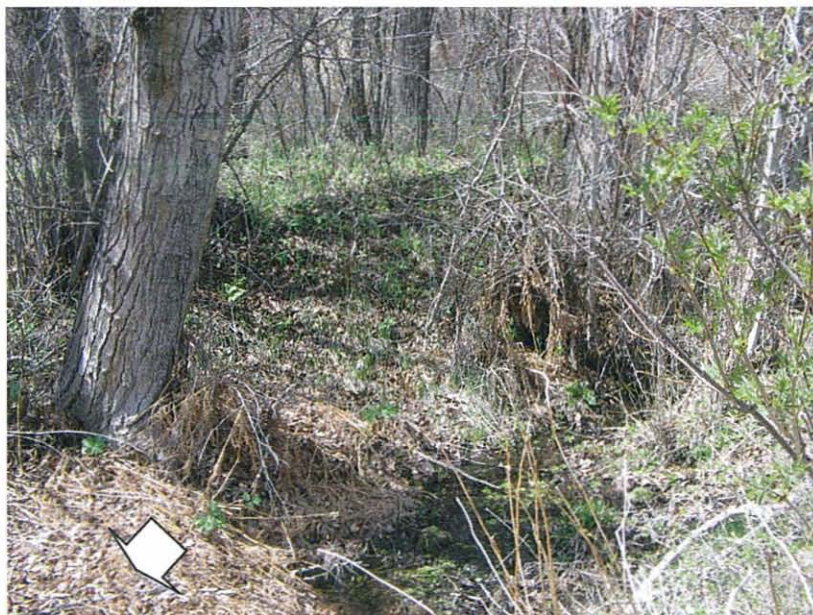
Spring headwaters. Tag A0014987 is on the tree to the left of the picture. Picture taken facing upstream. This is the POD that was originally recommended on 75-4126 and 75-10603.

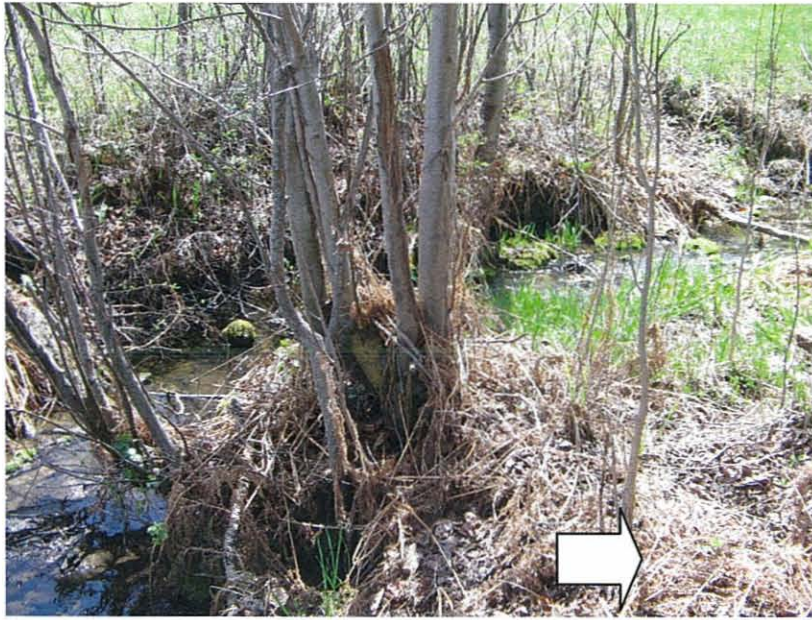
A view of the channel just below the headwaters. There is a lot of vegetation and common water plants in the area. Flow direction is generally indicated by arrow.

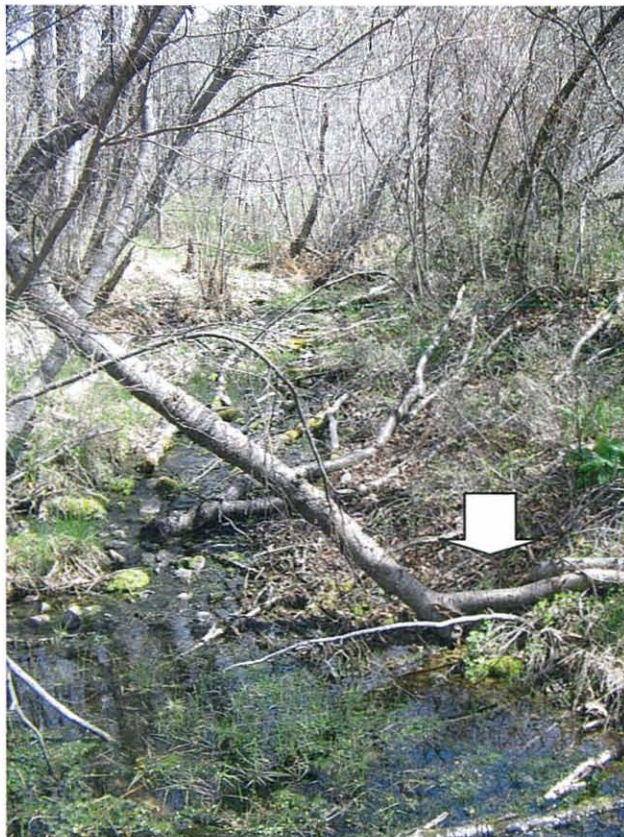
View of the channel further downstream. Picture is taken looking in upstream direction; flow direction generally indicated by arrow. A lot of deadfall is visible in background along channel. In foreground, water plants are visible in channel. These types of plants

are not common in regularly maintained ditches. No indications on channel of any kind of manipulation – shovels, picks, Cats, etc.

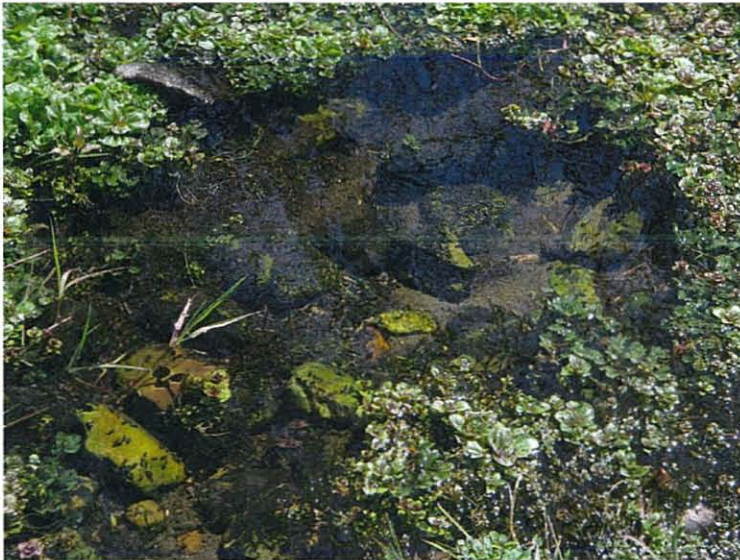
A close-up view of streambed. Notice great quantity of plants. Also, cobbles are clearly visible. This type of substrate composition is not common in maintained ditches, but is more indicative of natural channels.

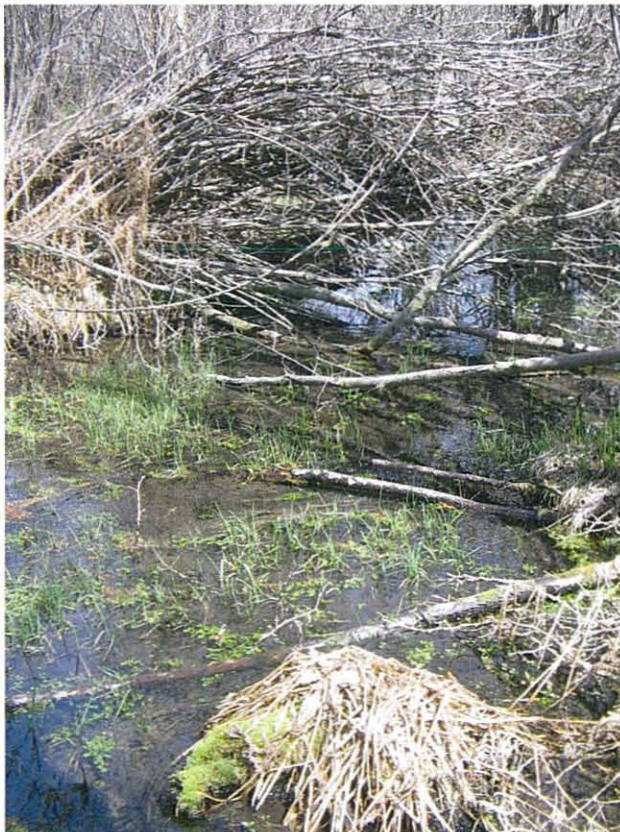
Another view of the channel with a clear view of copious deadfall and aquatic plants. Again, conditions here indicate a natural channel and not a maintained ditch.

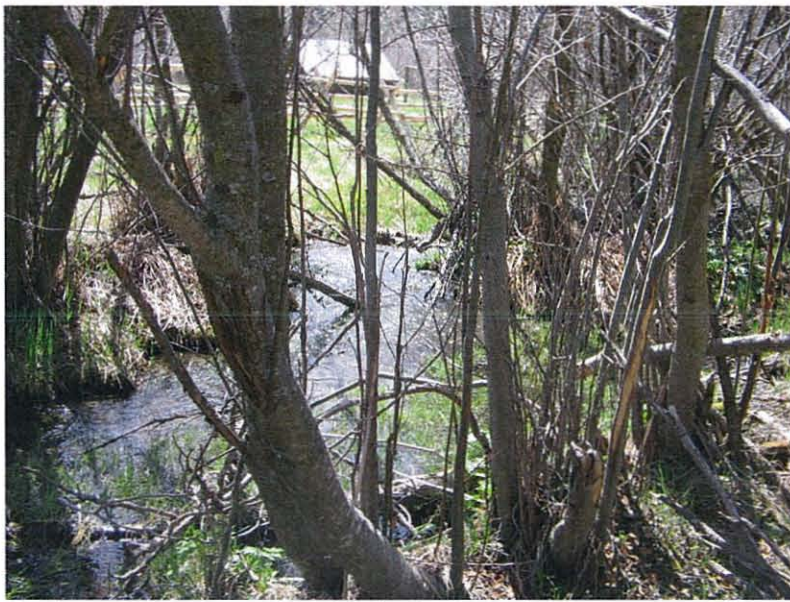
A view of the channel as it winds through some trees. This type of meandering channel again indicates a natural stream as opposed to a human-altered stream. Usually ditches on reasonably flat ground are modified to run along a straight line as opposed to meandering like this. Meandering channels are more indicative of natural paths.

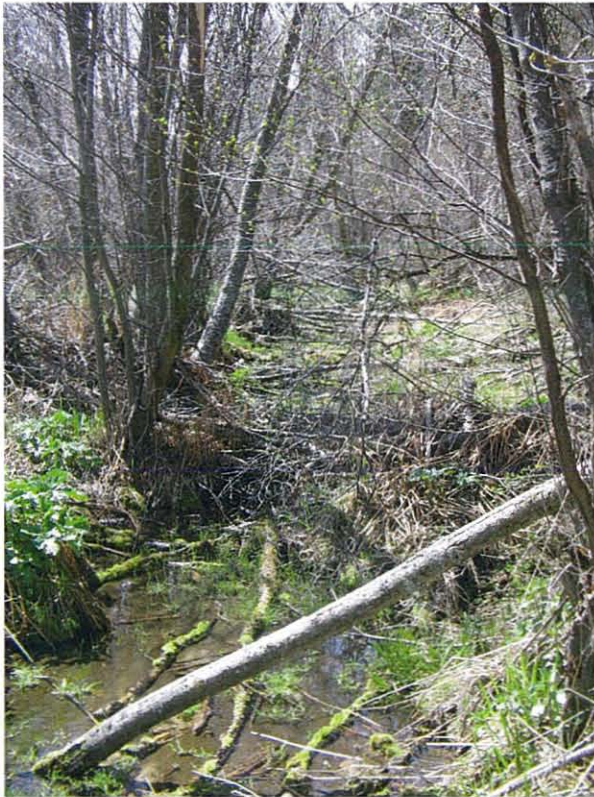
A view of the stream channel as it continues to wind through the Murphy property. Again, substrate composition and this type of channel geometry (wide, shallow channel) is indicative of natural channel and channel does not show signs of maintenance.

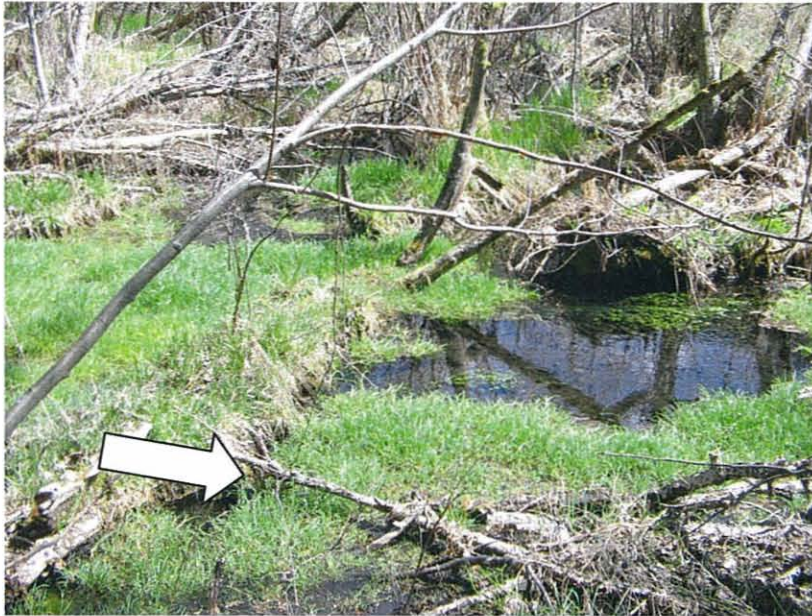
Another view of the channel as it continues toward the footbridge. The extent of aquatic plants here is again indicative of a lack of human intervention in the stream channel, as is the deadfall clearly evidence. Flow direction is indicated by the arrow. Flow rate was very slow, which would facilitate evaporation, again indicating a natural channel.

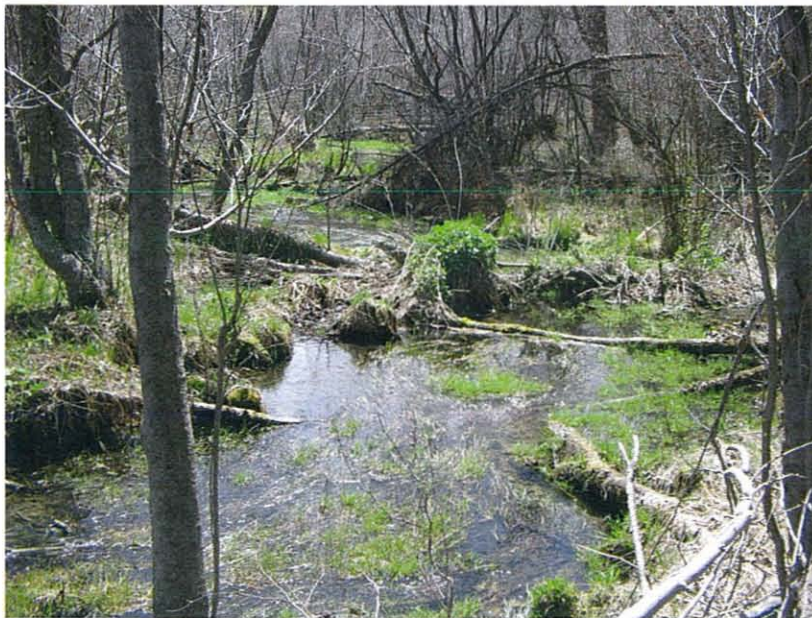
A view of the channel looking downstream. Copious amounts of aquatic plants and deadfall can be seen. Channel geometry is particularly evident here. Note how the channel is broad and flat. Usually ditches in an area like this would be D-shaped and much narrower.

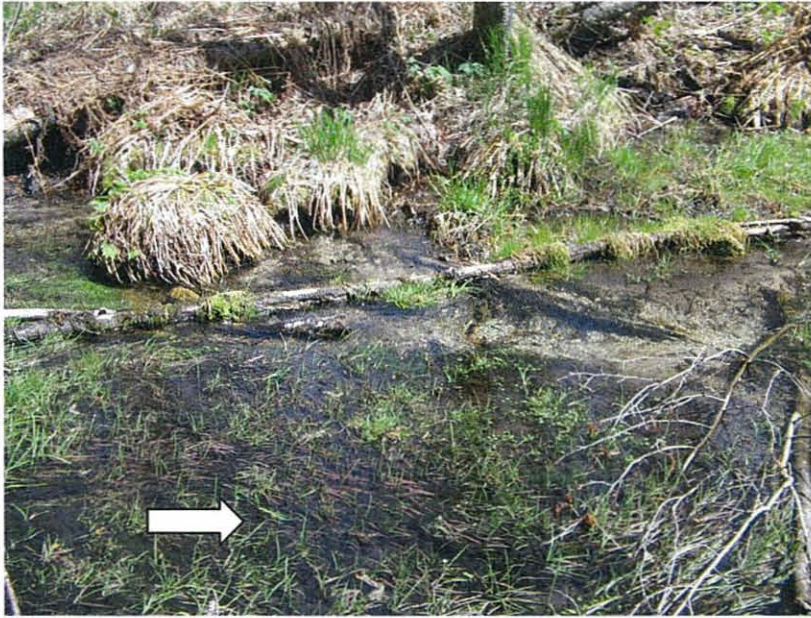
A more close-up view of channel bed and associated aquatic plants. Flow direction is indicated by the arrow.

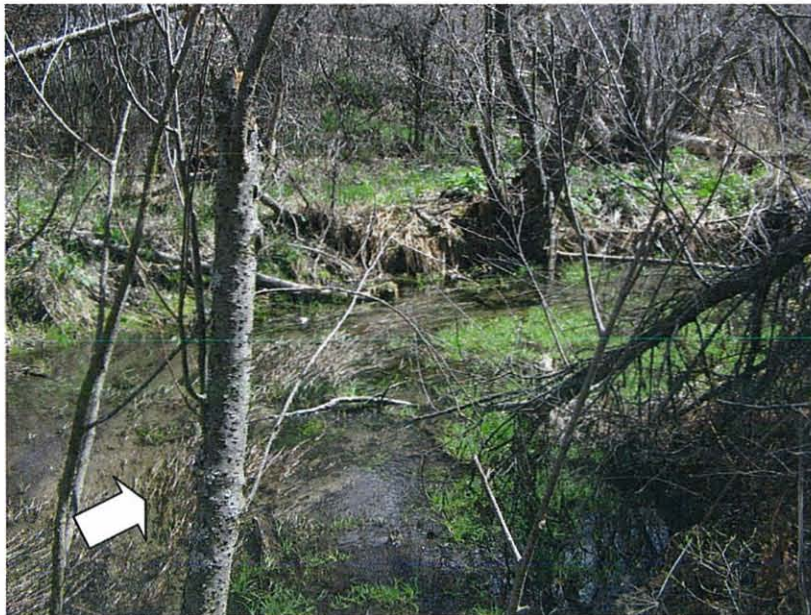
Another view of the stream as it meanders toward the footbridge. General flow direction is noted by the arrow, but flow direction at a given point clearly changes in the picture as the stream meanders.

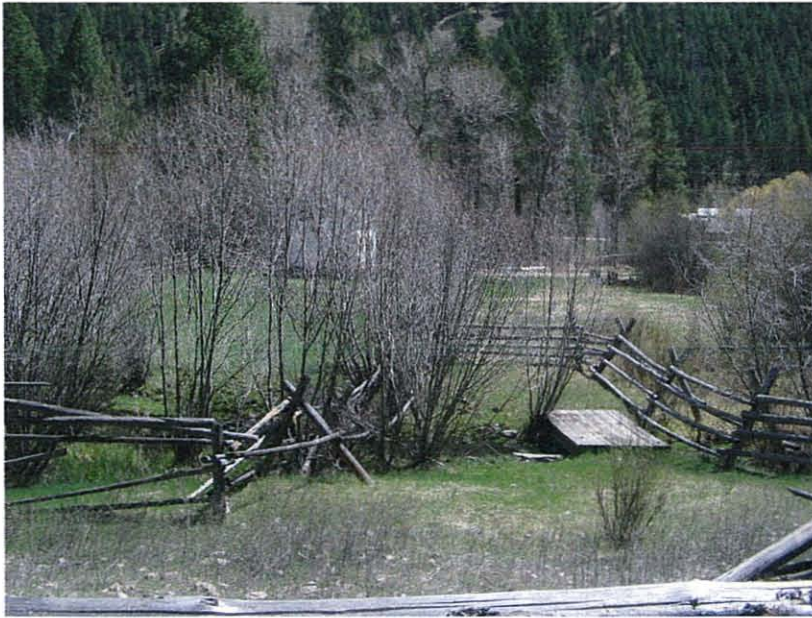
An overland view of the footbridge. The channel enters the land from the left and flow direction is to the right. The footbridge is clearly seen in the right third of the picture.

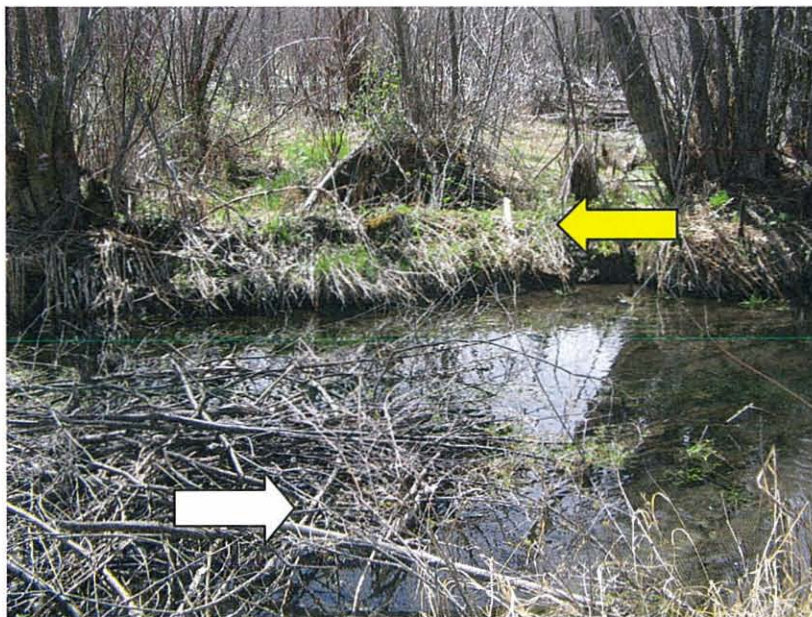
This picture was taken approximately 30-50 yards downstream from the footbridge. The berm seen in the top third of the picture, noted by the yellow arrow, is the first indication of human intervention on the stream. If the berm was not in place, the water would flow straight out from the perspective of this photo and continue along into a flat, shallow floodplain resembling a wetland/swampland similar to that seen upstream of the footbridge. Flow direction is noted by the white arrow.

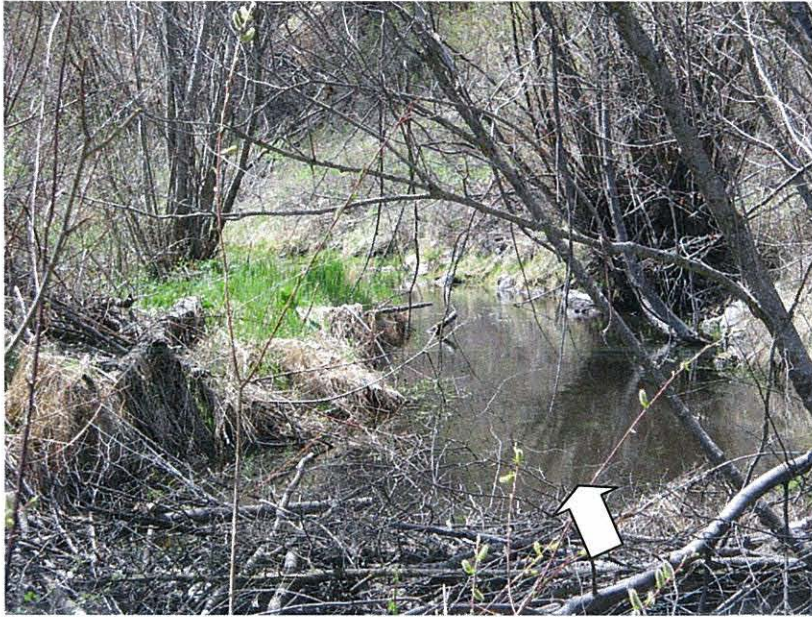
A view of the channel just below the berm. Note the more uniform shape of the channel and lack of aquatic plants and deadfall. Flow direction is noted by the arrow.

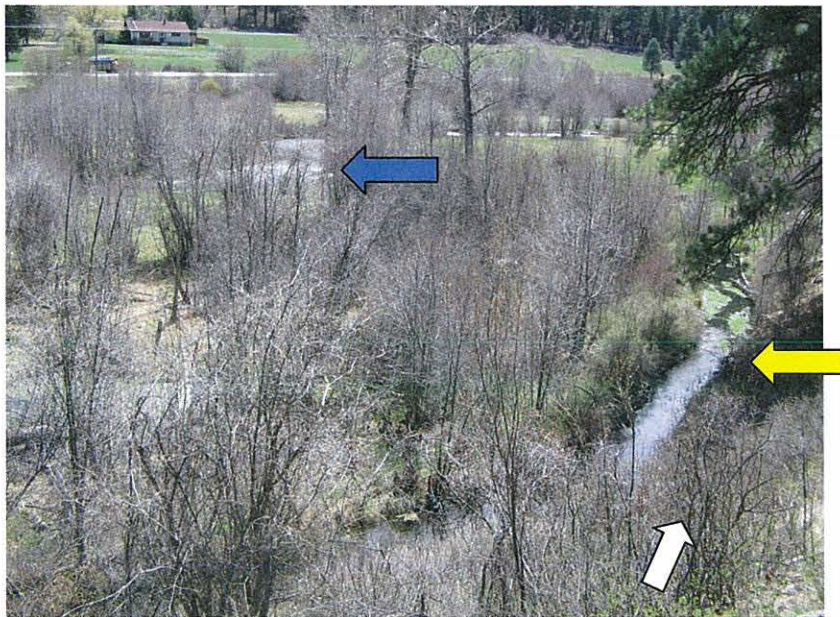
A view taken of the ditch and North Fork Salmon River from the hillslope above. The ditch is clearly visible in the right third of the picture and is noted by the yellow arrow. The North Fork is visible in the top third, or background, of the picture, and is noted by the blue arrow. General flow direction is noted by the white arrow. Again, the ditch/channel exhibits the characteristics of a human-altered and maintained ditch in this area, particularly in channel geometry (D-shaped channel), lack of aquatic plants and lack of deadfall.

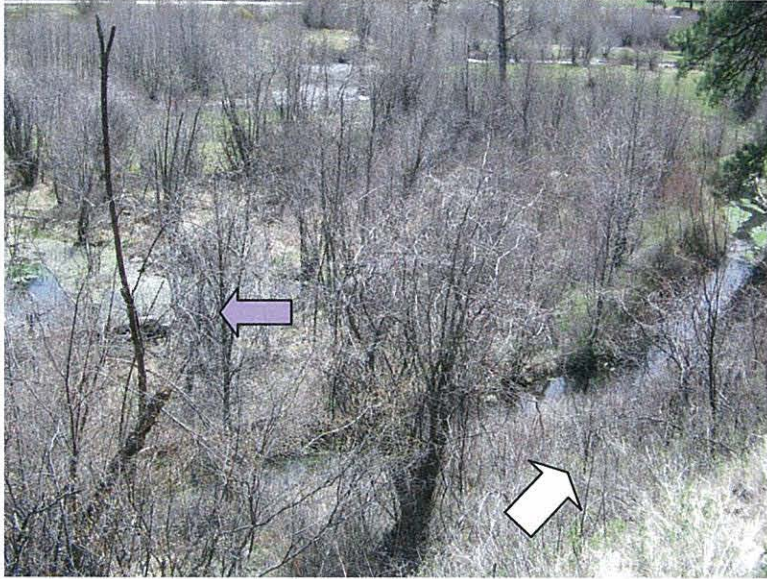
A final overhead view of the ditch and the North Fork from above. Note the left side of the picture where a marsh/swampland is visible. If not bermed, this is where the spring water would run, eventually converging with the North Fork. Instead, the ditch water is conveyed to downstream users. The marsh/swampland is noted by the purple arrow and flow direction is noted by the white arrow.

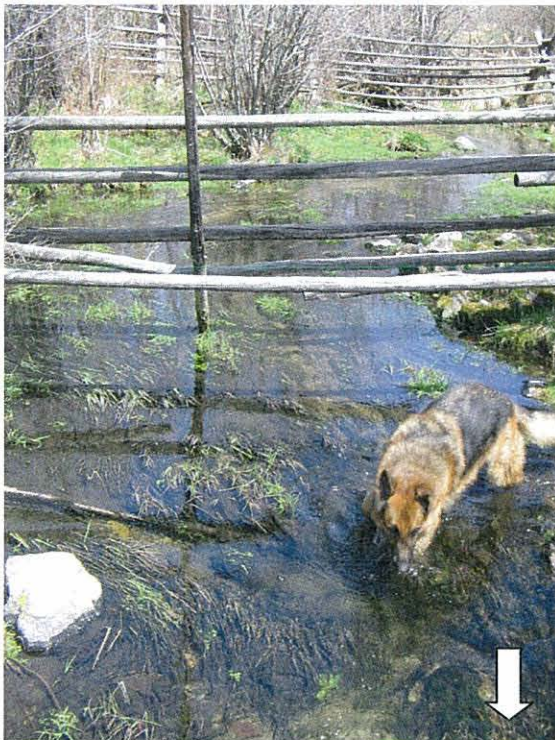
This picture was taken standing on the footbridge looking upstream toward the Murphy property. Extensive aquatic vegetation and a meandering stream path can be seen clearly. Flow direction is noted by the arrow.

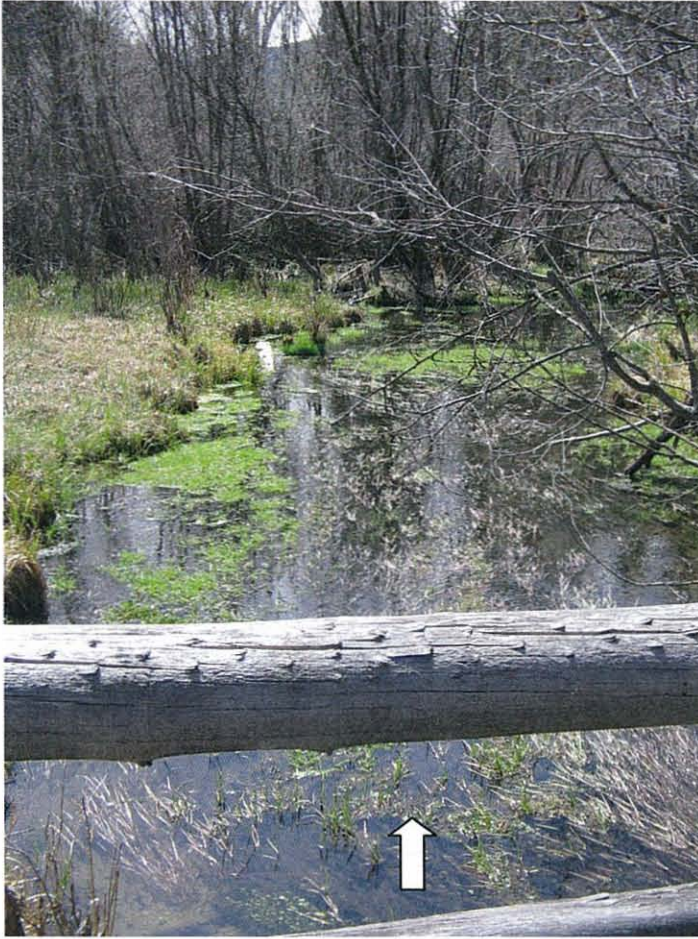
This picture was taken standing on the footbridge looking downstream toward the berm. The stream meanders right in the background of this picture and the berm is around the corner. Again, the channel exhibits wide, shallow geometry indicative of a natural channel, with extensive aquatic plants. Streambanks also are indicative of a natural channel in that they are sinuous where most ditches maintain uniform banks. General flow direction is noted by the arrow.
