## Dam Safety Section

### TRIP REPORT

**TO:** Dam File 75-14465  
**FROM:** John Falk, PE  
**DATE:** July 13, 2009  
**SUBJECT:** Chipps Creek Reservoir

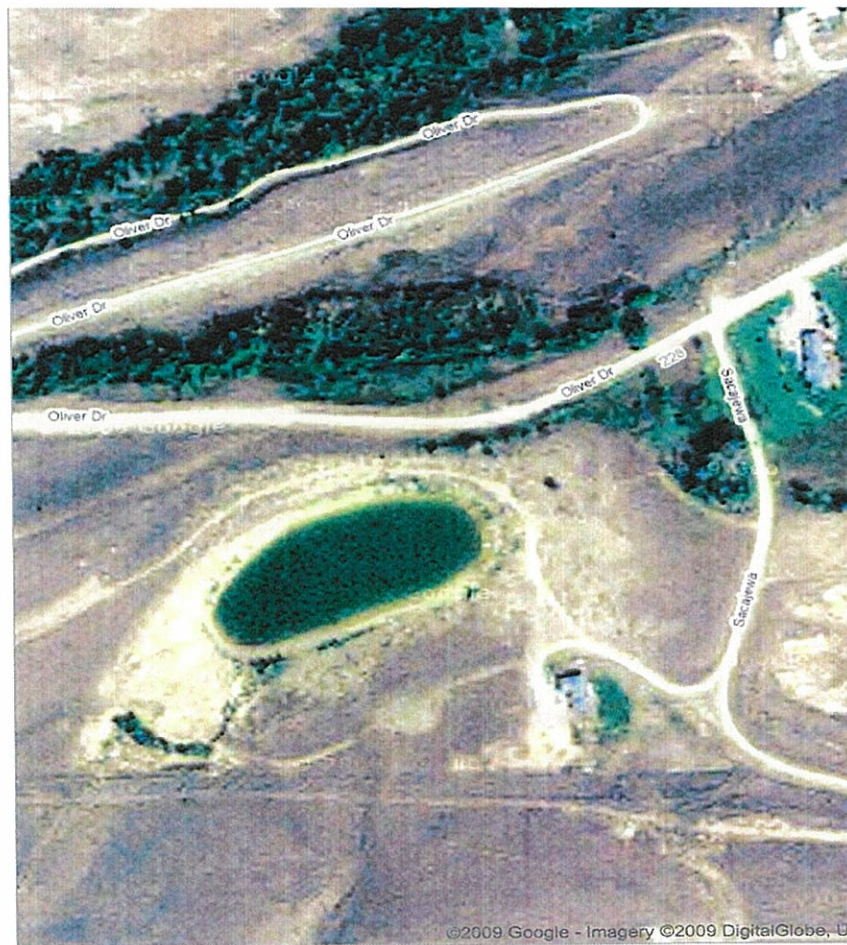
Photo 1 – Aerial view showing reservoir and its relationship to Oliver Drive. Note the location of the residence near the intersection of Oliver Drive and Sacajawea Road.

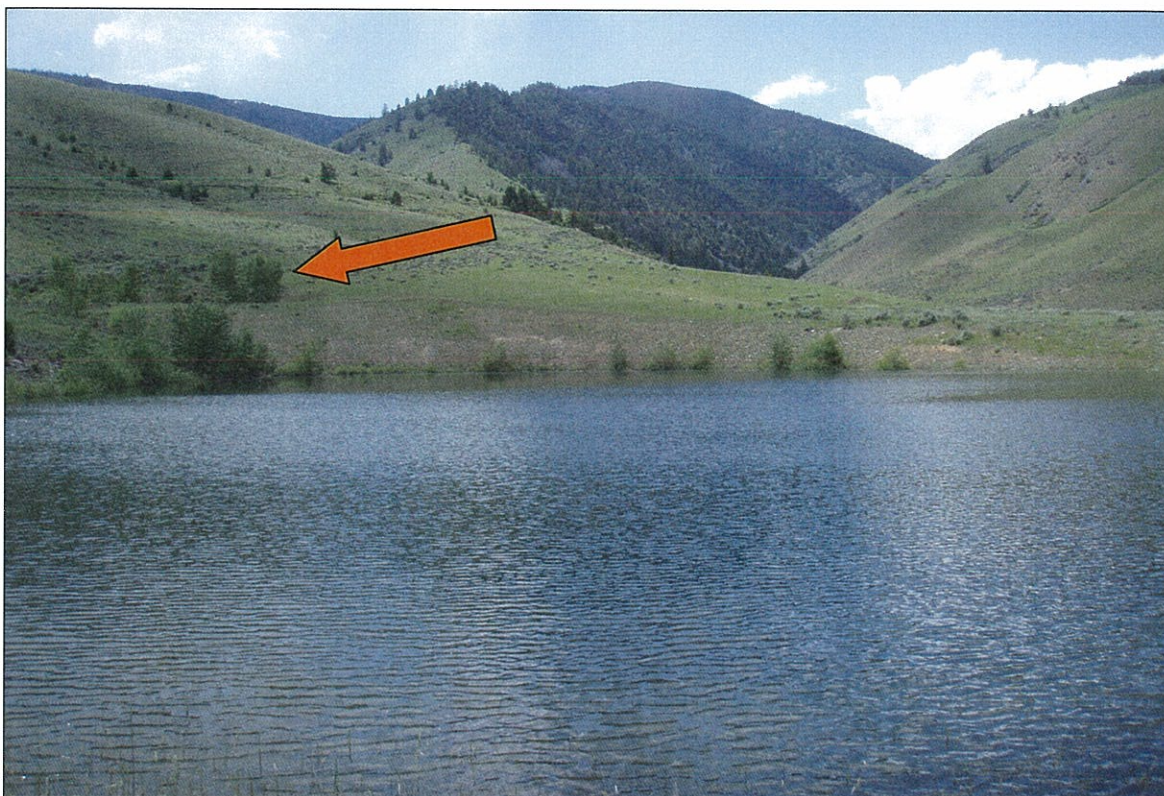
The reservoir apparently is filled by a combination of surface runoff from hillside drainage and water from a developed artesian spring (Photo 2). Flow into the reservoir at the time of the site visit was 30 gpm, or less. An emergency spillway did not appear to exist; neither could I locate a low level outlet conduit. Seepage was evident along the north and east, downstream toe of the embankment. Discharge rates were difficult to estimate due to a long strip of rounded river-rock that had been placed adjacent to Oliver Drive. This coarse gravel appears to function as a “French Drain” for the express purpose of diverting leakage from the reservoir away from the roadway (Photo 3). All seepage from the dam appeared to flow toward a common point at the downstream toe where it was routed into a small drainage ditch, presumably for irrigation purposes (Photo 4).

**Photo 2 (6/25/09) - Upstream view from dam crest looking across the reservoir to the primary source of water, supplied by a developed, artesian spring (shown by arrow).**

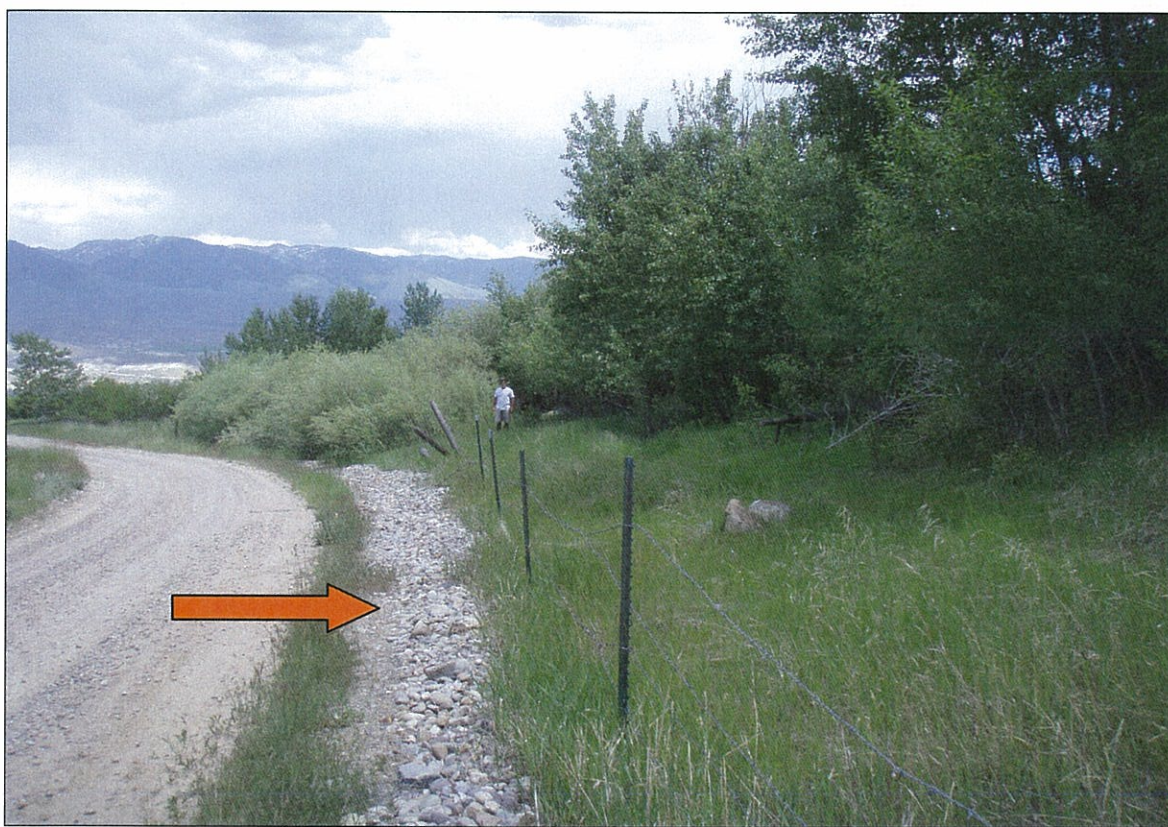
This project exists at an elevated risk for failure due to 1) the lack of an emergency overflow spillway to prevent overtopping of the embankment and 2) the absence of a low-level outlet conduit that could be used to lower or to drain the reservoir in the event of an emergency. Lastly, the lack of design drawings or construction details, together with the seepage along the toe of the slope contributes to my concern regarding the integrity of the embankment.

**Photo 3 (6/25/09) - Oliver Road, looking east along the north side of the existing embankment. Seepage from the toe of the slope is collected in the gravel drain material (shown by arrow). Note the heavy growth of trees and brush on the downstream slope of the dam.**

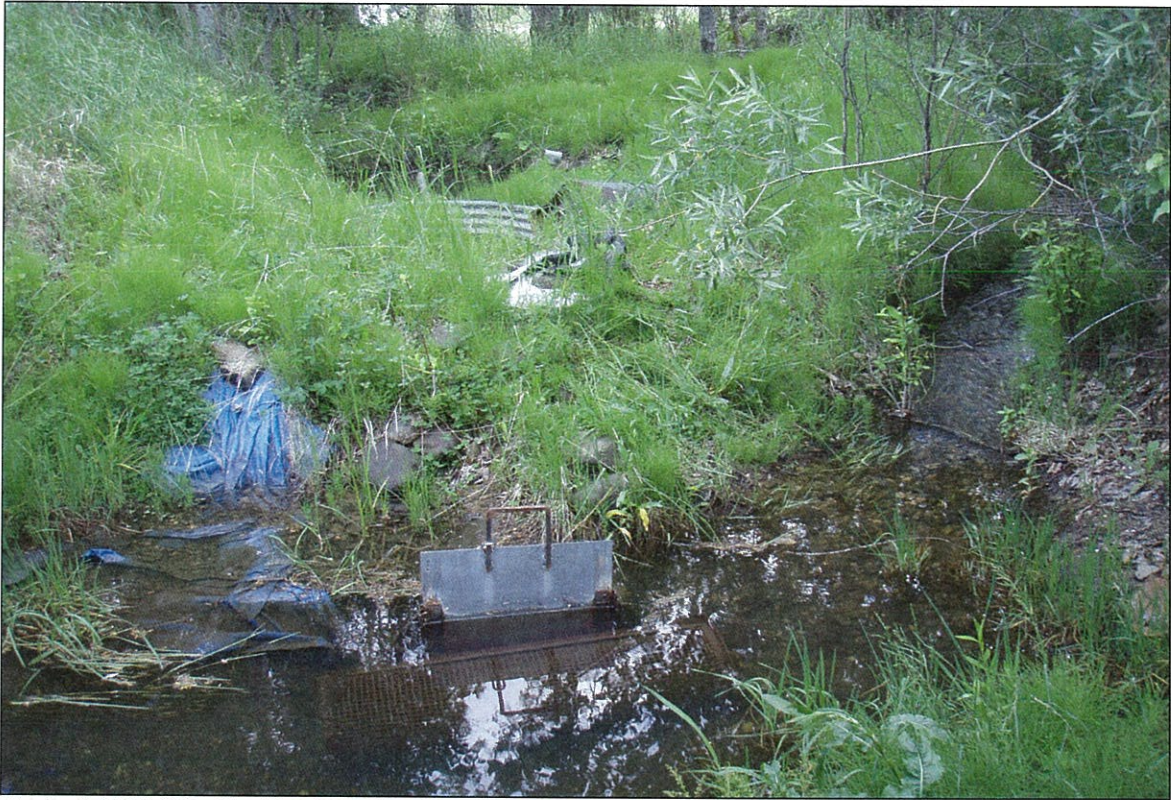
**Photo 4 (6-25-09) - Facility for collection of seepage from the dam. This feature exists on the east side of the embankment. At the time, the rate of flow in the ditch (right) was estimated ~20-25 gpm.**

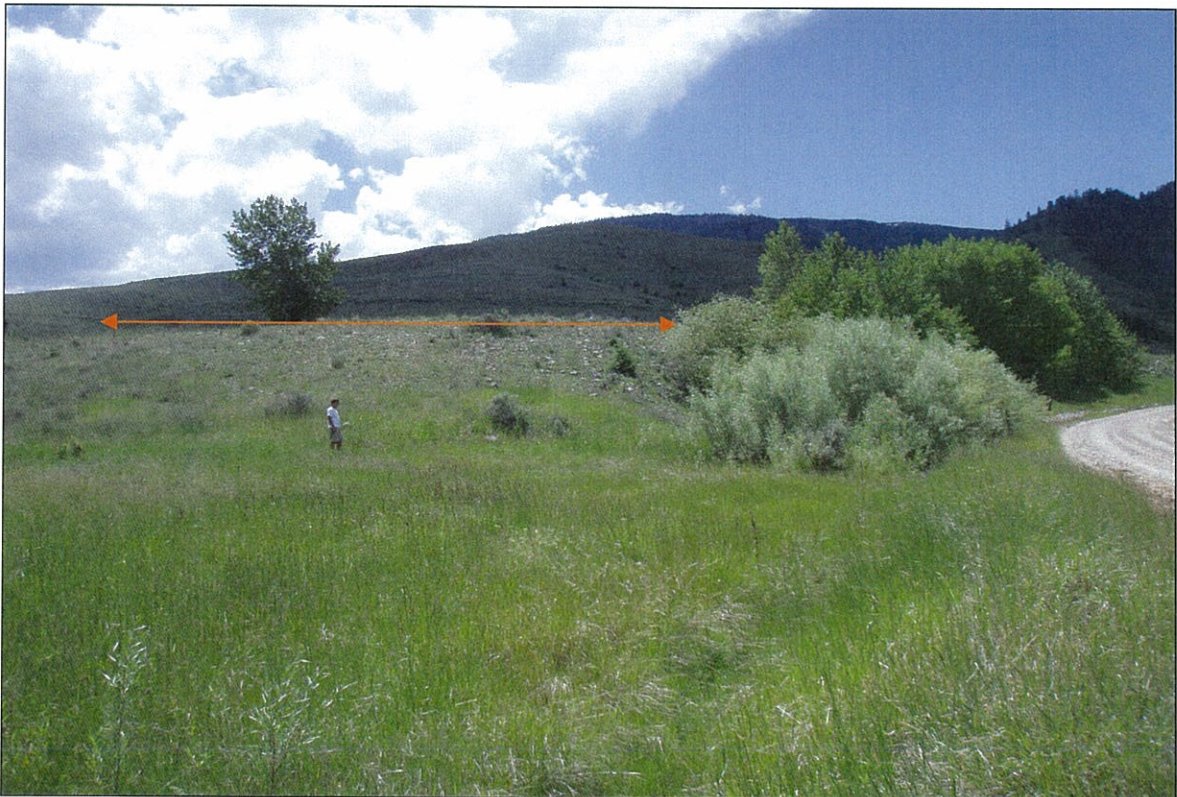
| • Embankment Height * | 15 feet (est) | Photo 5 |

**Photo 5 (6/25/09) - View looking at the downstream slope of the dam near maximum section. Note the location of Oliver Road (right), and the heavy growth of vegetation on north side of the embankment.**

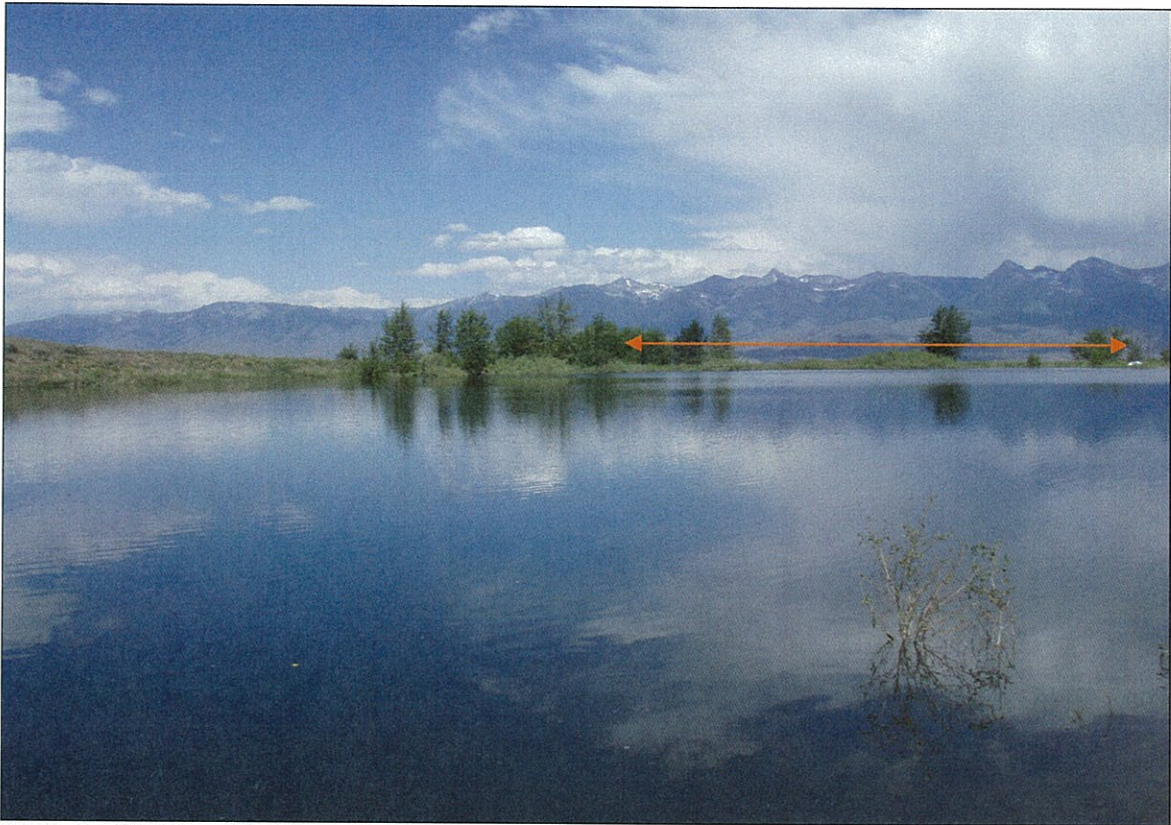
| • Freeboard | 1 foot (est) | Photo 6 |

**Photo 6 (6/25/09) - View from the back of the reservoir looking east, toward the crest of the embankment. Note the elevated water level referenced by the submerged vegetation.**

I recommend this dam be modified to include the installation of an emergency overflow spillway. Issuance of a formal Water Right to the owner(s) of this dam should not be approved until such repair is implemented to the satisfaction of IDWR Dam Safety. In the interim, this structure will be added to the state inventory of dams for regular inspection.

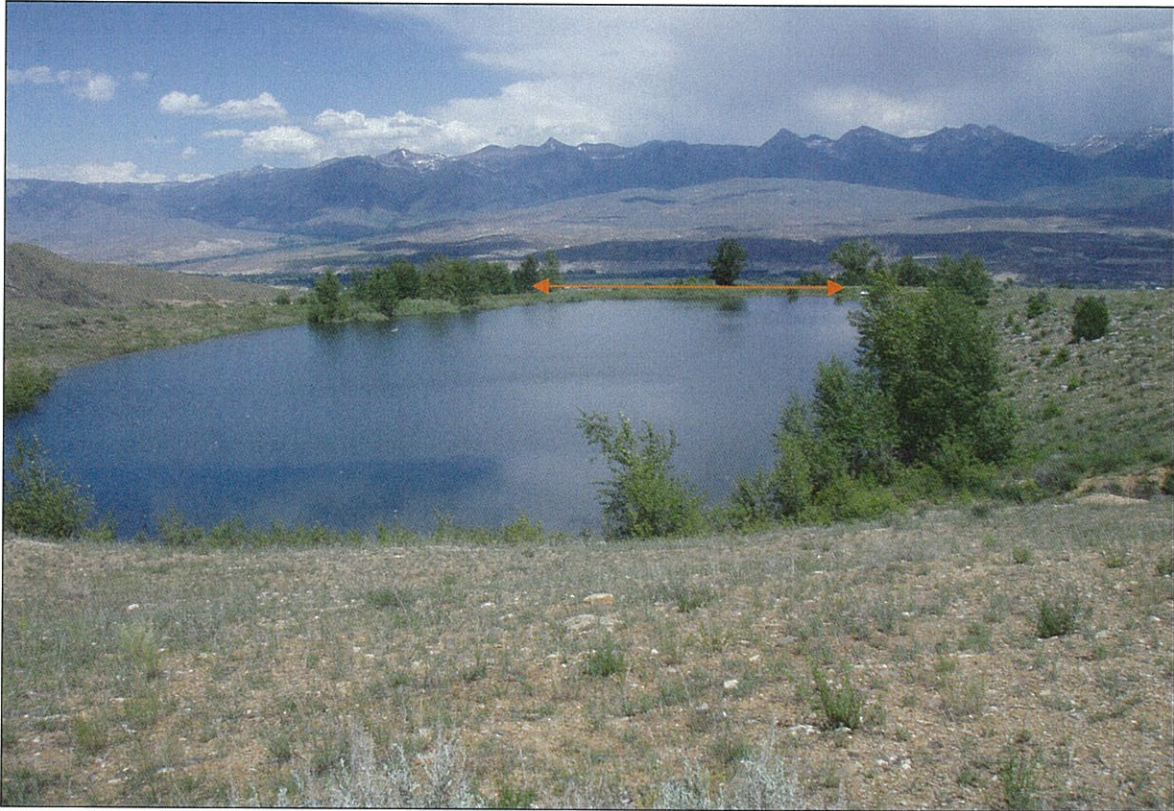
| • Pool Surface Area | 4 acres (est) | Photo 7 |

**Figure 7 (6/25/09) - Overview of existing dam (background) and reservoir. The treed area in the photograph right-front corner is the channel carrying water from the spring to the reservoir.**

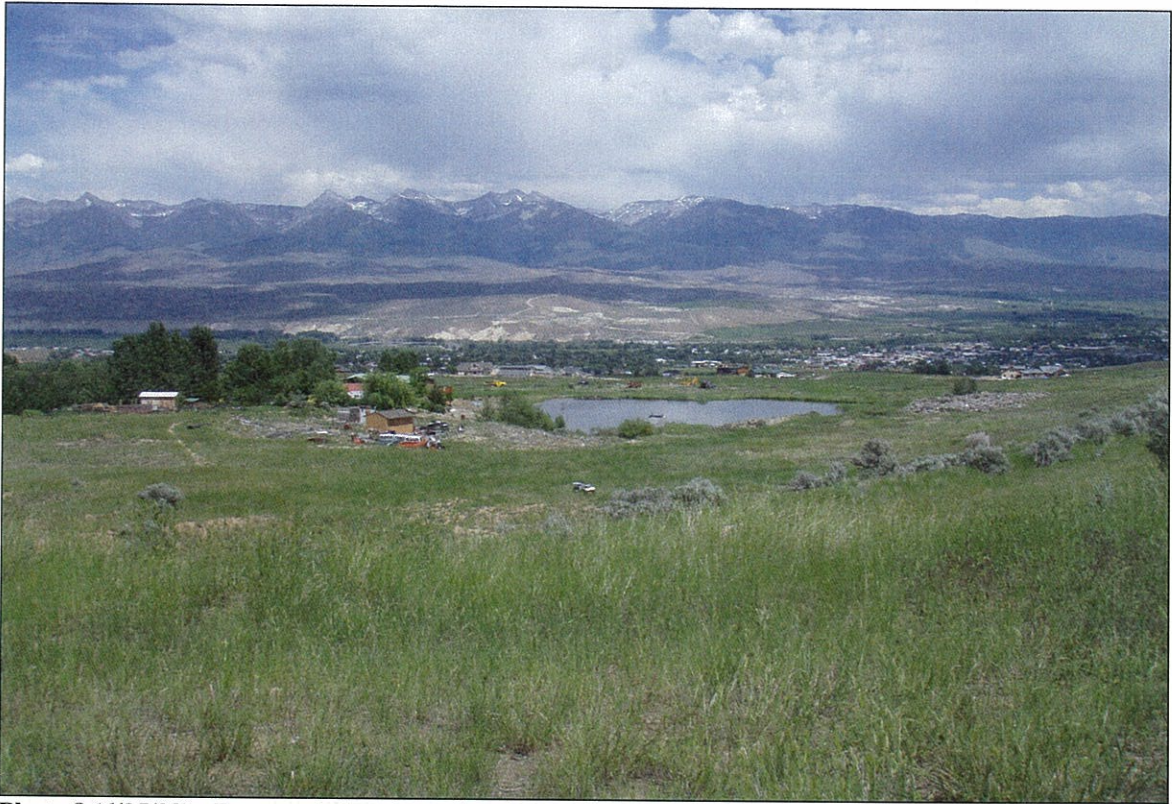
I also investigated the drainage path below the dam. A single residence on Oliver Drive exists in close proximity to the dam. In the event of a catastrophic dam failure and sudden release of reservoir contents, this property likely would experience significant flooding damages. A smaller, more shallow, and younger reservoir is located about one-quarter mile downstream. It appears that flood water from a catastrophic failure of the upper dam likely would overtop this pond, resulting in its failure. For these two reasons, the existing upper structure is rated a Significant-hazard dam.

**Photo 8 (6/25/09) - Eastward view from Sacajawea Road, located near downstream toe of existing (Chipps) dam. The small pond in the foreground lies within the inundation zone of the existing dam.**

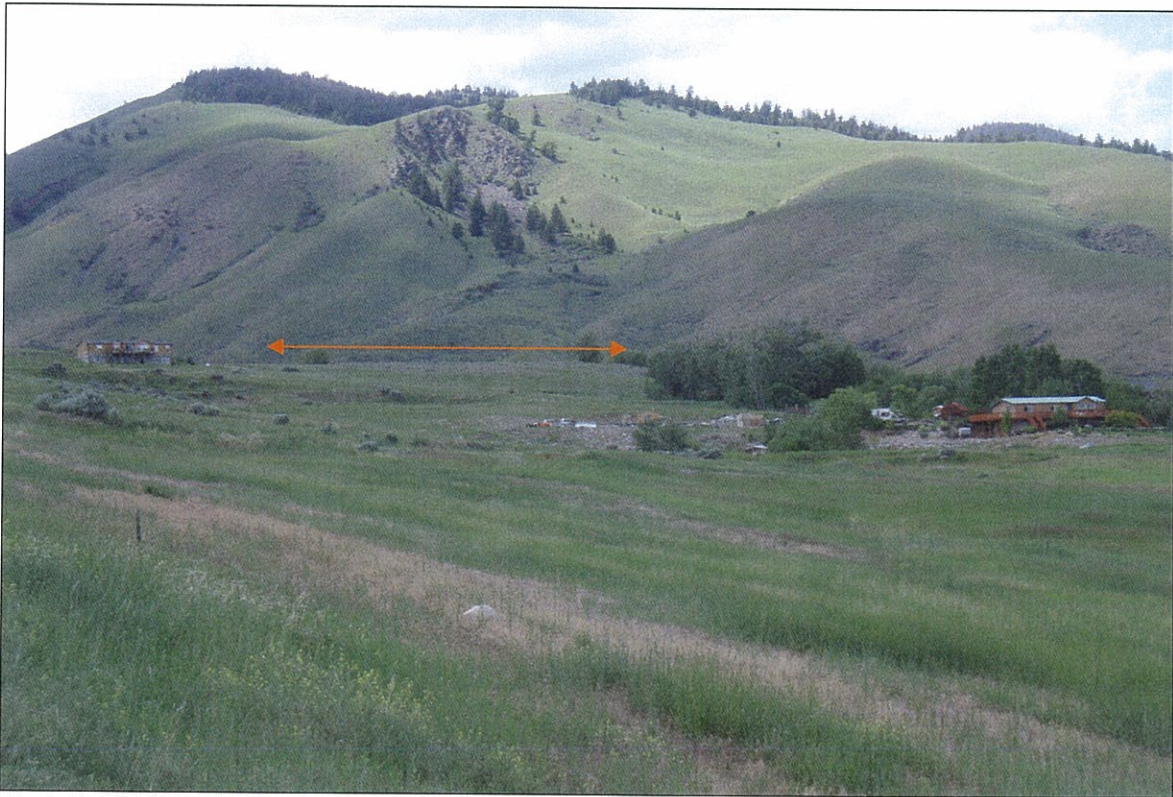
**Photo 9 (6/25/09) - Embankment from a downstream vantage point. The crest is highlighted with a colored line stretched above its length. In foreground is the small pond (shown above).**
