## Dam Safety Section

### TRIP REPORT

**TO:** Dam File 75-14465  
**FROM:** John Falk, PE  
**DATE:** July 13, 2009  
**SUBJECT:** Chipps Creek Reservoir

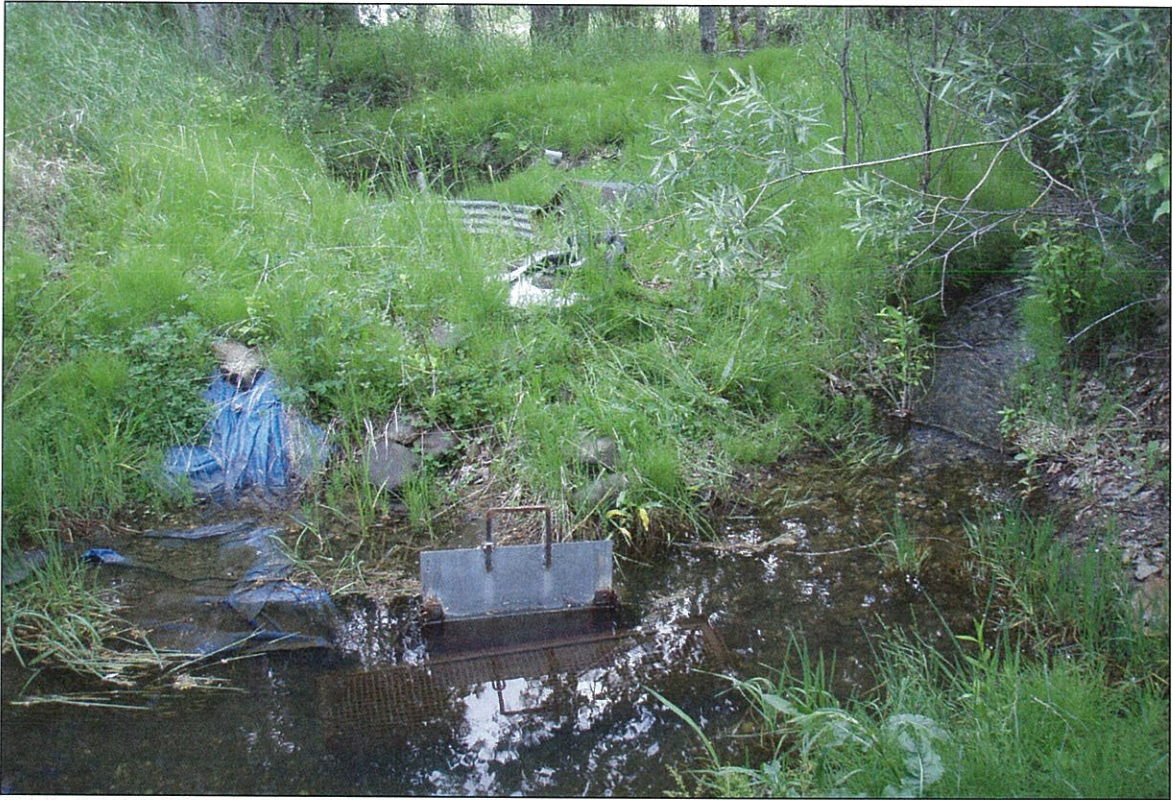
The reservoir apparently is filled by a combination of surface runoff from hillside drainage and water from a developed artesian spring (Photo 2). Flow into the reservoir at the time of the site visit was 30 gpm, or less. An emergency spillway did not appear to exist; neither could I locate a low level outlet conduit. Seepage was evident along the north and east, downstream toe of the embankment. Discharge rates were difficult to estimate due to a long strip of rounded river-rock that had been placed adjacent to Oliver Drive. This coarse gravel appears to function as a “French Drain” for the express purpose of diverting leakage from the reservoir away from the roadway (Photo 3). All seepage from the dam appeared to flow toward a common point at the downstream toe where it was routed into a small drainage ditch, presumably for irrigation purposes (Photo 4).

**Photo 4 (6-25-09) - Facility for collection of seepage from the dam. This feature exists on the east side of the embankment. At the time, the rate of flow in the ditch (right) was estimated ~20-25 gpm.**

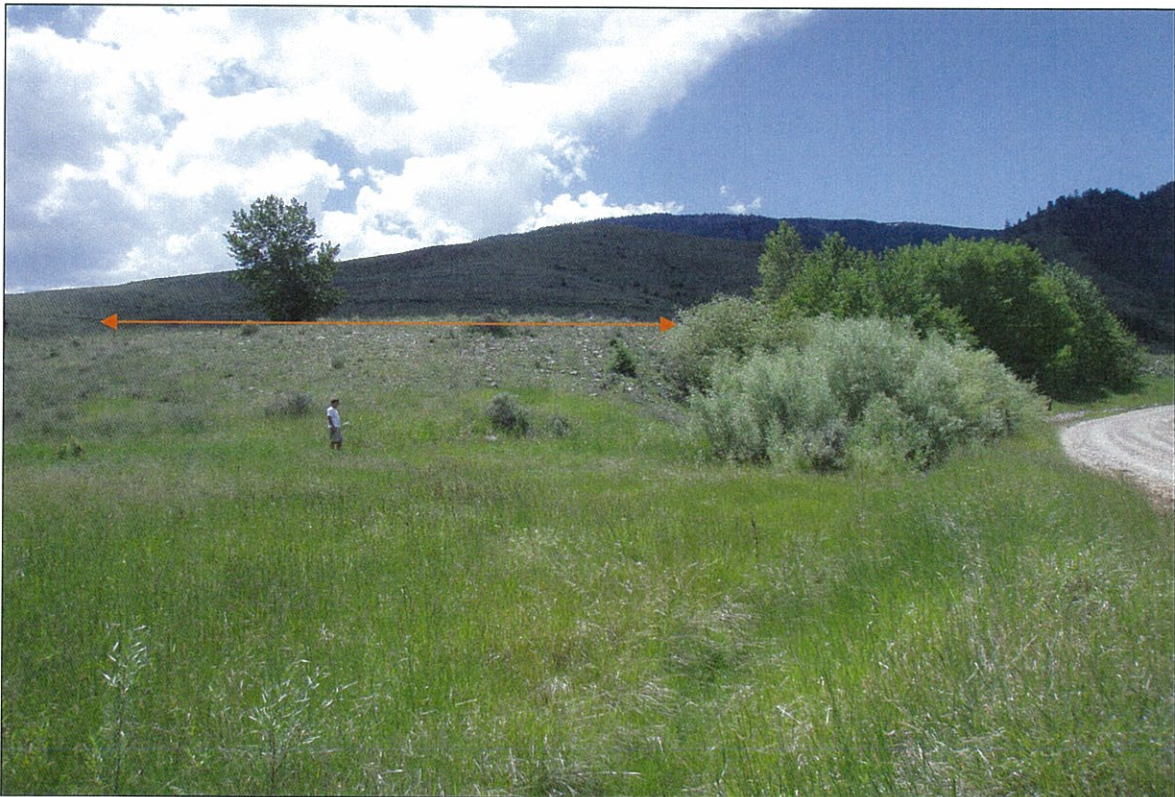
| • Embankment Height * | 15 feet (est) | Photo 5 |

**Photo 5 (6/25/09) - View looking at the downstream slope of the dam near maximum section. Note the location of Oliver Road (right), and the heavy growth of vegetation on north side of the embankment.**

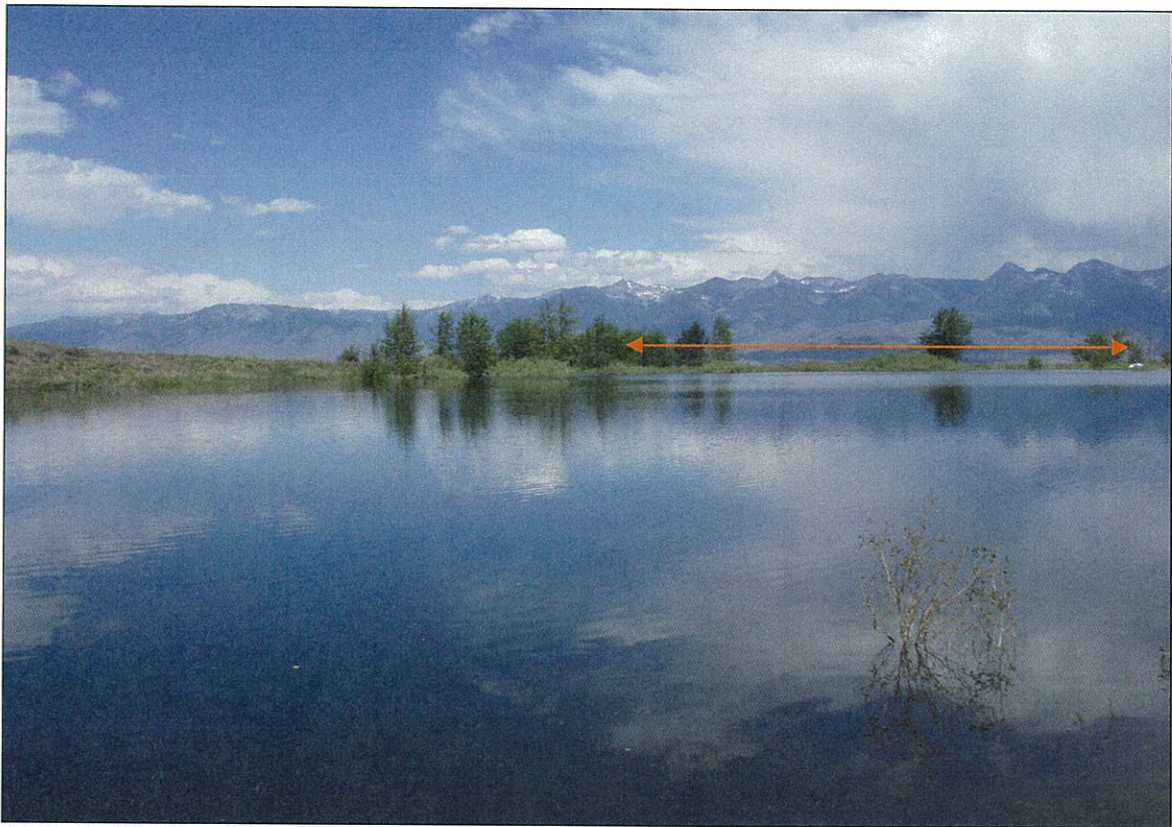
| • Freeboard | 1 foot (est) | Photo 6 |

**Photo 6 (6/25/09) - View from the back of the reservoir looking east, toward the crest of the embankment. Note the elevated water level referenced by the submerged vegetation.**

I recommend this dam be modified to include the installation of an emergency overflow spillway. Issuance of a formal Water Right to the owner(s) of this dam should not be approved until such repair is implemented to the satisfaction of IDWR Dam Safety. In the interim, this structure will be added to the state inventory of dams for regular inspection.

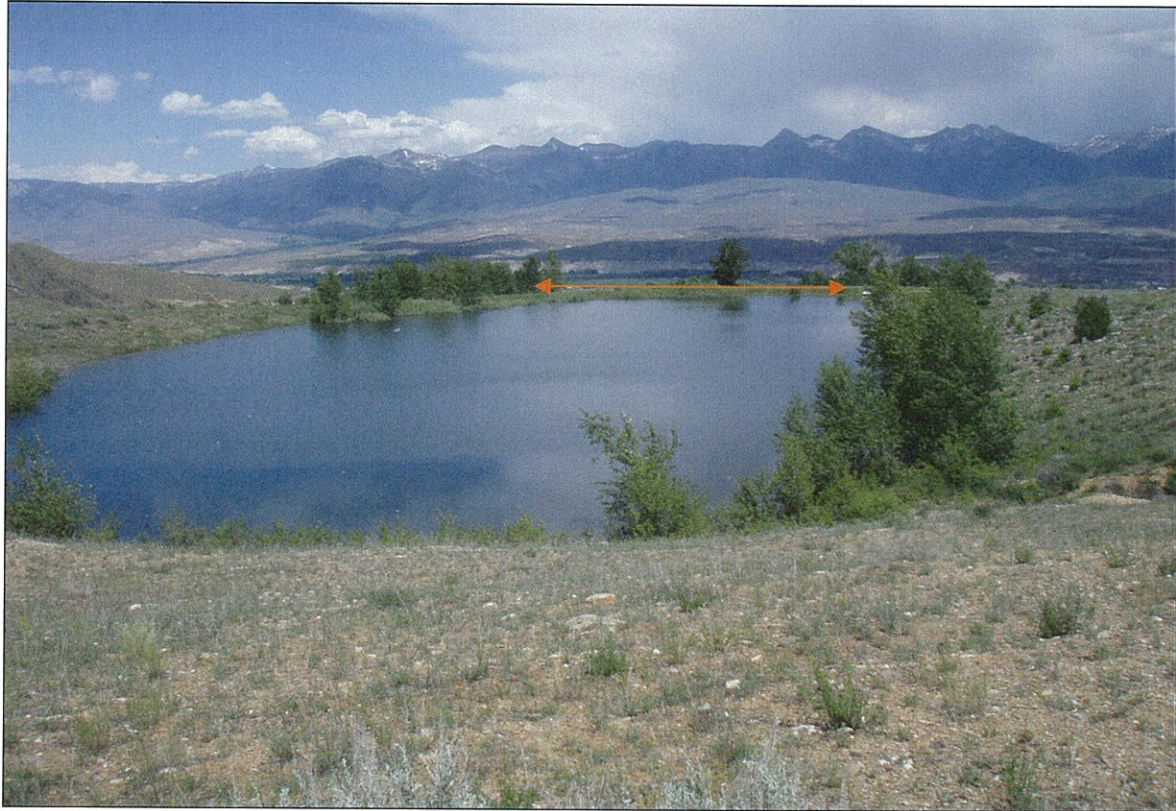
| • Pool Surface Area | 4 acres (est) | Photo 7 |

**Figure 7 (6/25/09) - Overview of existing dam (background) and reservoir. The treed area in the photograph right-front corner is the channel carrying water from the spring to the reservoir.**
