DEPARTMENT OF  
WATER RESOURCES

Memorandum

Re: 75-14601 (Hutchings) — *SRBA ordered amended PD for 75-14598*

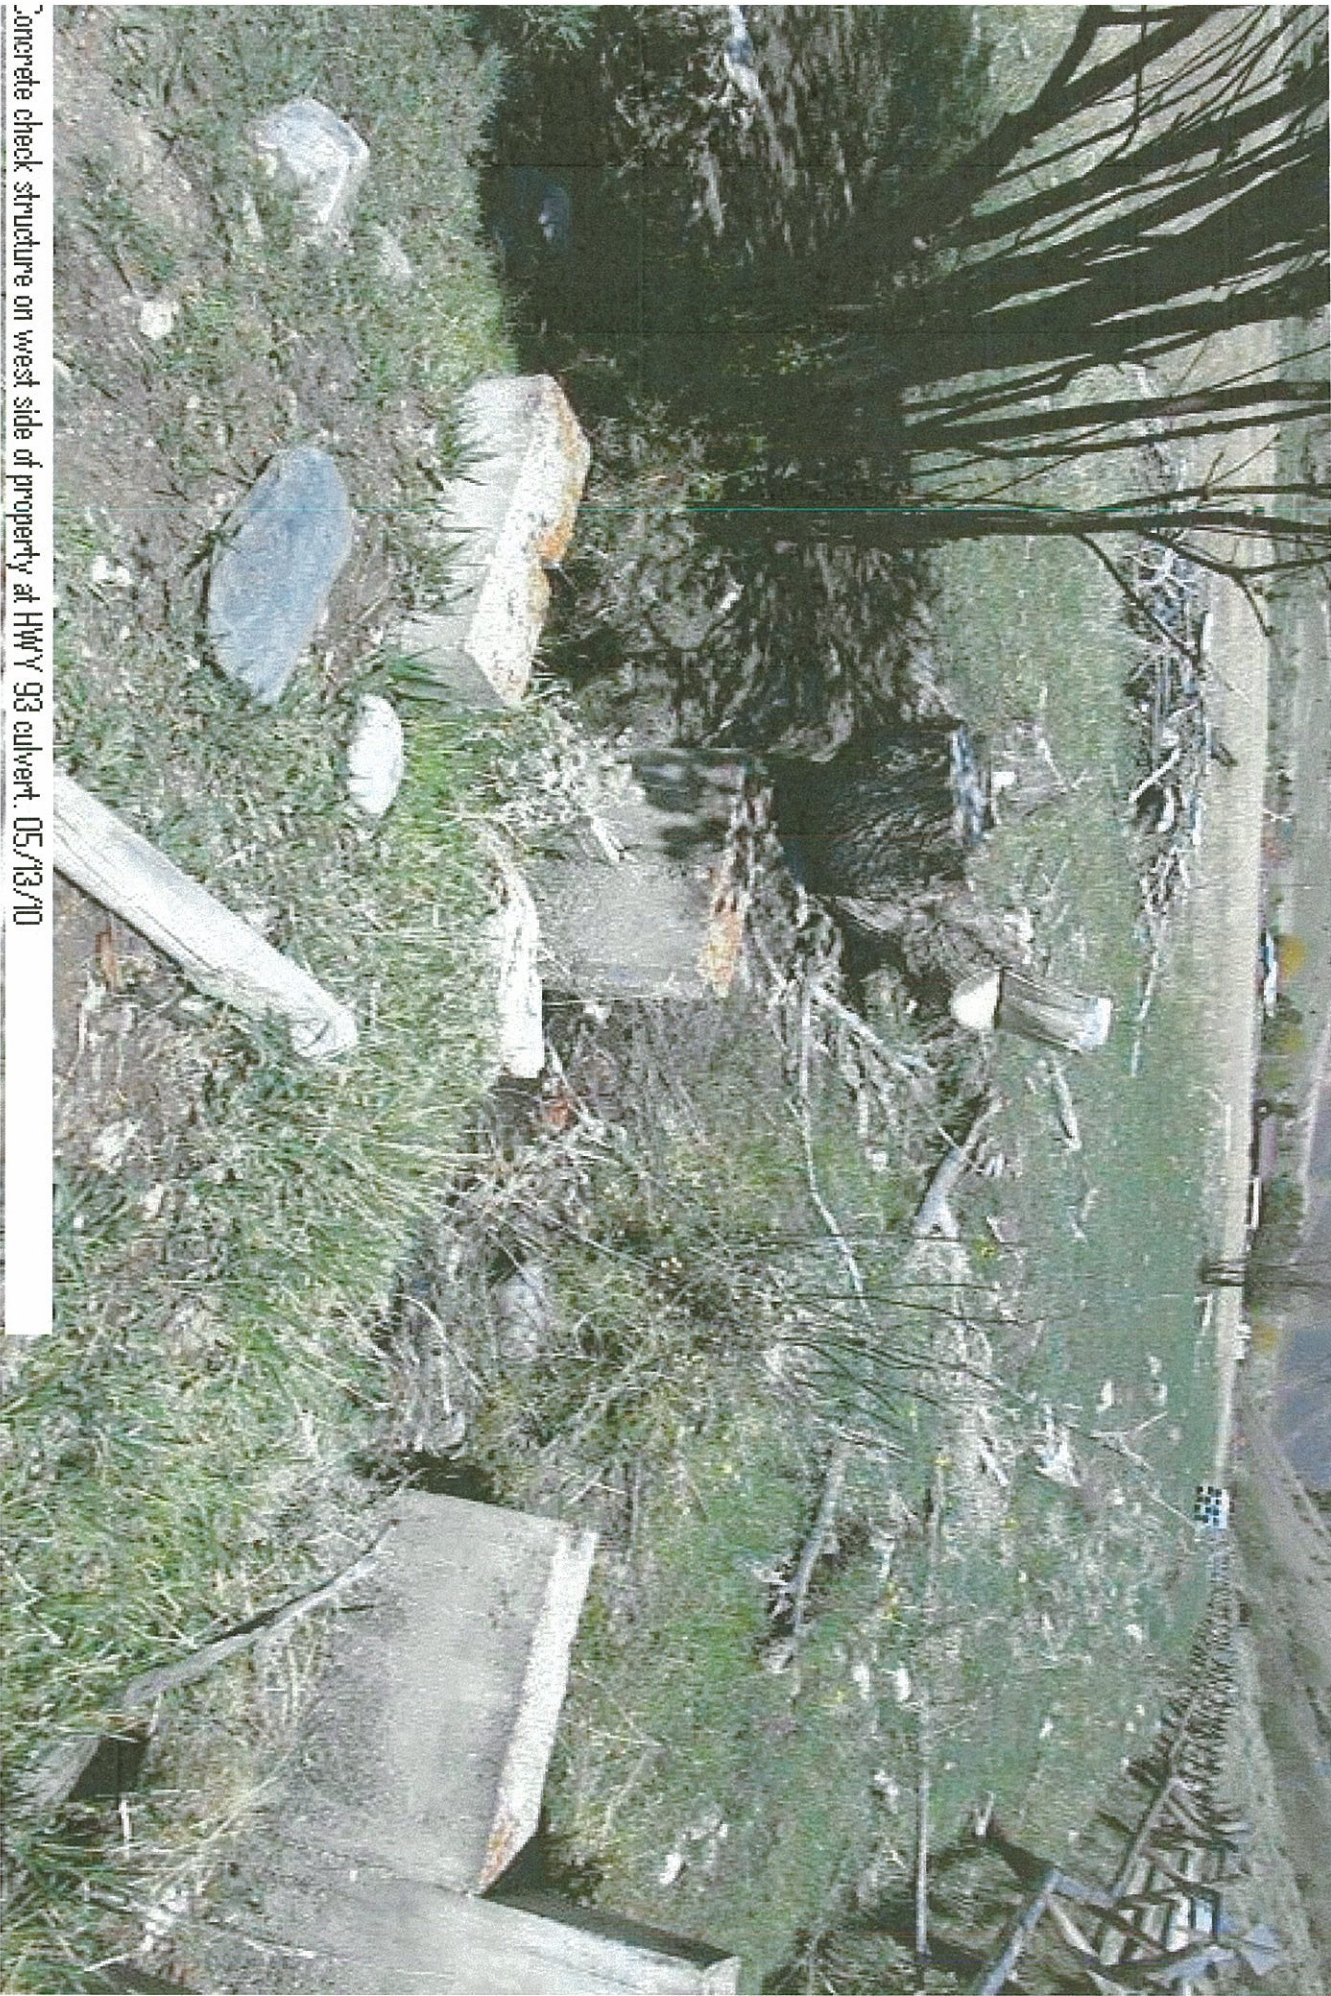
Concrete check structure on west side of property at HWY 93 culvert. 05/13/10

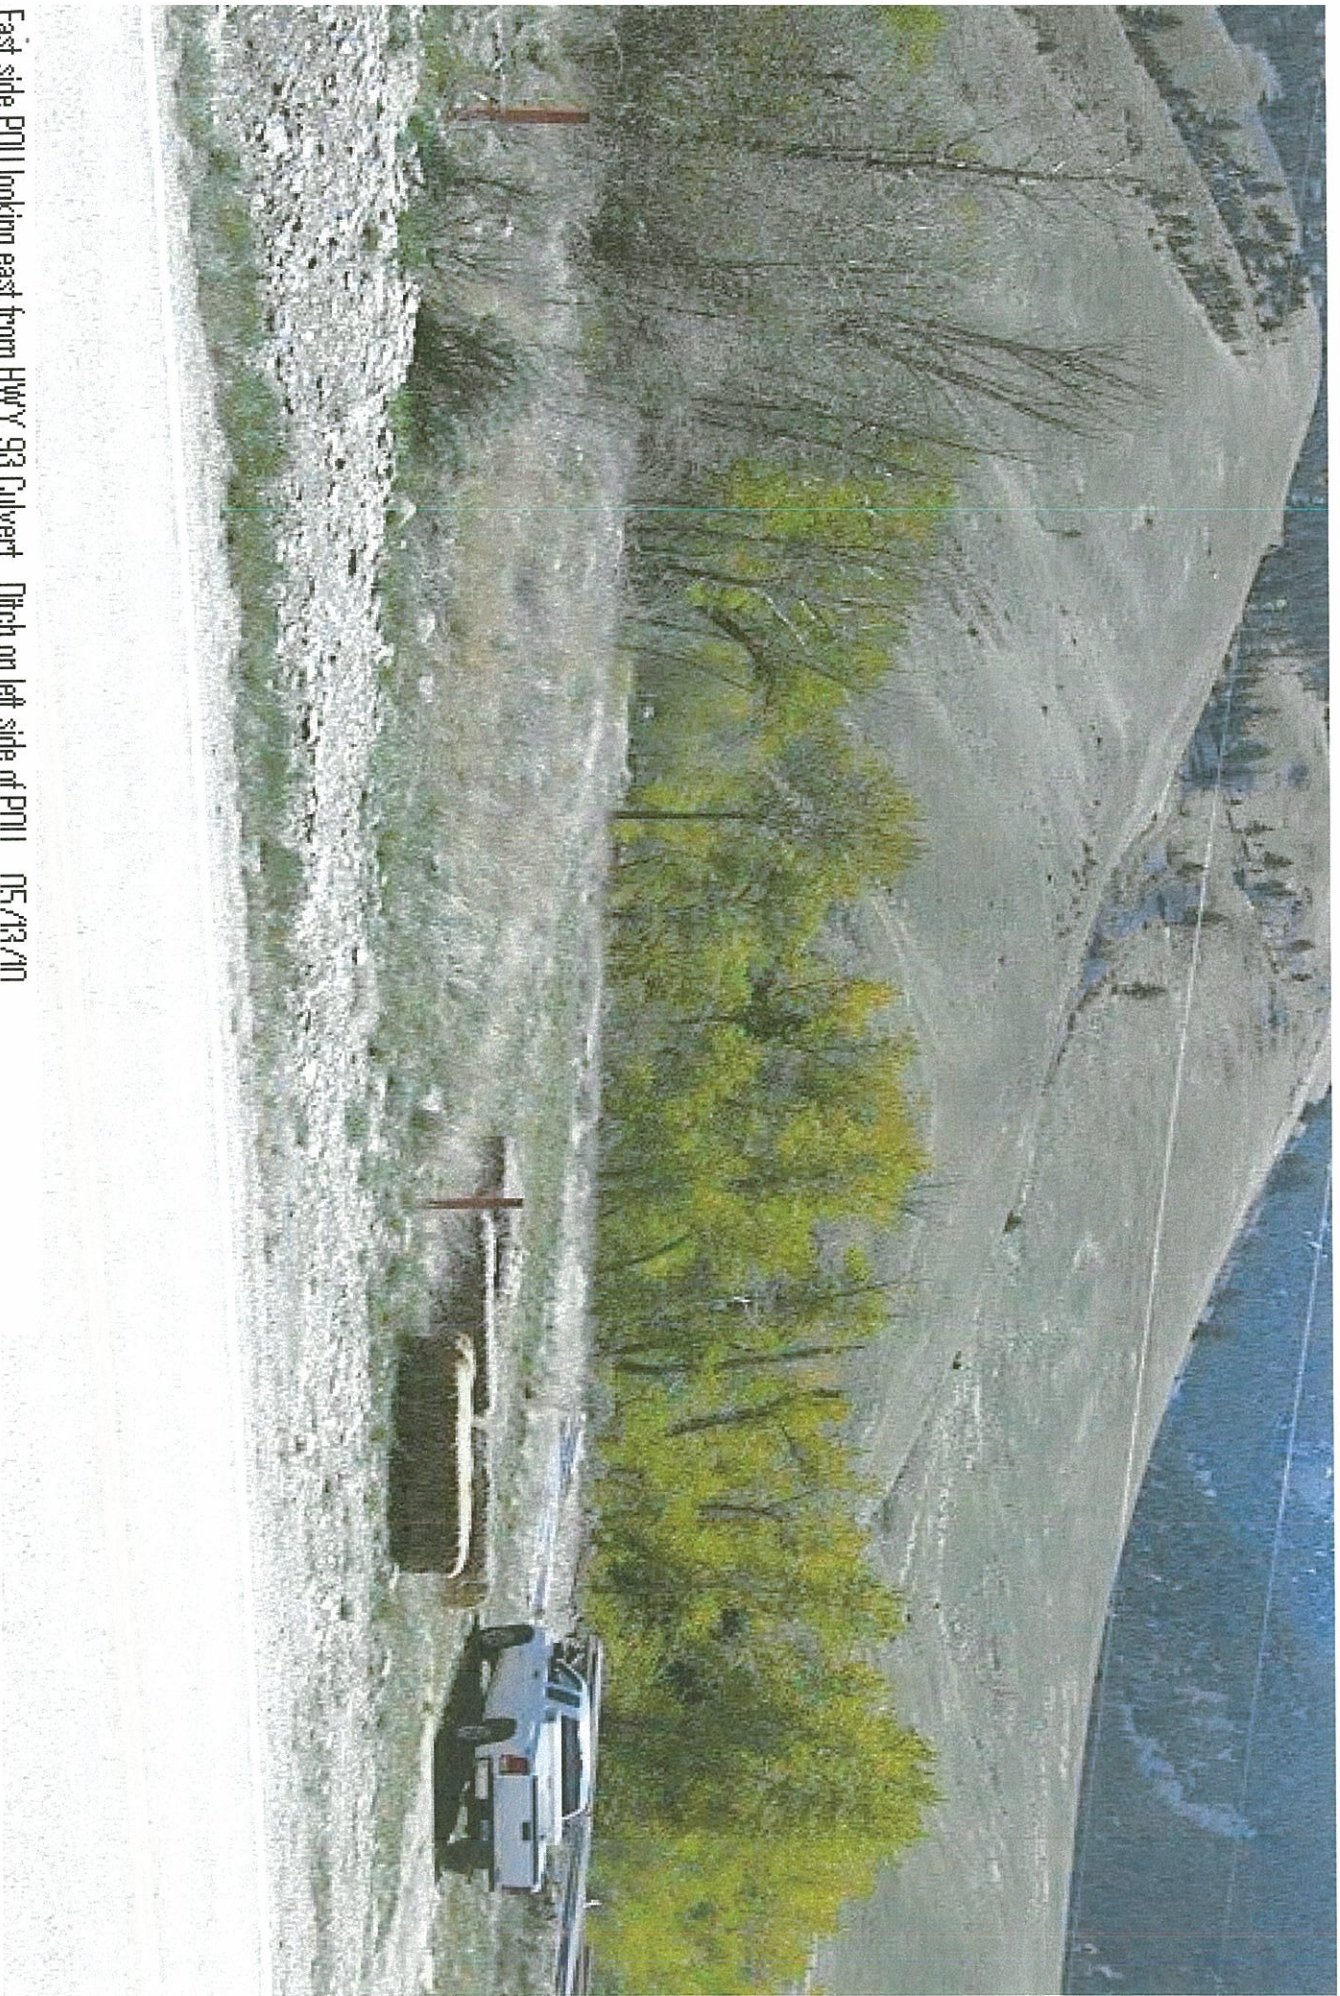
East side P111 looking east from HWY 93 Culvert Ditch on left side of P111 05/13/10

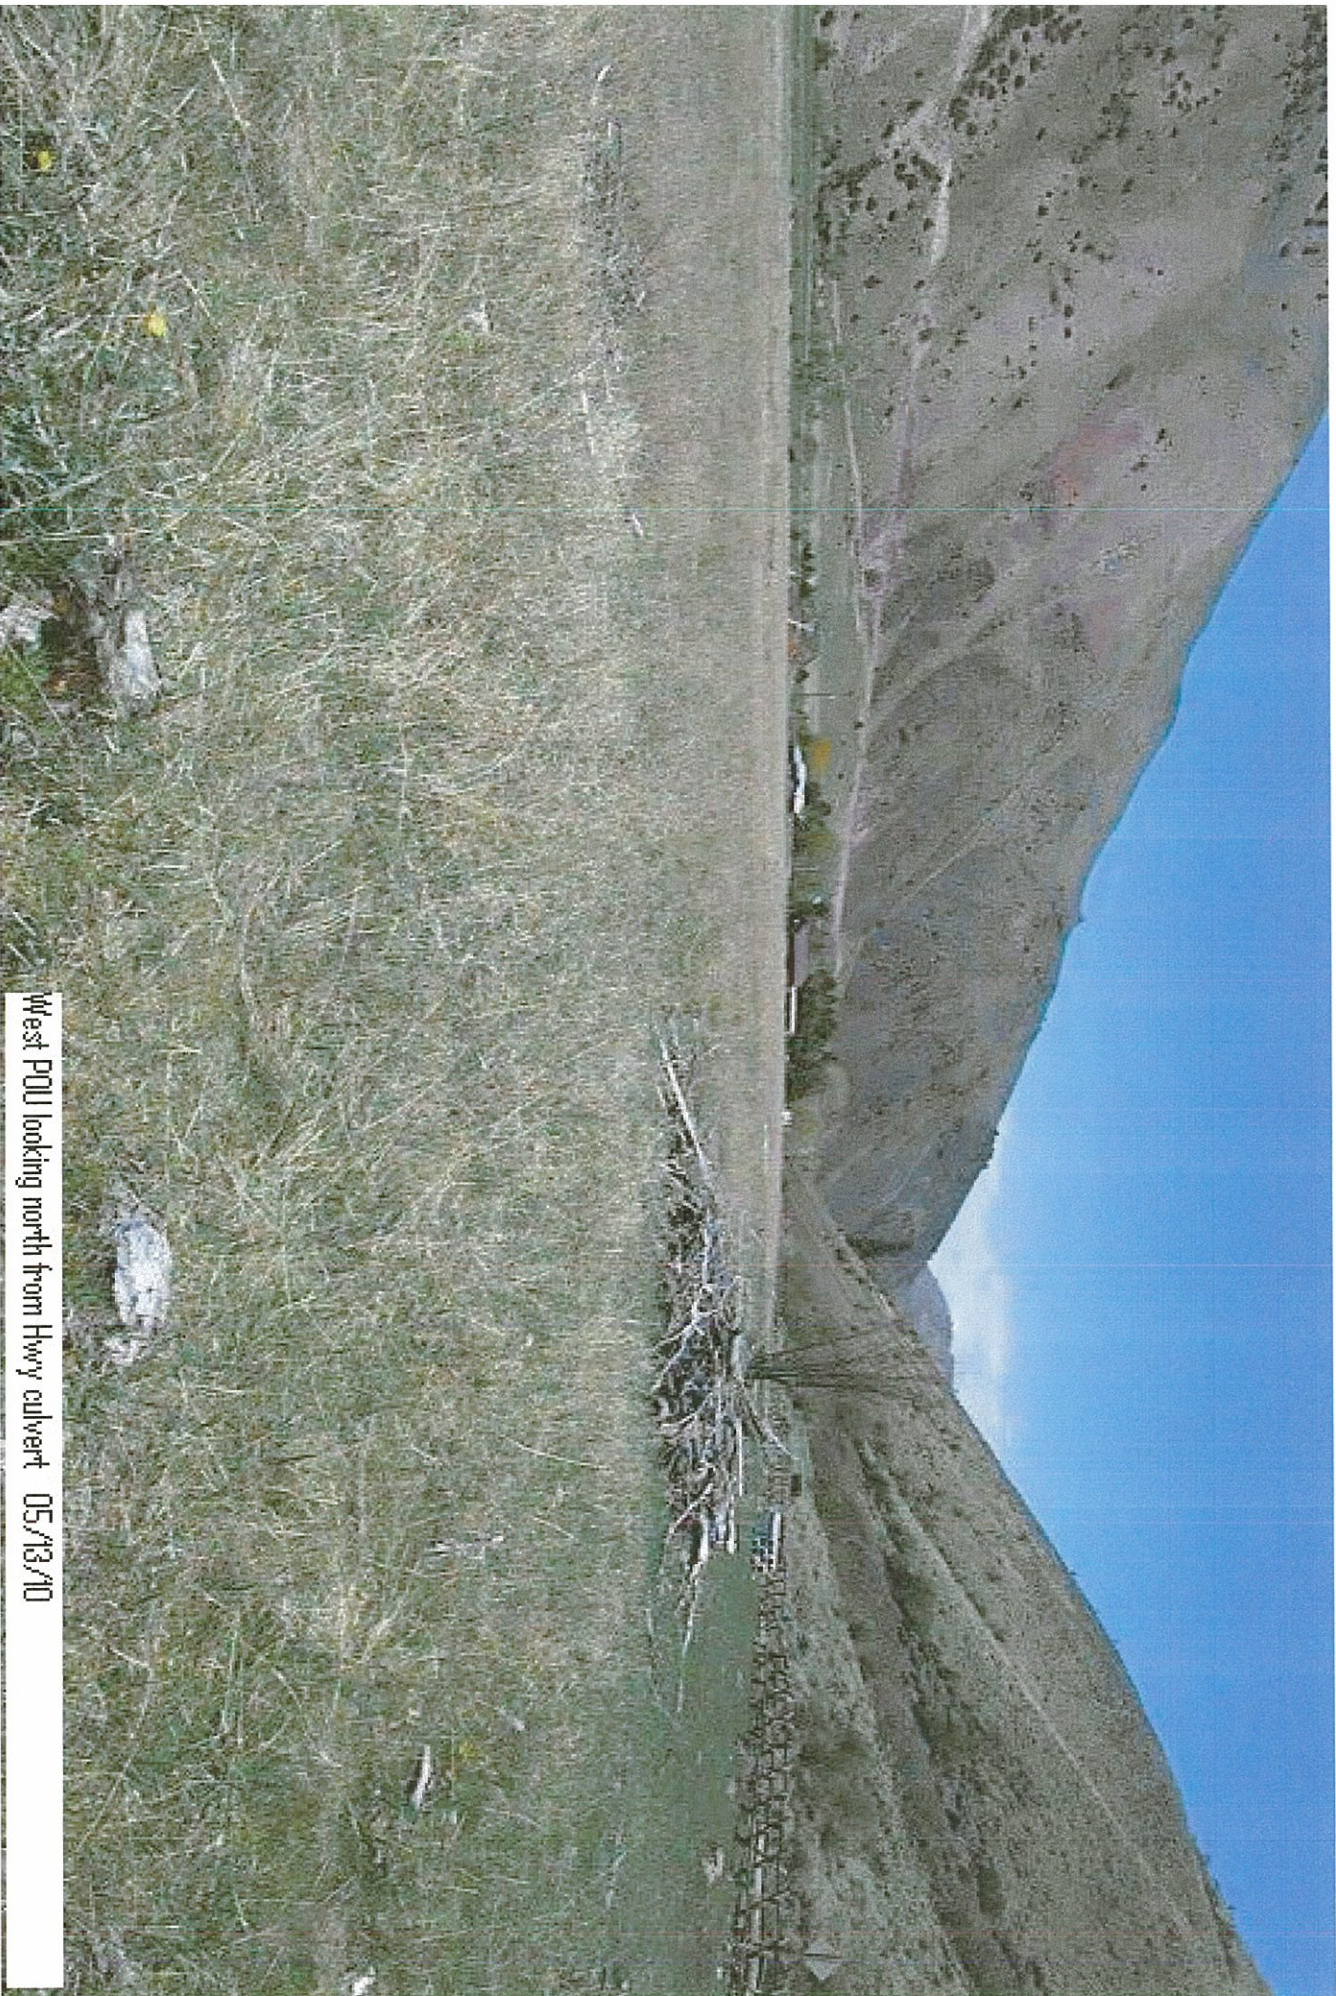
West POU looking north from Hwy culvert 05/13/10

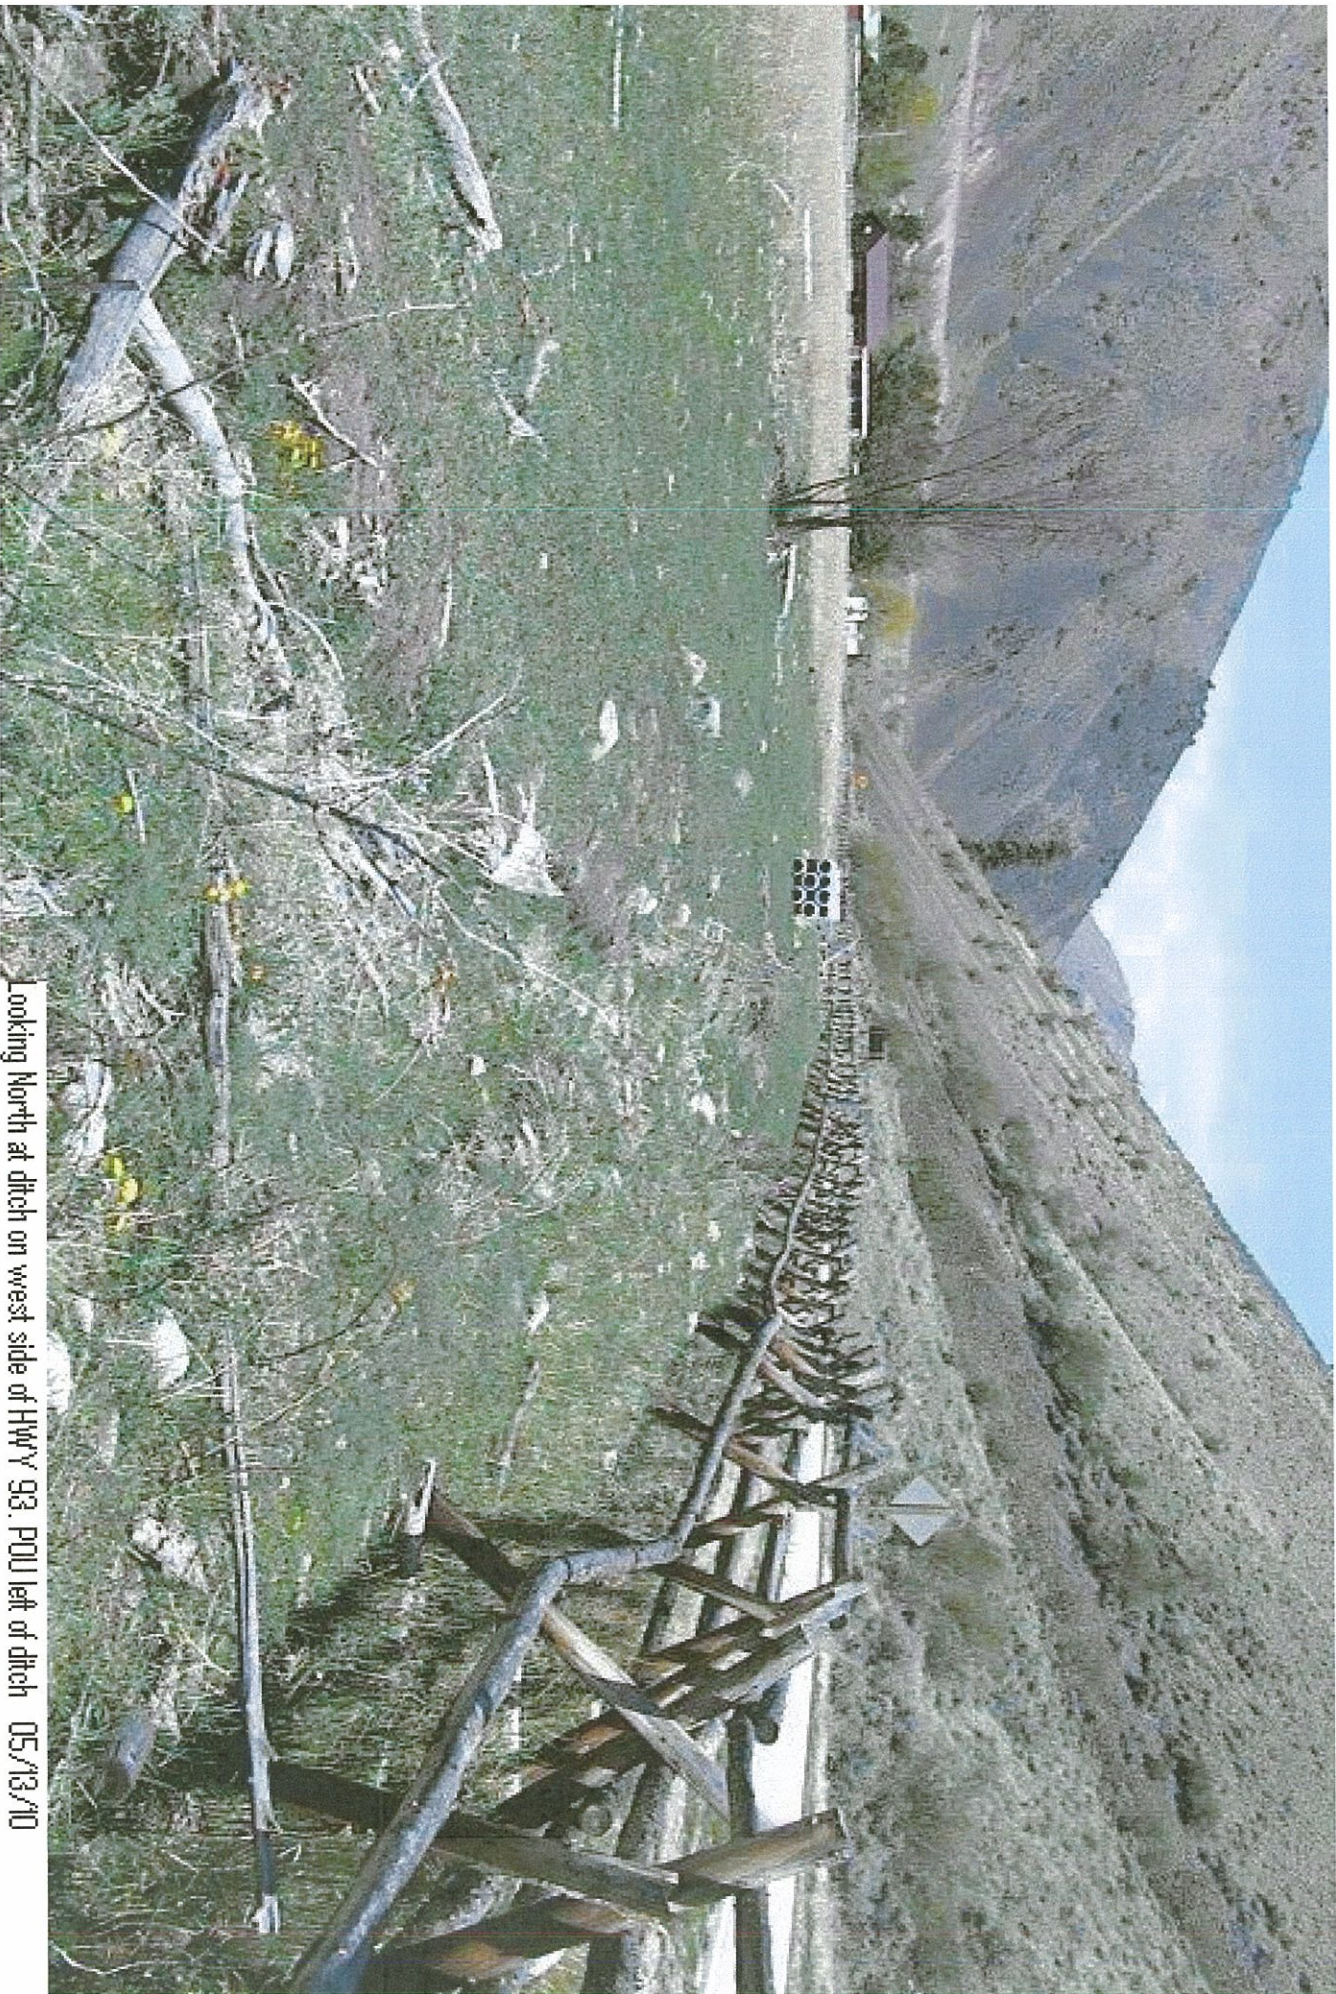
Looking North at ditch on west side of HWY 93. POI left of ditch 05/13/10

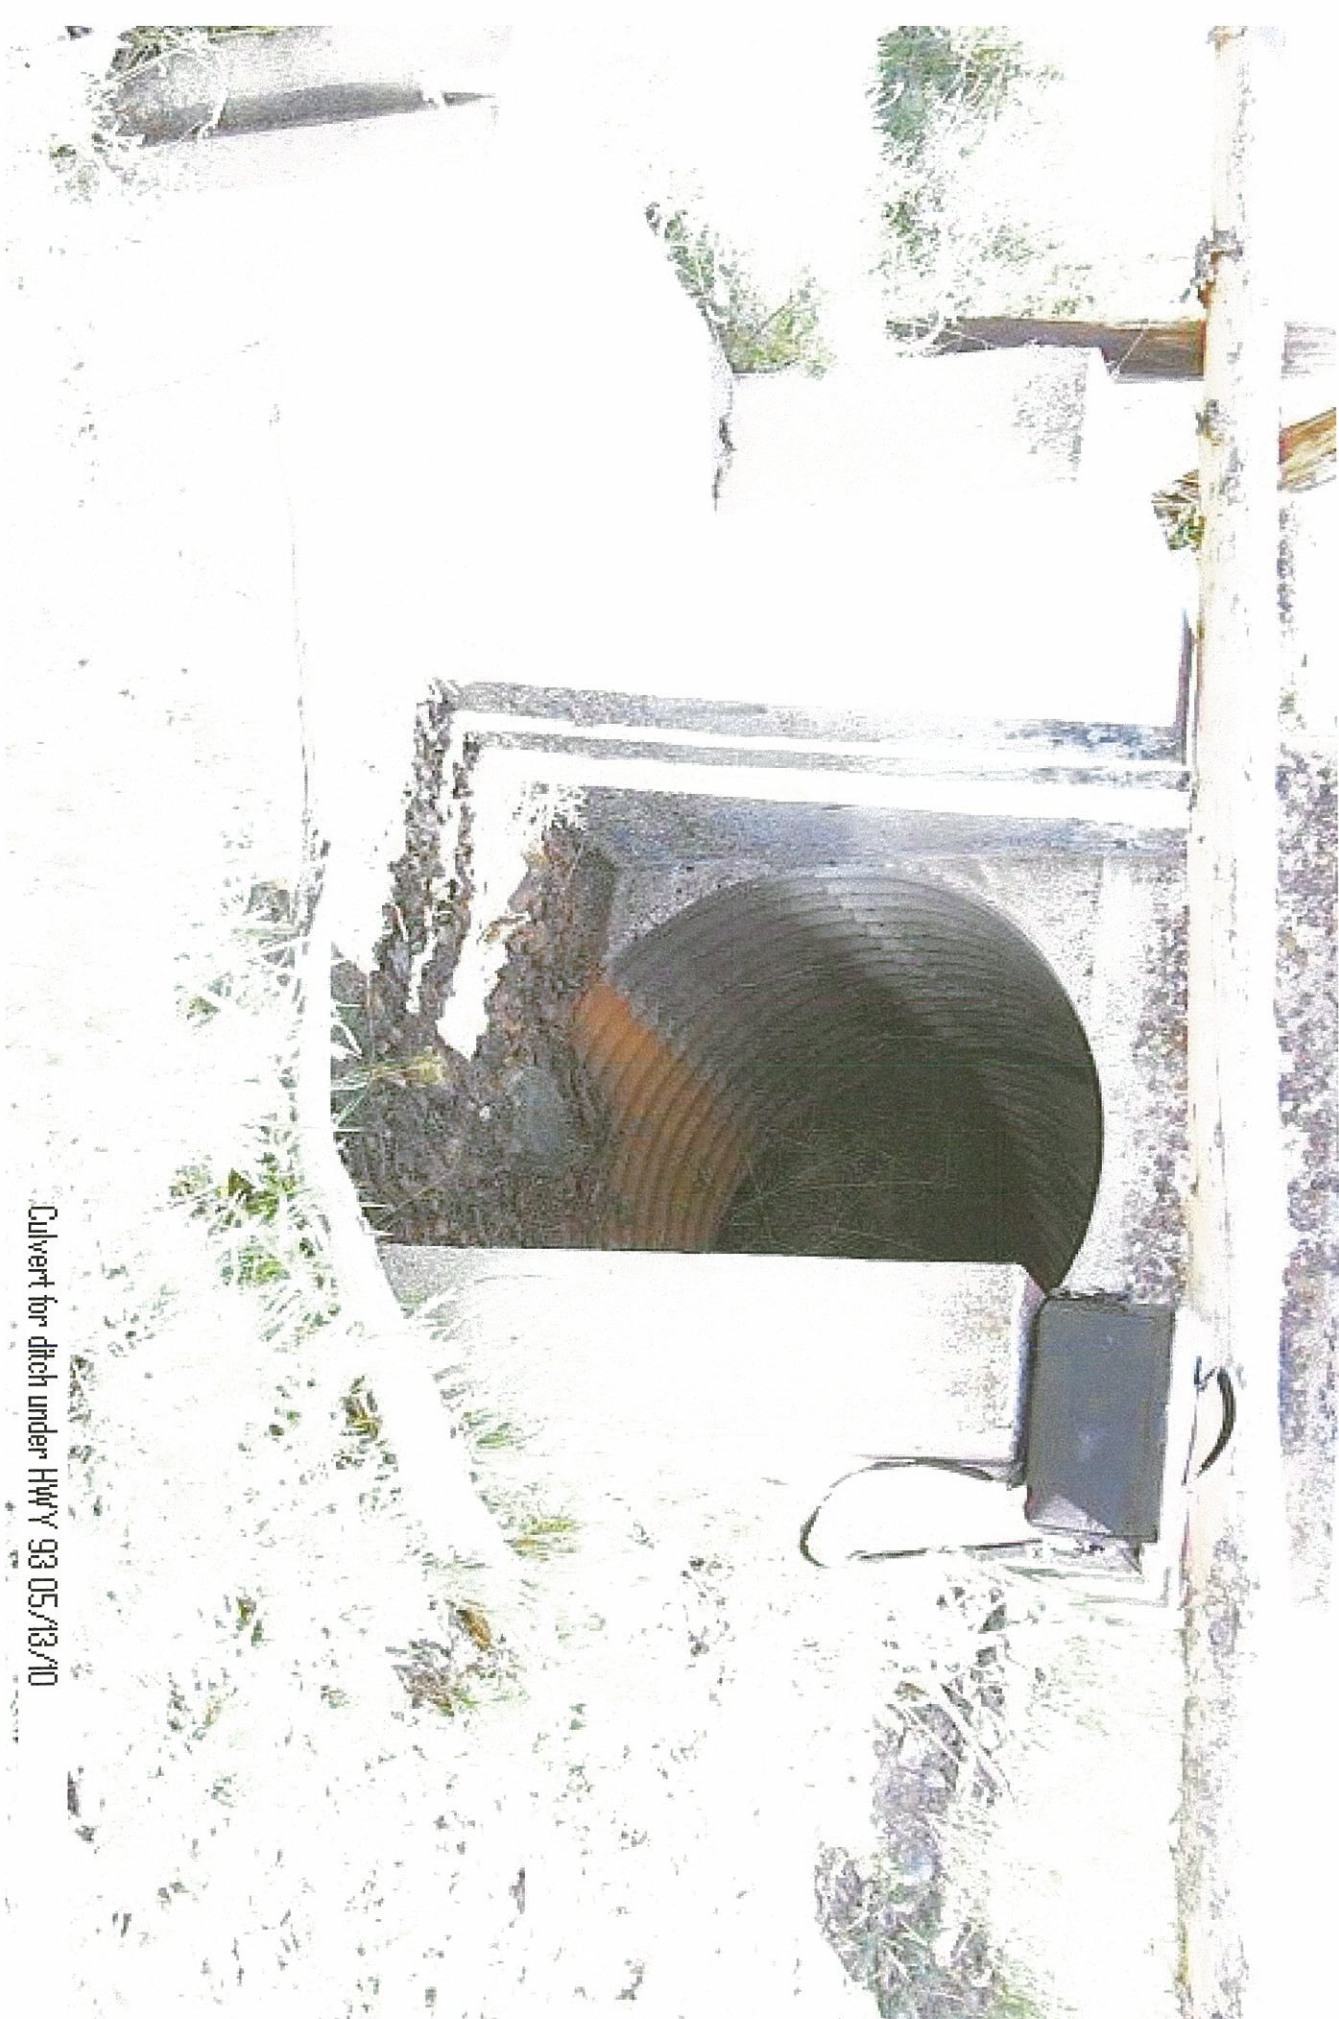
Culvert for ditch under HWY 93 05/13/10

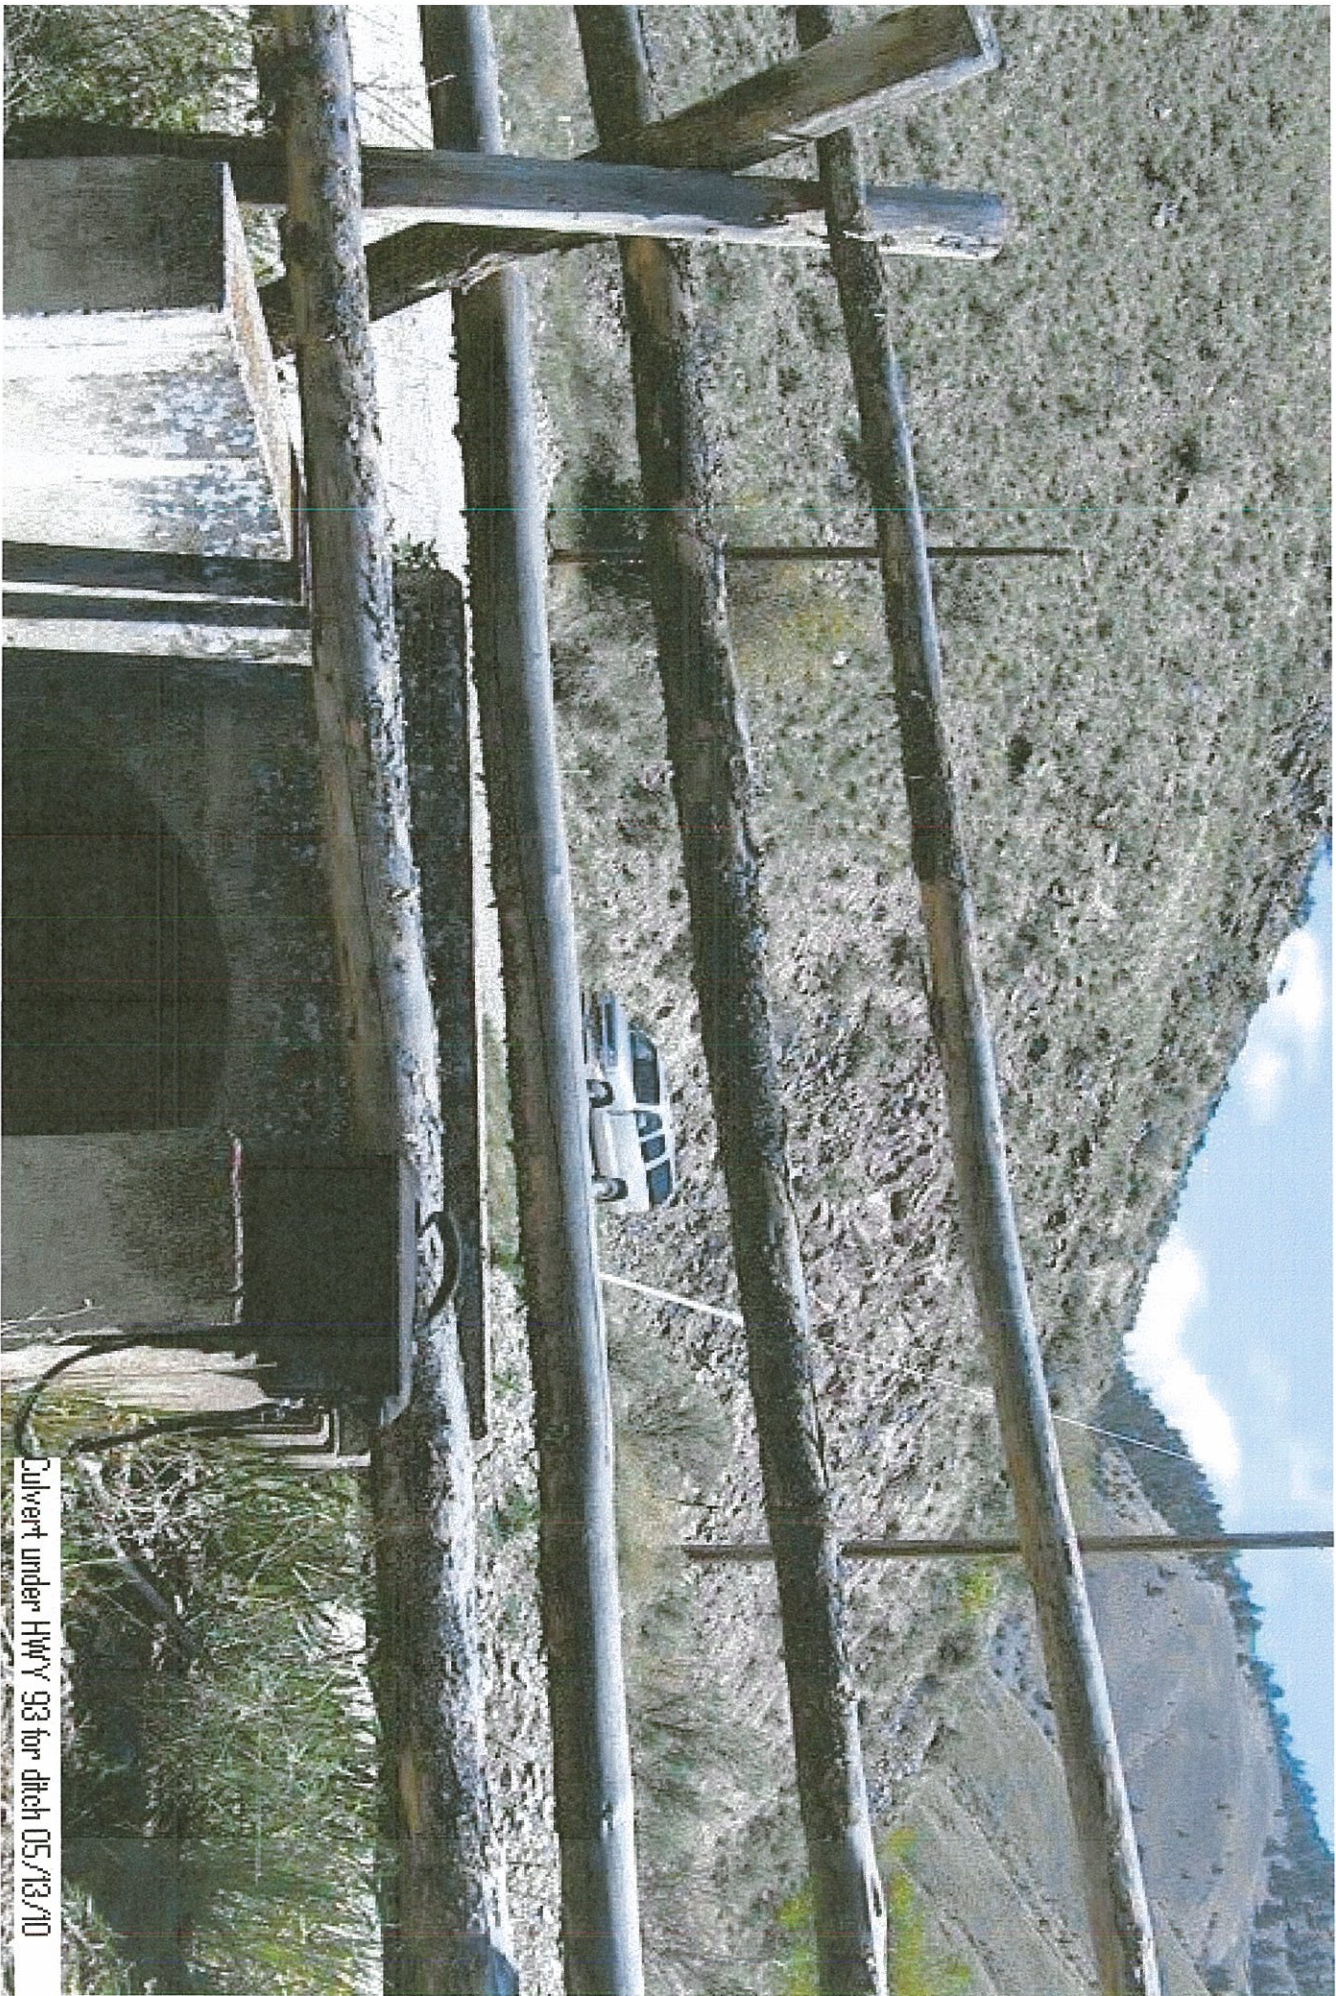
Culvert under Hwy 93 for ditch 05/13/10

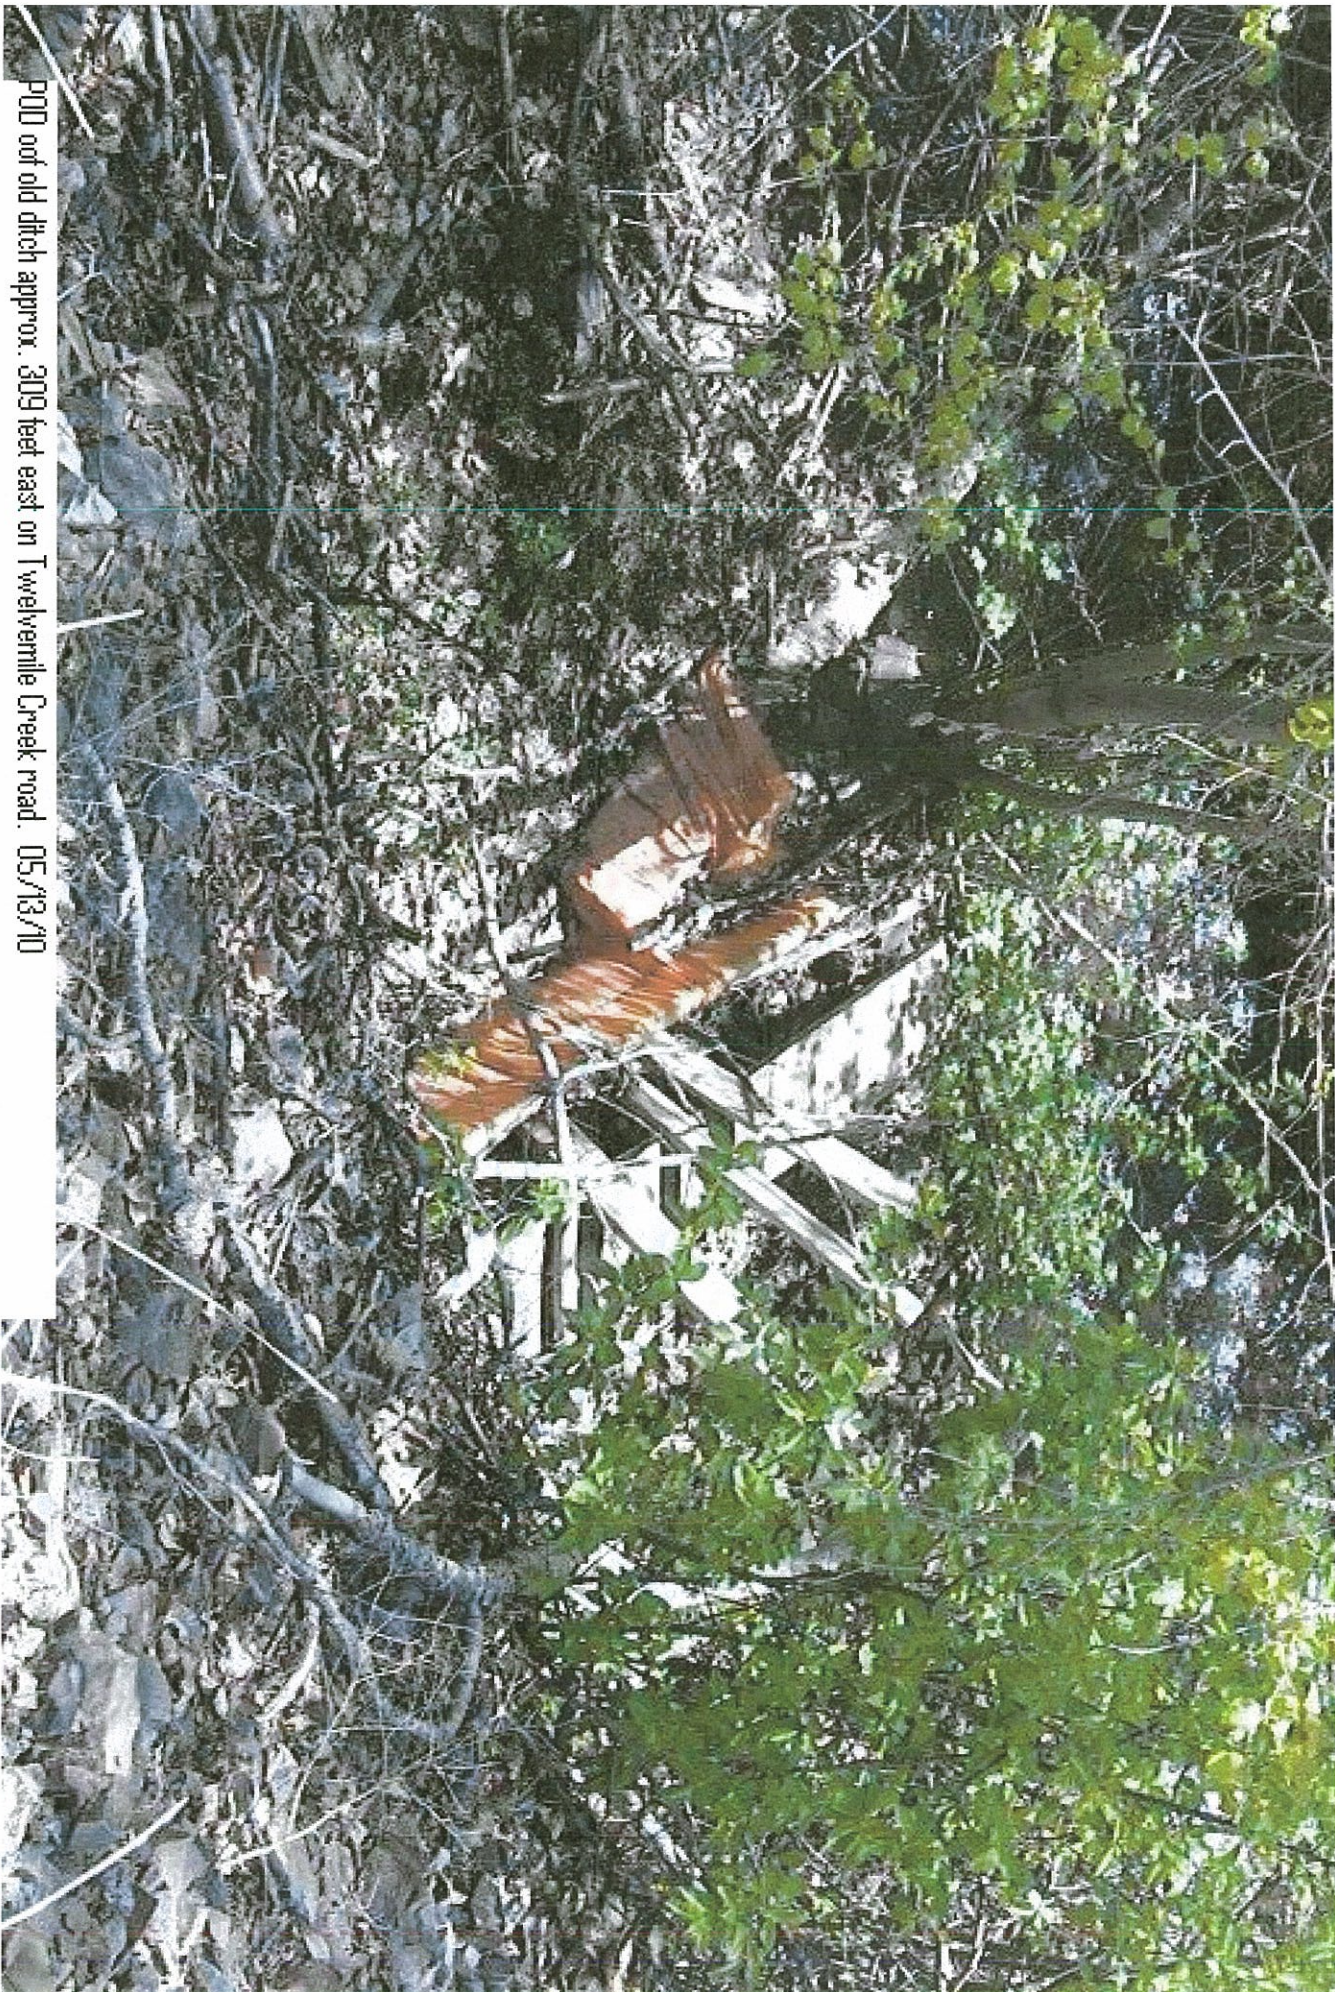
POD roof old ditch approx. 309 feet east on Twelvemile Creek road. 05/13/10

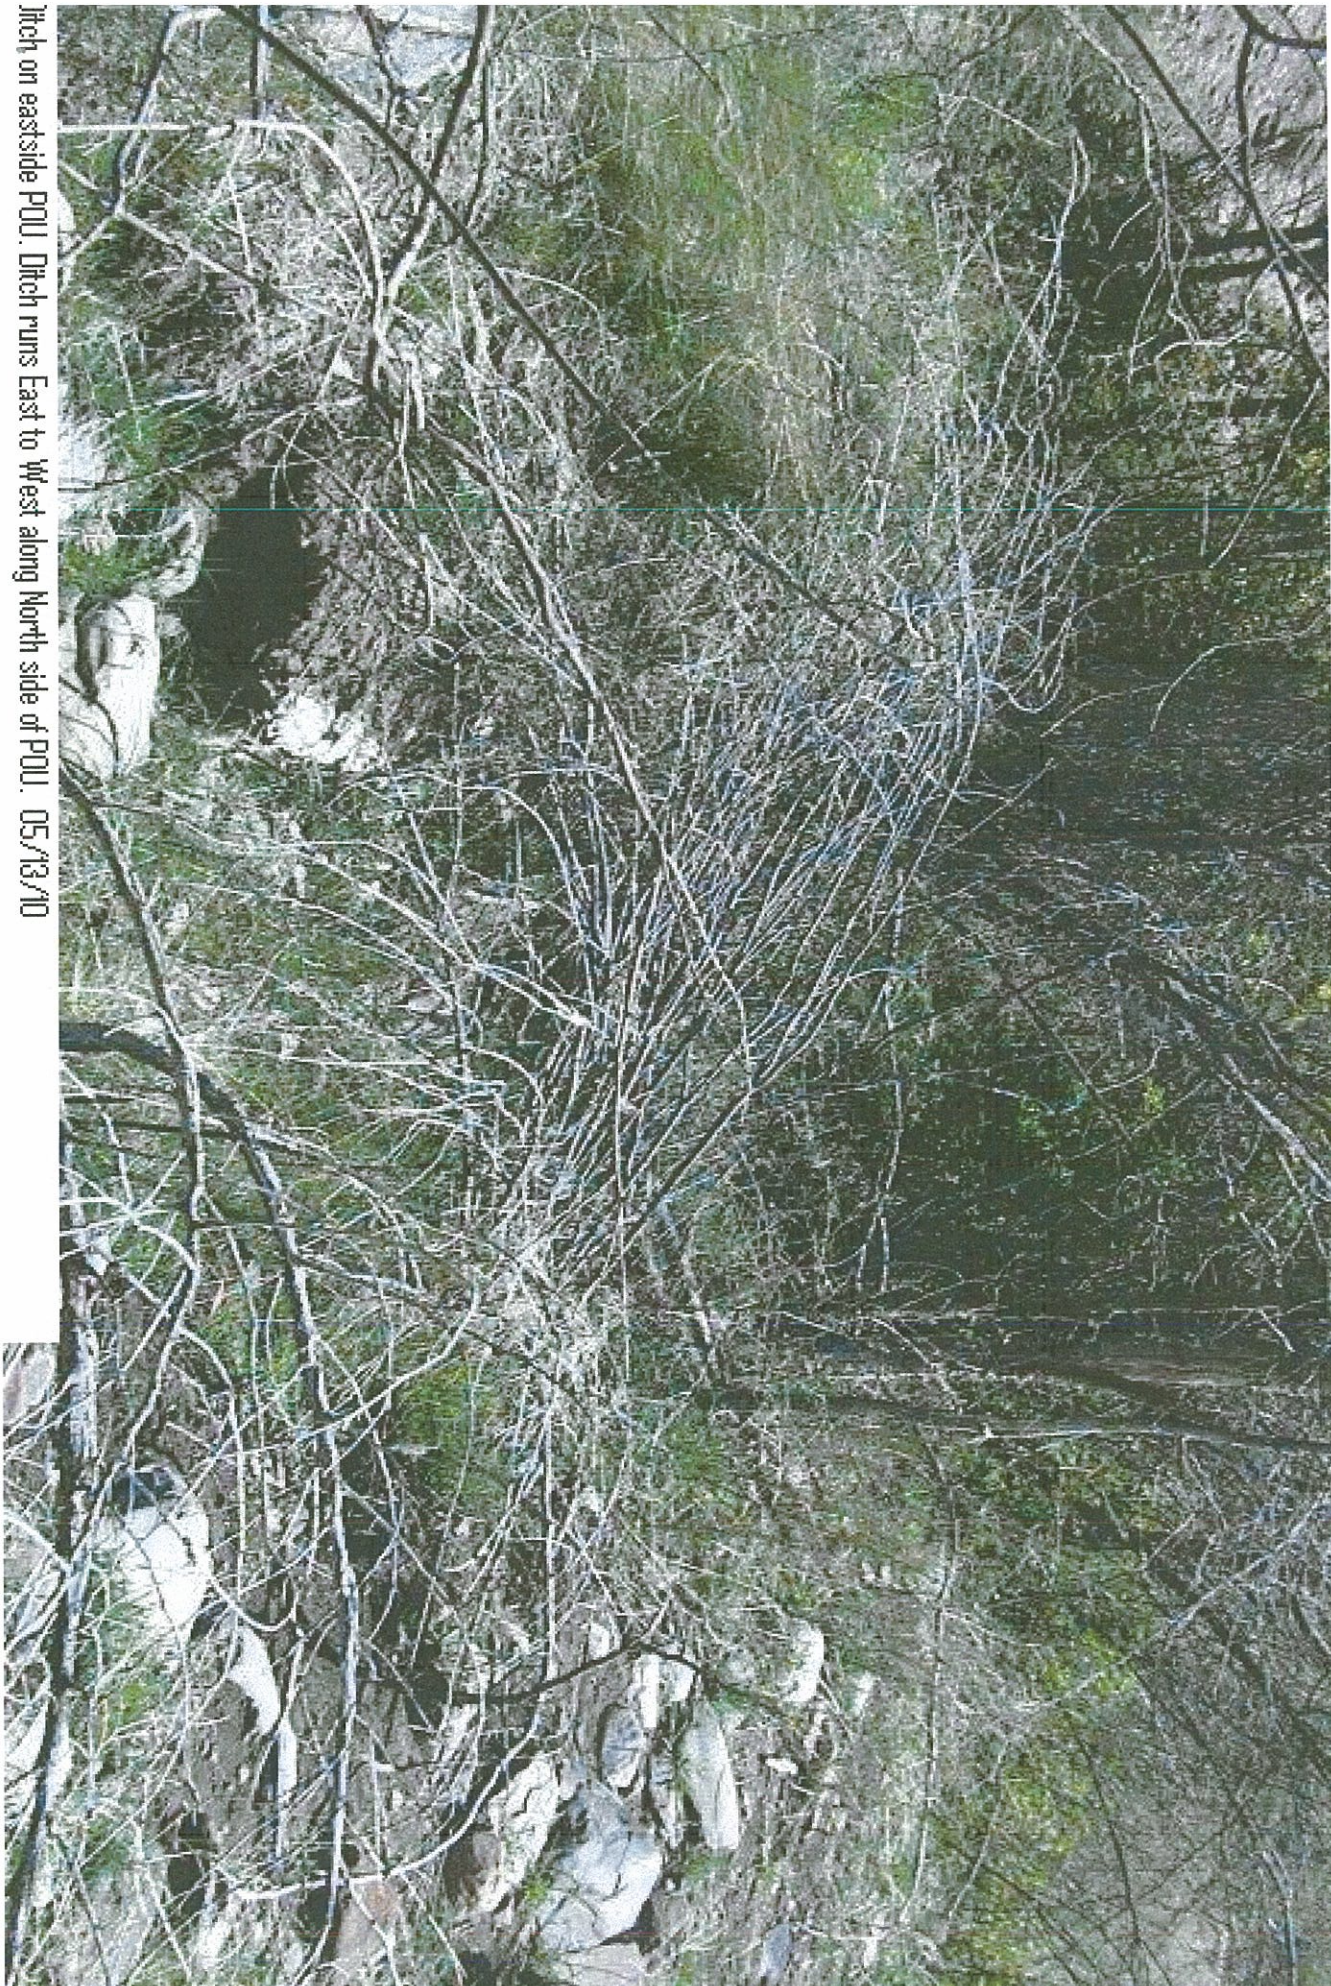
Jitch on eastside POU. Ditch runs East to West along North side of POU. 05/13/10
