**From:** Falk, John  
**Sent:** Thursday, October 14, 2010 6:03 PM  
**To:** Clelland, Steve  
**Cc:** Skinner, Corey; Galloway, Chuck; Hornbaker, Sonny  
**Subject:** Trail Creek Dam

## **TRAIL CREEK DAM**

# **PHASE I INSPECTION REPORT**

STATE OF IDAHO  
DEPARTMENT OF WATER RESOURCES  
RECORD OF INSPECTION OF DAM

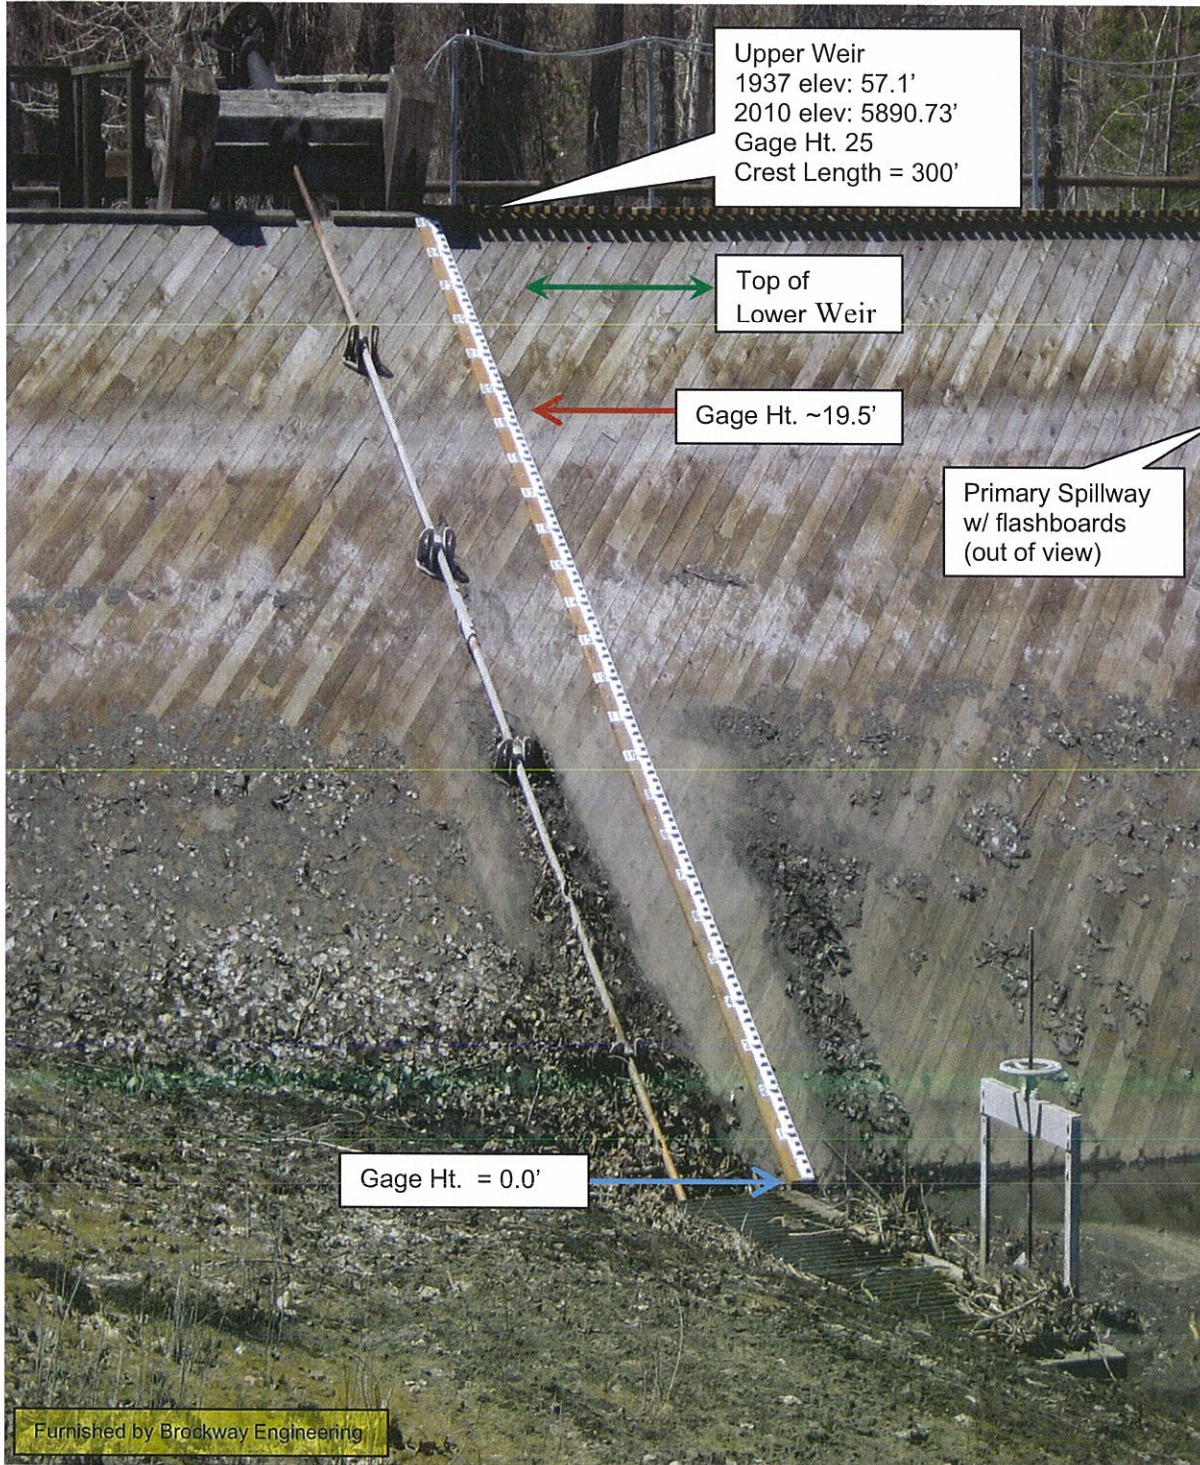
Photo 3 (5/17/2010) - Upstream face of Trail Creek Dam showing the staff gage relative to the low level outlet operating stem. The top of the gage is level with the top of the 300-foot long Upper Weir. Note the heavy stain on the diagonal planks and the corresponding gage reading at the top of the stain. The stain represents the maximum normal operating level of the reservoir. The flashboards in the primary spillway are seasonally adjusted, thus providing the structure adequate freeboard to help prevent the Lower Weir from being overtopped due to thunderstorms, snowmelt, and rain on snow events. The whole number division on the staff gage does not equal 1-foot increments of elevation!

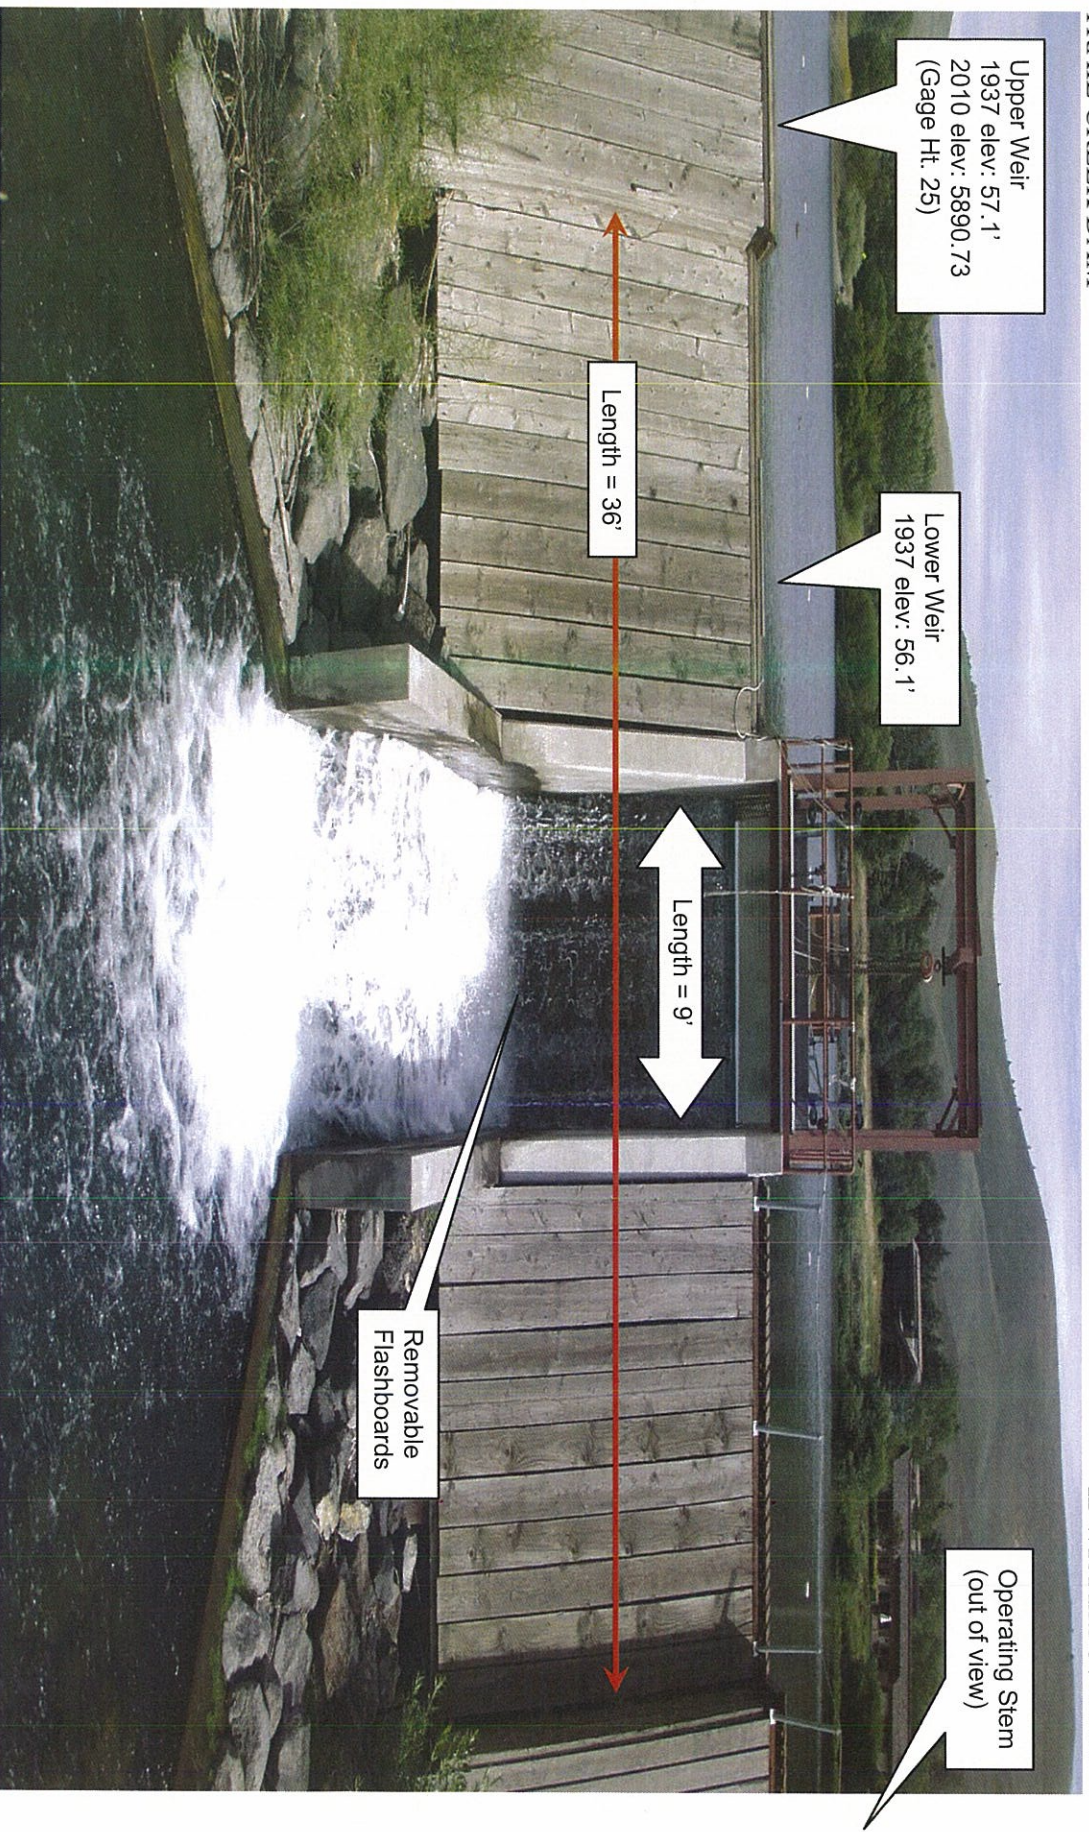
Photo 2 (8/19/2009) – View looking upstream at Trail Creek Dam illustrating the nested weirs and the primary spillway w/ removable flashboards. Compare to Photo 3 that shows the location of the staff gage on the upstream side of the dam. The elevations are referenced to the original design drawings (1937) and the 2010 survey (NAVD88 datum). The flashboard structure was not included in the original design. It is important to note that 81.3 acre-feet storage capacity as referenced in the 1981 Phase I Inspection Report (Figure 1) corresponds to the crest of the Lower Weir, design elevation 56.1 feet.

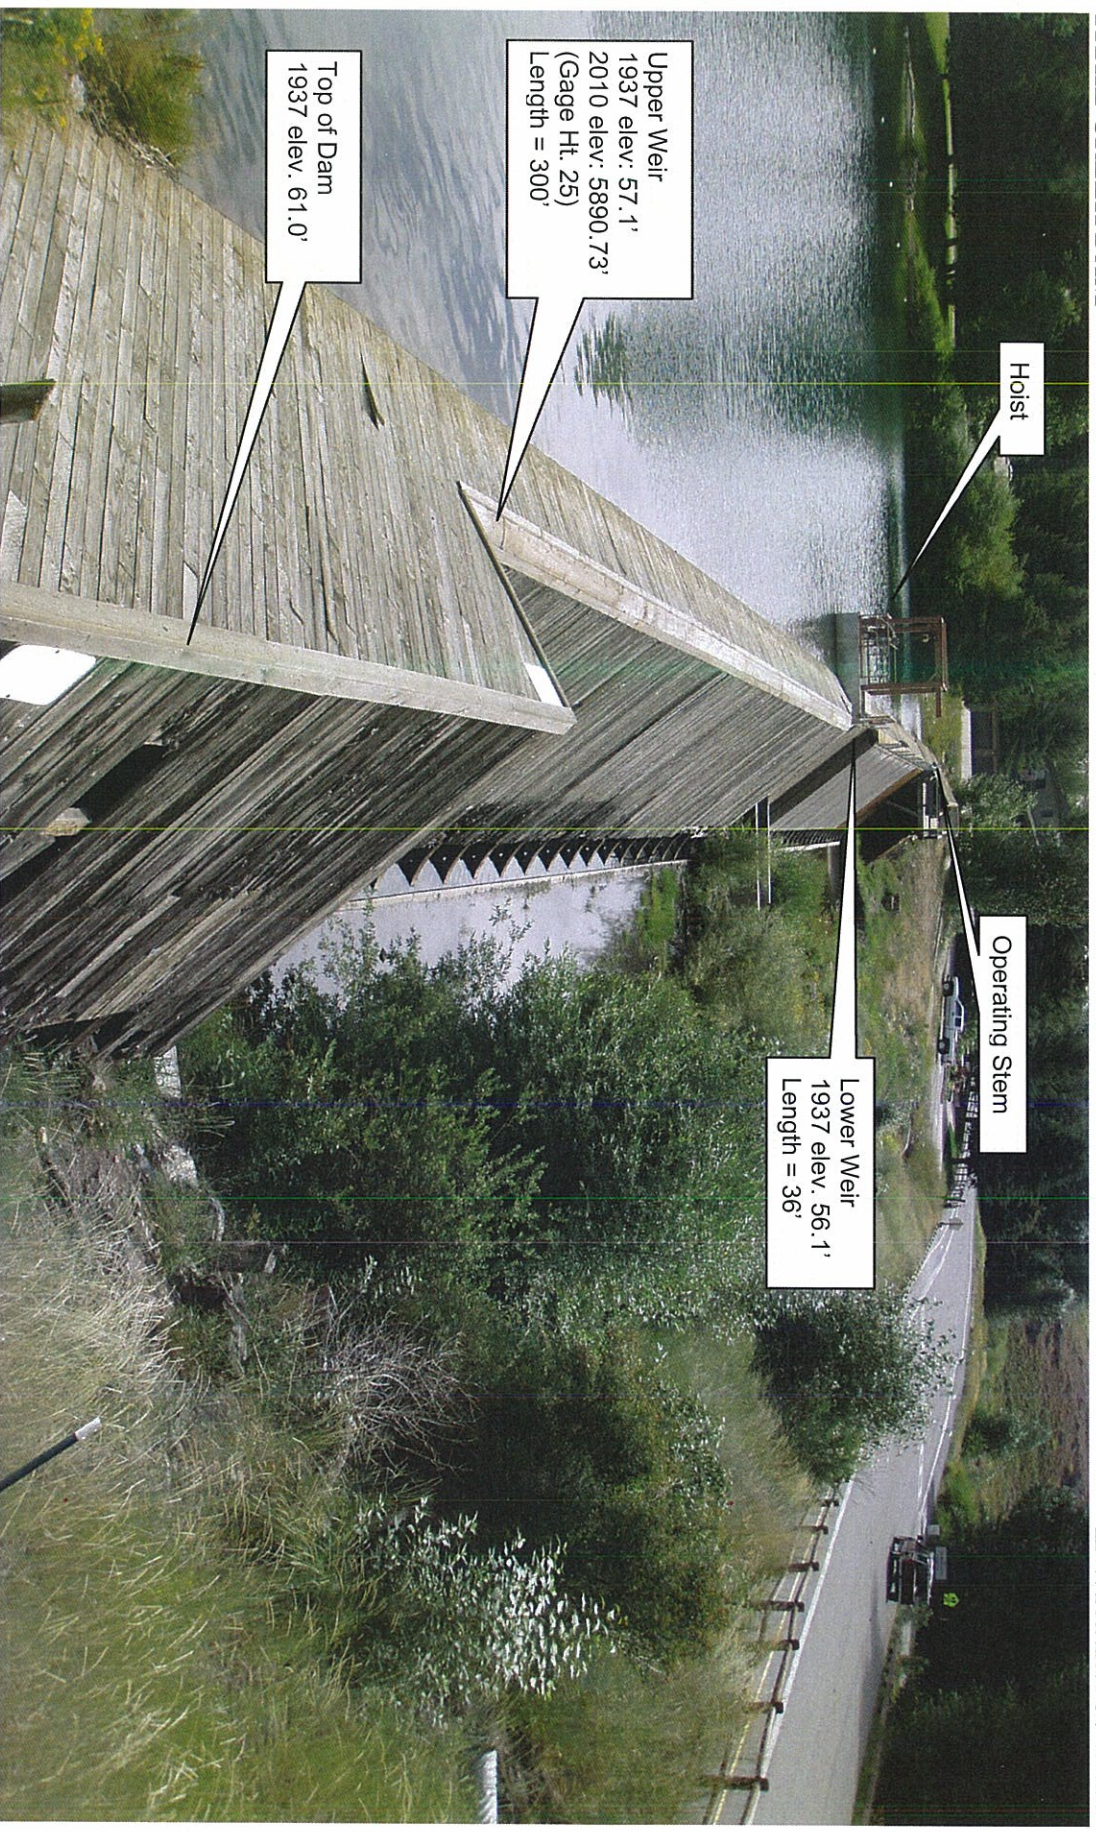
Photo 1 (8/19/2009) - View from the right abutment illustrating the multiple-crest, timber truss dam. Elevations and dimensions are those as presented on the original design drawings circa 1937 and the 2010 survey. Note the locations (front-to-back) of the upper weir (300' length), the lower weir (36' length), the mechanical hoist for installing/removing flashboards in the primary spillway (9' length), and the operating stem for the low level outlet conduit. The staff gage is located on the upstream side of the dam between the hoist and the operating stem (see Photo 3).

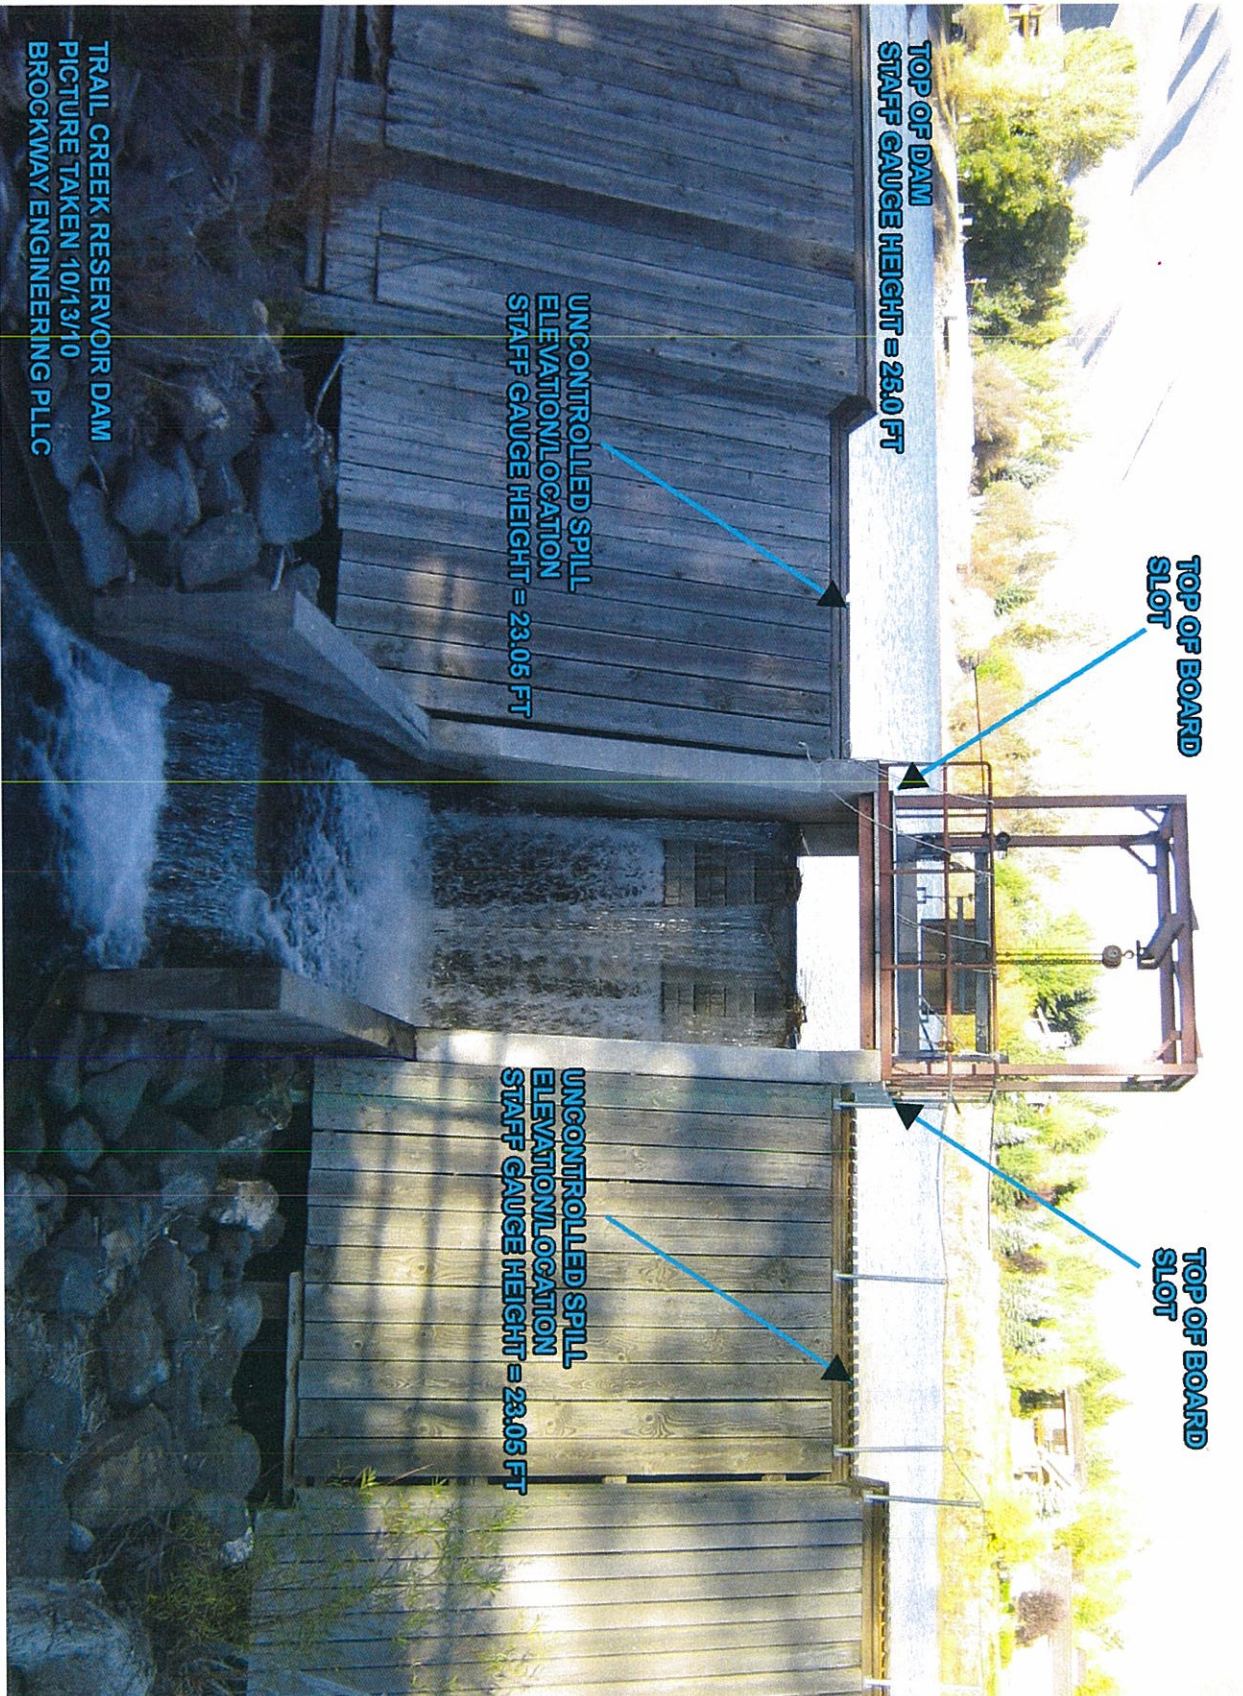
Figure 1

**TOP OF DAM  
STAFF GAUGE HEIGHT = 23.0 FT**

**UNCONTROLLED SPILL  
ELEVATION/LOCATION  
STAFF GAUGE HEIGHT = 23.05 FT**

**TRAIL CREEK RESERVOIR DAM  
PICTURE TAKEN 10/13/10  
BROCKWAY ENGINEERING PLLC**

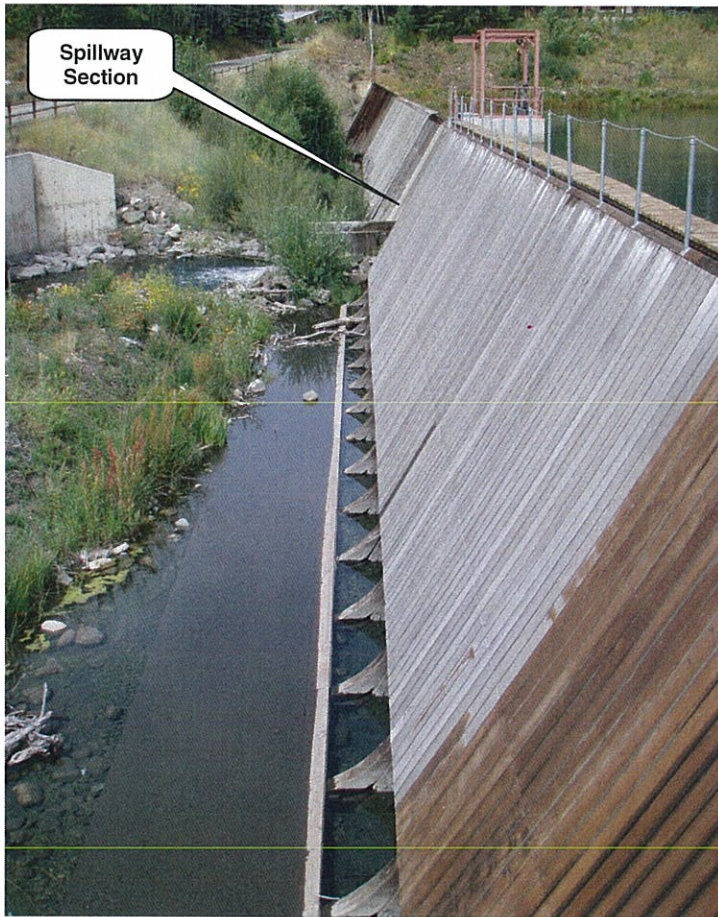
**LEFT:** View looking along the downstream face of the dam and the toe area from near the left (southeast) end of the dam. Note the standing water along the toe of the dam preventing access to the inside of the dam. Also note the vegetation growth (including willows) along the toe of the dam near the spillway section.

- Remove woody vegetation (willows and trees) along toe of dam.
- Investigate and repair eroded areas as needed.
- Make efforts to reduce ponding of water along toe and inside dam.

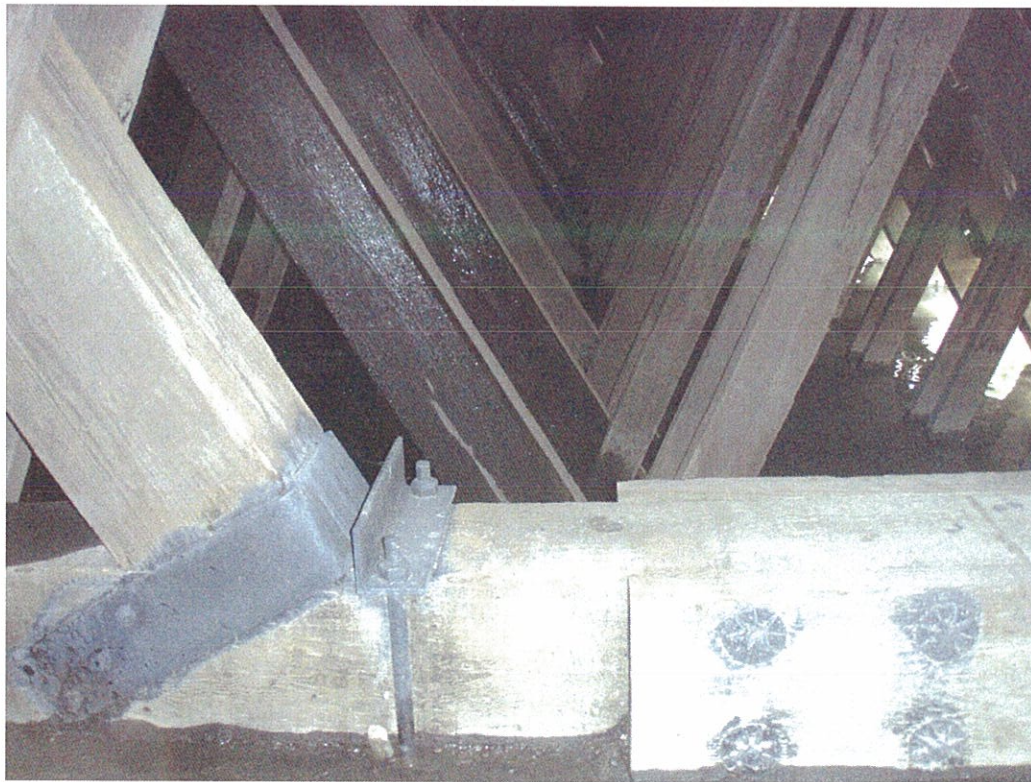
**BELOW:** View inside the dam near the right (northwest) end of the dam. Note the steel truss member connections in the foreground of this view. The steel truss member connections inside the dam were sandblasted and coated in 2004.

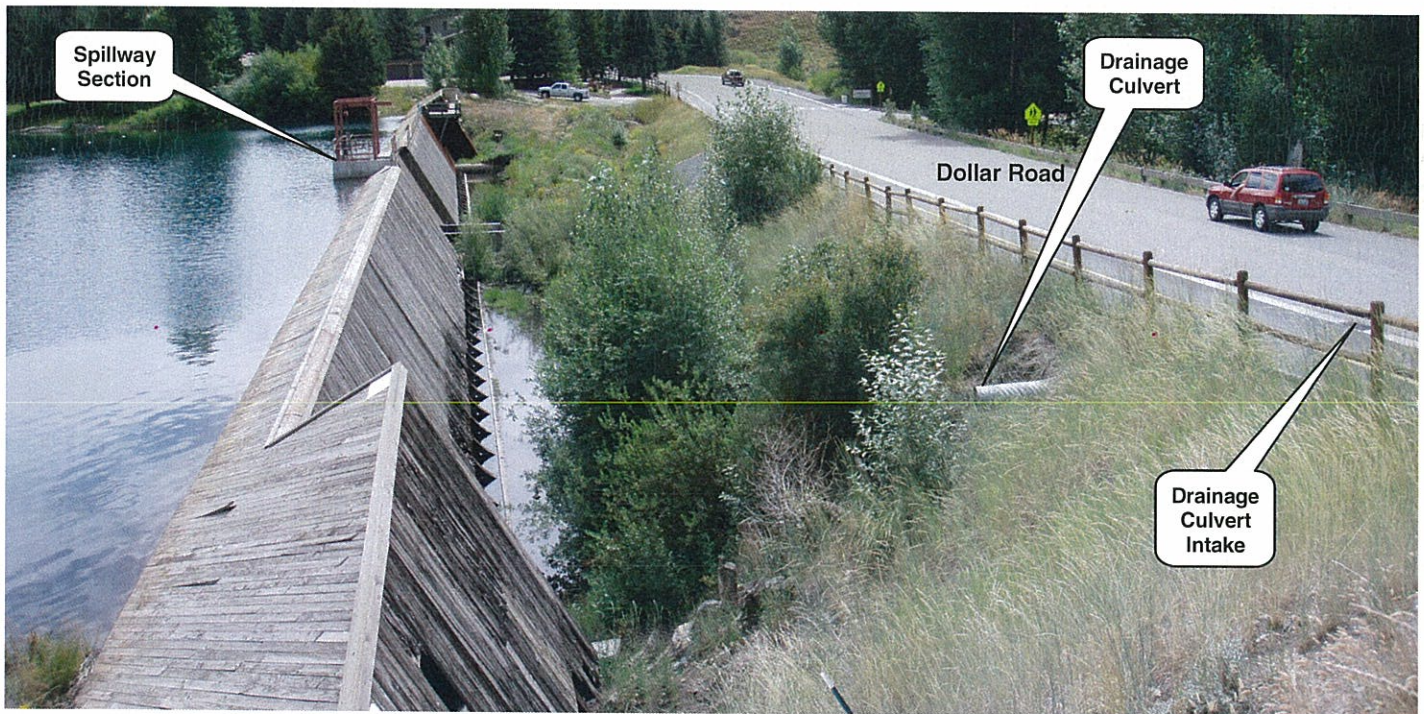
**ABOVE:** View from the right (northwest) abutment area showing the dam and the area directly downstream. Note the vegetation and standing water along the toe of the dam. Also note the drainage culvert from the paved roadway (Dollar Road) that discharges directly downstream of the dam.

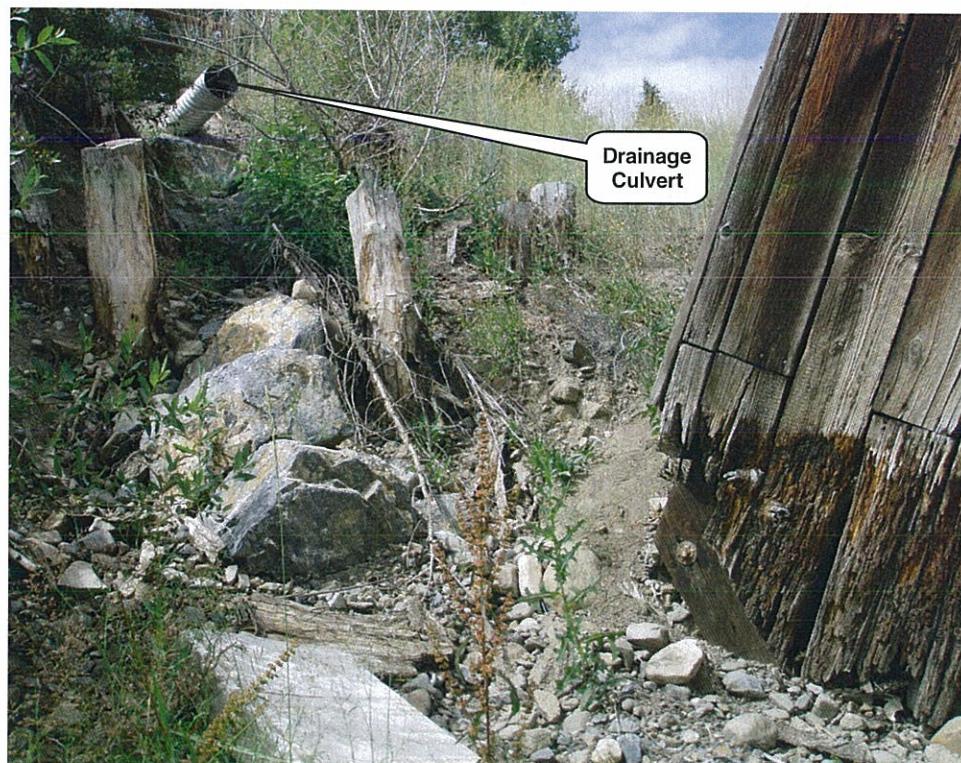
**BELOW:** View from the toe of the dam looking downstream towards the drainage culvert noted in view above. Note the eroded material, below the culvert, in the foreground of this view.

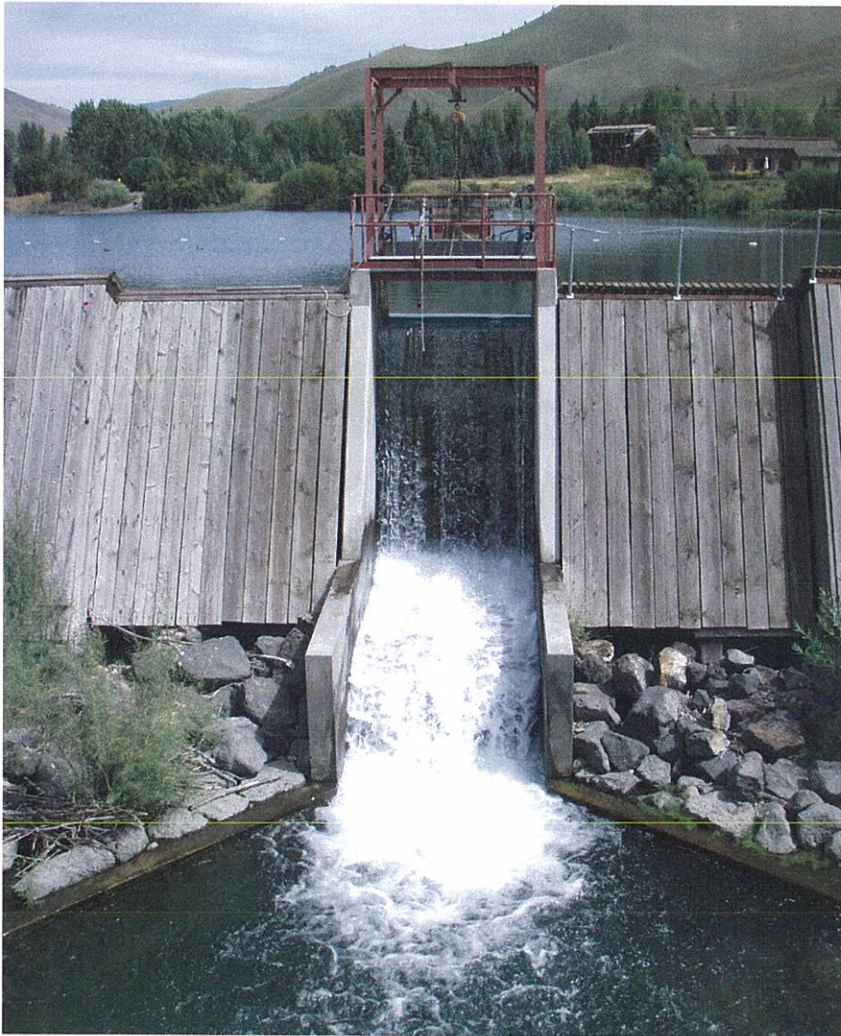
**LEFT:** View from directly below the dam looking back at the spillway section of the dam showing the flow over the spillway stop logs and the relative reservoir level at the time of the inspection. Note the high tail water elevation and the willow growth along the spillway wing walls and toe of the dam. Erosion has been noted under the spillway wing walls during previous inspections.

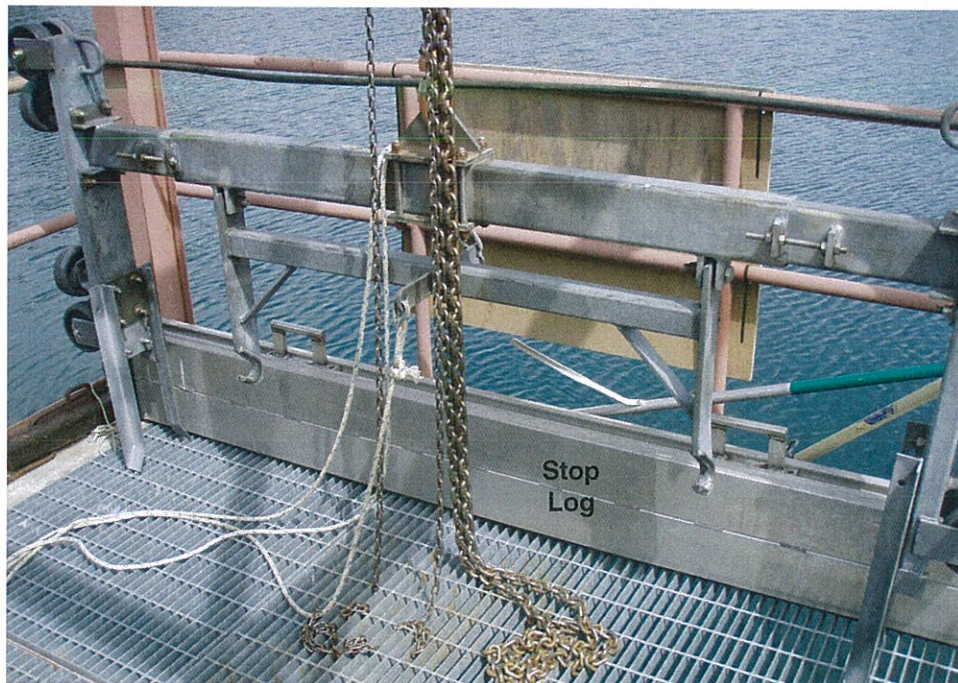
**BELOW:** View of stop log and lift mechanism at the top of the spillway structure.

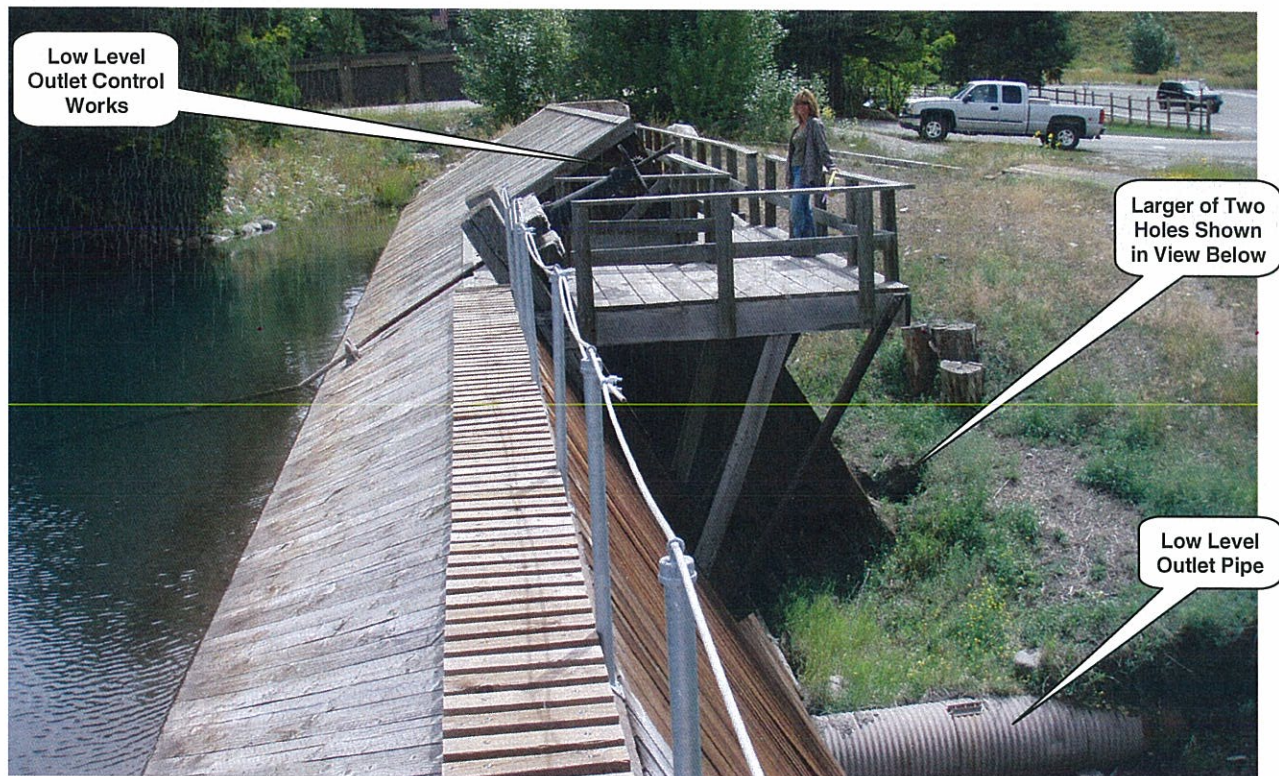
**ABOVE:** View from the dam crest looking towards the low level outlet section near the left (southeast) end of the dam. Note the location of the hole shown in view to the left.

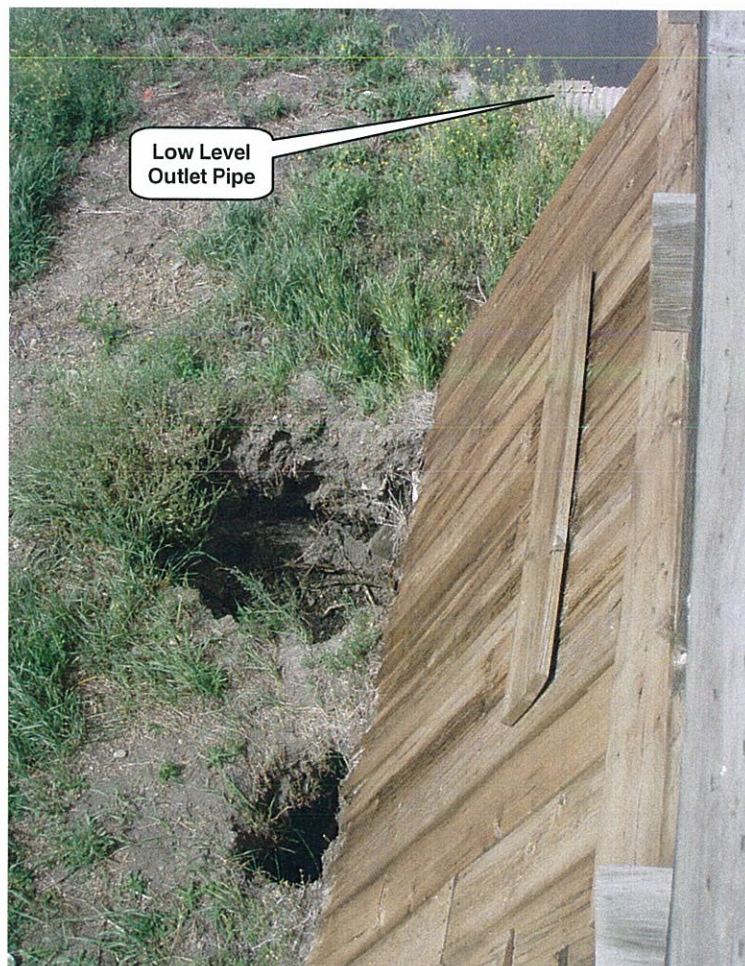
**LEFT:** View from atop low level outlet walk way looking down at two holes located along the toe of the dam to the left (southeast) of the low level outlet. The larger of these two holes is the hole that is visible in the view above. The exact cause of these two holes is unknown, but it is possible that they may be related to water inside the dam. The presence of these holes is not a structural threat to the dam, but their presence is unusual. The holes should be backfilled with granular material and the area monitored in the future.

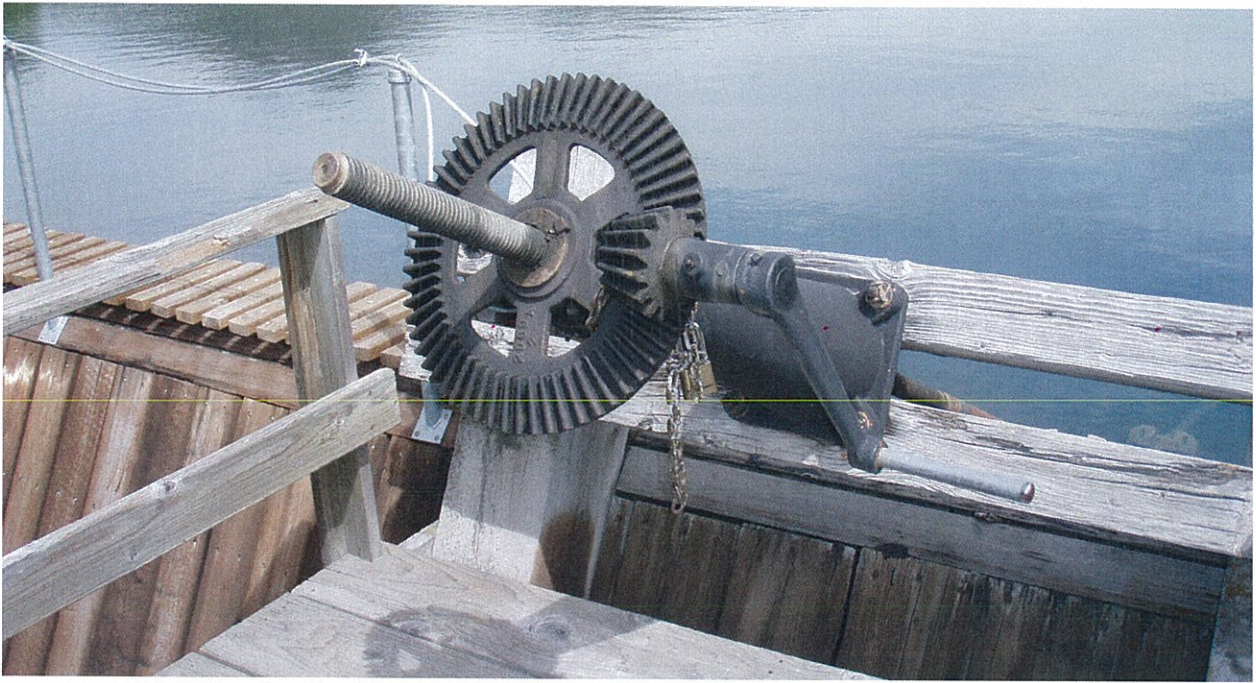
**ABOVE:** View of outlet control works on top of the dam.

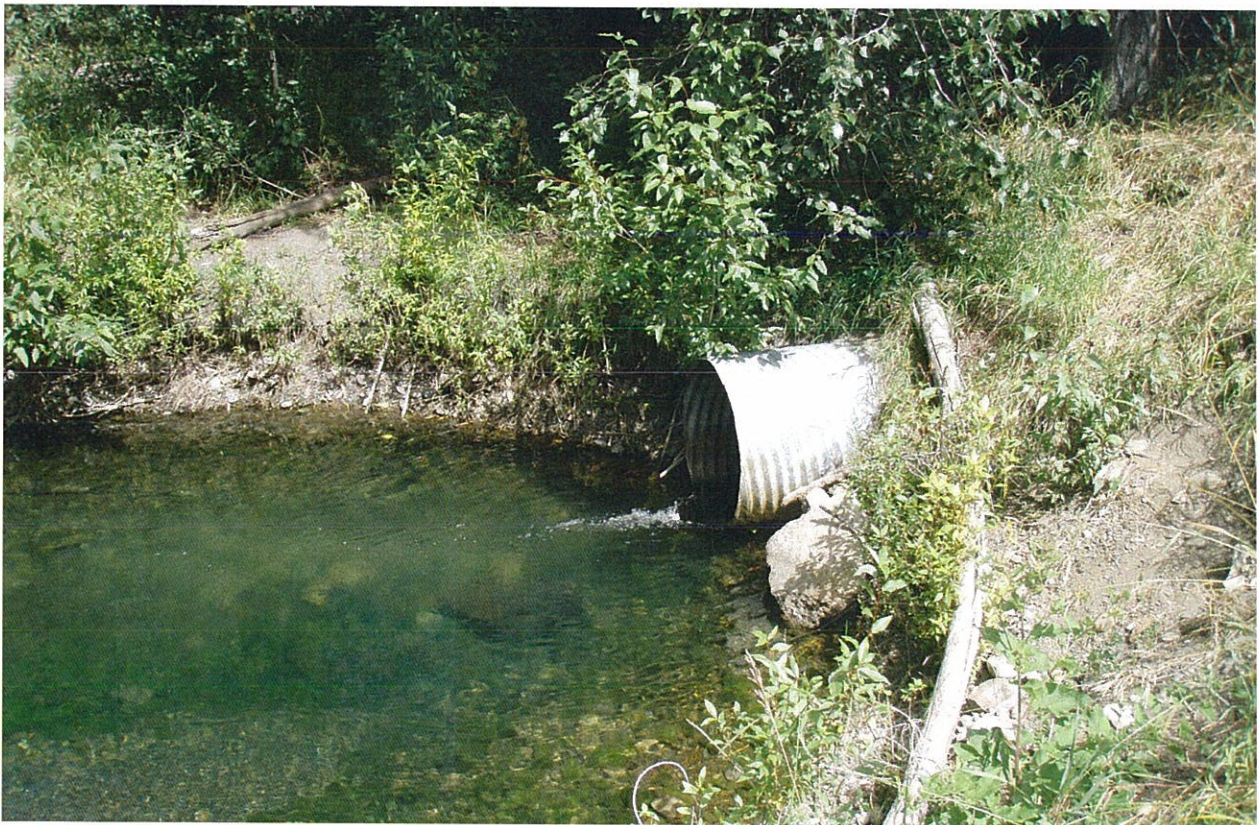
**BELOW:** View of the downstream end of the low level outlet below Dollar Road.
