TO: Files 75-14510 and 75-14511  
FROM: Monica Van Bussum  
DATE: August 24, 2010  
RE: Field exams of August 24, 2010

This memo serves to document my observations of the Terry Family Trust property and water use on the property. I was accompanied by Charles Terry and his daughter, Linda Borchert.

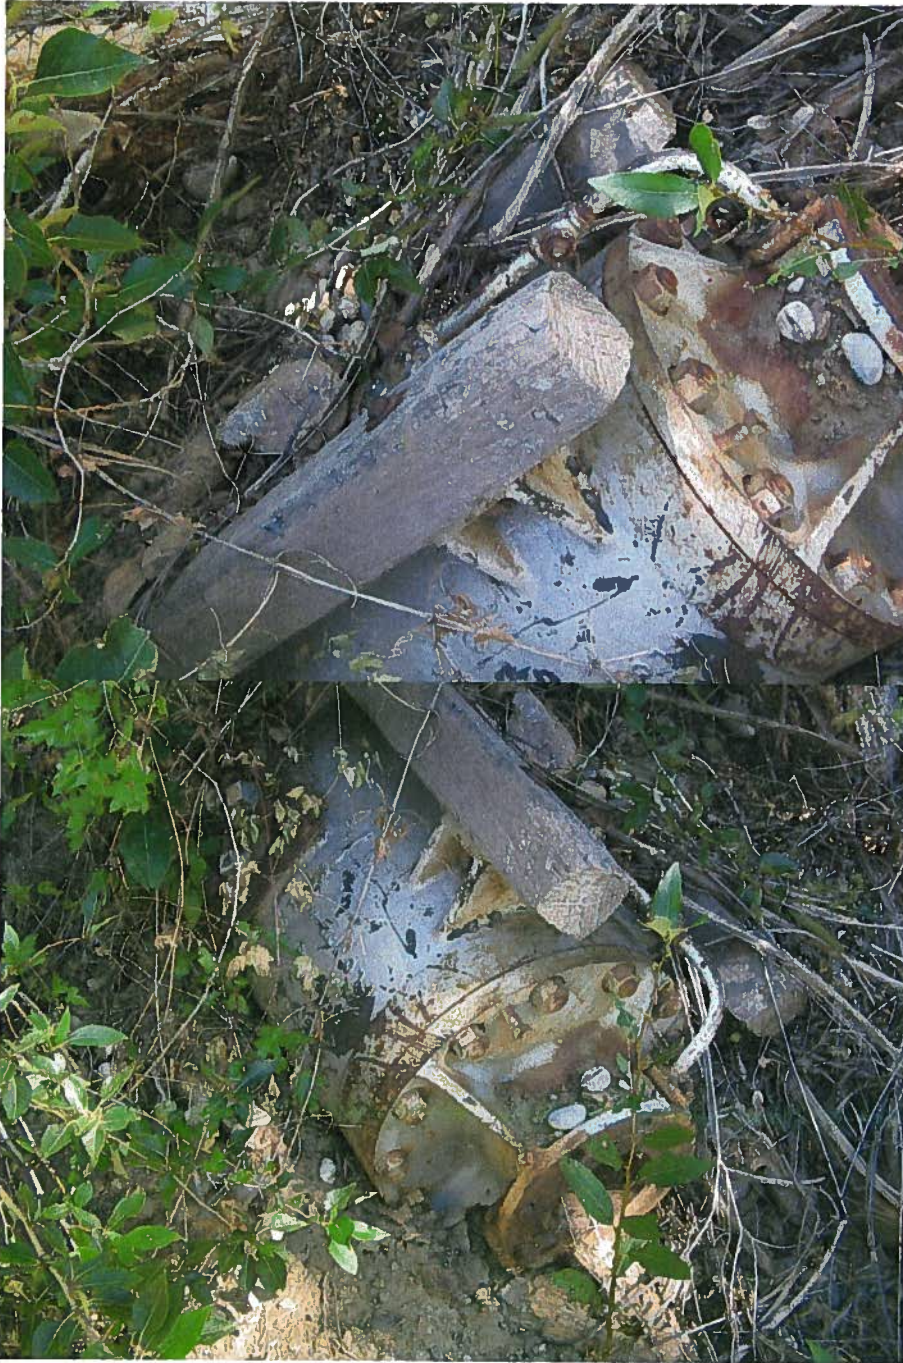
Photos of the old pump that used to sit in the Salmon River. At some point, Mr. Terry and another man tried to move the pump from the river to repair it. Mr. Terry tells me this is a 35hp pump. The pump has clearly not been used for a number of years, judging by the debris buildup around it and its general condition.

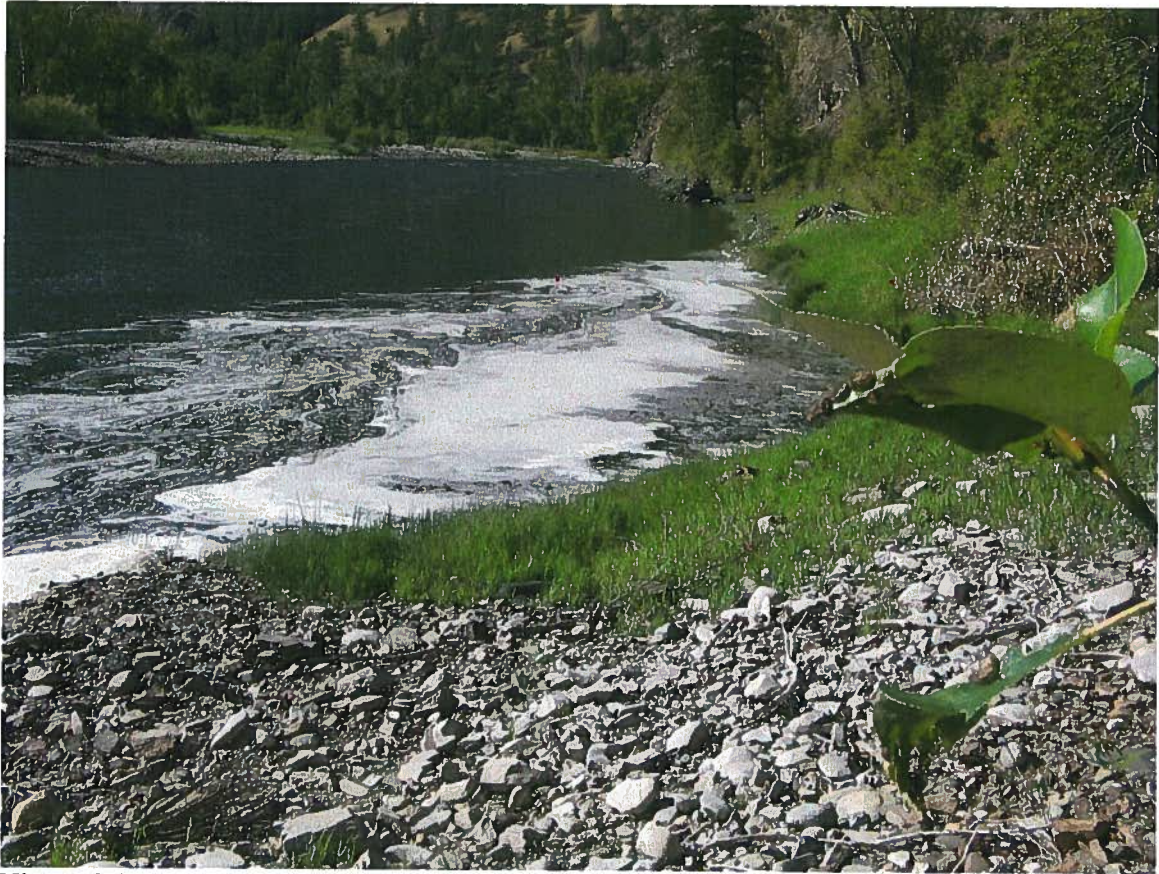
View of the pump's location when it was in the River. There are a couple of power poles in the immediate vicinity.

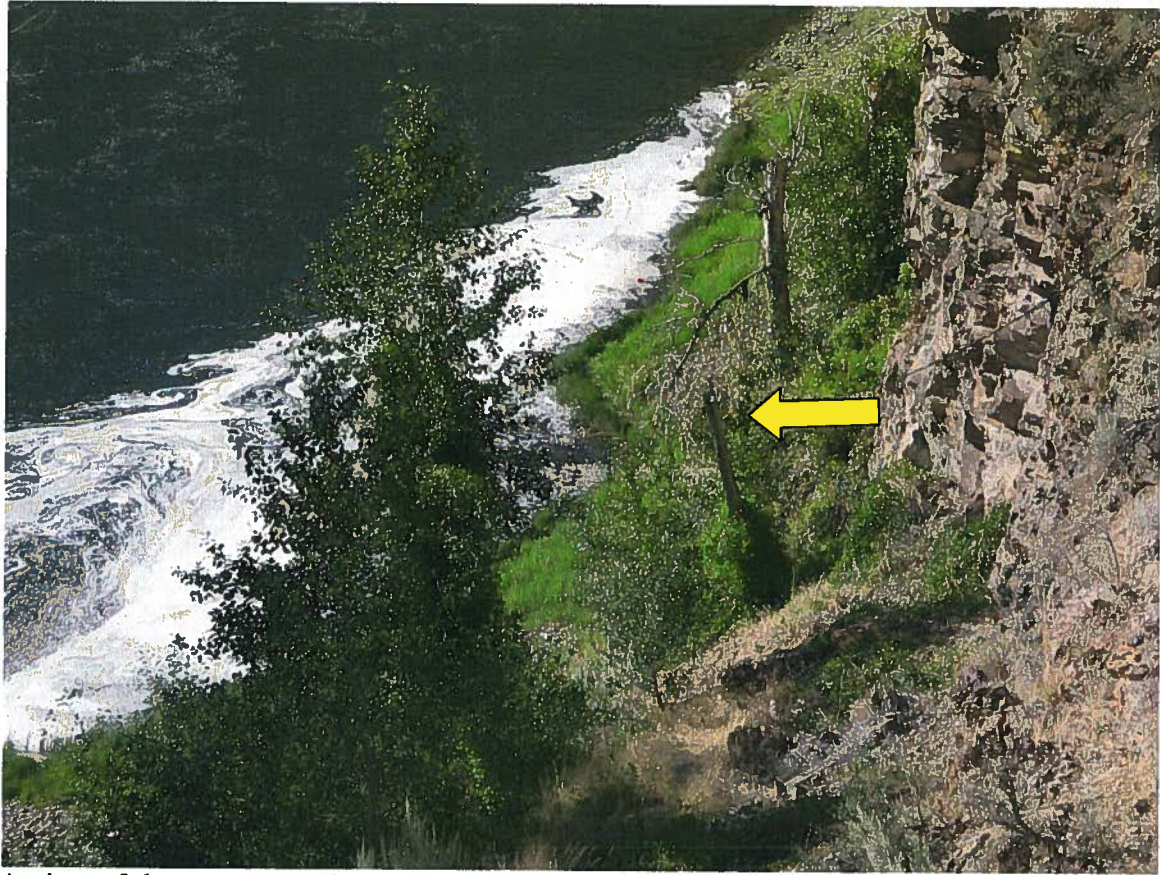
A view of the pump area from above. The foamy portion of the water is the general location of the pump when it was in use. The pump currently sits under the trees at the left of the picture. The power pole is indicated by the yellow arrow.

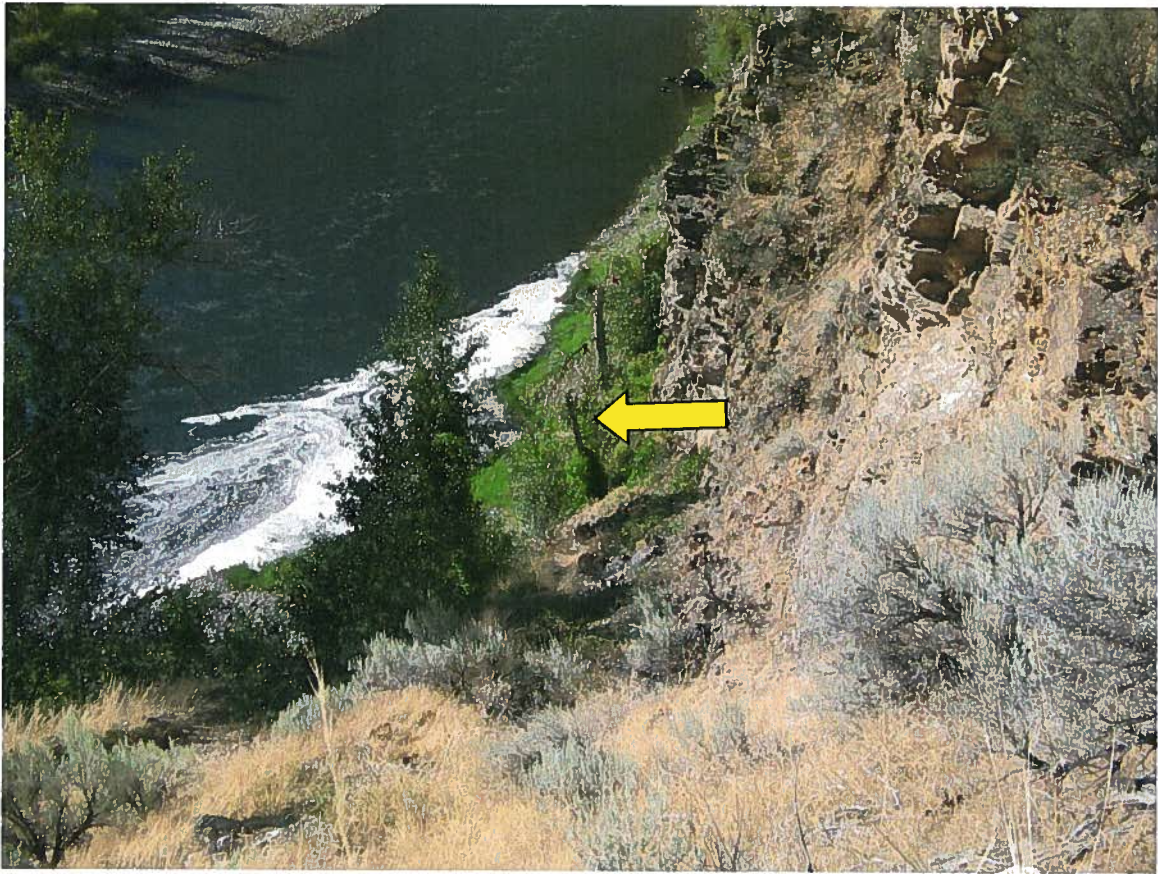
A view of the point of diversion from the Salmon River from the top of the hill. The power pole is noted by the yellow arrow.

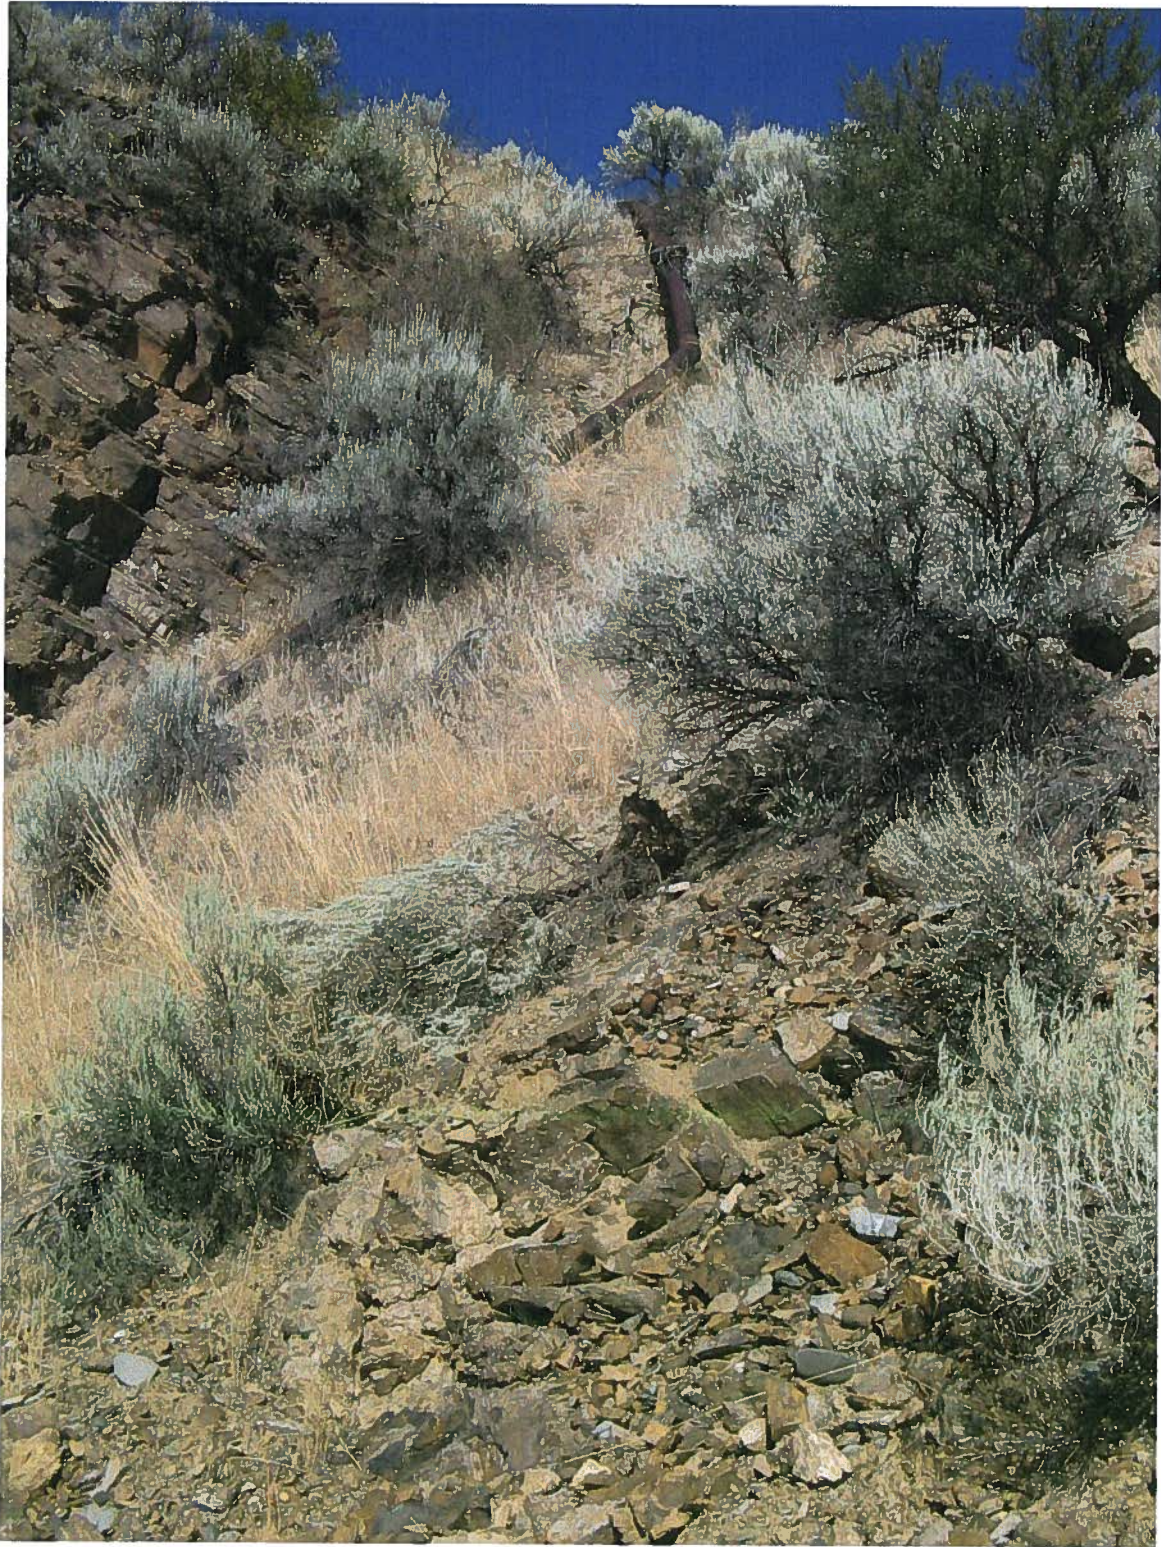
Photo taken while standing on the hill looking up. The river is to the photographer's back and downhill. A metal pipe can clearly be seen in this photo, indicating the path of the pumped water from the river.

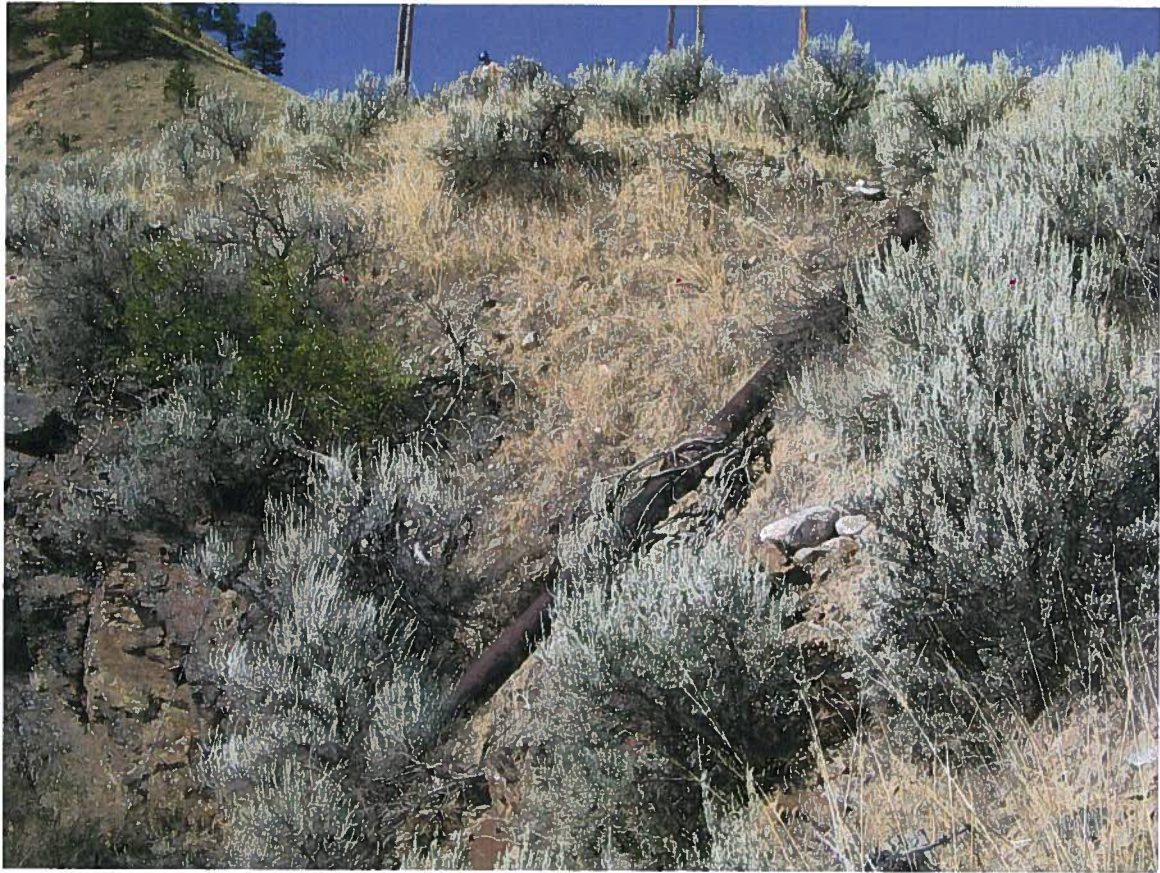
Photo taken further uphill from the river. The river is again to the photographer's back and downhill. The metal pipe can be seen bisecting the picture from the lower left to the upper right. Mr. Charles Terry is in the background at the top of the hill.

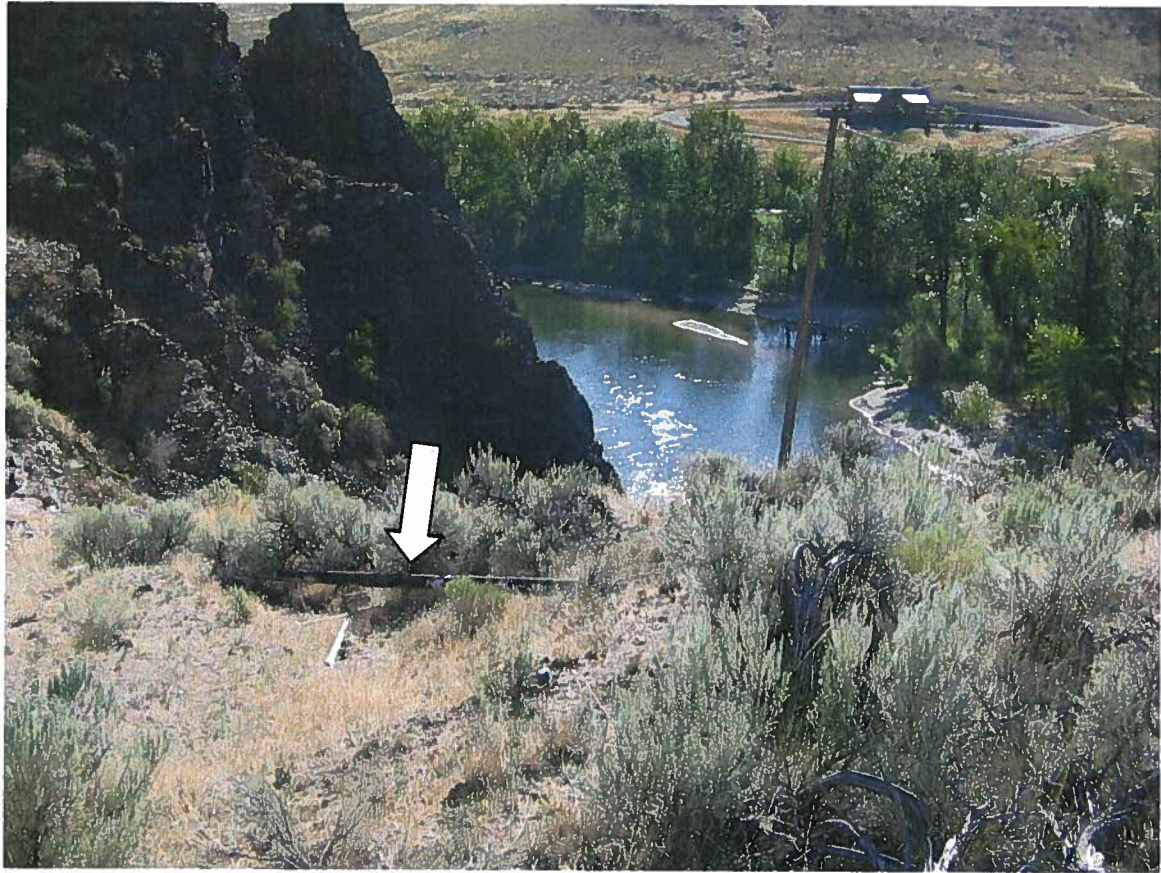
Overlooking the Salmon River from the top of the hill over which the water was pumped. The metal pipe seen in earlier pictures is noted here by a white arrow.

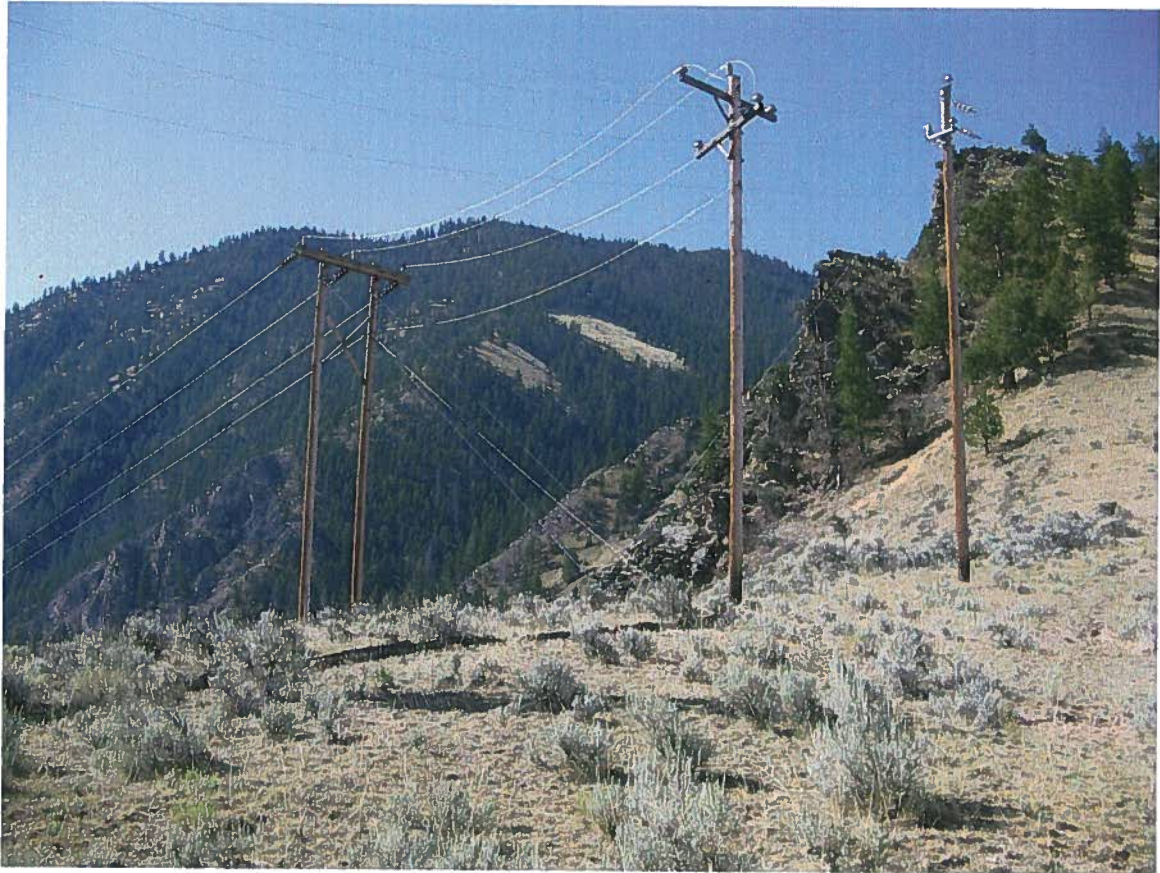
Power poles connected to the power pole at the bottom of the hill that would have operated the pump. The metal pipe seen in earlier pictures is to the left and slightly behind the photographer.

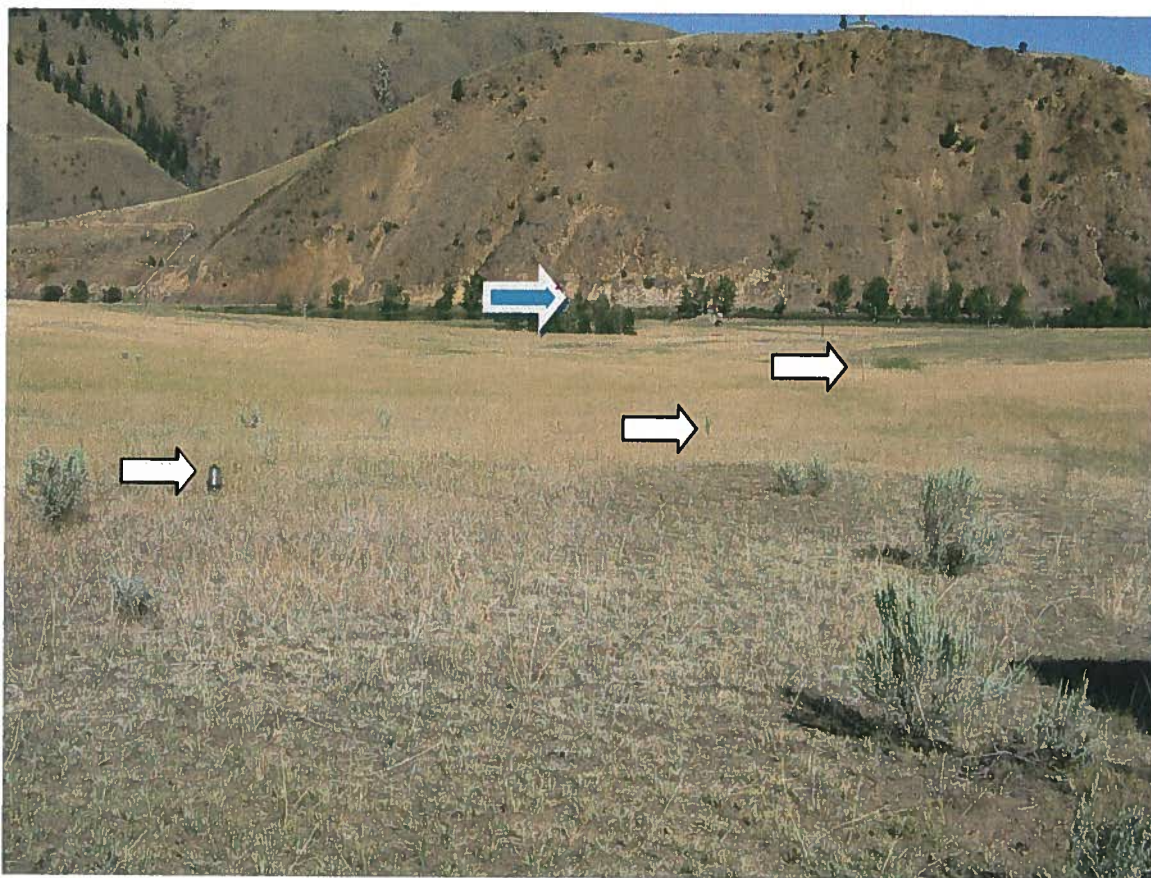
Photo taken looking down the underground mainline that would have operated the pressurized irrigation systems. A couple of poles are seen showing outlets, as well. All irrigation points marked with white arrows. The Salmon River is in the background and its flow direction is indicated by the blue arrow.

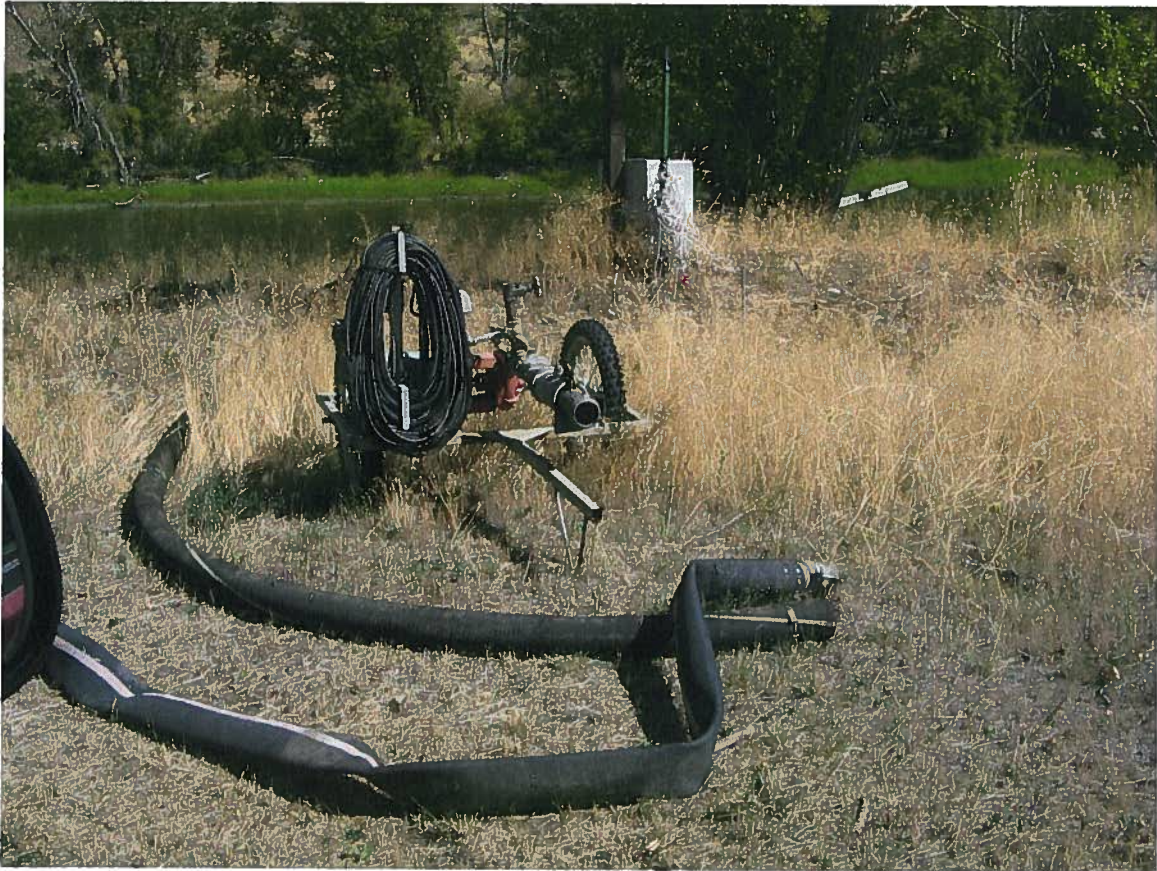
The pump apparatus installed pre-1987 that allowed irrigation of the small parcel near the house. This may be recommended as an accomplished change in point of diversion for the Salmon River late claim.
