## **FIELD EXAMINATION OF CSRBA WATER RIGHT CLAIM**

**Claim Identification Number:** 91-7502

**Date of Examination:** 03/01/2016

**Examination Location:** 1955 E Round Lake Rd, St. Maries, ID 83861

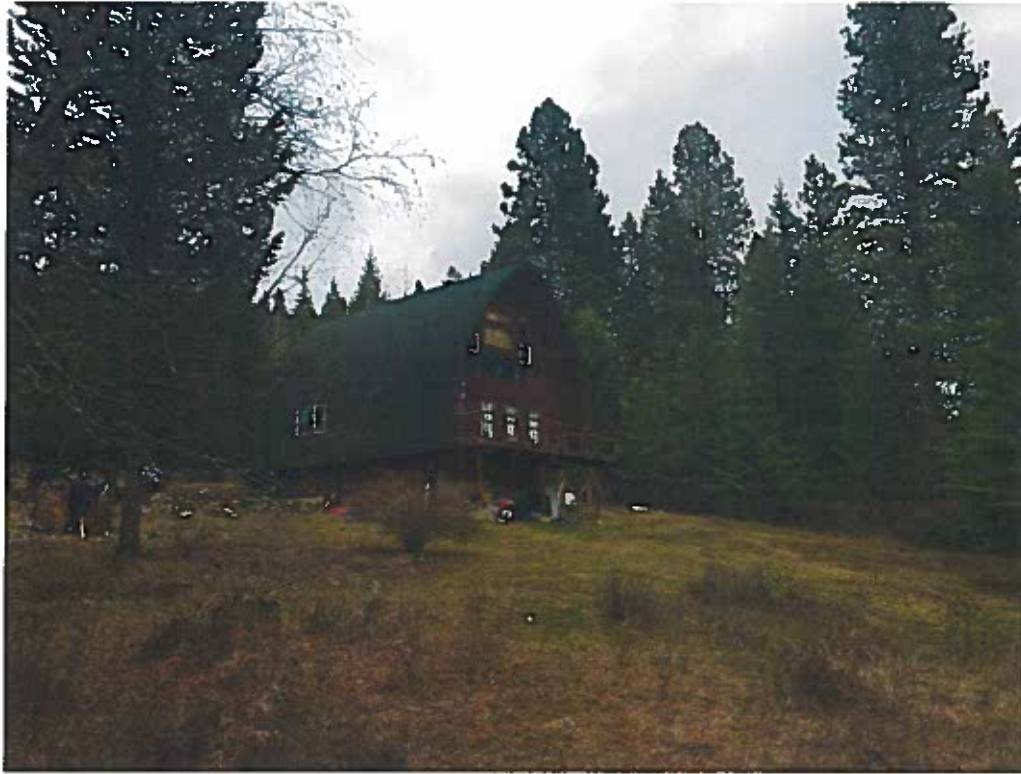
1) Place of Use – Home

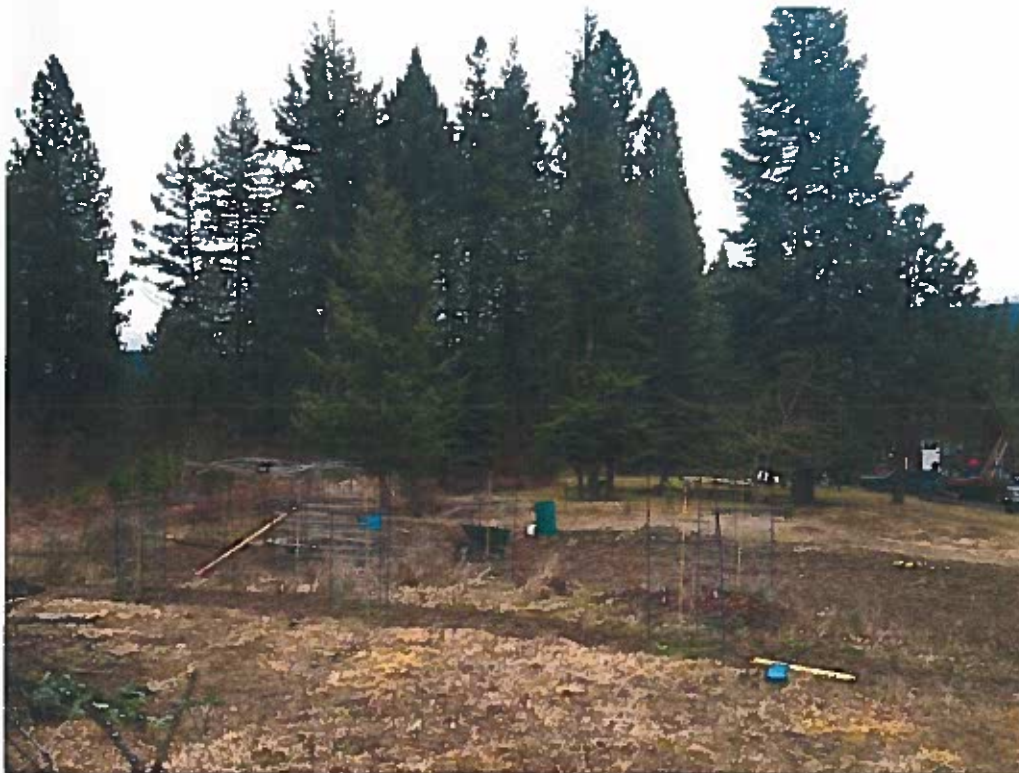
2) Place of Use – garden and plantings on north side of house

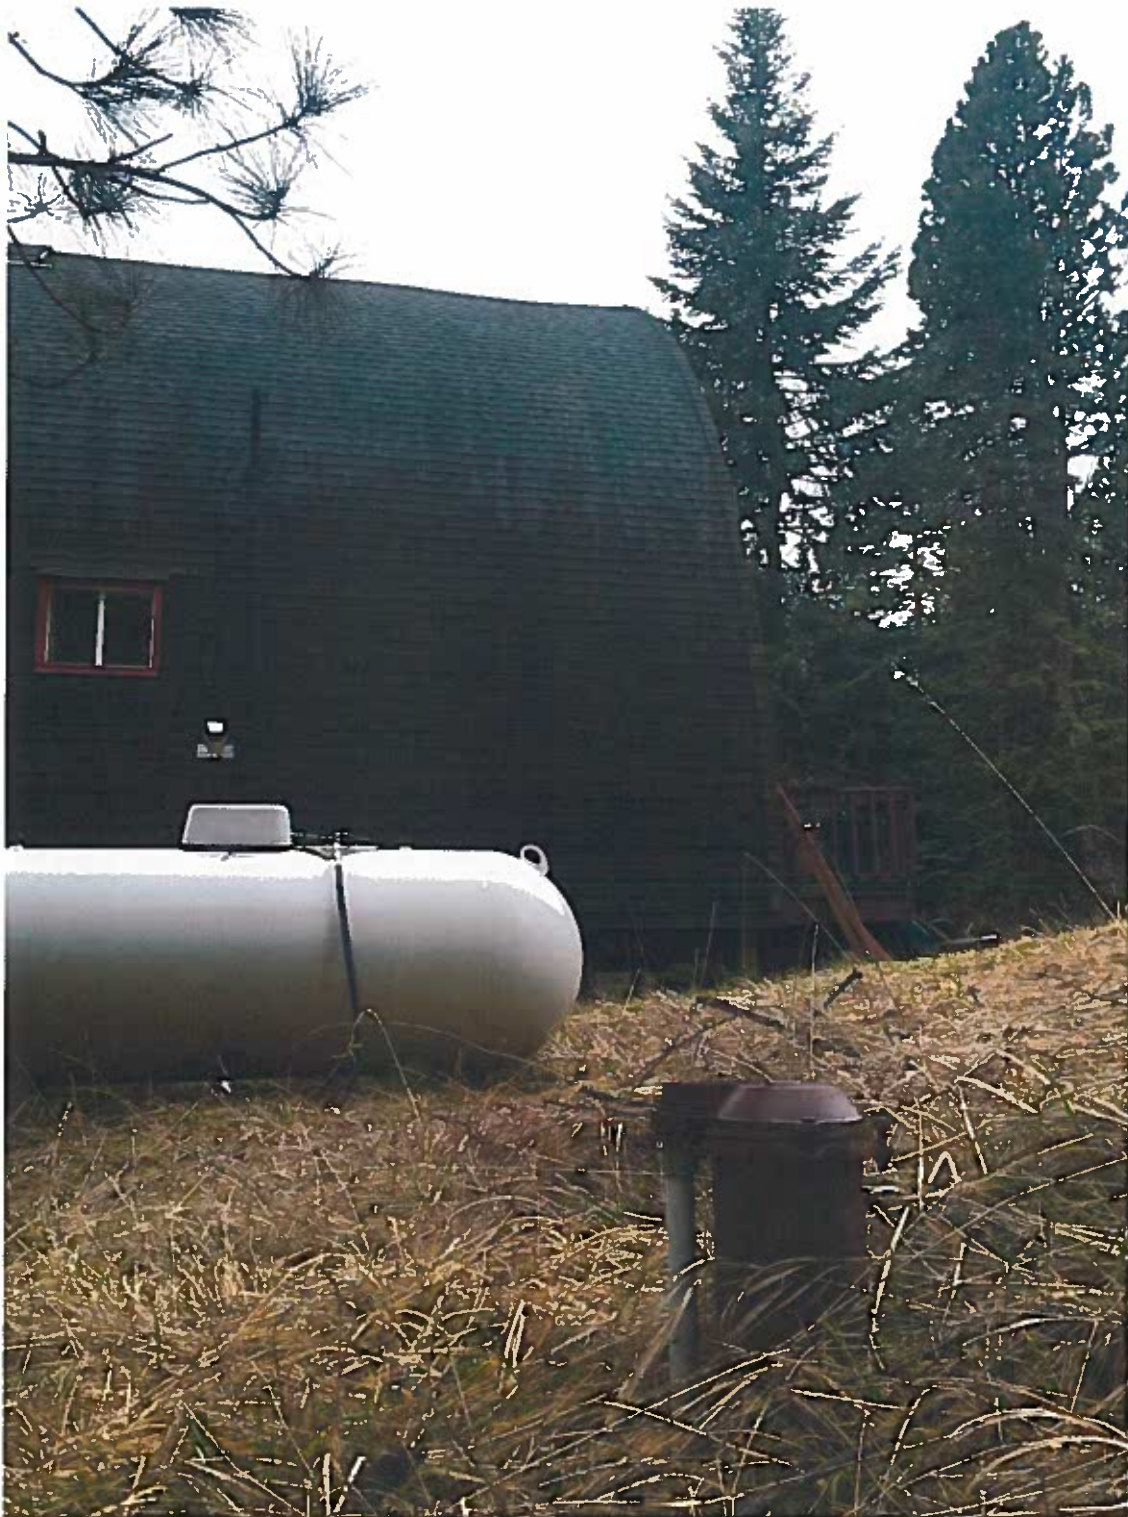
3) Point of Diversion – Original Well

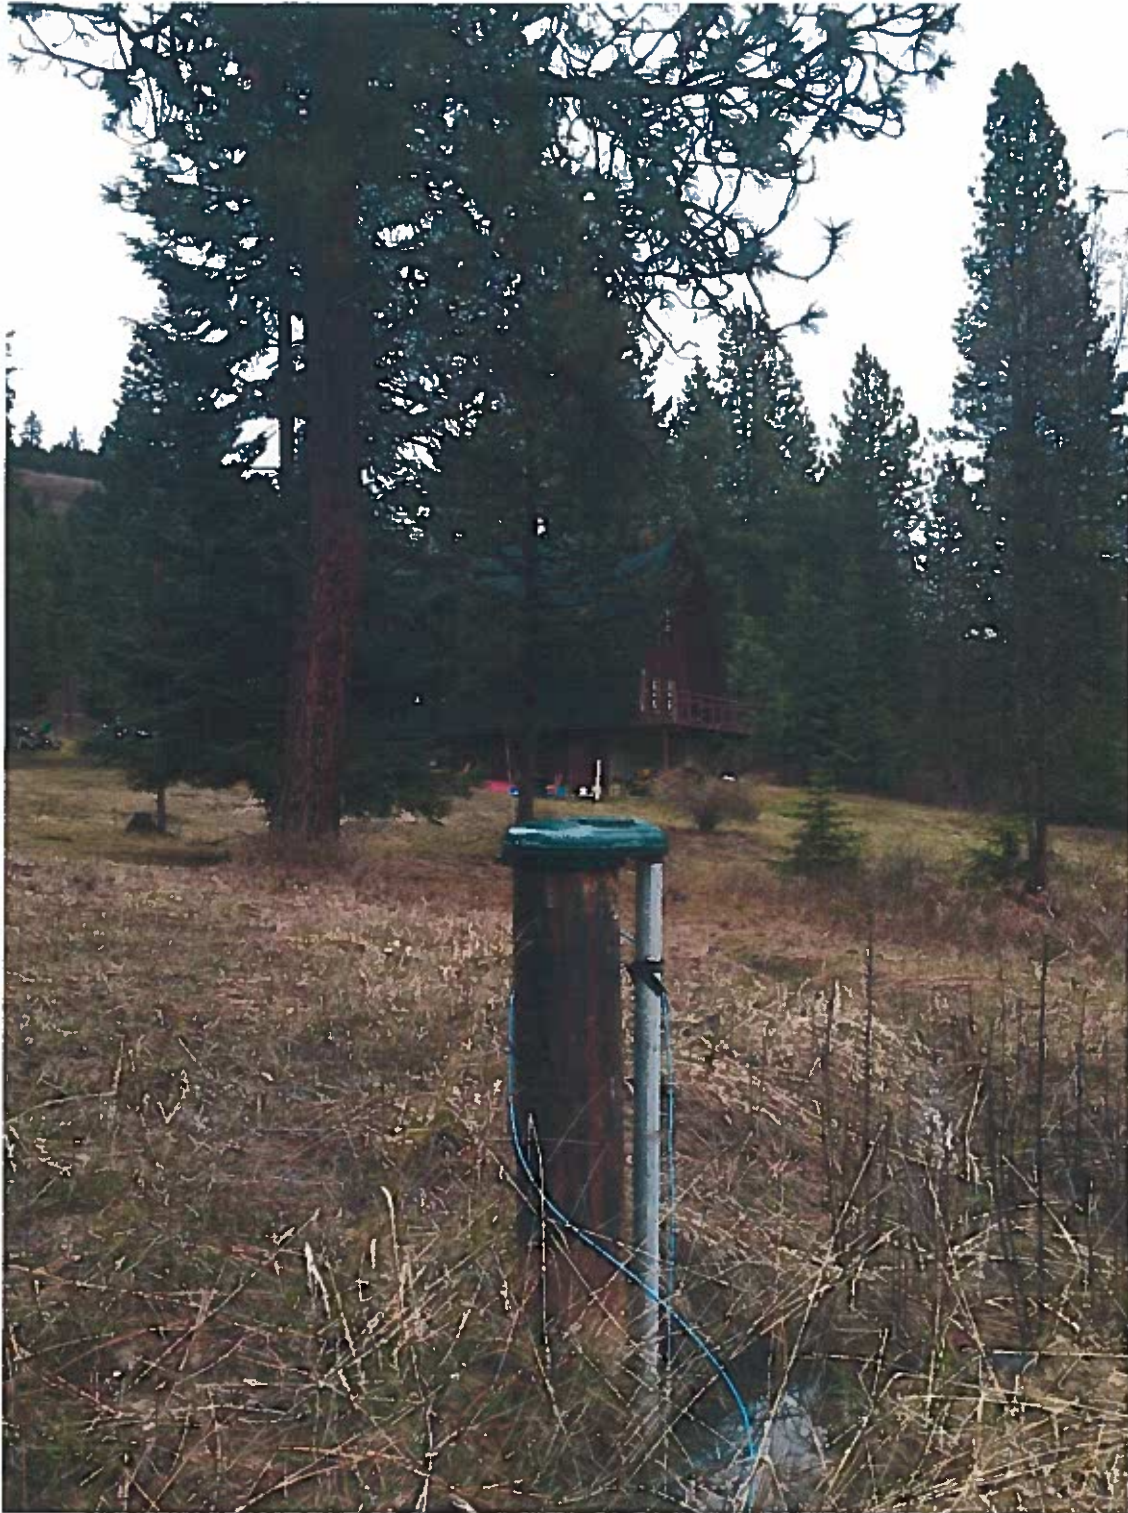
4) Point of Diversion – Replacement Well
