## FIELD EXAMINATION OF CSRBA WATER RIGHT CLAIM

**Claim Identification Number:** 92-4130, 92-7141, 92-7206, & 92-7212

**Date of Examination:** 5/19/2016 & 5/20/2016

**Examination Location:** 517 Middle Fork Santa Creek Rd, St. Maries, ID 83861

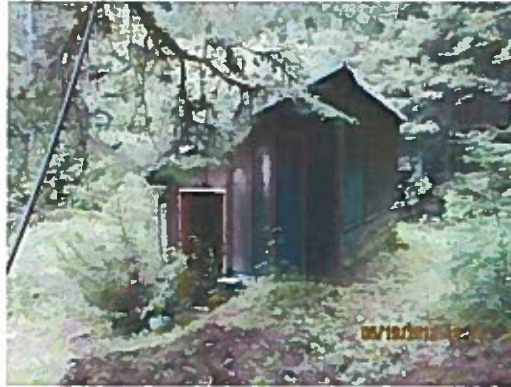
Pump House

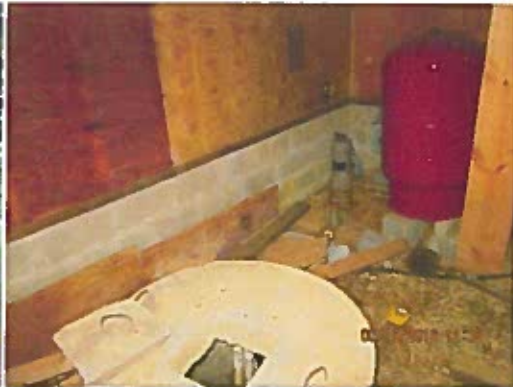
Cistern, pump, and pressure tank  
(not connected)

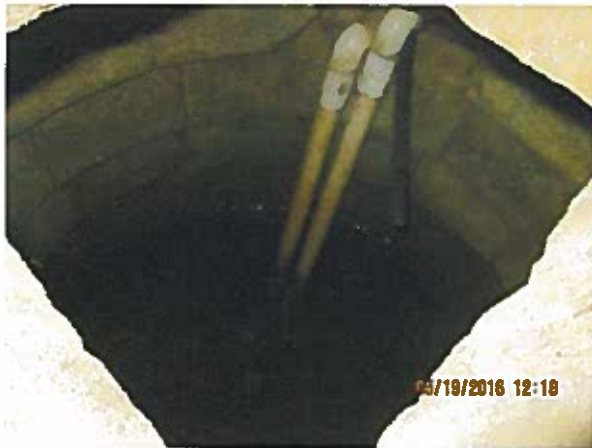
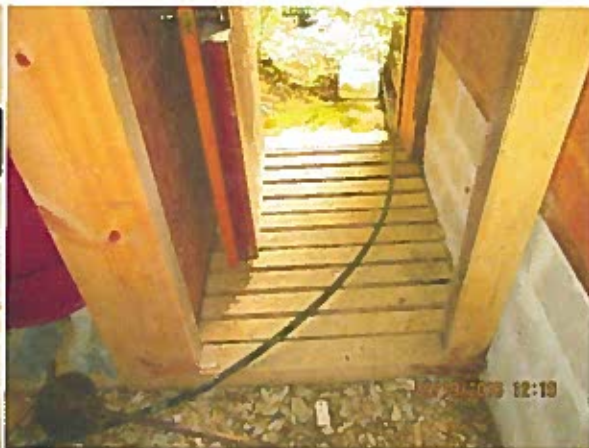
Mr. Hagan was unaware of the spring locations. After expansive searching, the springs could not be located. A small plastic conduit pipe was observed running into the concrete cistern from a nearby well at the southeast side of the home. The well water may have been used to fill the cistern when flows from the springs were insufficient.

Black plastic conduit into cistern and out the pumphouse

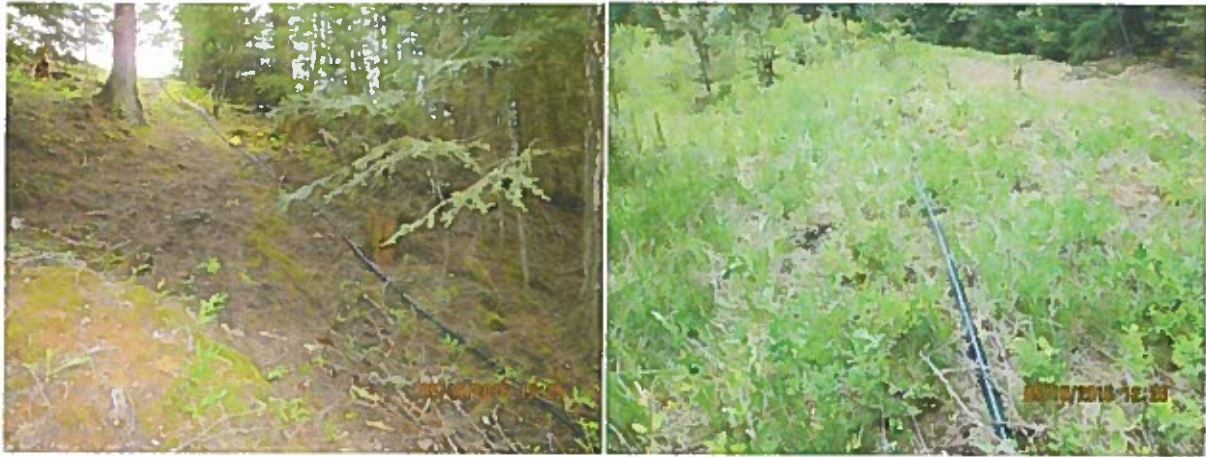
Plastic conduit from cistern up and over hill towards well on south side of home

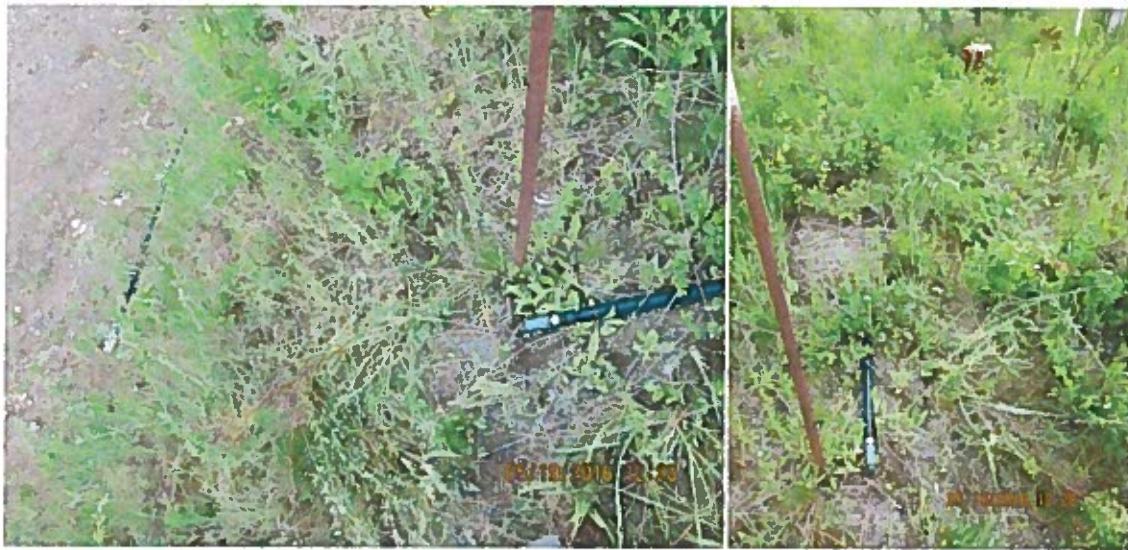
Conduit runs from cistern to connection point at well

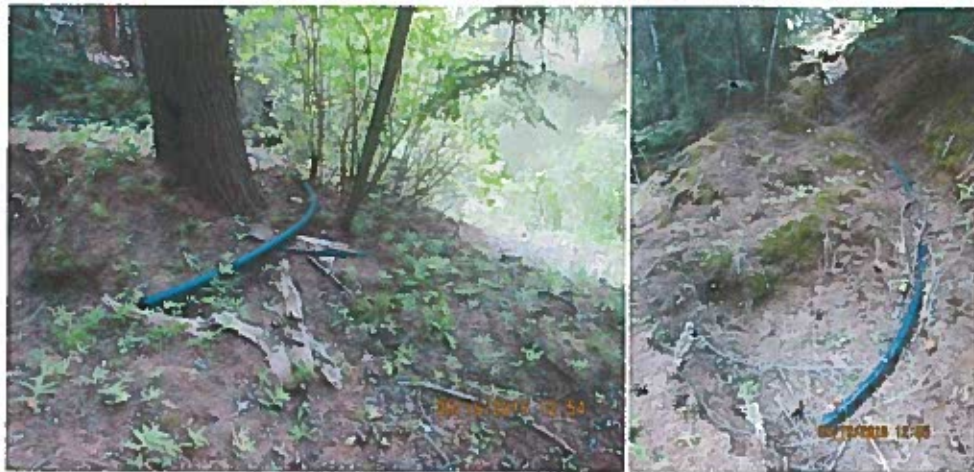
Historically, the spring water may have been used to maintain water levels in the two small ponds on the west side of the home. Currently, no spring water supply could be located. There is a water line from one well on south side of home into the cistern in the pump house, and another large water line (approximately 4 inch) running from a different well northwest of the home down to the smaller of the two ponds.

Large water line running from pond through trench up hill

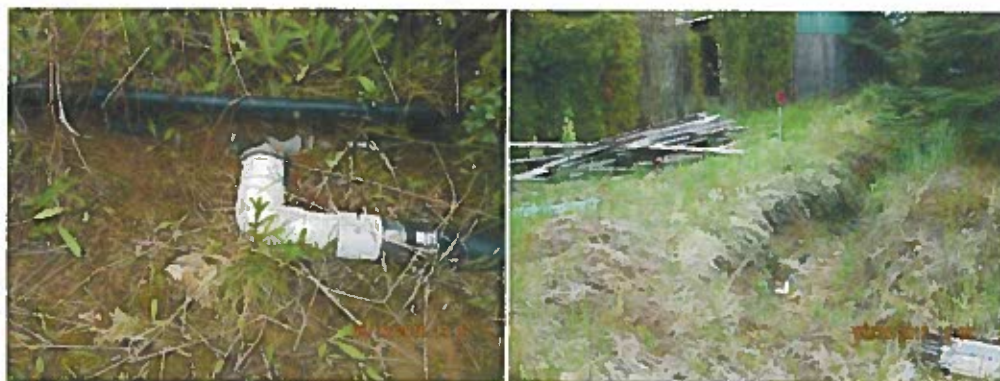
Pipe runs up trench from pond to a T, one side leading to spigot and the other towards a nearby well. Cannot confirm the connection to the well, as the line is buried.

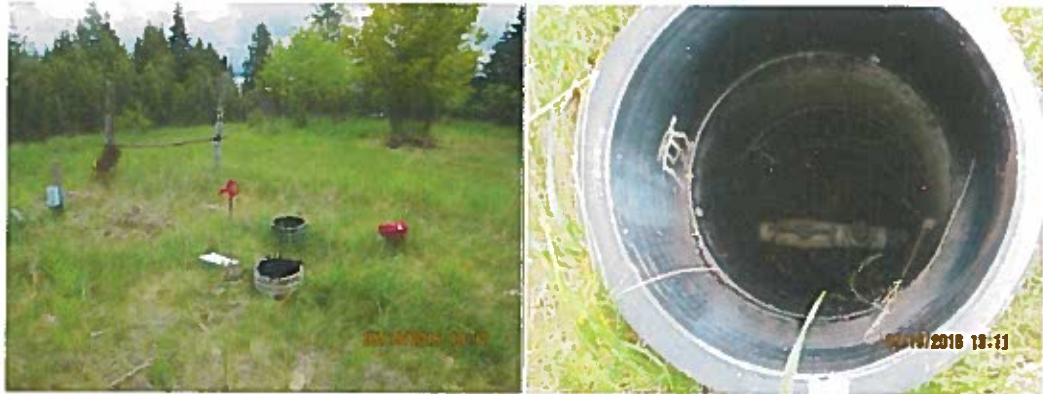
Well located northwest of home with control valve on pipe of same diameter as the one running down the hill to the pond. No conformation on where this pipe actually leads though.

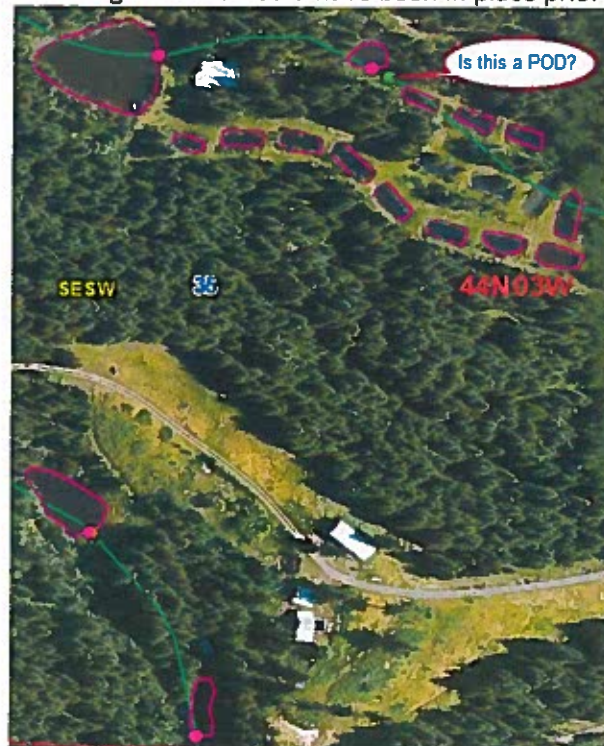
**Discussion:** The license lists one POD in the SESW of S35 and then states in the remarks that there are 4 POD's located in the SESW of S35. There are at least 4 on-stream ponds which account for 4 PODS. But, the map in the WR file shows a 5<sup>th</sup> POD from a 48" dike diverting water into the raceways?

The mapped PODs appear to be correct. The ponds are on-stream, so the 4 PODs are correct. The stream channel of the upper ponds runs down from the brood stock pond and just north of the raceways just inside the tree line down to the largest reservoir. The 48" dike passes flow from the "brood stock pond" into that channel. Water must have been pumped from the brood stock pond into the raceways below at one time.

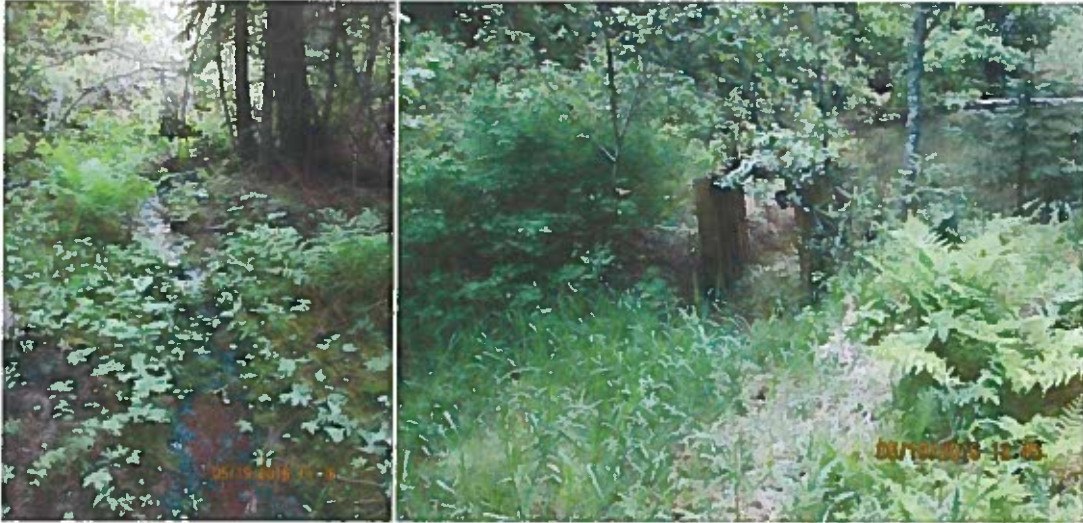
Seepage from toe of dam (pond 1 on map) flows down draw into lower pond (pond 2 on map)

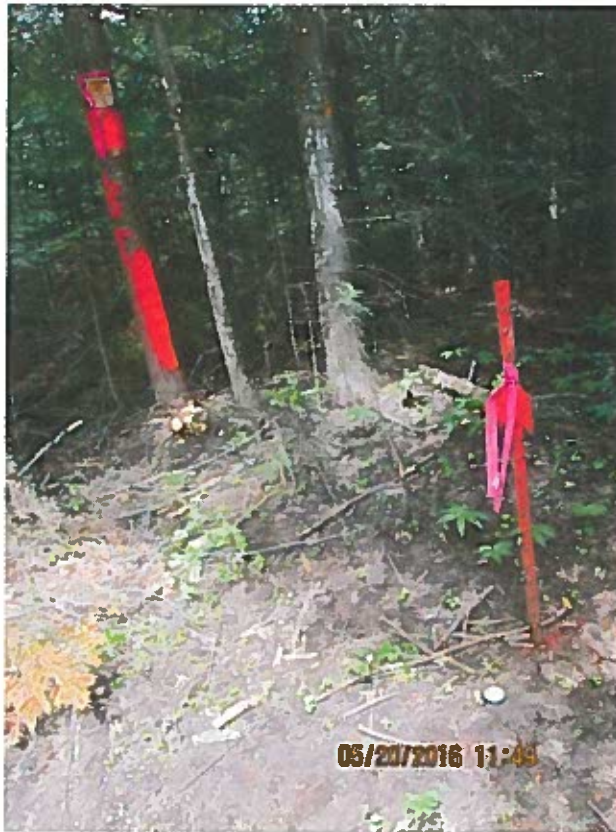
Surveyed marker and cap of SW 1/16 S 35

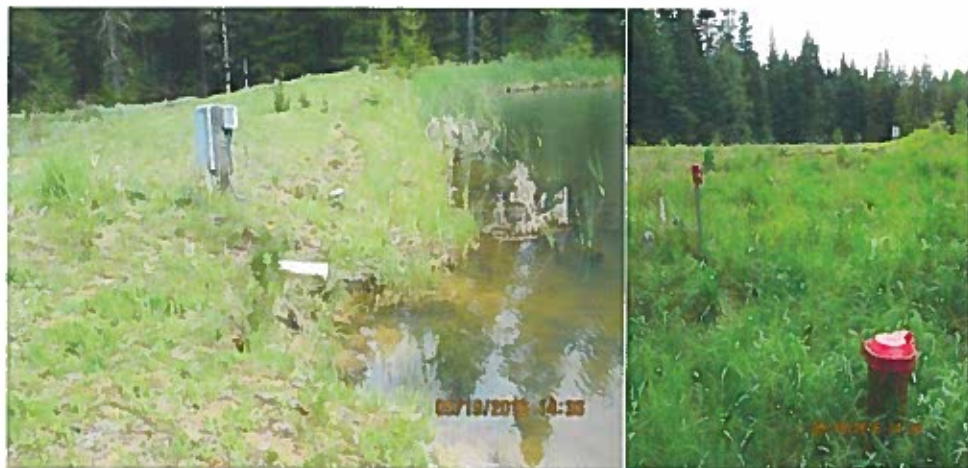
The 48" dike appeared to only pass water into the natural channel, which then flows down to the largest reservoir. A wooden structure on the bank of that pond may have supported a diverting pump at one point, but none is there now. The two lower ponds are located at the end of a small stream channel which enters the smaller pond on its far west end. Water then passes through a spillway on the northeast corner of the pond through a short channel and into the larger pond. The water then flows out of the larger pond from approximately the middle of the west side of the pond and follows a channel southeast into a natural channel. This water course can be seen in the imagery. Two wells are located on the east side of the larger pond. There is a PVC pipe approximately 6" diameter running underground from one of the well locations into the pond, and a 2" PVC pipe running underground from the other well location into the pond.

Pipe into pond and nearby well. (power box visible in both)

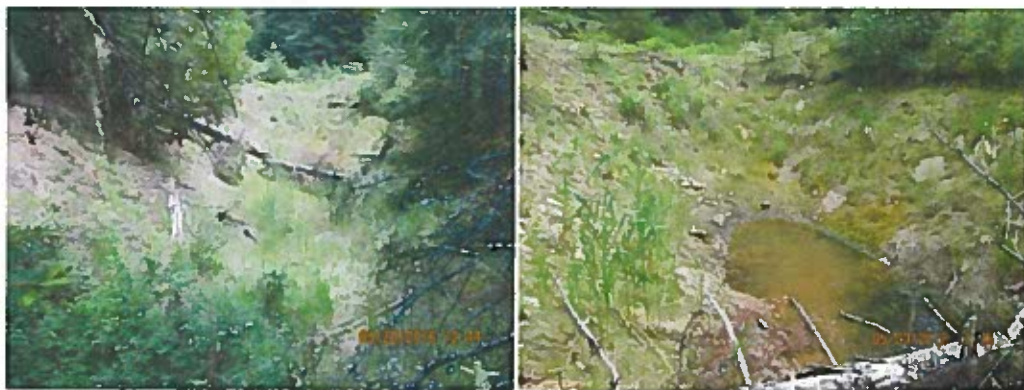
Currently, the "pond" is empty and contains approximately 8 inches of standing water. There was no clear path to access to the pond and I had to fight through brush to get to it.

There is a small draw directing runoff or seasonal flow into the pond depression. There is hardly a defined channel so it is likely to be only very minimal intermittent flows.

Recreational storage pond (looking down draw which feeds it)

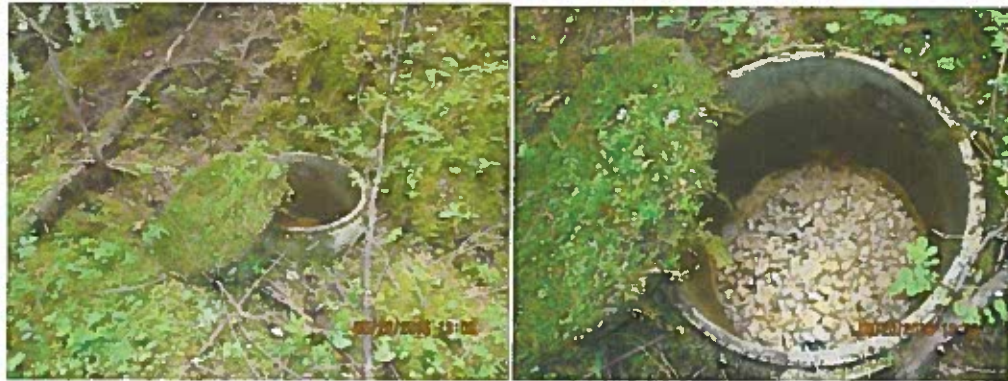
The concrete cisterns pictured in the original license exams could not be found. There are PVC pipe stubs coming from ground near the cabins and also one water spigot and control valve at Cabin B. No water is currently connected to the homes. The "pump house over shallow concrete cistern" pictured supplying water to Cabin A on the property diagram is no longer there. Only a dry concrete cistern remains.

Concrete cistern depicted on property diagram, but pump house is gone

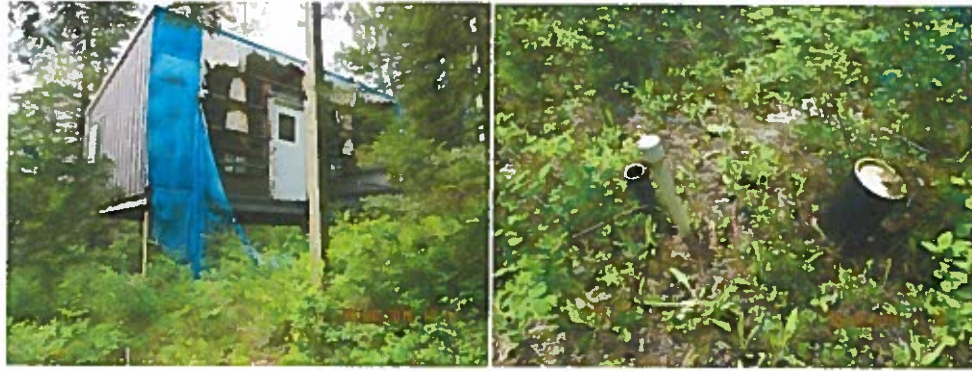
Cabin A – missing wall and pipe stubs. Looks like previous owner intended to expand the cabin out over the stubs eventually.

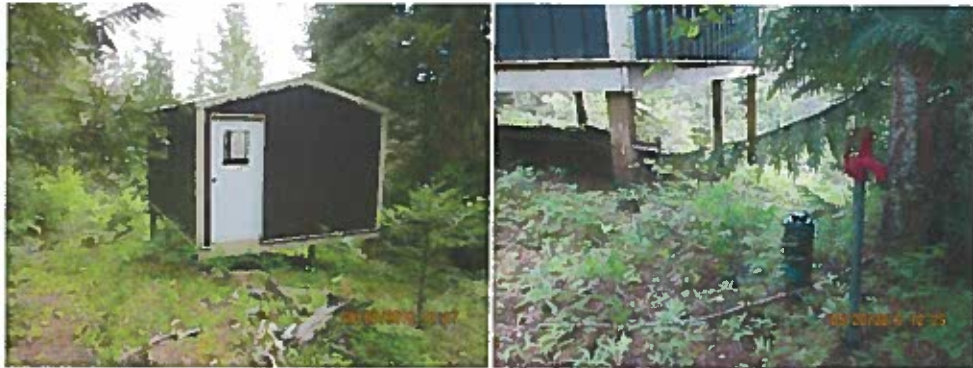
Cabin B – 2" PVC pipe stub under corner of home and water spigot with control valve next to the home.
