# IDAHO DEPARTMENT OF WATER RESOURCES

## --- DAM SAFETY RECORD OF INSPECTION ---

**Name of Dam:** Twin Lakes

**IDWR File No:** 95-0973

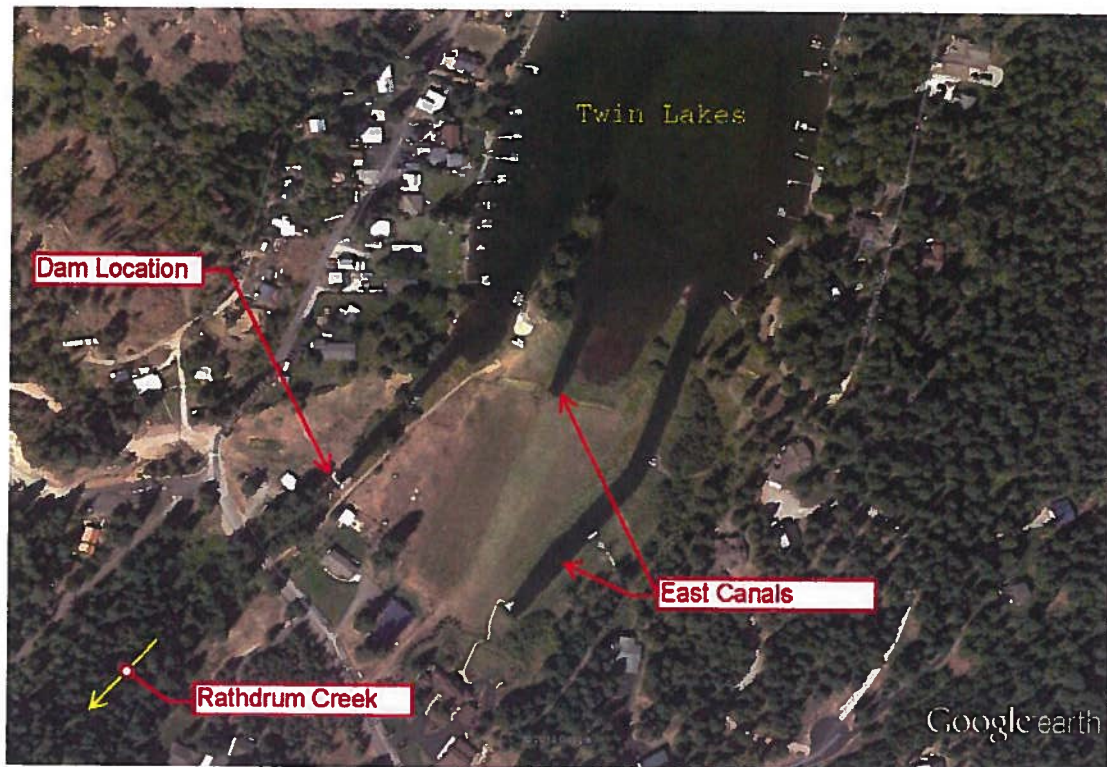
If "Yes", explain: \*\*Two possible channels east of dam that do not show up on 1961 USGS Quadrangle.

Figure 1 depicts an aerial photo showing the east channels. Dam Tender reports they were there the 1960s and the current owner is Roger Bacon on W Gamay Ct.

Figure 1 - Dam Location Map

7. Recommend reviewing the possibility of embankments/barriers on the east channels during the next inspection.

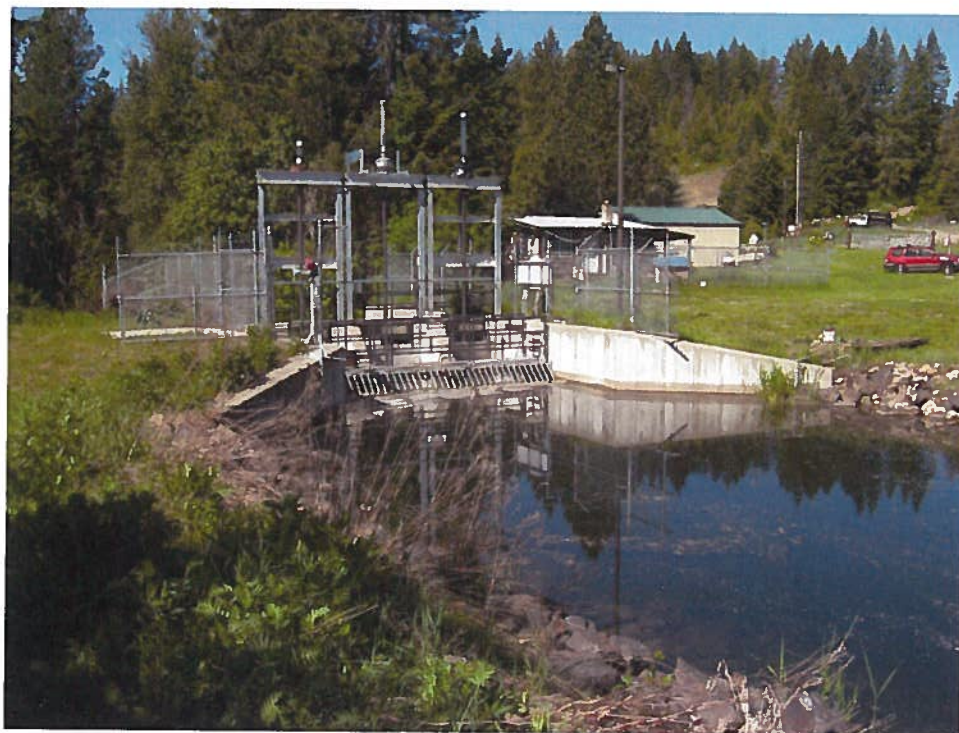
Photo 1 (06/06/2013) - Overview of Dam and Facility

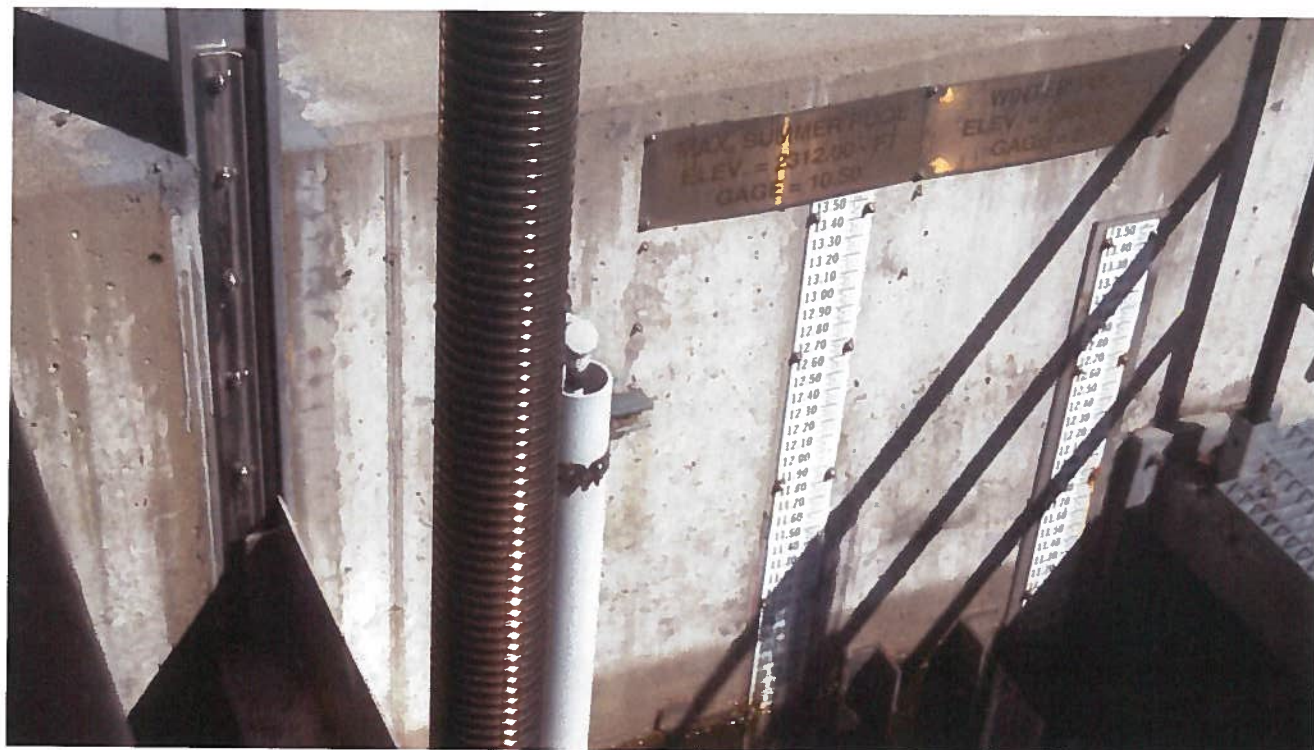
1. FCD = Flood Control District
2. 12 ft Gate + 2.3 ft to top of Gate = 14.3 ft
3. Hydraulic Height at Top of Closed Gate.
4. Reportedly matches Old Staff Basis (Photo 2)
5. From historic data entry. Operations Plan (2005) lists V=9,400 ac-ft
- \* Downstream Toe is Rathdrum Creek
- \* Upstream slope, Crest, Downstream Slope all consist of concrete and have no vegetation.
- \*\* Re-visit the possible east channels during the next inspection cycle.

Photo 2 (06/06/2013) - Staff Gages and Stage Signage

4. The high and low lake level signs at the dam (Photo 2) should be reviewed, and if needed replaced, to ensure that they convey the proper stage and elevation data to the dam personnel and officials. The signs appear to depict new dam levels, but it is not readily apparent, as the range of levels does not match the levels provided in the 2005 Operations Plan. These signs should be clearly marked as to which gage they reference. For example, "Old Dam Staff" or "New Dam Staff".

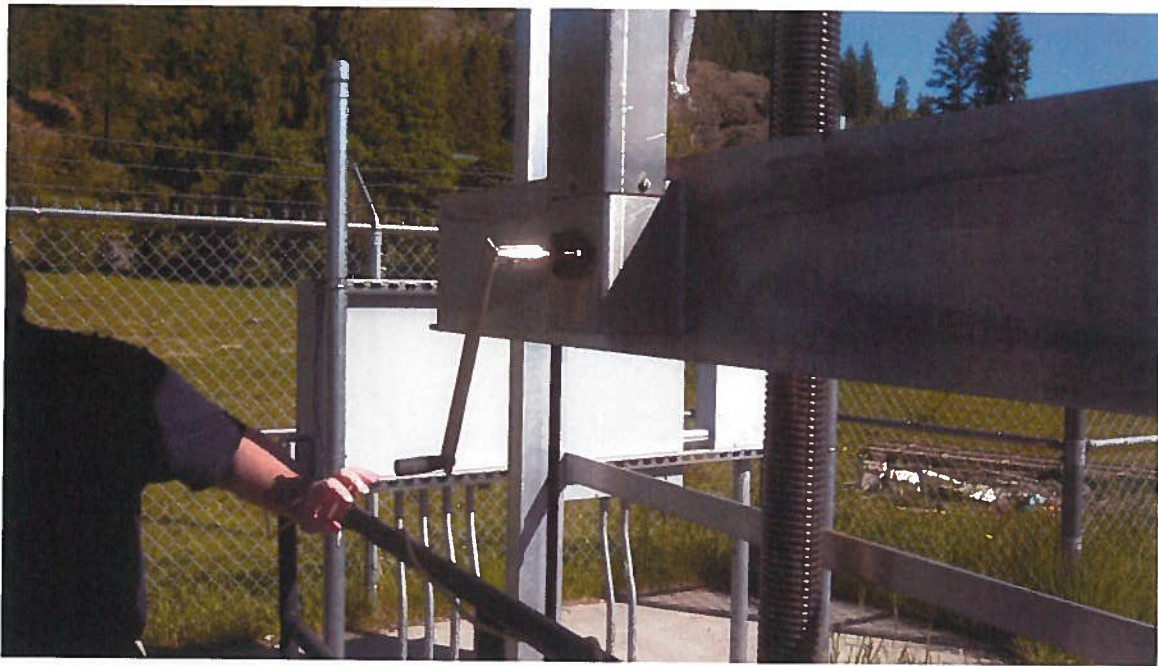
Non-functioning right gate (Photo 3), problematic nature of aluminum gates (left and right gates are still aluminum). The 1977 Operations Plan limits outflow to 165 cfs to avoid flooding Rathdrum. The 2005 Operations Plan limits outflow to 160 cfs. Dam Tender reported that the water has come one vertical inch from the living room floor of a downstream home during a release of around 400 cfs.

Photo 3 (06/06/2013) - Inoperable Right Gate Mechanism

1. The owner should repair the damaged right gate/opening mechanism and closely observe, and in needed replace, the remaining aluminum gates (left and right gates) to prevent the type of failure that is reported to have occurred at the center gate.

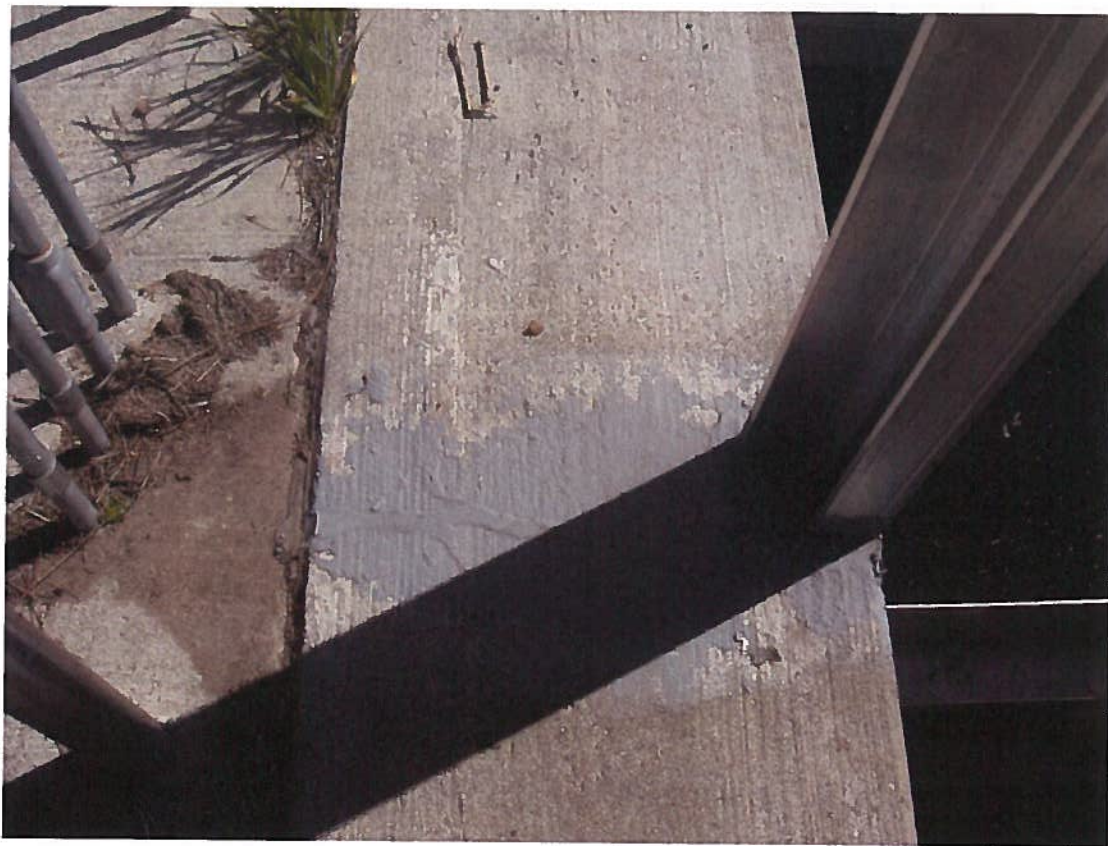
Reportedly, the center gate has failed two time in recent years, and the electric motor was replaced in 2010. According to the dam tender, hydraulic induced vibration tore the aluminum center gate "like paper". The gate was replace with like and failed a second time. The second replacement was with a stainless steel gate. The left and right gates are still aluminum, but reportedly were reinforced some during the last replacement of the center gate in 2010. The right gate is reported to be currently inoperable (Photo 3) due to possible problems with the manual crank mechanism. The Dam Tender reports that he has never fully exercised the gates. The gate manufacturer in the 2005 Operations Plan call for gate operation every three months. Also, a crack perpendicular to the direction of flow formed in the concrete abutment and piers after construction. The crack follows the axis of the gates' alignment (Photos 4,5,6,7). The Dam Tender has filled the cracks with sealant.

Photo 4 (06/06/2013) - Crack in Right Abutment at Gate Centerline

5. Monitor the crack in the concrete abutment and piers for continued displacement. Make repairs as necessary. Keep the crack sealed to prevent corrosion of the reinforcing steel and embedments.

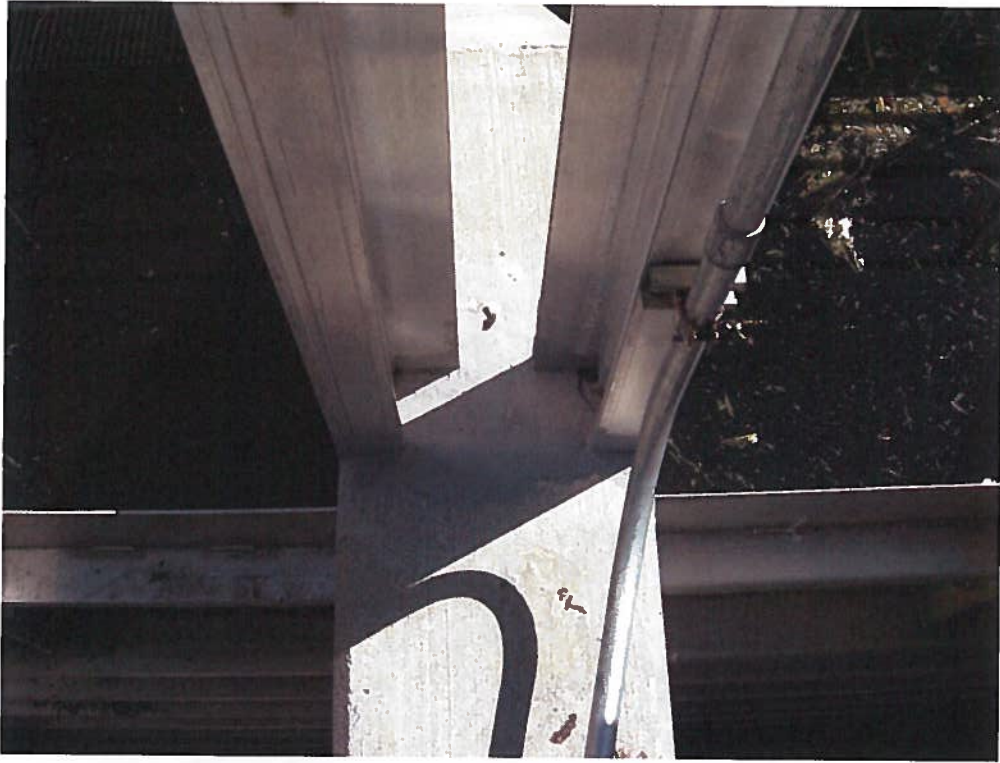
Photo 5 - (06/06/2013) - Right Pier Crack at Gate Centerline

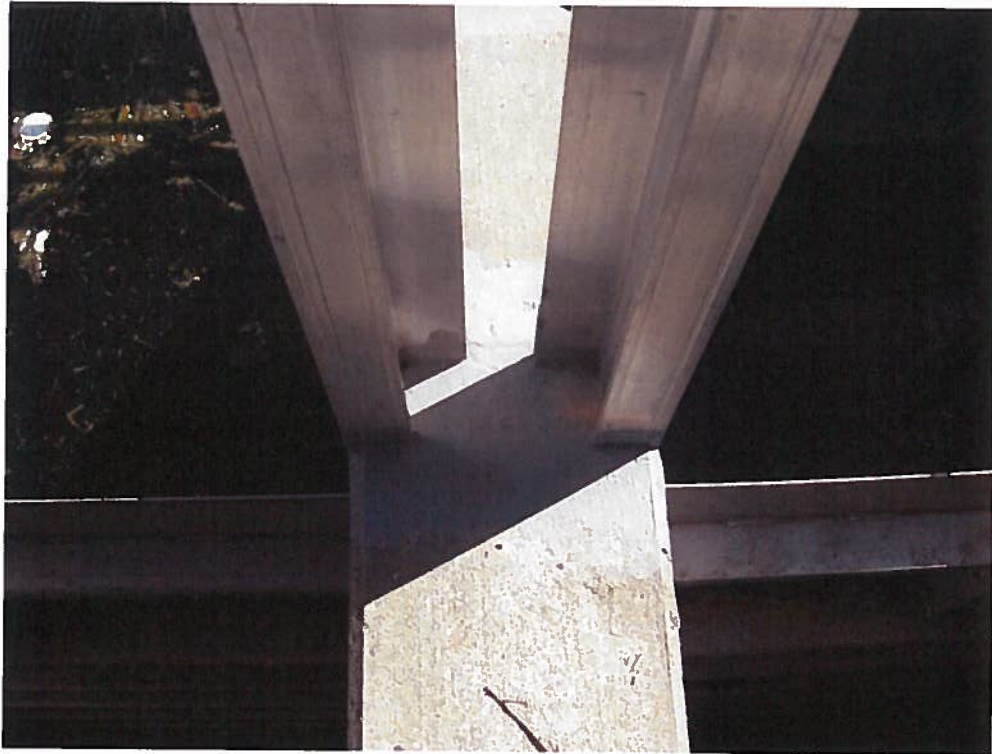
Photo 6 (06/06/2013) - Left Pier Crack along Gate Centerline

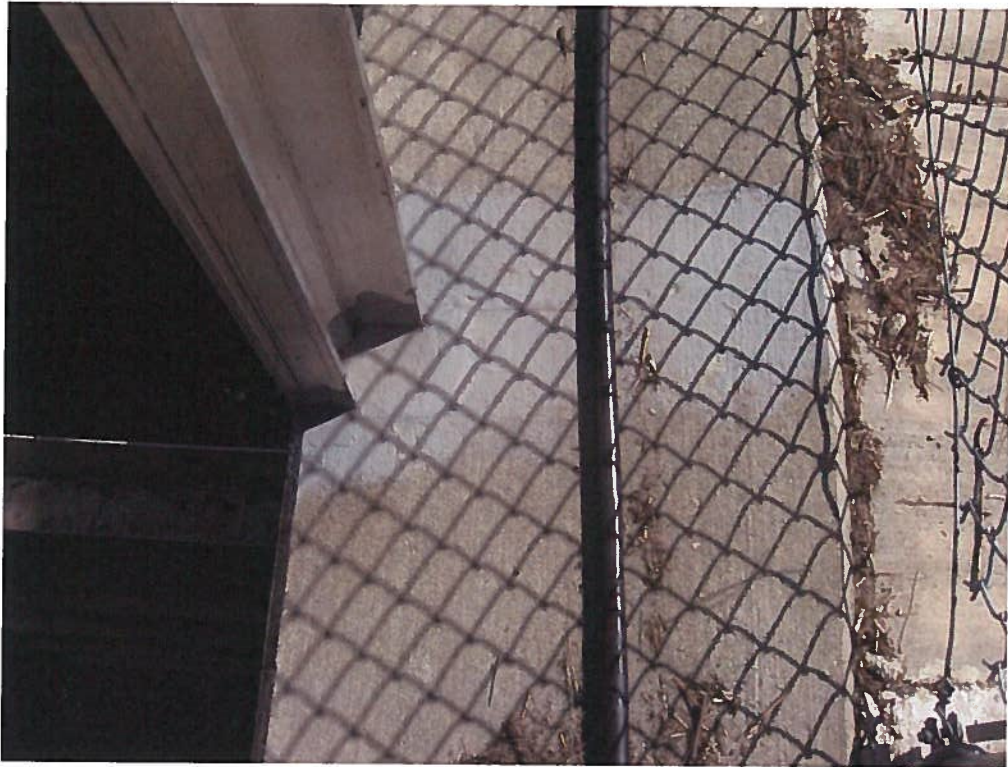
Photo 7 (06/06/2013) - Left Abutment Crack along Gate Centerline

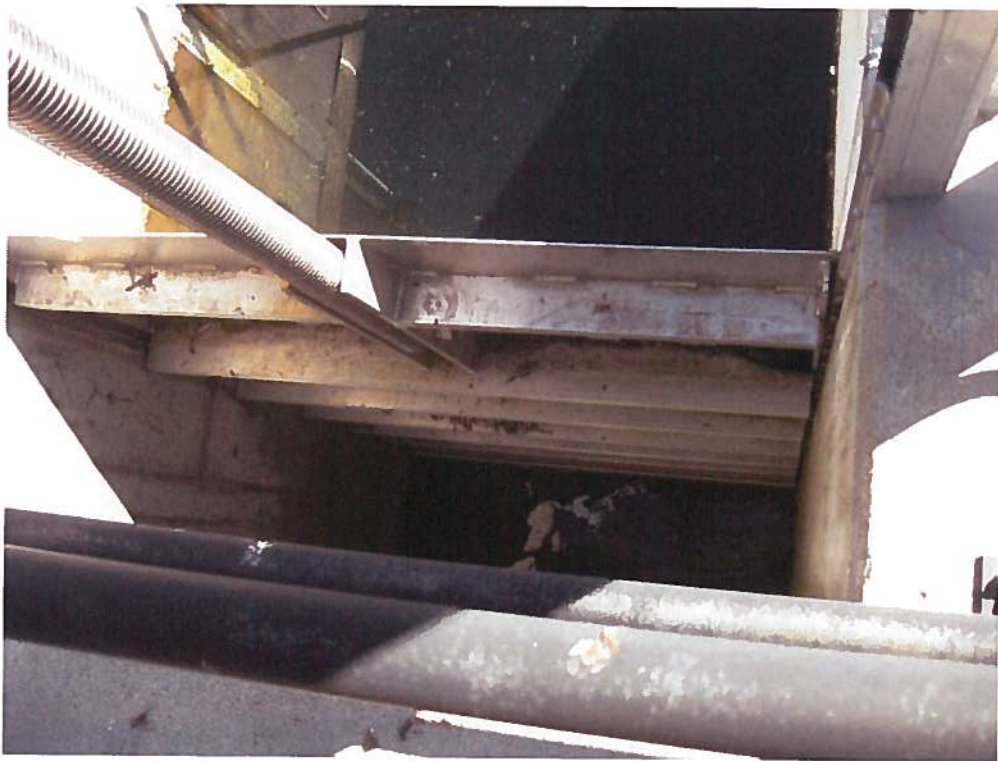
2. The lake level was at 10.2 ft and Q= 19.2 cfs under gate(s) at time of visit from instrumentation. The right gate was closed (Photo 8). The left gate was open (Photo 9), and the center gate was closed but leaking (Photo 10) what appeared to be as much water as the opened left gate.

Photo 8 (06/06/2013) - Right Gate Closed

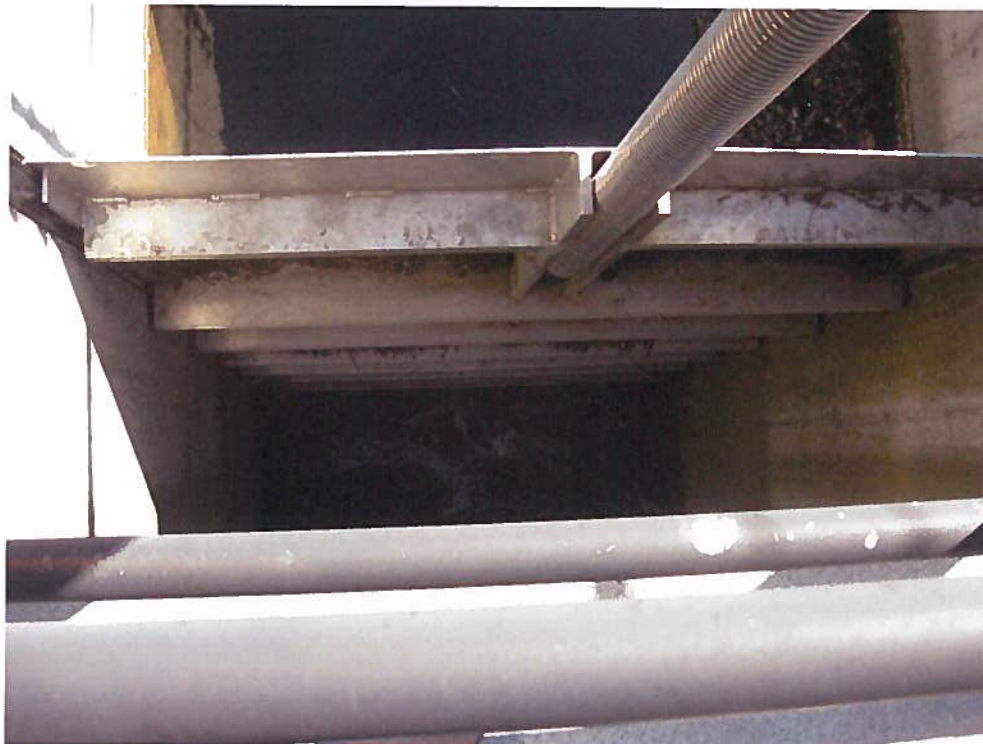
Photo 9 (06/06/2013) - Left Gate Open, Note Flow at Base

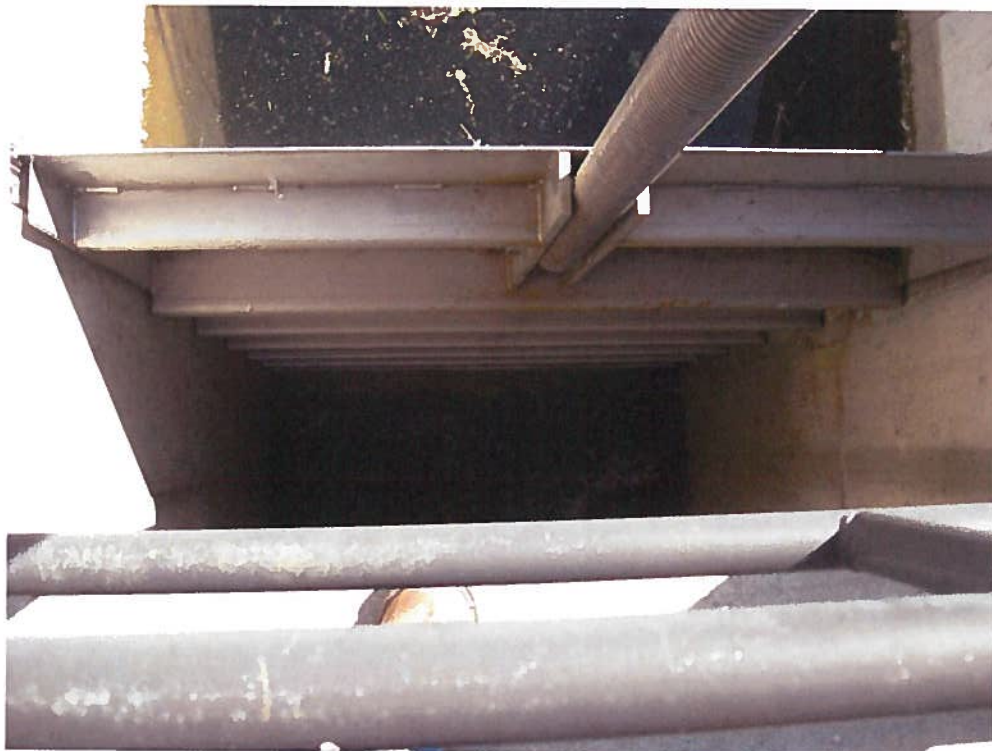
Photo 10 (06/06/2013) - Center Gate Reported Closed, Note Flow at Base

2. The leak under the center gate should be investigated and repaired as necessary.
3. The owner shall follow the Operations Plan (maintenance, exercise gates, etc.) for the dam. To ensure that the Operation Plan is properly followed, the staff gages at the dam should be clearly marked as to depth basis, e.g. which staff is on the old dam basis and which one is the new dam basis.

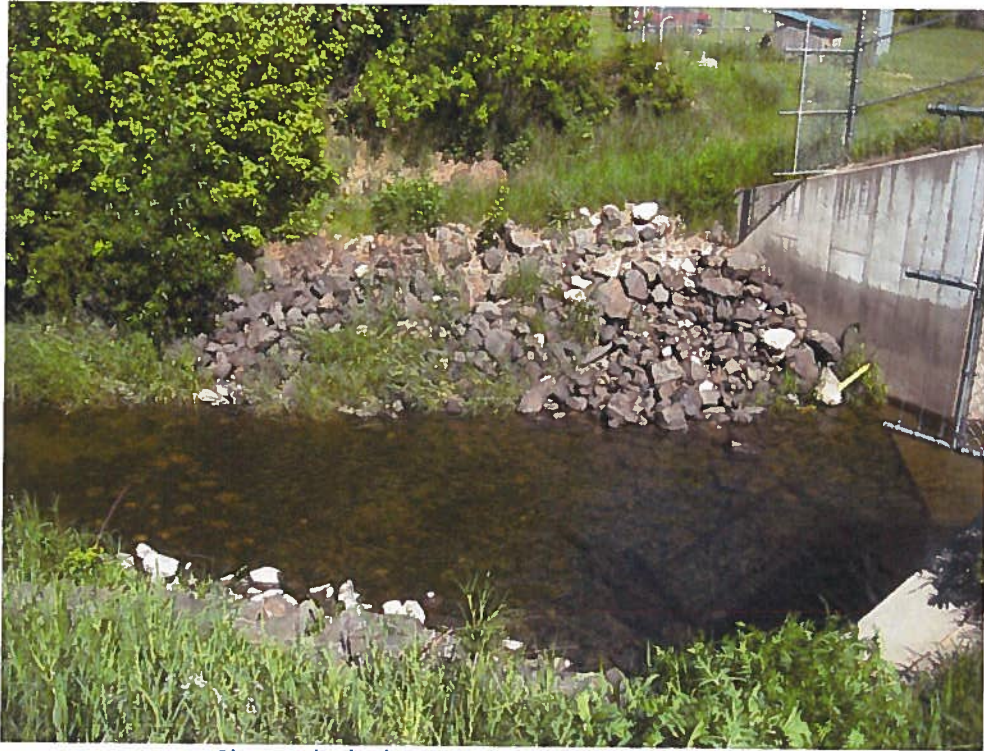
Photo 11 (06/06/2013) - Right Downstream Groin Area

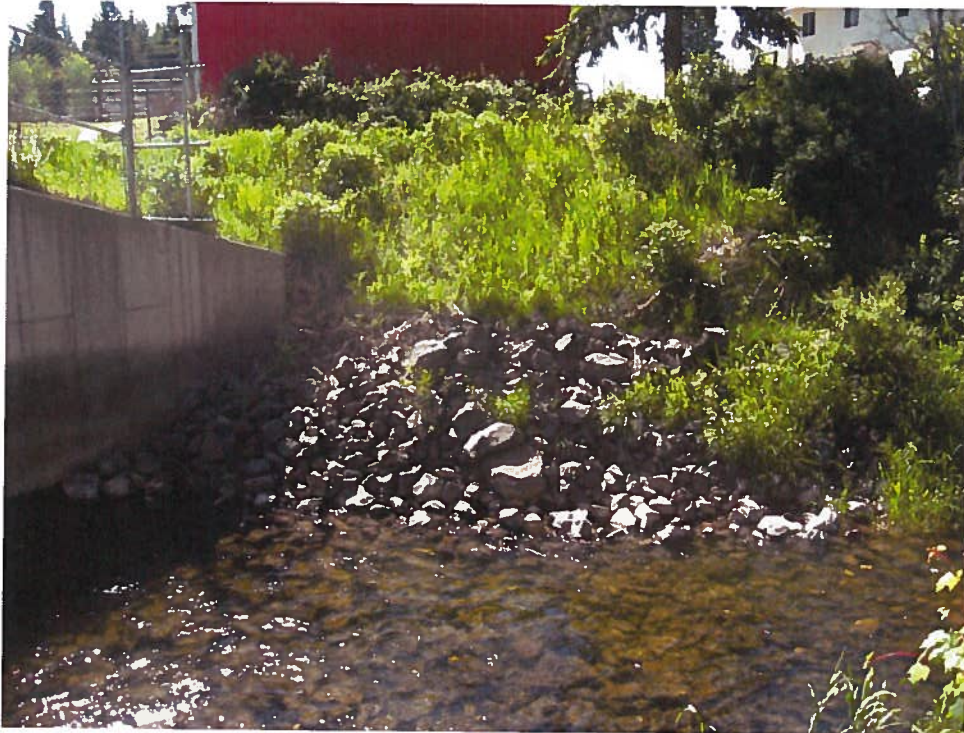
Photo 12(06/06/2013) -Left Downstream Groin Area
