## FIELD EXAMINATION OF CSRBA WATER RIGHT CLAIM

**Claim Identification Number:** 94-7165

**Date of Examination:** September 11, 2018

**Examination Location:** 619 Larson RD, Mullan ID

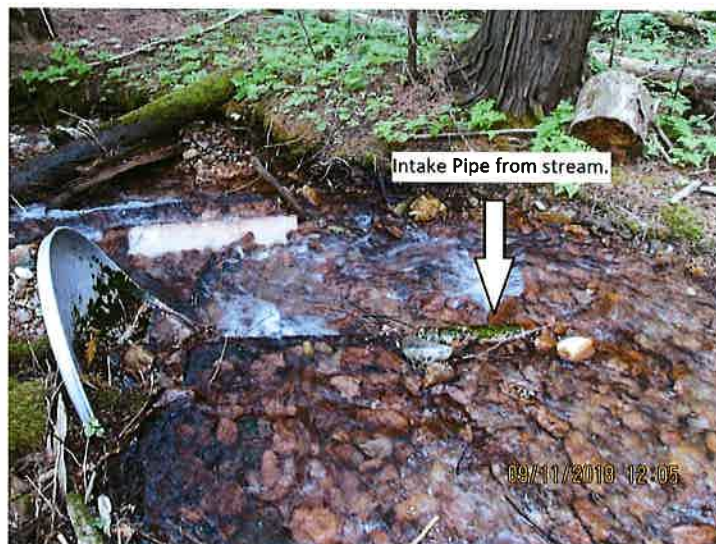
**Field Examination Notes:** Claimant no longer lives on the property. Met with current caretaker, and he attempted to explain the system to me, but he was not able to go with me due to medical reasons. This caretaker has lived on this property for approximately 3 years. Based upon information in the water right backfile, I was able to identify parts of the original system including a dam/collection box (Figure 3) located at N 47° 28.393' W 115° 45.361. Due to the dense tree cover, I was unable to obtain an accurate GPS location at the start of the side channel where water is first diverted from the stream. That diversion is approximately 20 feet west northwest of the dam coordinates described above, which does not appear to be on BLM Property. The coordinates of the dam/collection box are the closest to the POD that I could gather. I also observed 2 other pipes in the surrounding area, but only one of those pipes was in Gentle Annie Gulch Creek (Figure 1), it doesn't appear that pipe is part of the current system.

Figure 1. A pipe located in Gentle Annie Gulch Creek.

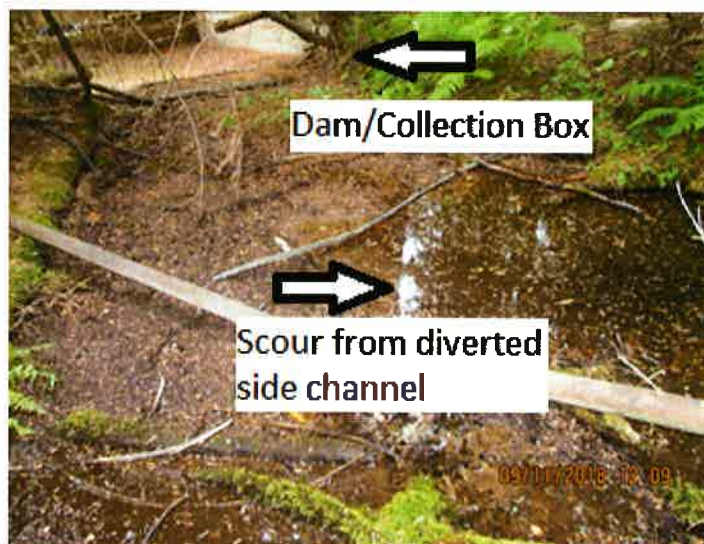
Figure 2. The side channel being diverted from Gentle Annie Creek Gulch into the dam/collection box.

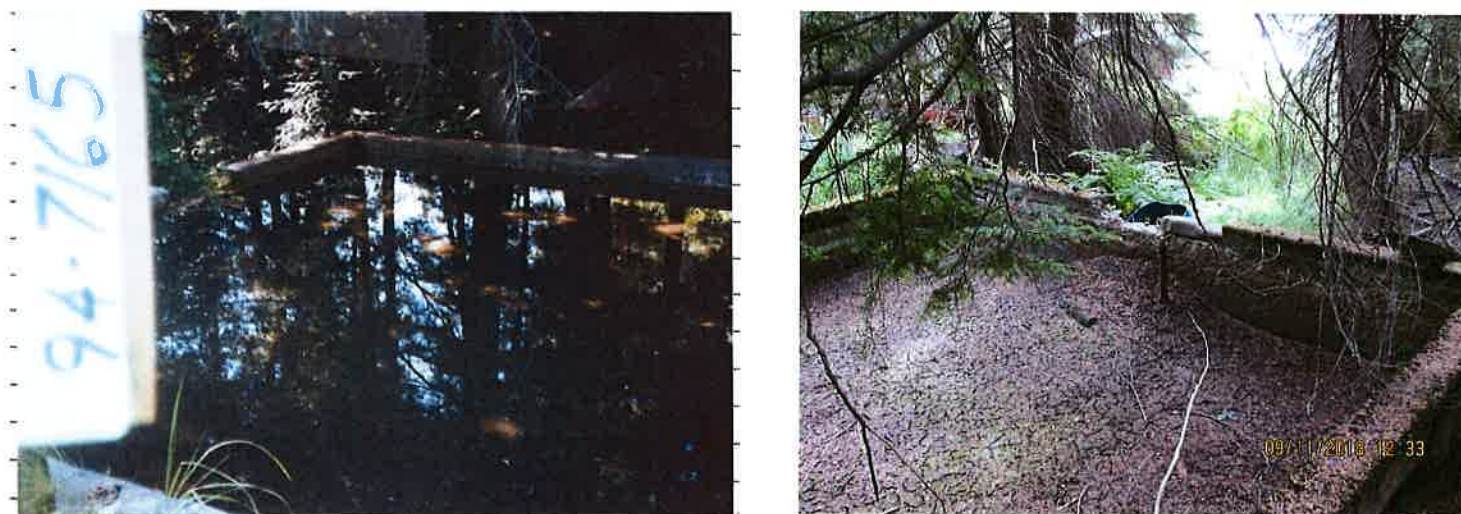
Figure 3. Photo on the left is from the Water Right Backfile. The photo on the right is the current dam/collection box on the property, at the GPS location described above.

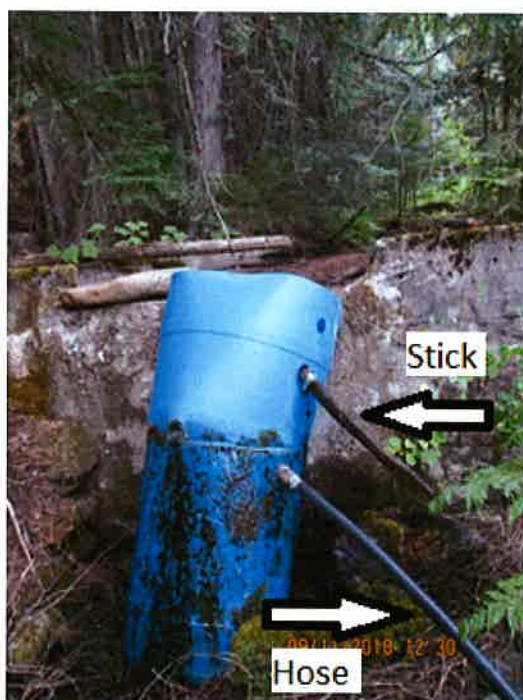
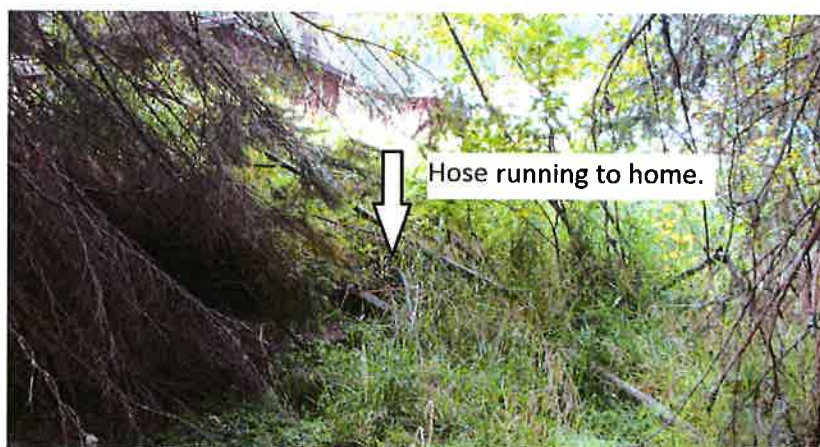
The caretaker explained that the water delivery system was not currently functioning as originally designed due to a blockage somewhere in the piping, but was unsure of the location of that blockage. His explanation of the current system was a barrel in the stream with a hose attached to it. While on the backside of the property I found a barrel tower (~1.5 55-gallon barrels stacked on each other) with a hose attached (Figure 4), but it was not in the stream; rather it was approximately 20 feet east of the stream just below the dam/collection box. The barrel was full of water and appeared to be functioning. There is evidence, scour in the soil, of a side channel being diverted from Gentle Annie Gulch Creek into the dam/collection box (Figure 2), which matches the map of the original system and included in the water right backfile for 94-7165. The dam/collection box is approximately 15 feet by 20 feet.

Figure 4. Water delivery system currently in use. Photo on the left showing the barrel tower with hose attached. Photo on the right showing the hose going towards the home.
