## Panhandle Health District Drinking Water Supply Report

**System:** Conkling Marina & Resort

**Date of Survey:** July 21, 2015

**Conkling Marina & Resort Water System Overview**

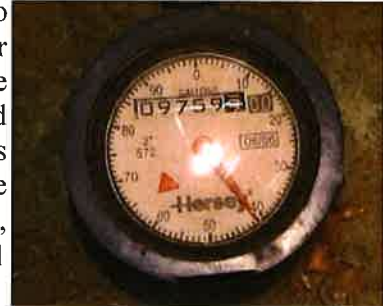
A Chlorination and Contact Time Report form will be provided to you with built in calculations which will require daily meter readings to determine peak hourly flow as well as daily free chlorine residual monitoring. The report form must be submitted to PHD monthly by the 10<sup>th</sup> of the following month. It is important to accurately read the meter; the solid zeros must be read from the red needle. For example; in the picture to the right, the flow meter reading at the time of the survey was 9,759,941 gallons.
