Today I viewed a dam belonging to Bud Koster, Box 269, Route 4 Moscow, Idaho. Mr Koster gave me two letters concerning upcare for this dam.

STATE OF IDAHO  
DEPARTMENT OF WATER RESOURCES  
RECORD OF INSPECTION OF DAMName of dam: \_\_\_\_\_ Stream: \_\_\_\_\_ ☒ OffstreamName of owner: Wallace Location: 40N 5W 533 SWIndividuals accompanying inspector: NoneReservoir characteristics: Dam height 14' hgd Surface area 1.0ac Storage capacity 5.5 ac-ftHazard class: low Photographs: 2

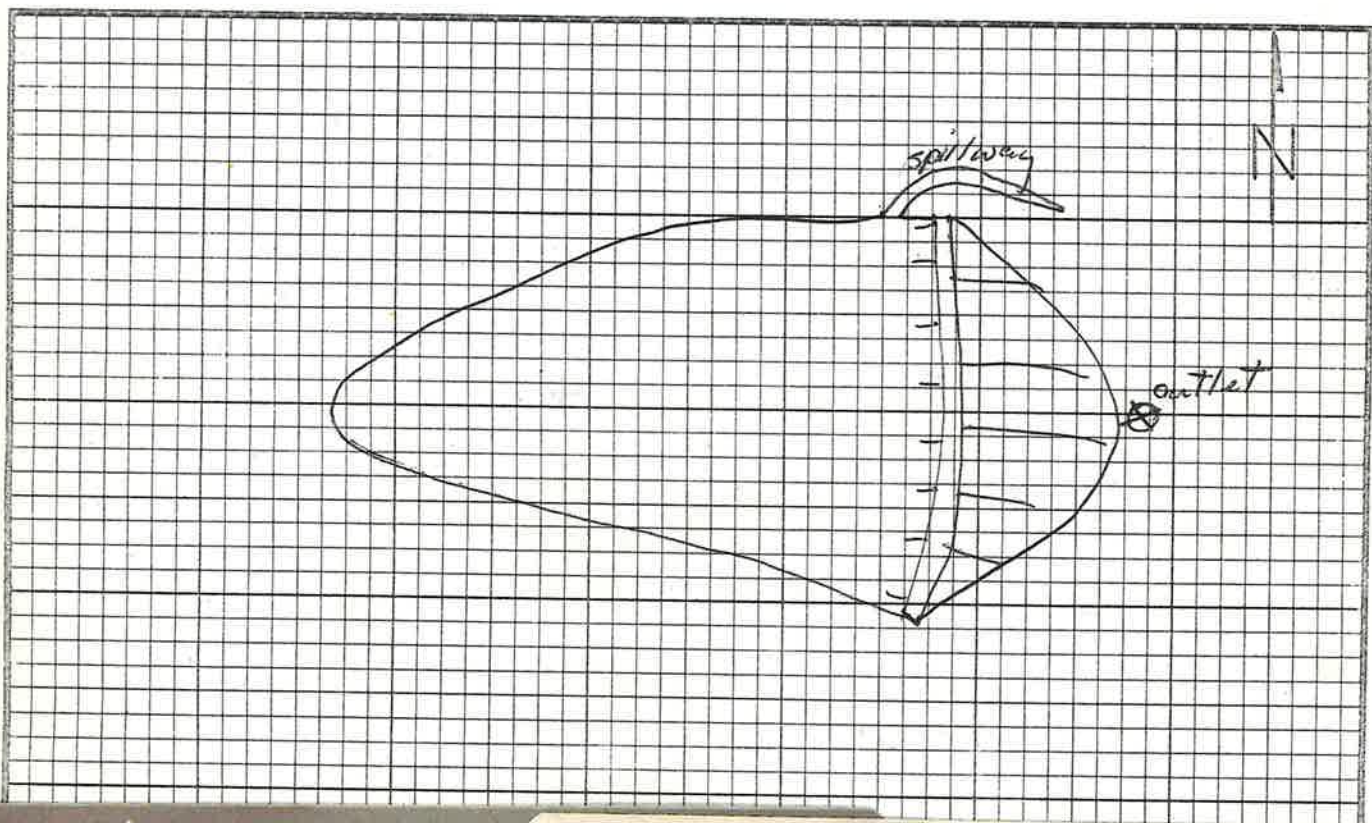
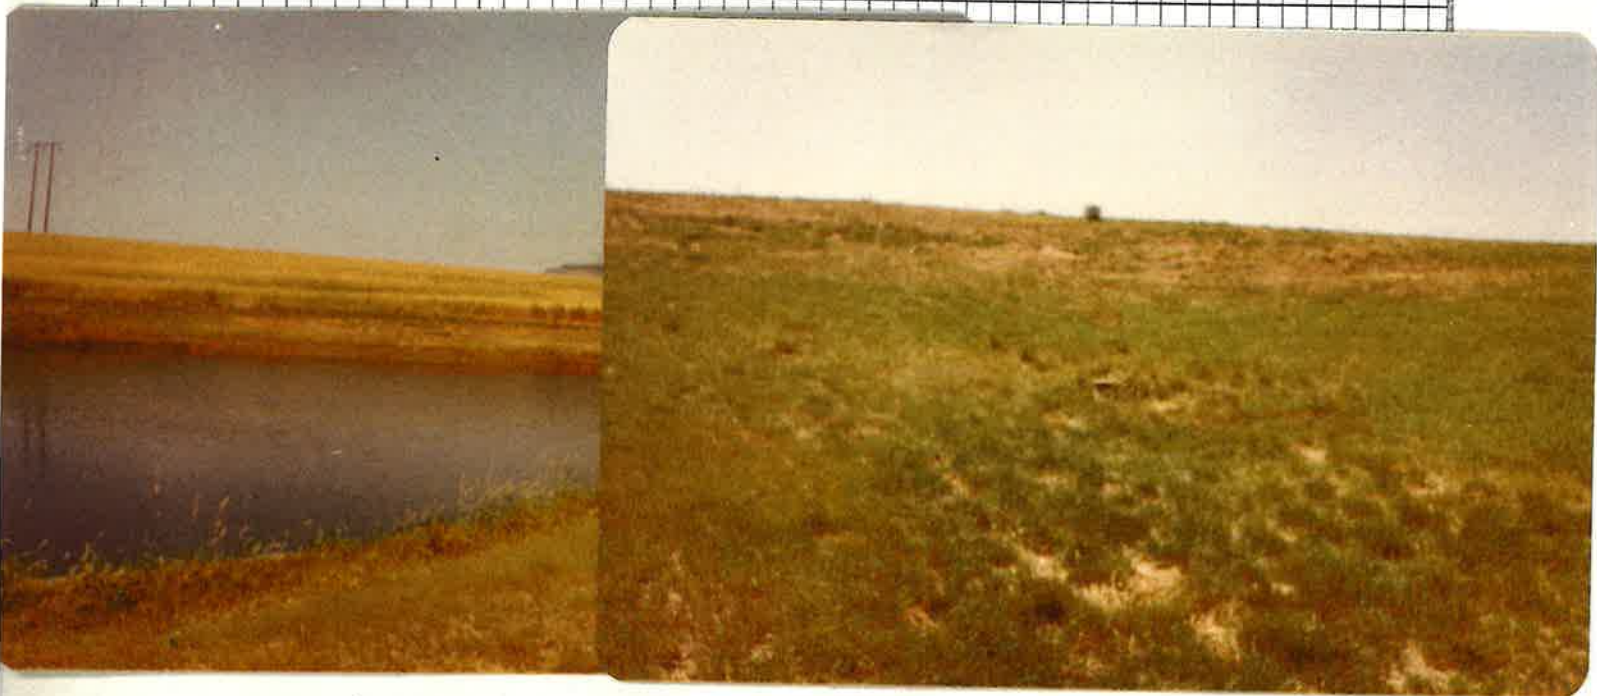
SKETCH OF DAM SHOWING LOCATION OF SPILLWAY AND OUTLET WORKS AND ANY MAINTENANCE PROBLEMS:

good condition
