FIELD EXAMINATION OF CSRBA WATER RIGHT CLAIM

Claim Identification Number: 95-9676

Exam Report Completed By: Linda Werner on 9/27/2019 J.W.

Date of Exam: September 4, 2019

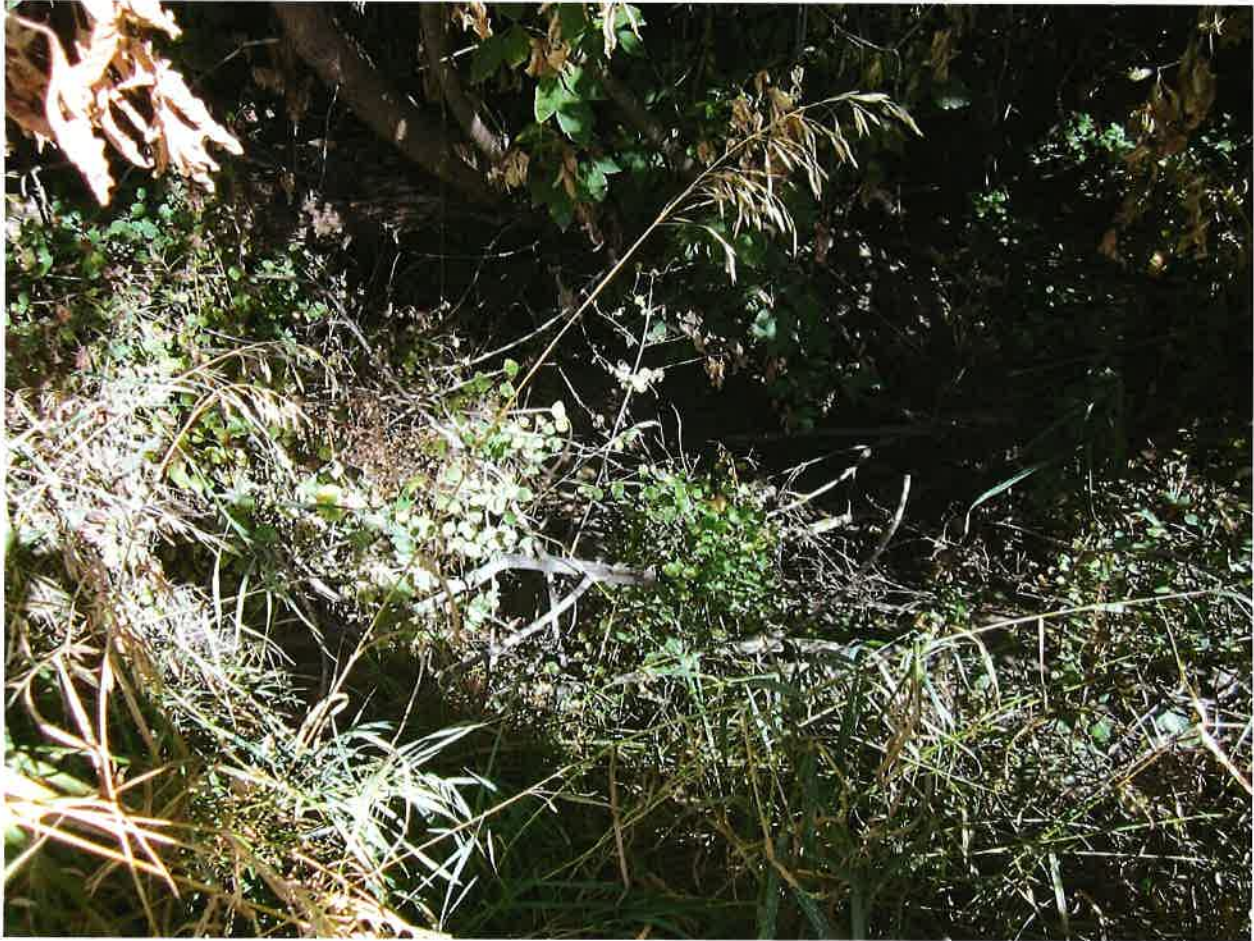
*Figure 1- First culvert where creek runs under road and enters property on the North side running south.*

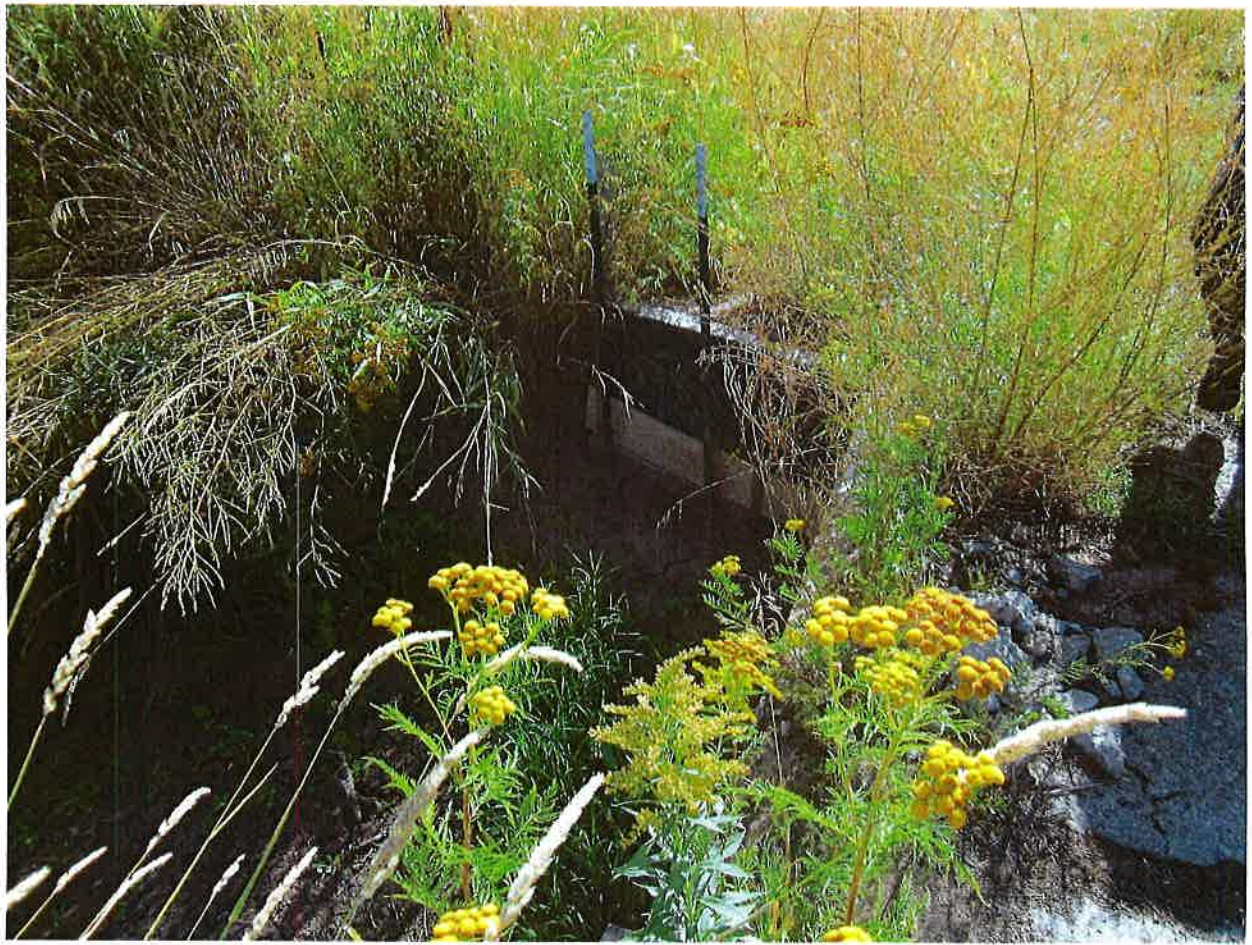
*Figure 2- Diversion from creek (next to original culvert) towards south east creating "Flood Creek" which then runs parallel to creek/road southward until about 30 ft. in trees. "Flood Creek" ends about 30 ft. in trees, water flows freely.*

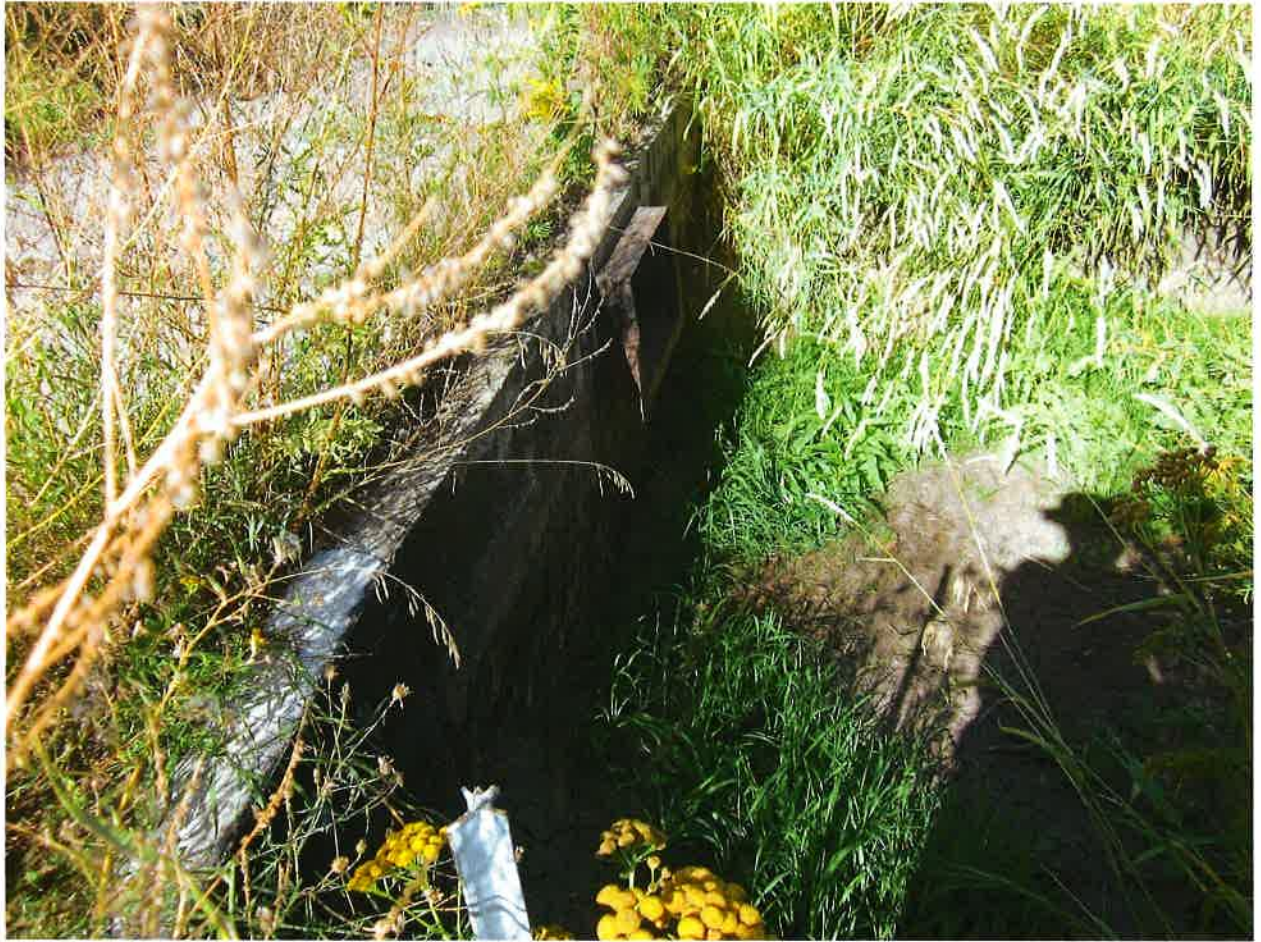
*Figure 3- Original culvert for creek to run under path.*

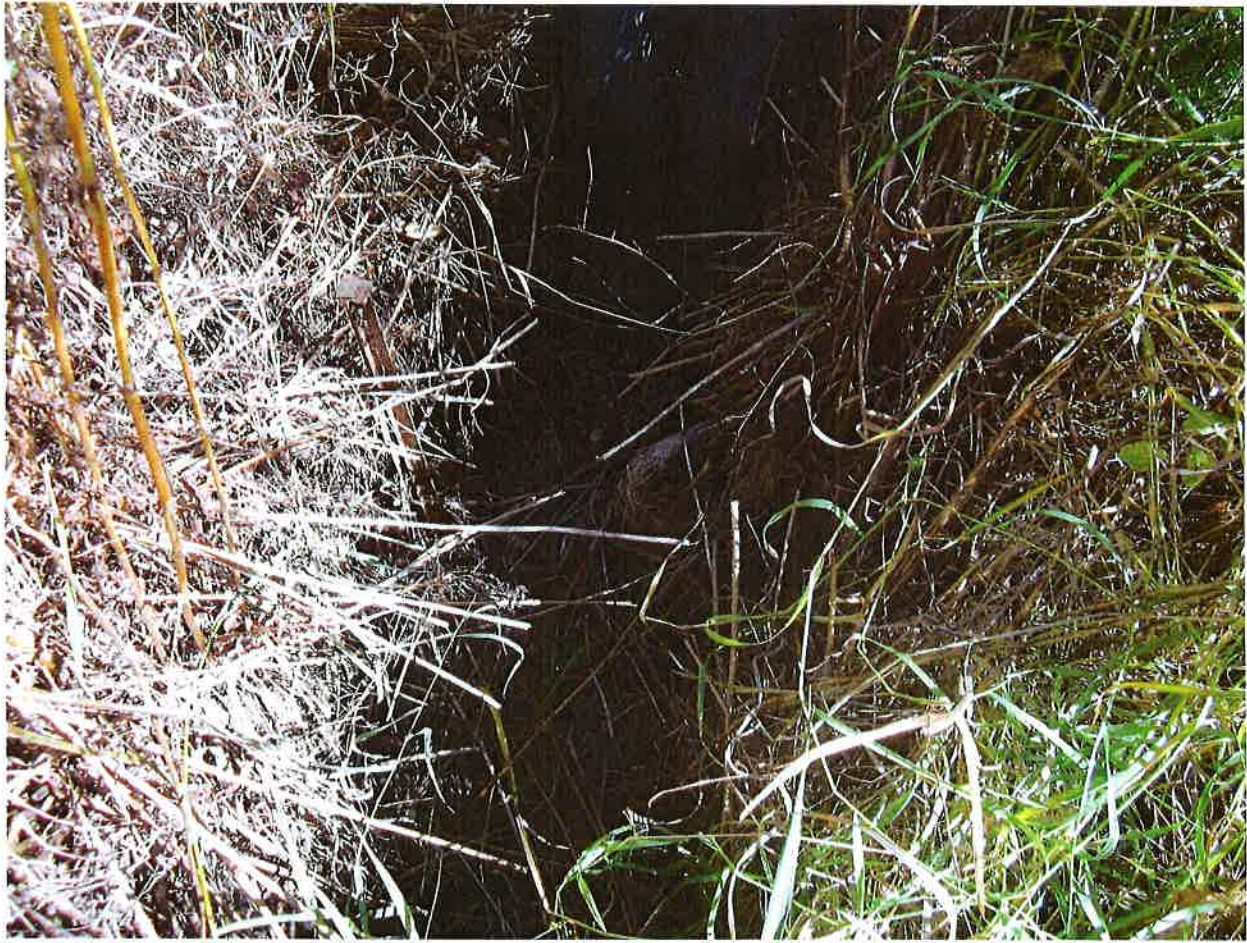
*Figure 4- Old diversion from creek, diverting water east under road/lot line.*

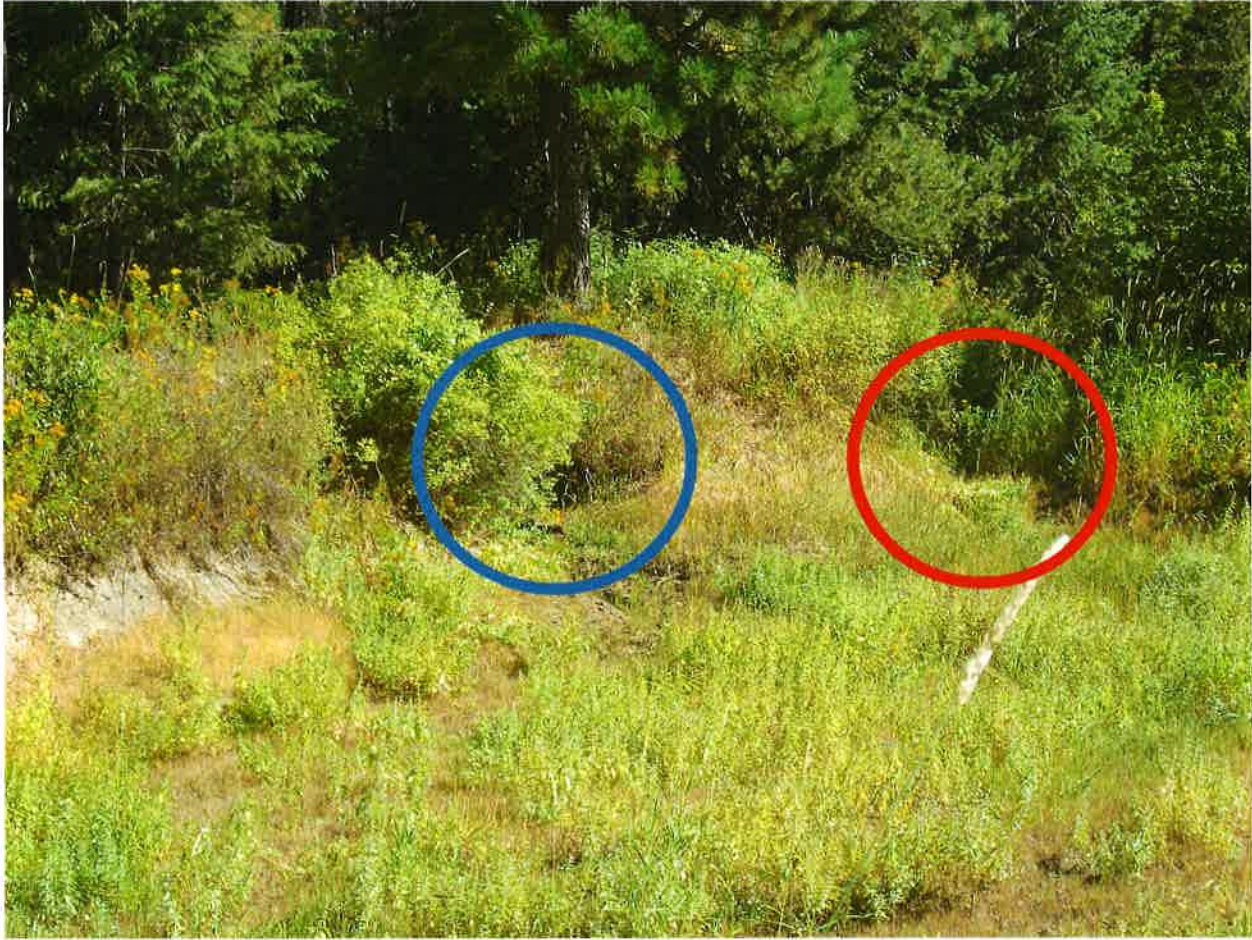
*Figure 5- Point where creek drains into dugout/pond that does not hold water (blue circle, left). Point where water drains out of dugout/pond heading east, then turning south (red circle, right).*

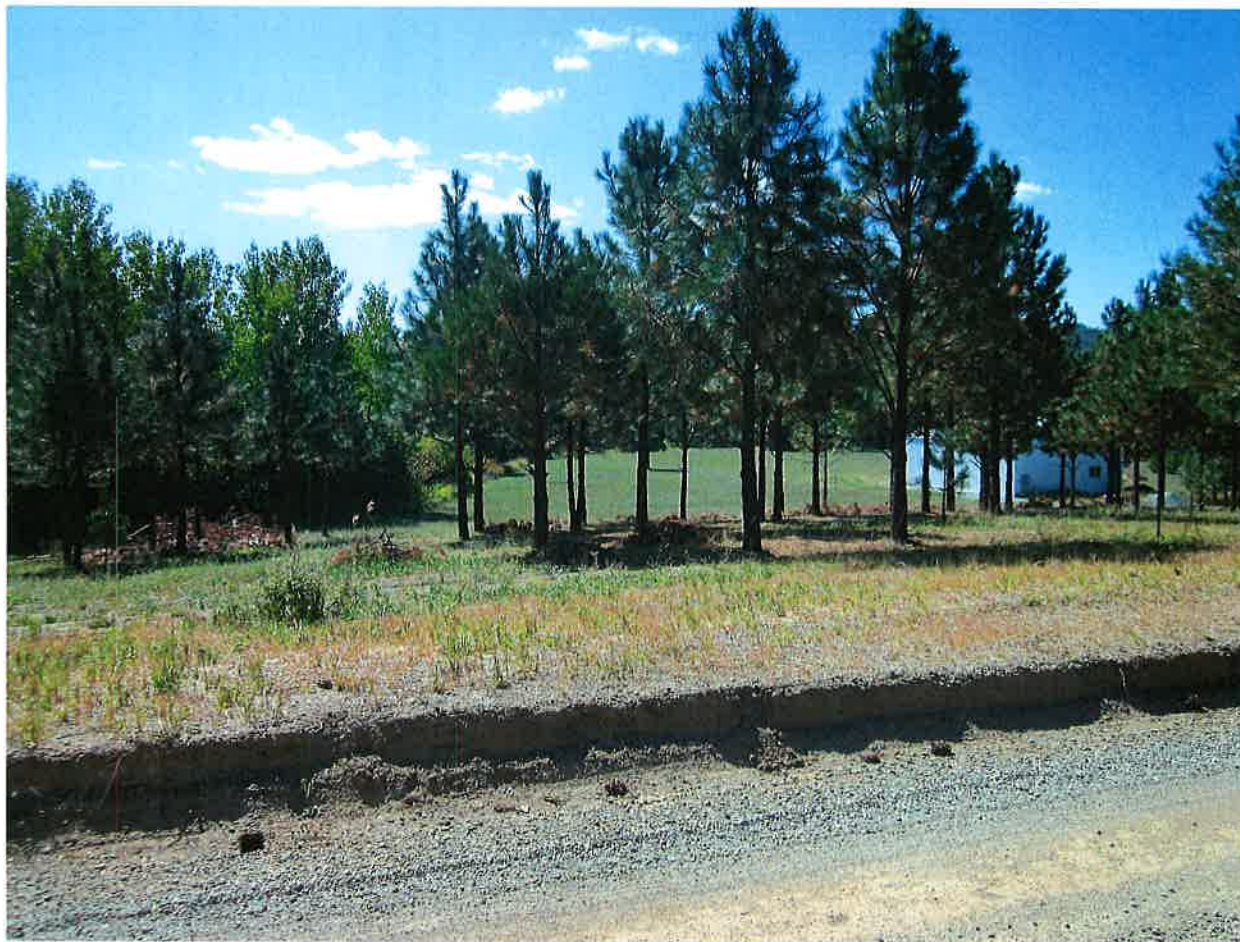
*Figure 6 – Looking south at place of use in the NWSW-8-T54N-R5W*

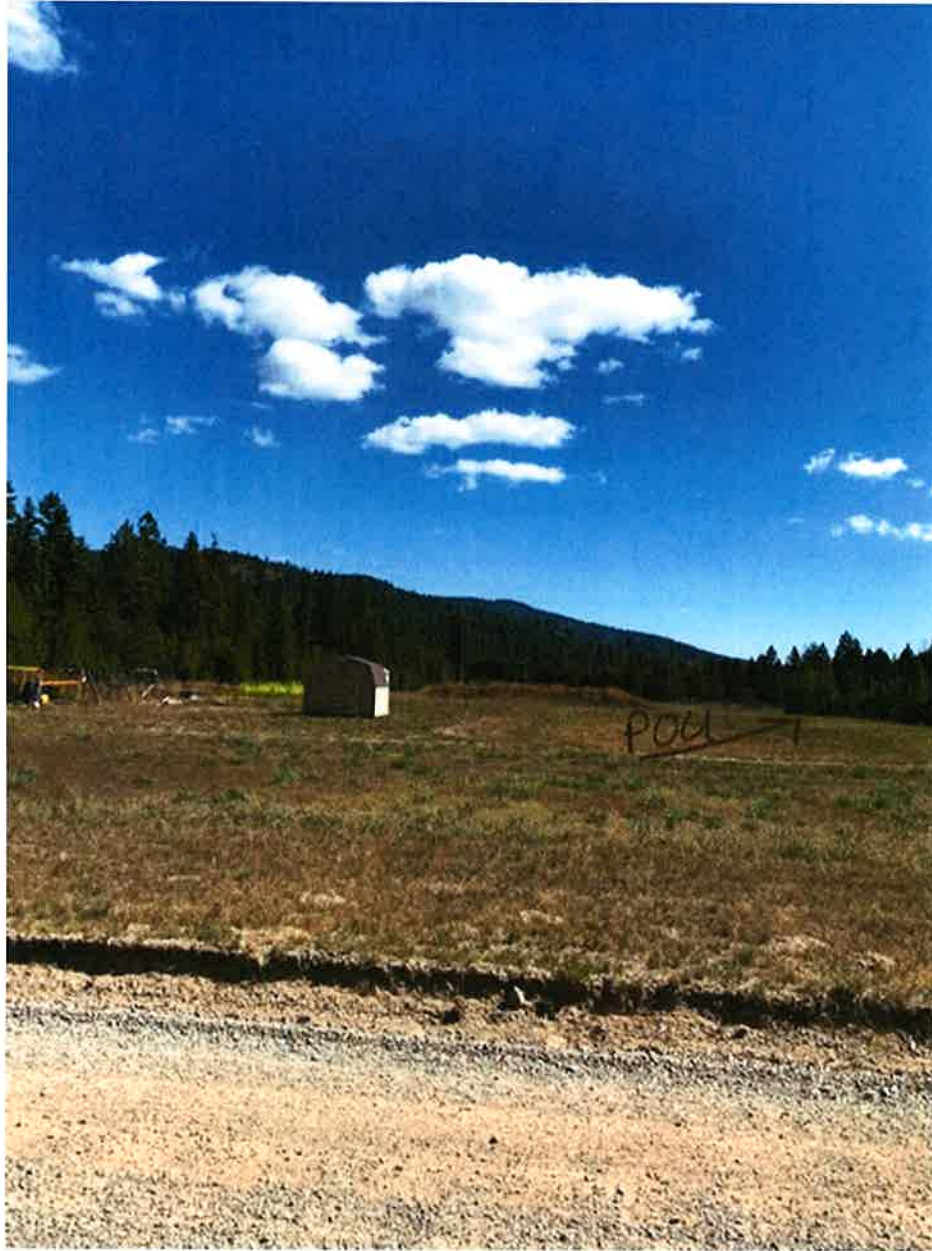
*Figure 7 - Place of Use in SWSW-8-T54N-R5W*

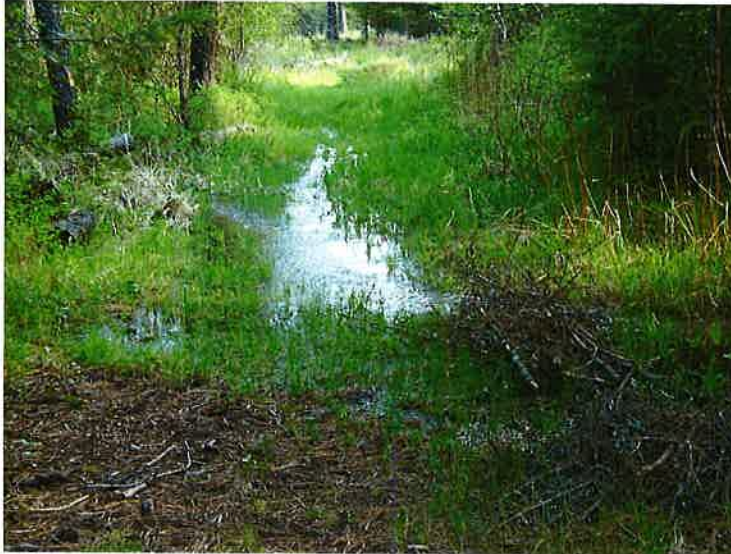
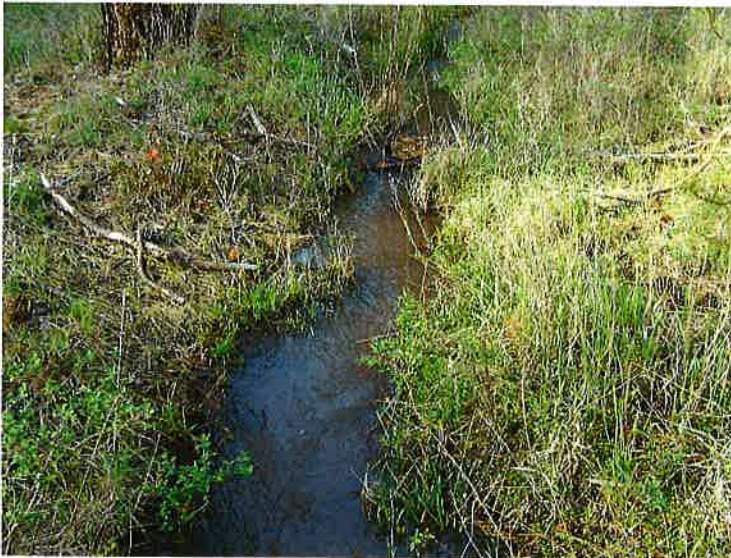
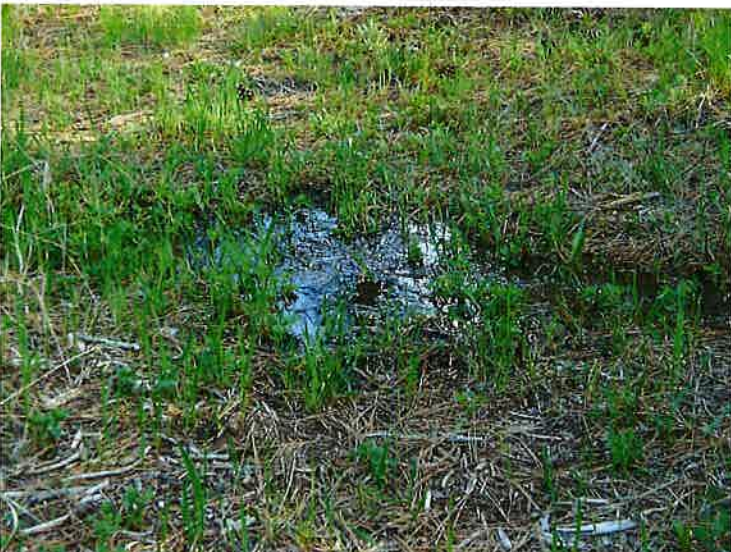
The first two photos are of downstream flooding. The reason for the flood diversion ditch is to prevent water from flooding access road.  
Date of photo: 5/17/2008

"Dad's" Diversion 5/17/2008

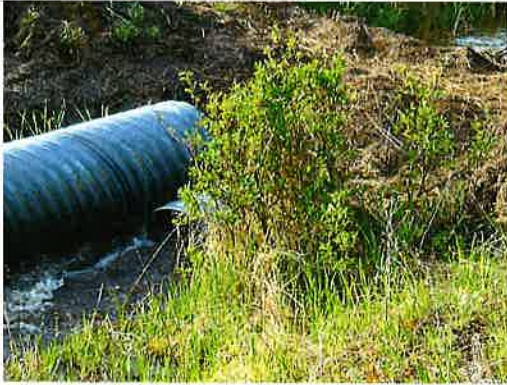
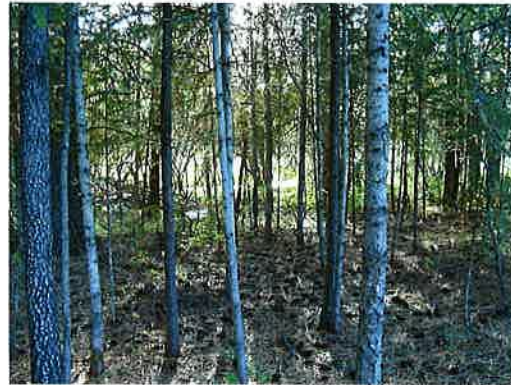
Roz's Property (E1/2NW1/4SW-8-T54N-R5W) Photo Date: 5/17/2008

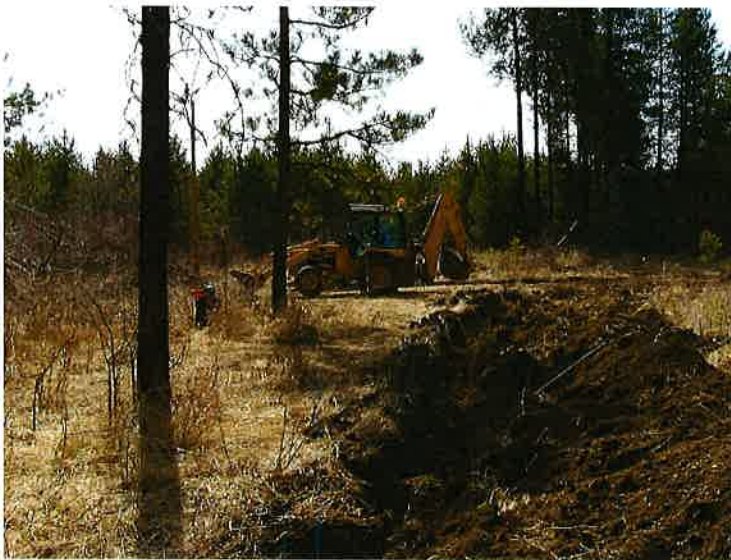
NESWSW-8-T54N-R5W

Pond Work 4/8-9/2009

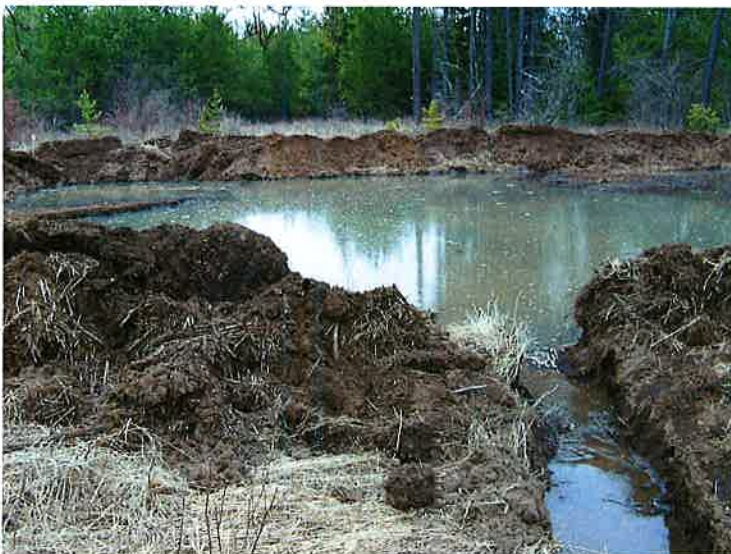
Pond full – 4/11/2009

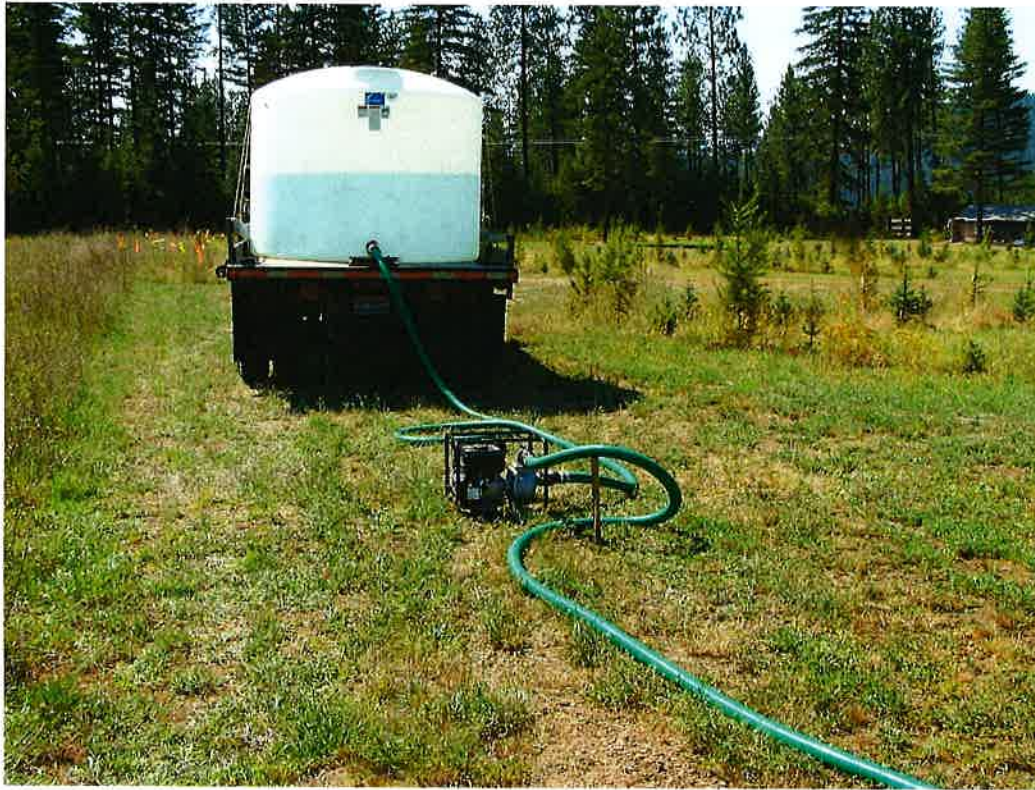
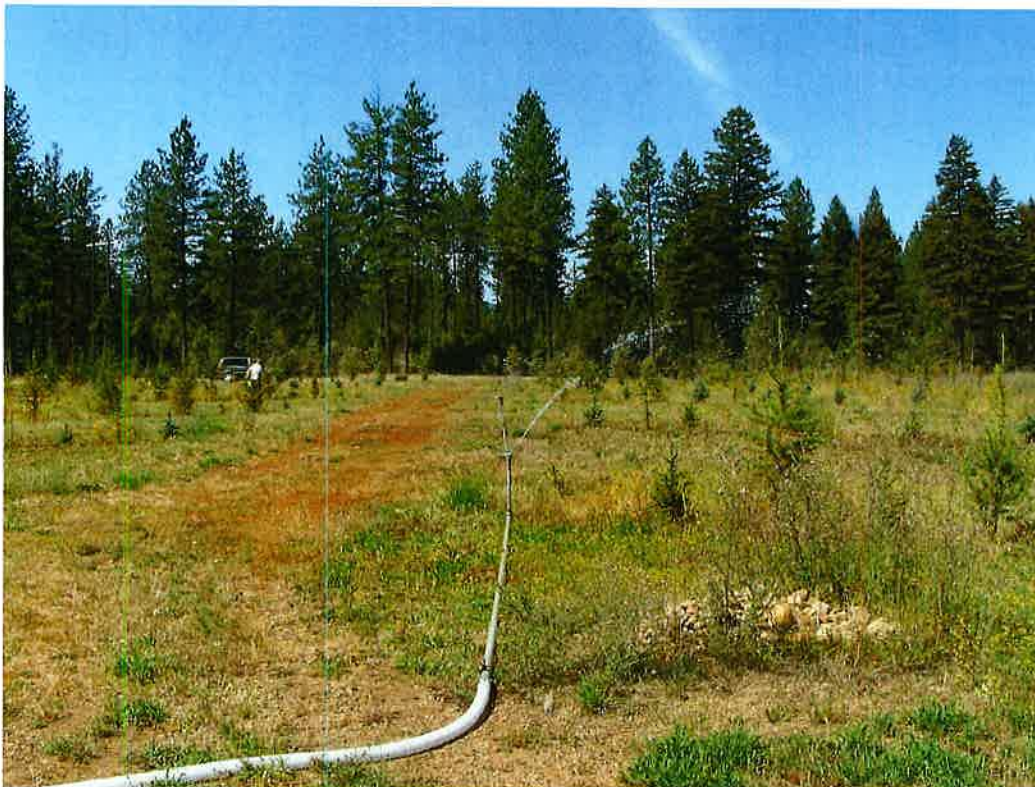
8/7/2012 – Watering of trees from water truck. Water Supplied by Well Located Near Home in NESW-8-T54N-R5W  
Claimant did not notate on photo list where place of use is. He did mention during exam that they were watering the trees in the SWSW-8-T54N-R5W. This may be that location. OK
