STATE OF IDAHO  
DEPARTMENT OF WATER RESOURCES  
BENEFICIAL USE FIELD REPORT

**Permit No:** 11-7839  
**Exam Date:** 8/25/2020

1. Current Owner:  
LYNN SWENSON AND NATALIE SWENSON  
PO BOX 242  
SPANISH FORK, UT 84660
2. Accompanied by:  
KIM NATE  
Relationship to permit Holder:  
RANCH ASSISTANT

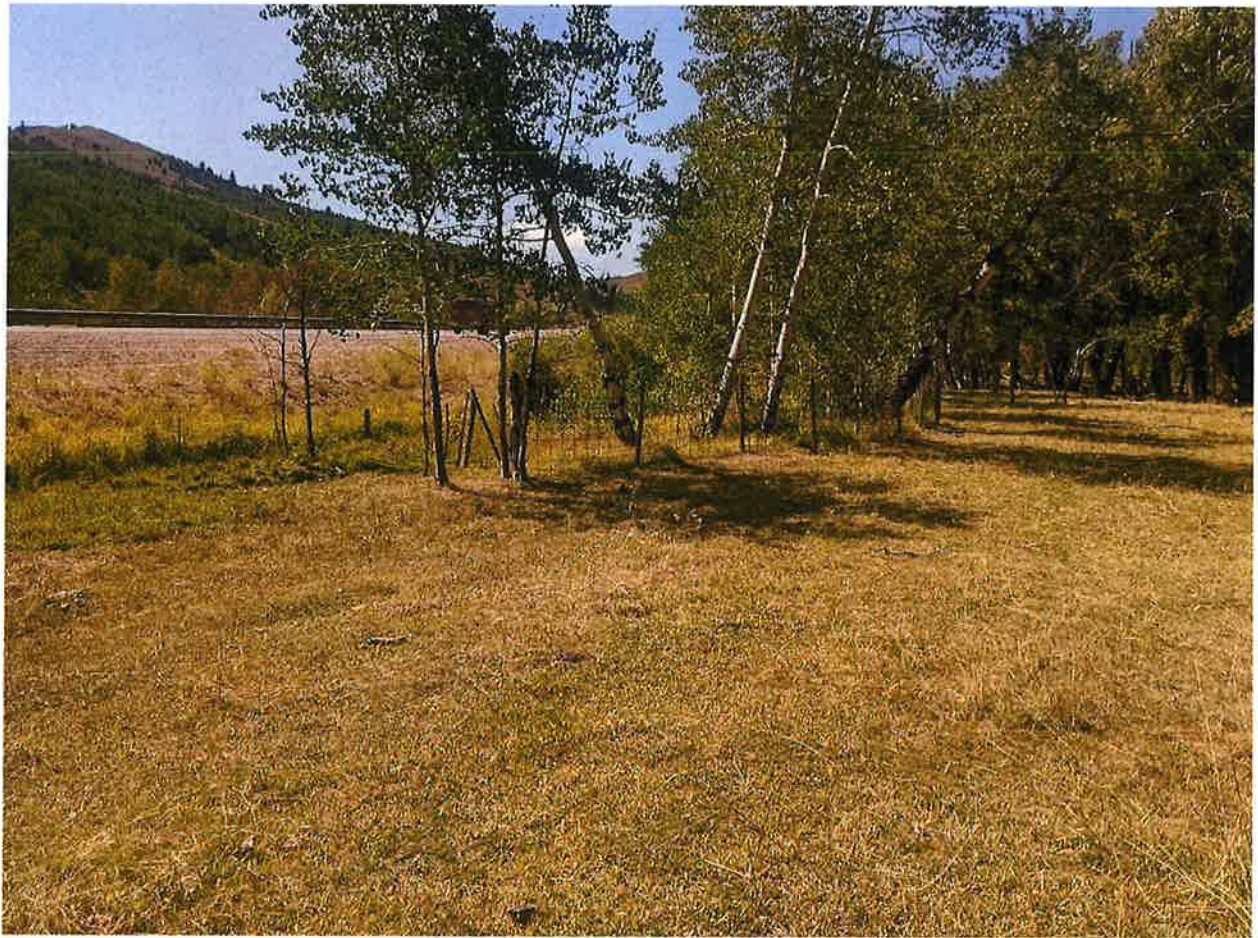
Photo 1a (above): View of the point of diversion. The spring & spring box are located within the fenced-off area.

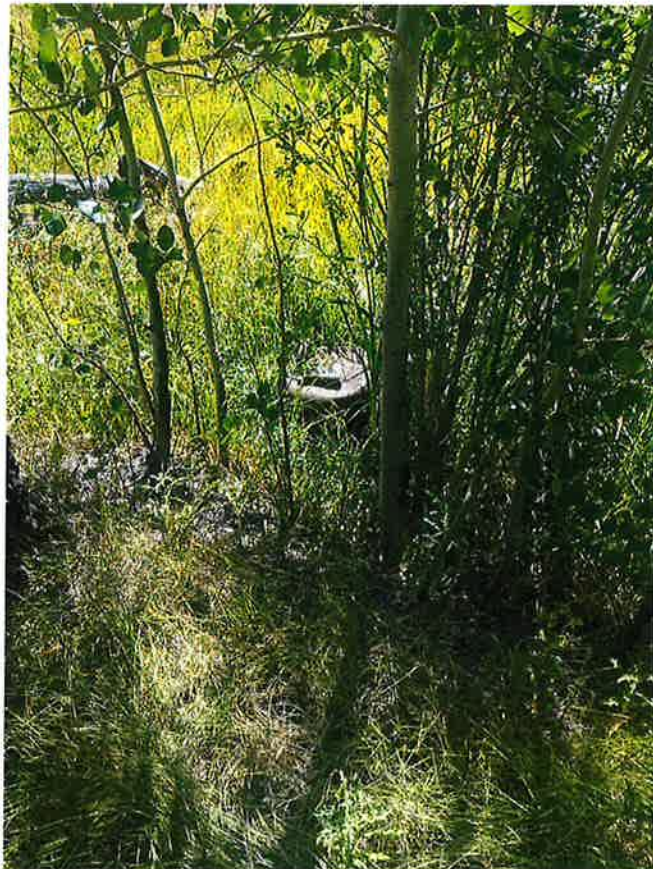
Photo 1b (left): Close-up view of the collection device (spring box). The dense vegetation made a more clear view of the diversion system impossible.

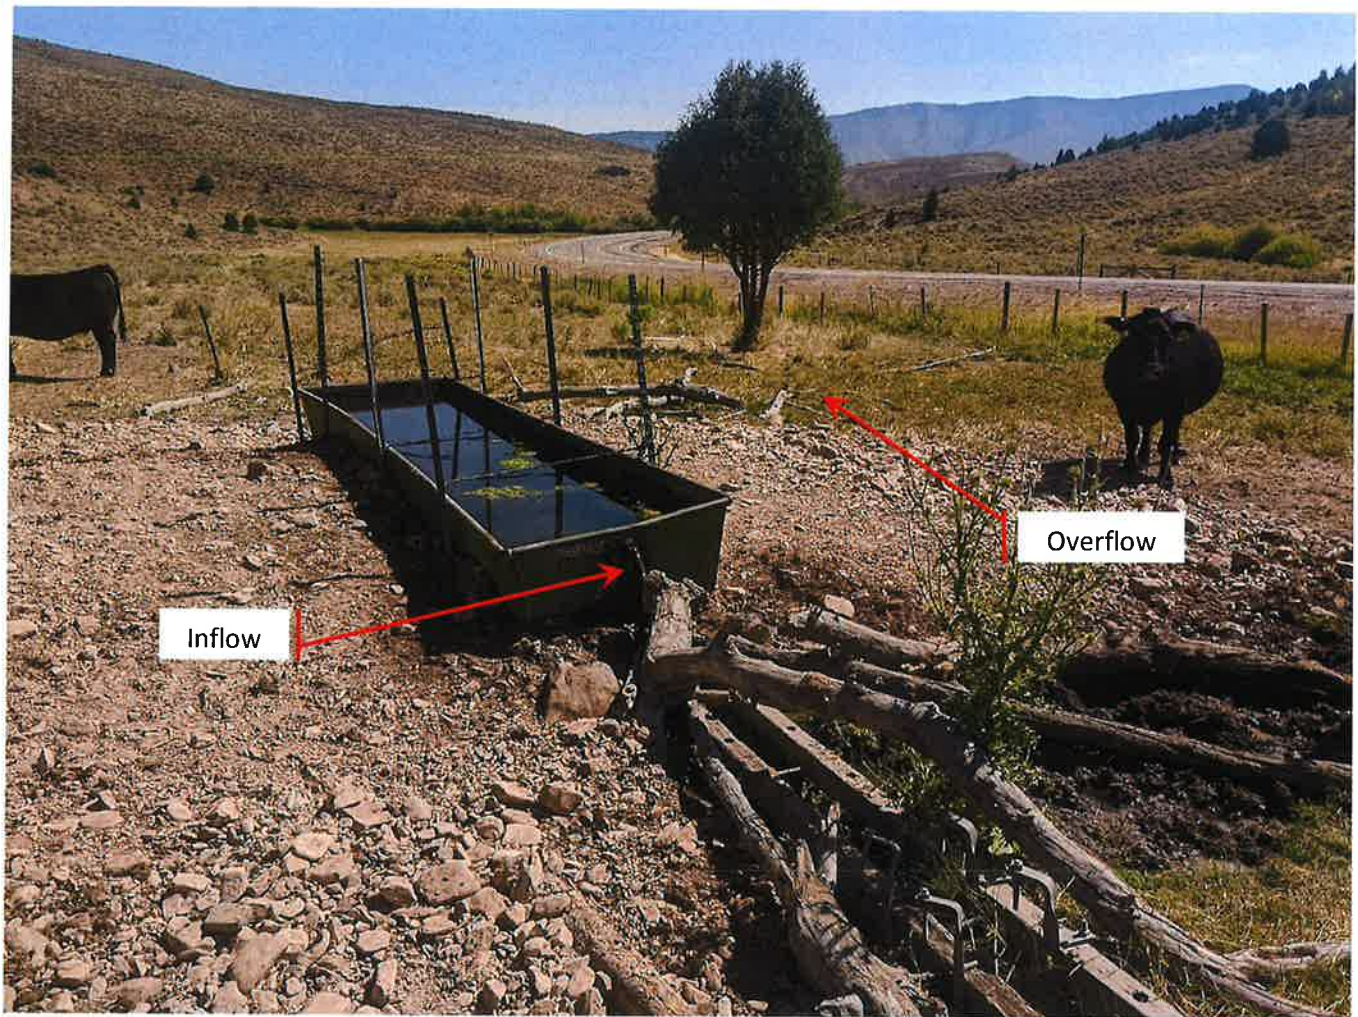
Photo 2: View of the trough filled by the spring shown in the previous photos, depicting the locations of the inflow and overflow pipes.
