STATE OF IDAHO  
DEPARTMENT OF WATER RESOURCES  
BENEFICIAL USE FIELD REPORT

**Permit No:** 11-7840  
**Exam Date:** 8/25/2020

1. Current Owner:  
LYNN SWENSON AND NATALIE SWENSON  
PO BOX 242  
SPANISH FORK, UT 84660

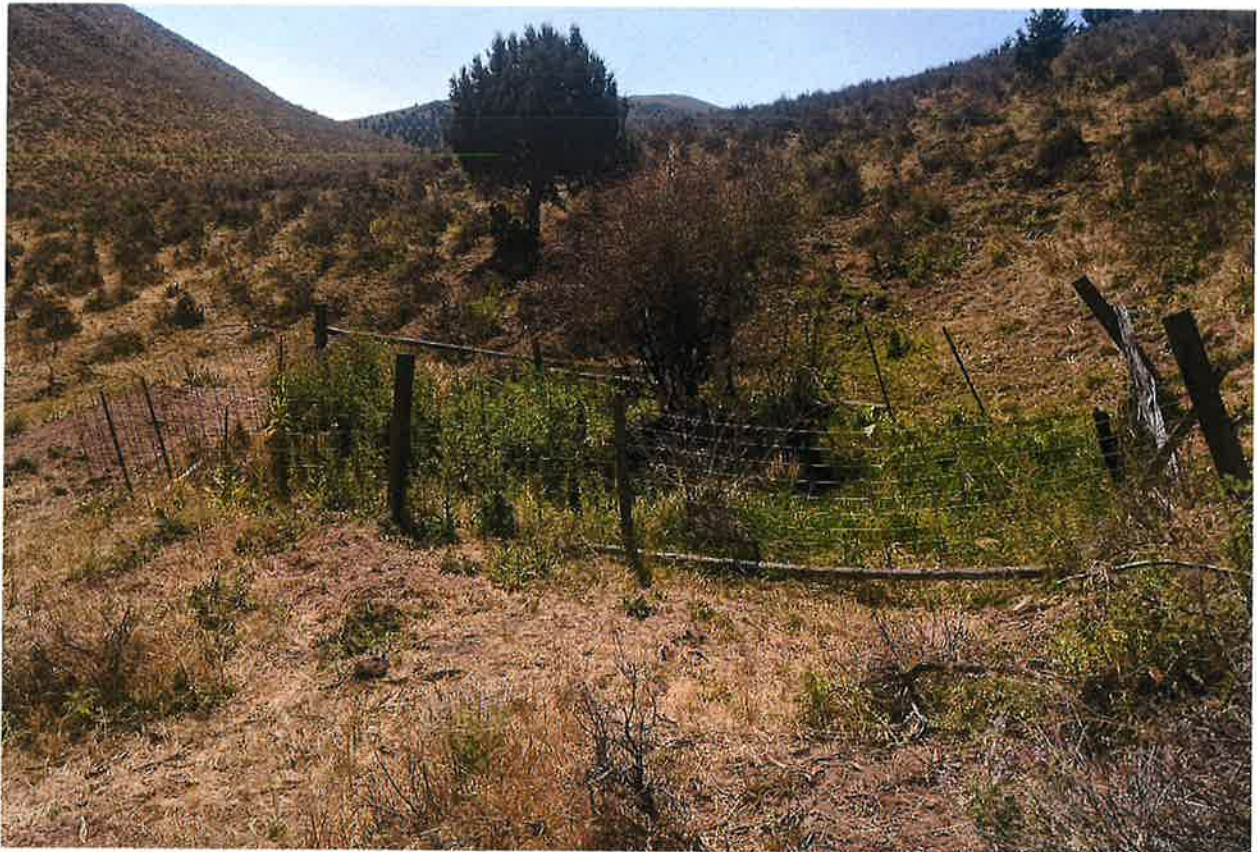
Photo 1: View of the point of diversion. Although difficult to photograph due to dense vegetation, the spring & spring box are located within the fenced-off area.

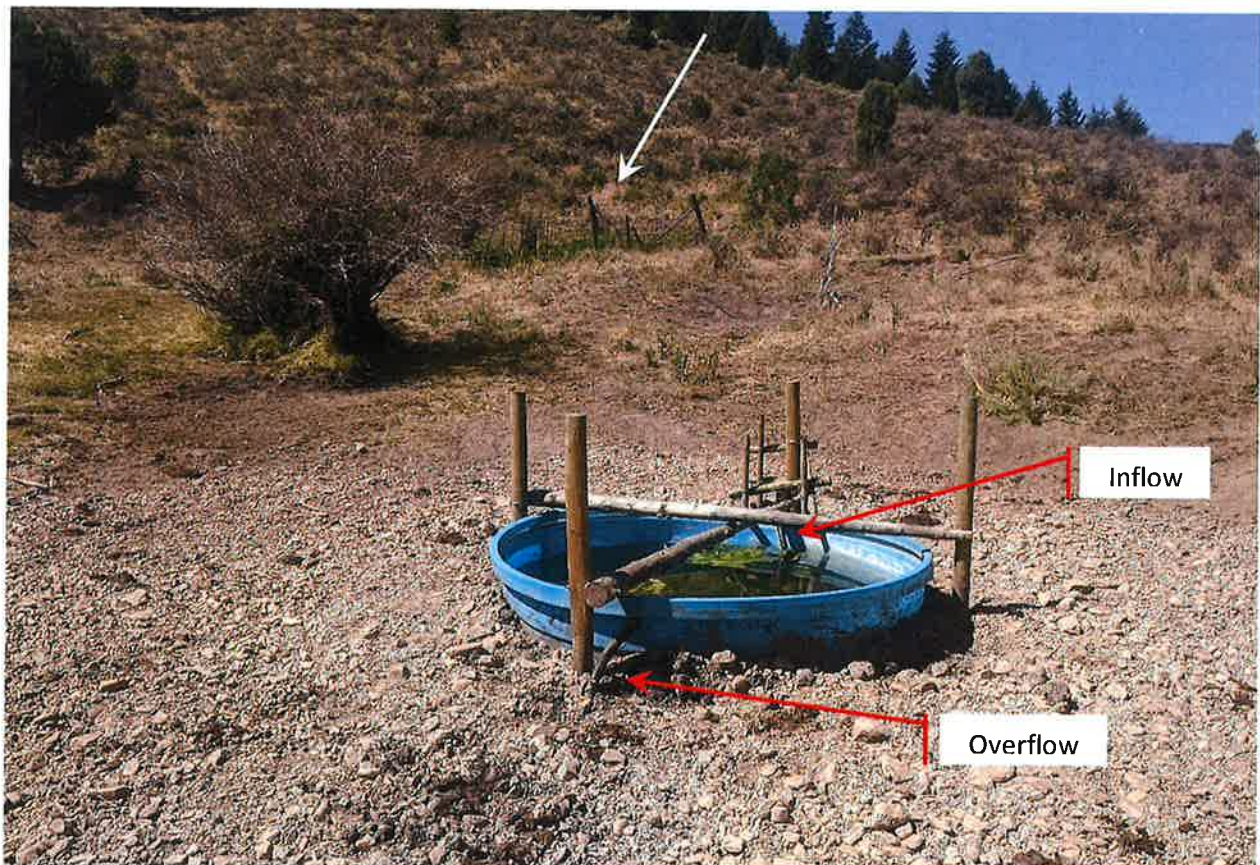
Photo 2: View of the trough filled by the spring shown in the previous photo, depicting the locations of the inflow and overflow pipes. The spring is visible in the background, indicated by the white arrow.
