STATE OF IDAHO  
DEPARTMENT OF RECLAMATION

STATE OF IDAHO  
DEPARTMENT OF WATER RESOURCES  
RECORD OF INSPECTION OF DAM

Name of dam: Monroe Stream: Monroe Creek ☒ Offstream  
Name of owner: John Mainvil Location: SW $\frac{1}{4}$ SW $\frac{1}{4}$ , Sec. 31, T. 13N, R. 6W, B.M.  
Individuals accompanying inspector: John Mainvil  
Reservoir characteristics: Dam height 45 Surface area 10 Storage capacity 320  
Hazard class: low Photographs: #11 & 12

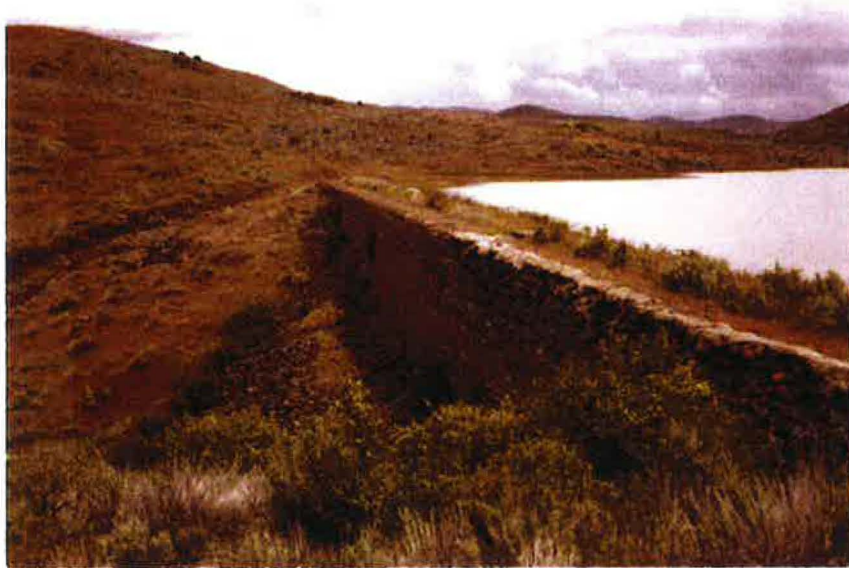
UPSTREAM SLOPE	CREST	DOWNSTREAM SLOPE	TOE AREA
Surface cover material	<u>EARTH + GRAVEL</u>	<u>→</u>	<u>ROCK MASONRY WALL + ROCK</u>	
Growth	<u>NONE</u>	<u>SMALL BRUSH</u>	<u>MINOR BRUSH</u>	
Settlement or cracks	<u>NONE NOTED</u>	<u>→</u>		
Surface erosion	<u>NONE</u>	<u>→</u>	<u>DETERIORATION IN MORTAR WALL</u>	
Debris	<u>NONE</u>	<u>→</u>	<u>SOME DRIFTWOOD FROM OVERFLOW</u>	
Animal burrows	<u>NONE</u>	<u>→</u>		
Crest width and slope measurements	<u>≈ 3:1</u>	<u>16' WIDE</u>	<u>VERTICAL</u>

Downstream slope

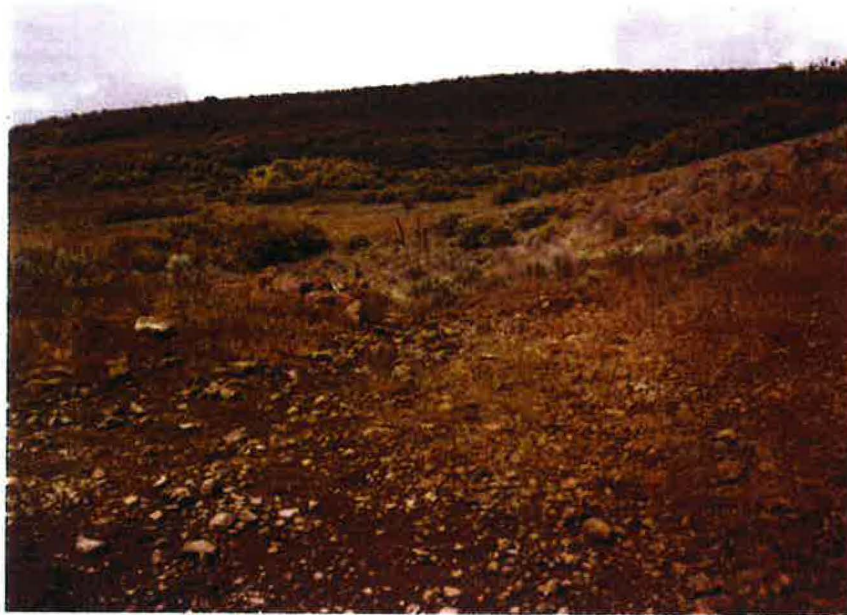
CONDITION OF SPILLWAY: FAIR  
DAM IS OVERFLOW - ALSO EMERGENCY SPILLWAY

Emergency spillway

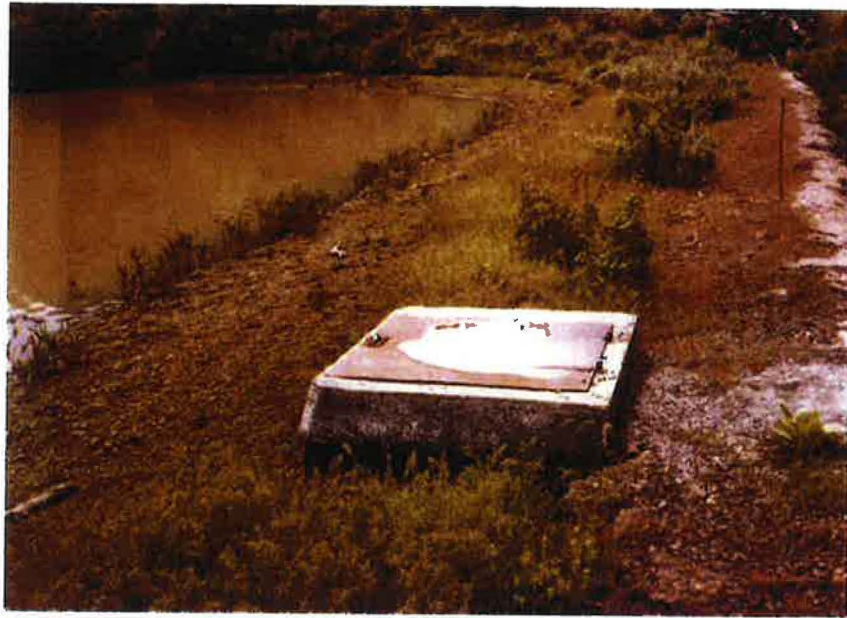
Description and condition: OUTLET CONTROL BOX LOCKED

Outlet control box, locked
