STATE OF IDAHO DEPARTMENT OF WATER RESOURCES BENEFICIAL USE FIELD REPORT

Permit No: 13-7966 Exam Date: 7/17/2020

3. SOURCE:
SPRINGS

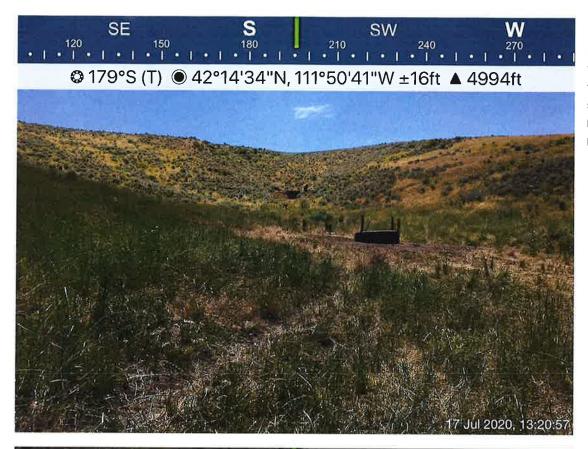
Overall location, water trough in the foreground and the spring location in the background and up the hill.

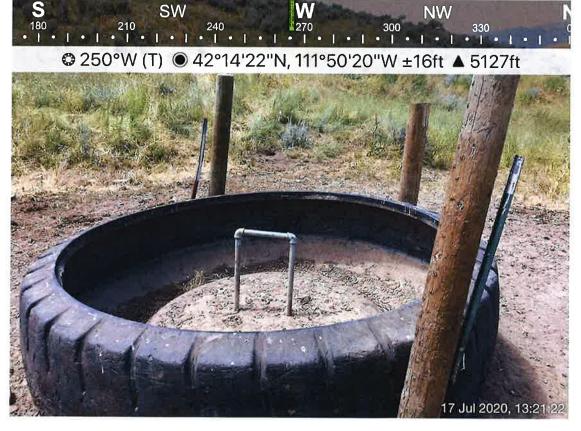
Water trough has a 1 inch pipe with a hole on each up and down pipe. One hole allows for water to flow into the trough, the other allows for over flow to flow out.

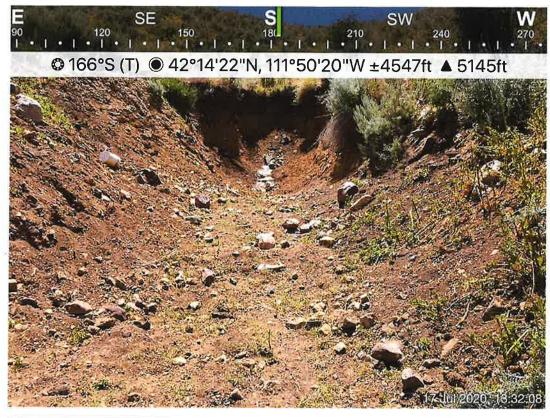
Location of excavated soil.
Brett Reeder confirmed that this is the location of the spring. He says that the spring box had collapsed and plan on replacing it in the future.

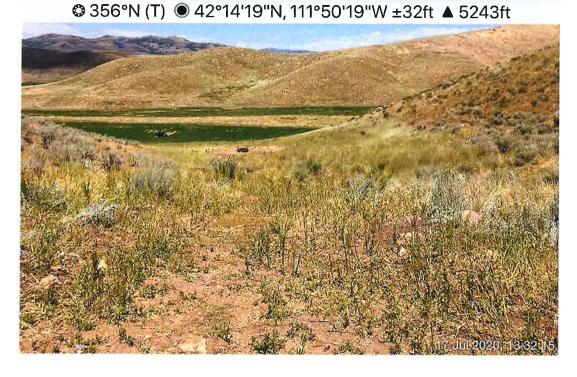
View of the water trough from the spring location.

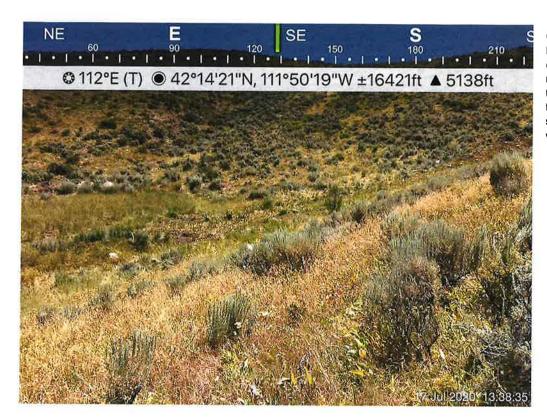
Grasses are greener in the lowest part of the draw compared to the grasses moving up in elevation along the spur. Possible indication that water was present. The spring location is visible to the very right of the photo.
