Ott Water Engineers  
150259 Jim Ford Creek Hydro  
General

May 23, 1989

SUBJECT: Jim Ford Creek Hydroelectric Project

RE: JIM FORD CREEK HYDROELECTRIC PROJECT  
GEOTECHNICAL EVALUATION AND RECOMMENDATIONS  
WEIPPE, IDAHO

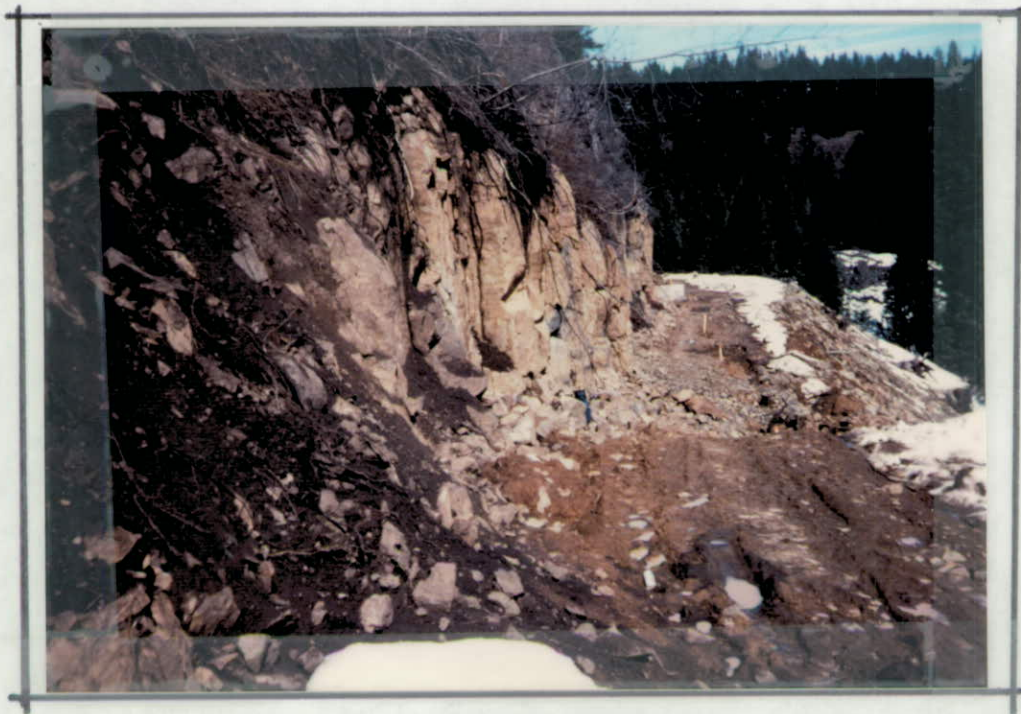
Photo 1 -- General View of Area Where Penstock Broke

**Observations.** Figures 1 and 2 show the approximate location and condition of the slide. [Several photographs will be added showing the conditions observed.] The slide occurred roughly between stations 81 + 25 and 82 + 75 where the penstock is buried beneath the road and at the transition from 48-in dia CMP to 42-in dia steel pipe. The slide exposed about 60 ft of pipe. The CMP broke a few feet upstream from the transition. I could not see all of the CMP because it was partly buried in earth, but it appeared to me that the pipe split circumferentially in a groove between two corrugations. You had cut a hole into the CMP and reported that inspection revealed the CMP to be bowed for a length of about 15 ft upstream from the break. You said that the steel pipe was too slick to inspect. I did not observe any distortion in the exposed steel pipe.

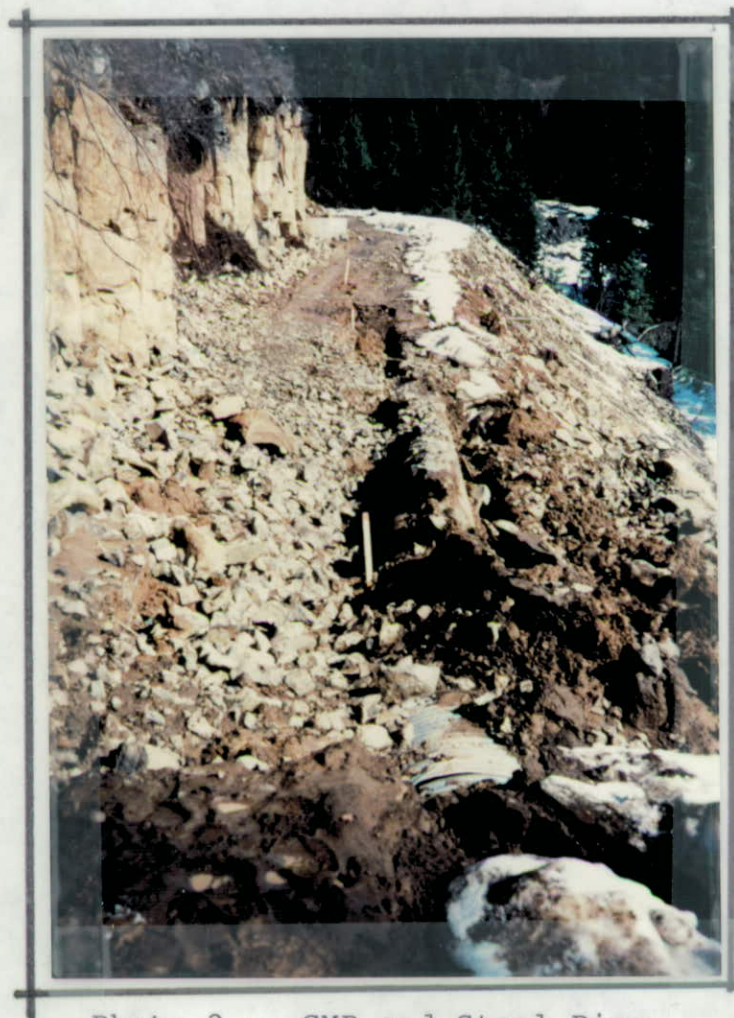
Photo 2 -- CMP and Steel Pipe

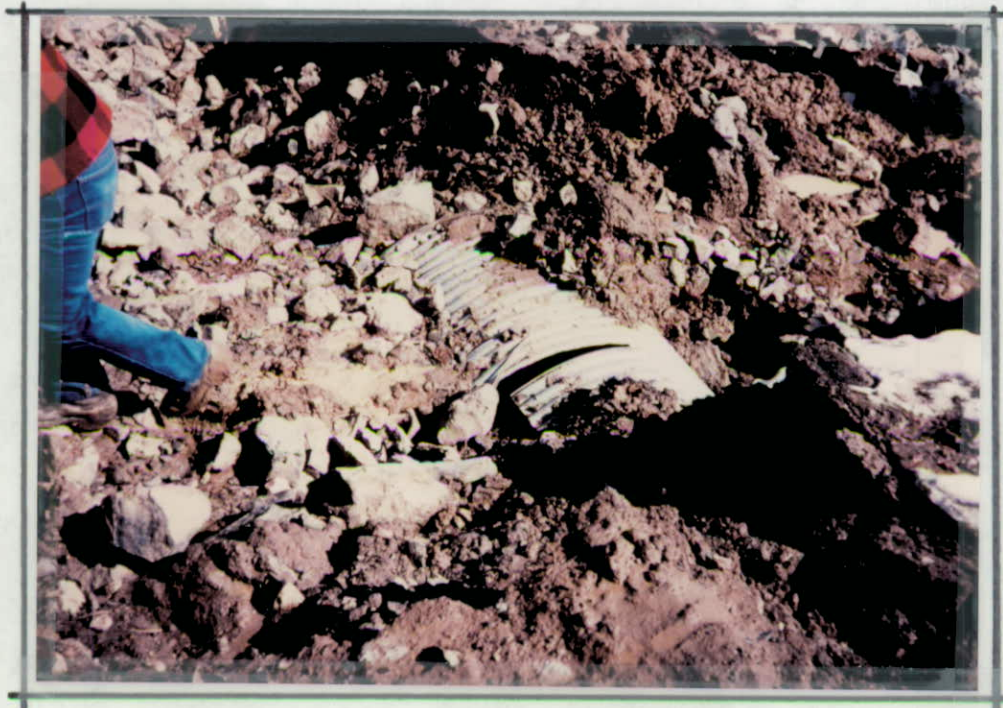
Photo 3 -- Break in CMP

The steel pipe does not appear to have moved the same amount as the earth around it. Some road fill was perched on top of the pipe, so it appears that the earth slumped, exposing the pipe and exerting enough force to break the CMP.

**Conclusion.** Settlement occurred in the saturated, uncompacted fill and in the natural soil underlying the fill. Settlement of the steel pipe redistributed the stresses about the CMP causing it to fail, thereby increasing the water percolating through the slope as the pipe emptied. The added water exacerbated settlement.

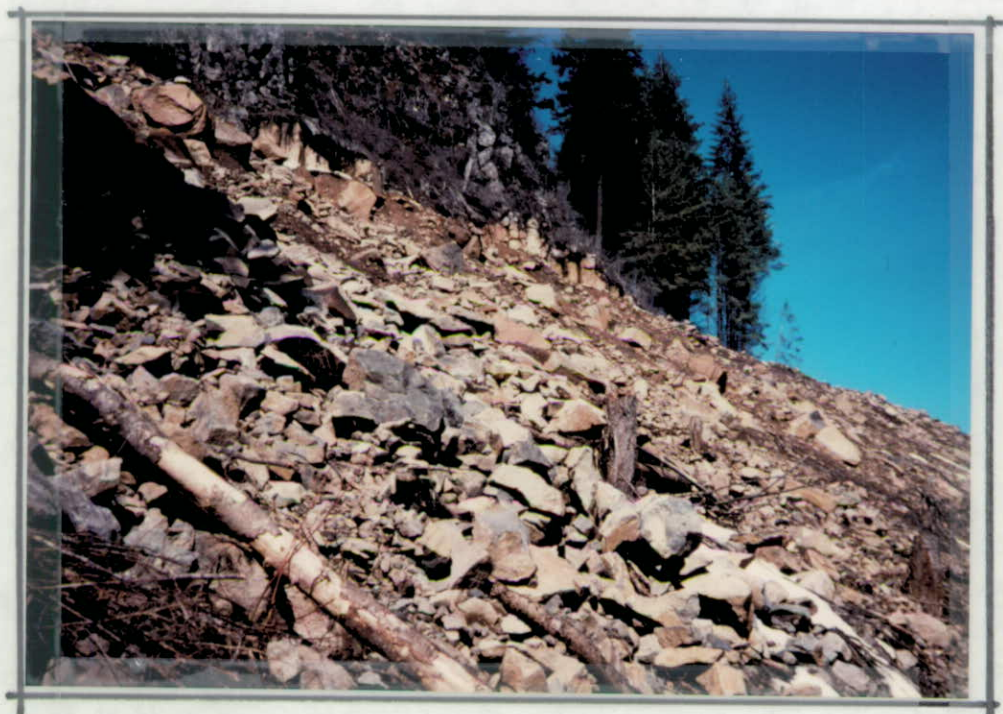
Photo 4 -- Slope Below Break in CMP

There is no discernable evidence of the slide in the slope below the road. There is no bulge in the slope, the toe, or in the woods below. There are no trees showing tilt reflective of recent movement.

**Remedy.** Realign the penstock to take advantage of being able to support it with rock. Anchor the penstock to rock. Improve drainage. Buttress the toe of the slope, especially the slump below station 79+00, with free-draining material.

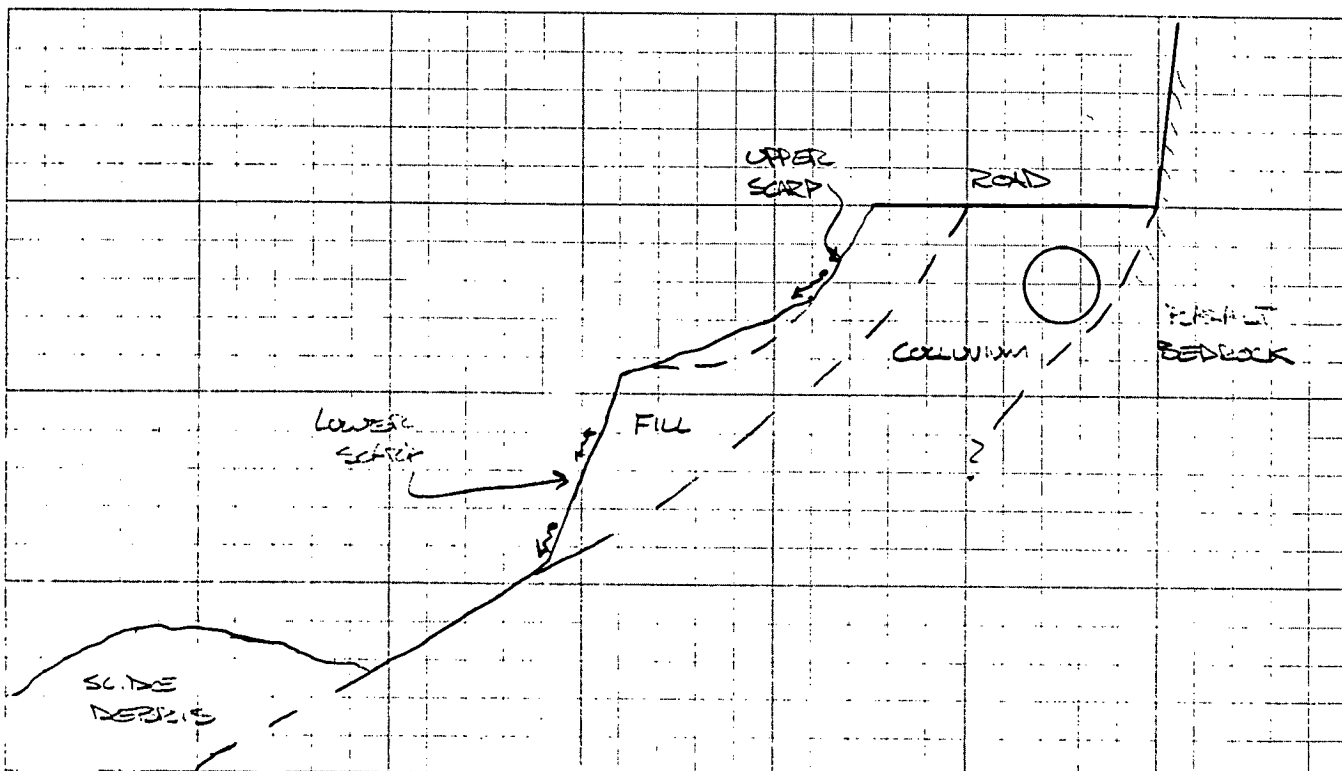
FIGURE 1.

Approximately 10 to 15 feet below the upper scarp is the lower scarp. This scarp was approximately 10 feet high with a slope of approximately 65 to 70 degrees (Figure 1). We understand that this scarp formed over the weekend of March 10 and 11, 1990. Downslope of the lower scarp, the failed material had moved up to about 100 feet and had knocked over trees and buried a lower access road. The slide debris was up to approximately 10 feet in thickness and consisted predominantly of clayey silt, with little to trace sand and gravel. The slide debris was very soft and wet and at the time of our site visit, it would not support the weight of a human being. Exposed immediately below the lower scarp was stiff clayey silt. This material is interpreted to be colluvium composed predominantly of the loess soils which blanket much of the upland area in the vicinity of the project.

The slope failures between Stations 80+70 and 81+00 appear to have been due to sliding of the saturated, soft fill soils at the contact between the topsoil/fill and the underlying stiff, clayey silt colluvium. The failures were probably initiated due to infiltrating water from snow-melt and rain fall into the soft, relatively permeable, fill resulting in a loss of strength and due to high seepage forces flow at the contact between the fill/topsoil and the stiff colluvium. The failures did not appear to result in damage to the penstock at the time of our site visit. The penstock appeared to have been placed in the stiff colluvial soils and backfilled with compacted clayey silt. These materials appeared to be relatively stable; however, continued upslope failures could jeopardize the penstock. For this reason we recommend that the following measures be implemented to stabilize the area.

SCHEMATIC SECTION  
THROUGH AREA OF  
SLOPE FAILURE

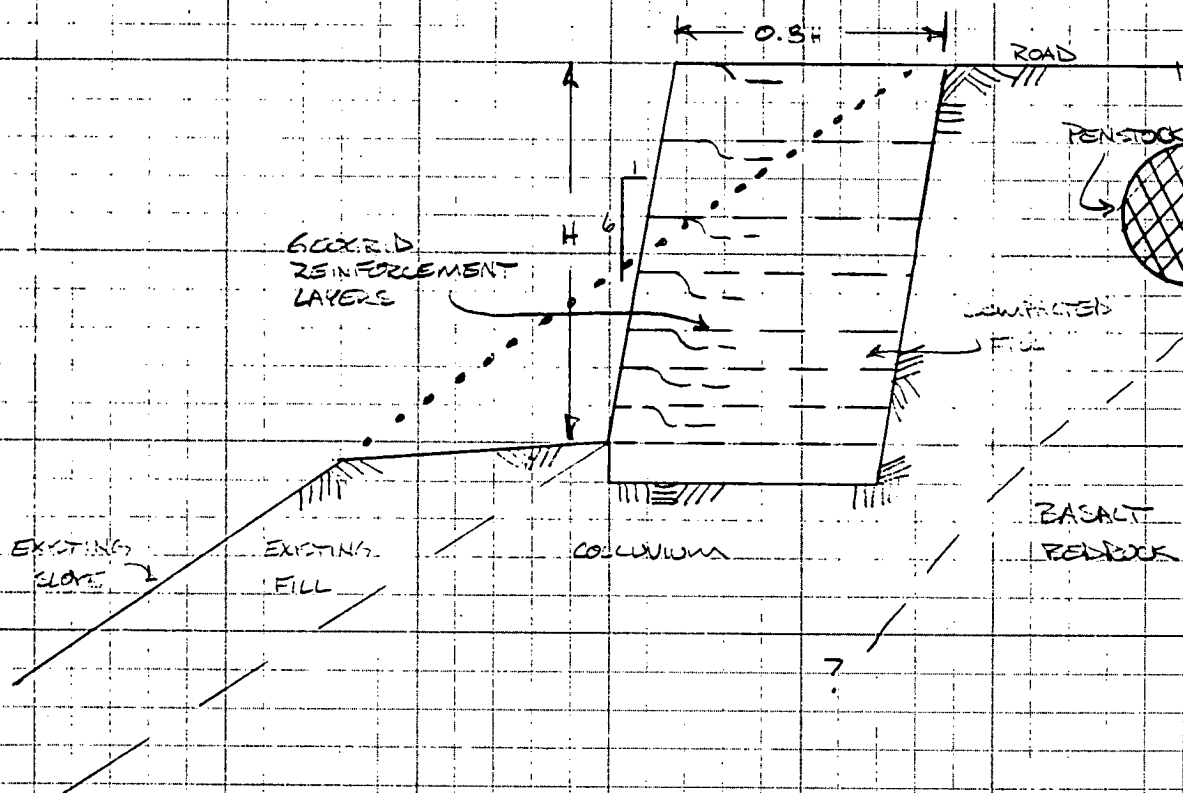
FIGURE 3.

SCHEMATIC SKETCH OF  
REINFORCED FILL

② How will you get the backslope of the excavation to 60:40 stand at 14:60 while you bring up the reinforced fill? Better think about this some more.

For the proposed reinforced fill, we recommend using the reinforcement system illustrated in Figure 3. This section is based on a maximum fill height of 10 feet and a maximum surcharge load of 250 psf.

We recommend that the reinforced fill be constructed between Stations 79+00 and 81+30. In addition, it is our opinion that it is possible to construct the reinforced fill almost immediately. The onsite fill from the vicinity of Station 86+00 appeared to be suitable for use, provided that the rock larger than six inches in longest dimension is removed.

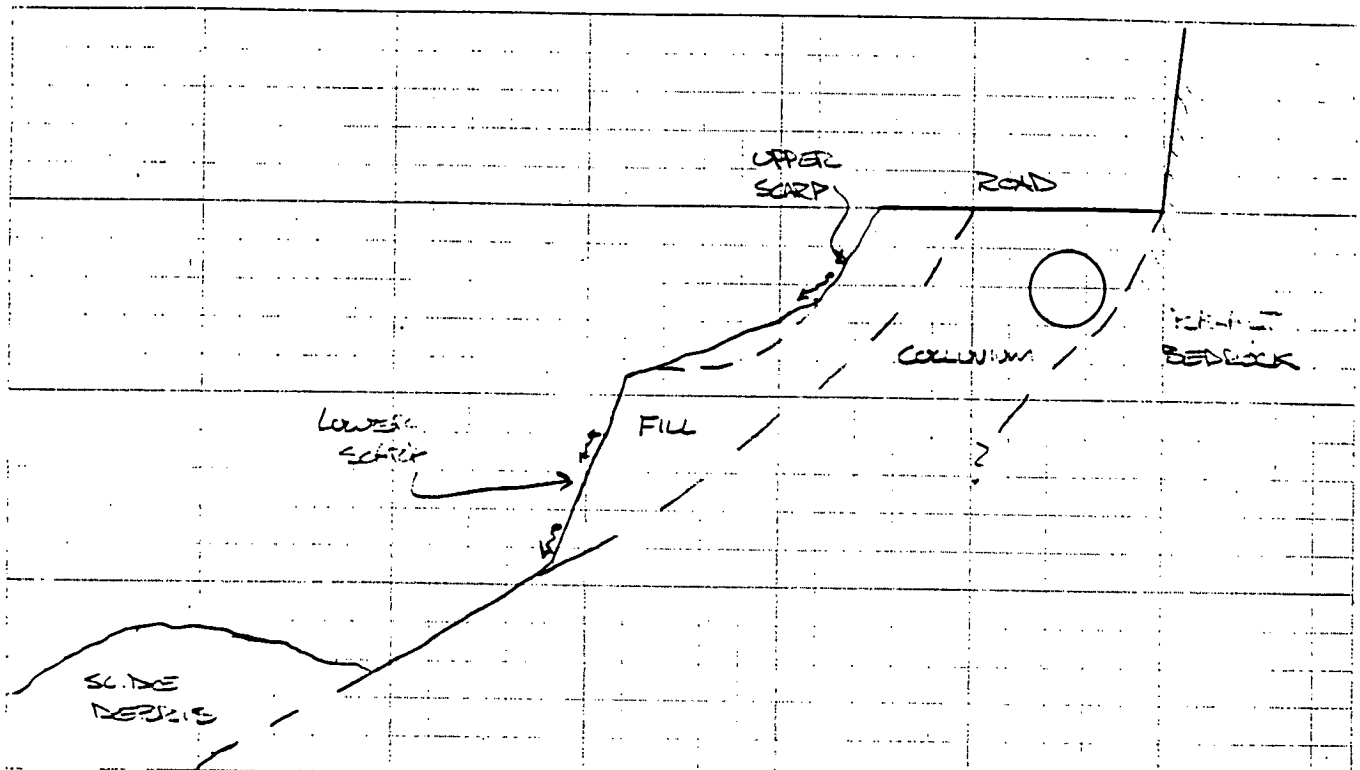
FIGURE 1.

SCHEMATIC SECTION  
THROUGH AREA OF  
SLOPE FAILURE
