## Field Investigation – Narrative

# **Eckhardt Enforcement Case #E2017-1235 (potential unauthorized pond issue)**

Enforcement Case No: E2017-1235

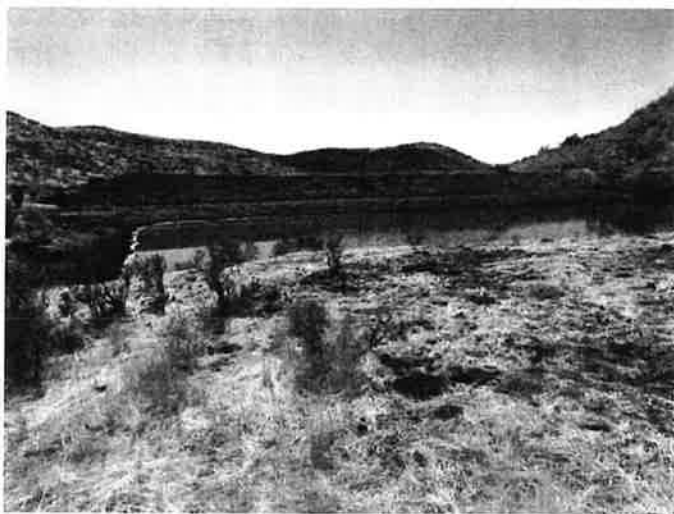
Picture 1

The spillway for the constructed dam is located on the southeastern portion of the pond. There is possibly a spring that feeds this pond as it was nearly full at the visit.

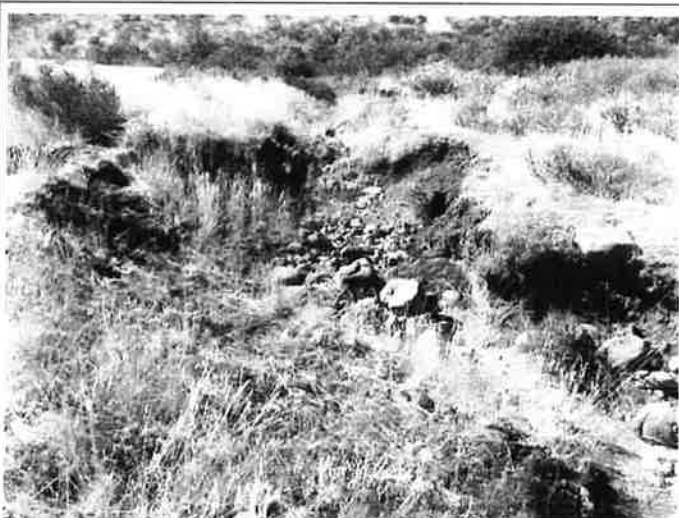
Picture 2

Defined channel present downstream of the pond.

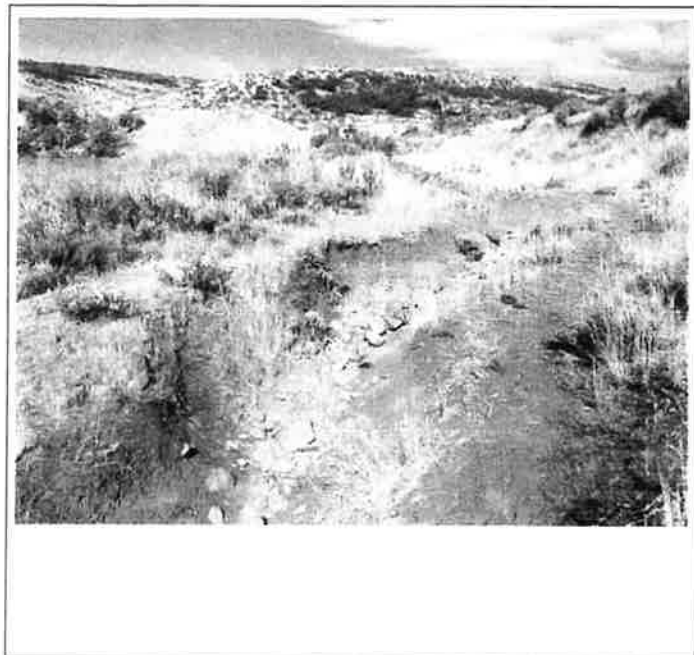
**Picture 3**

Defined channel present

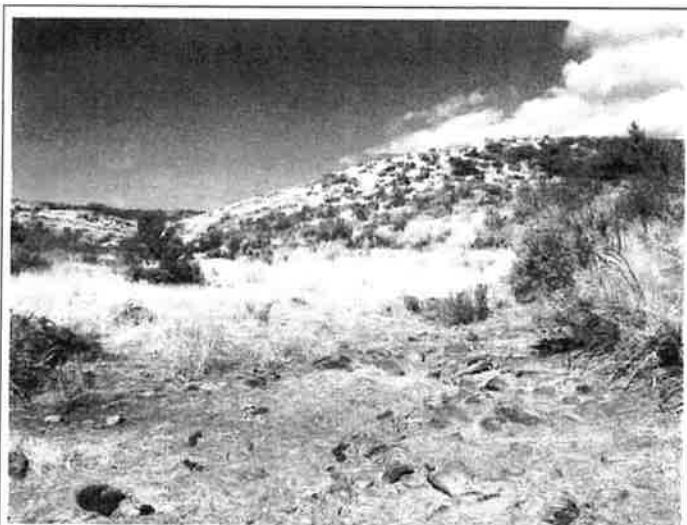
**Picture 4**

There's cobbles present the appear to be in some sort of channel.

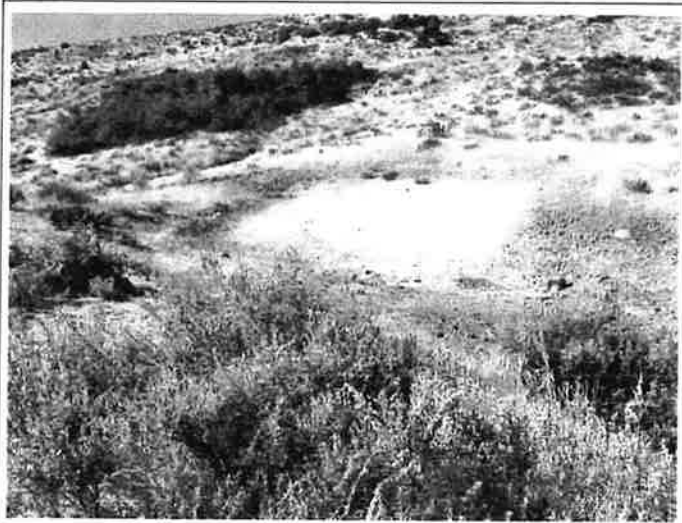
**Picture 5**

Looking to the west, standing on the dam with the spillway to the west of the pond. Eckhardt states that this pond rarely captures water since the drainage doesn't produce much water.

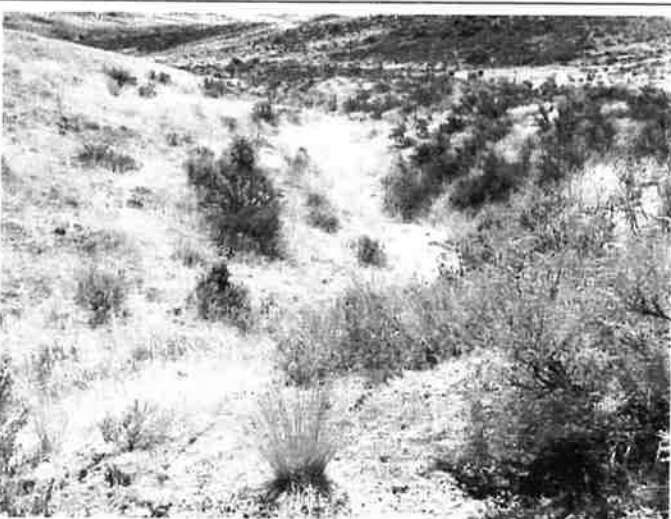
**Picture 6**

Photo shows historic channel that appears to not carry water any longer. Overgrown vegetation seems to indicate a dry channel.

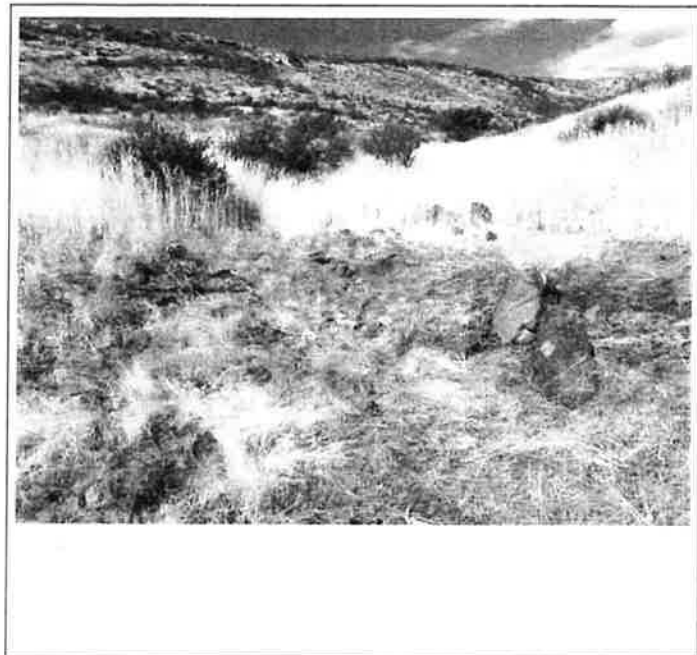
**Picture 7**

There doesn't appear to be the presence of a channel upstream of the pond.

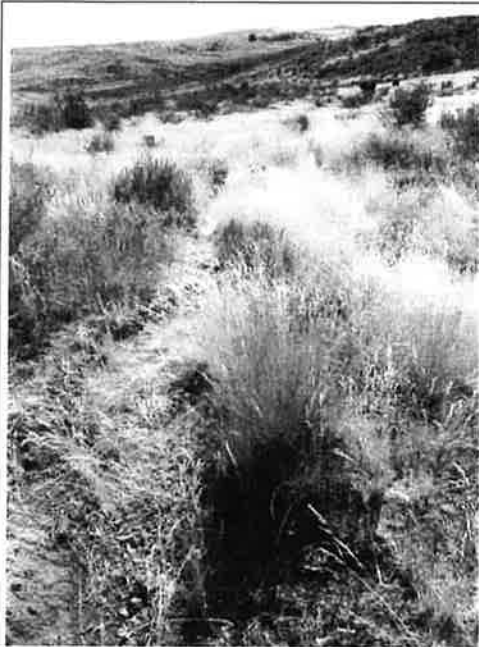
**Picture 9**

Again, overgrown vegetation indicates that water  
hasn't flown in recent times down the spillway.

The pond is shallow, maybe 2 feet deep or so to  
the spillway from the bottom of pond.

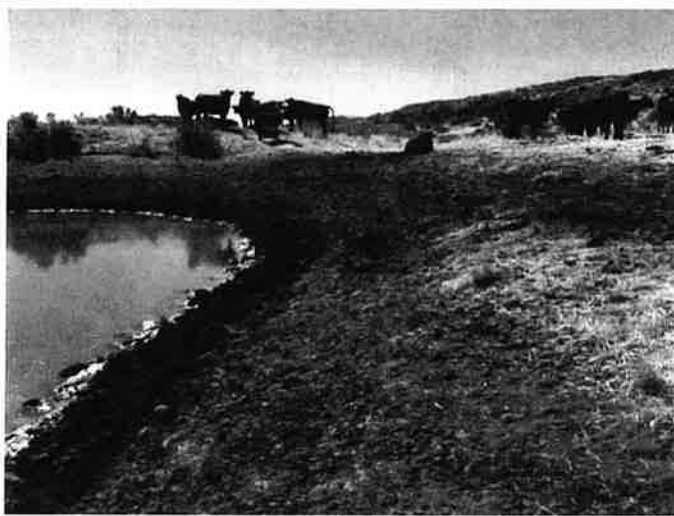
Picture 11

A cow is laying in the spillway for this pond.

Eckhardt said the pond is excavated another 3'  
deeper than the current water level.

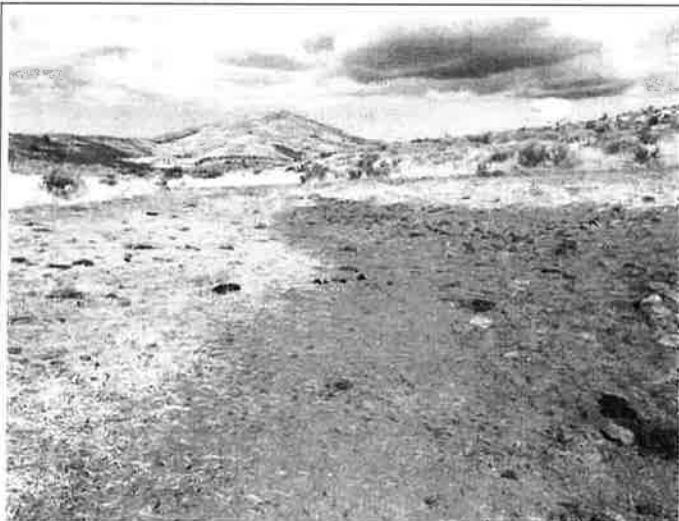
Picture 12

Drainage to the pond. Eckhardt stated that this is  
a perfect place for a pond since it captures water  
that comes down the drainage.

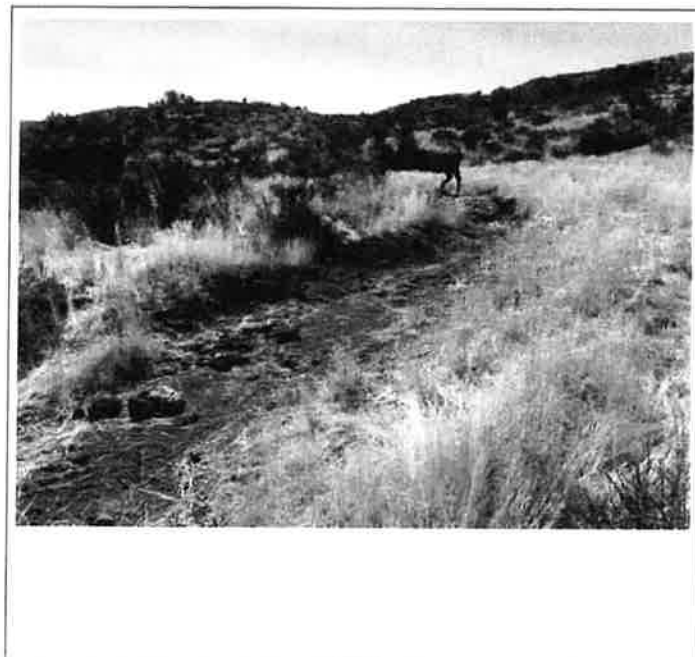
**Picture13**

DRG shows that this pond is constructed in a  
channel that eventually leads to Jenkins Ck.

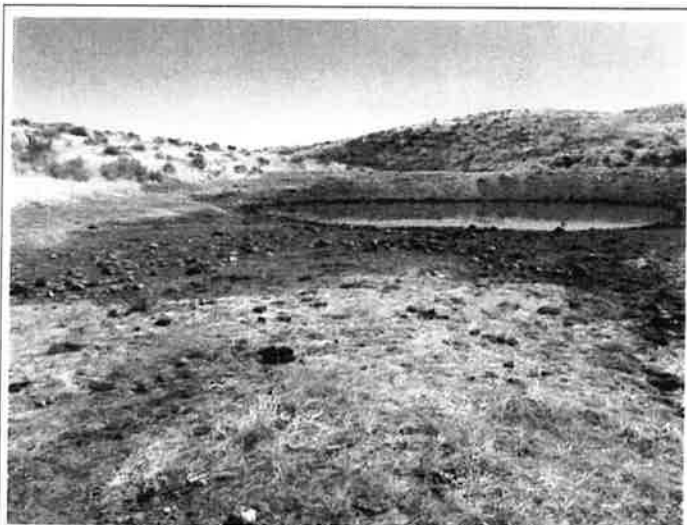
**Picture14**

Dam

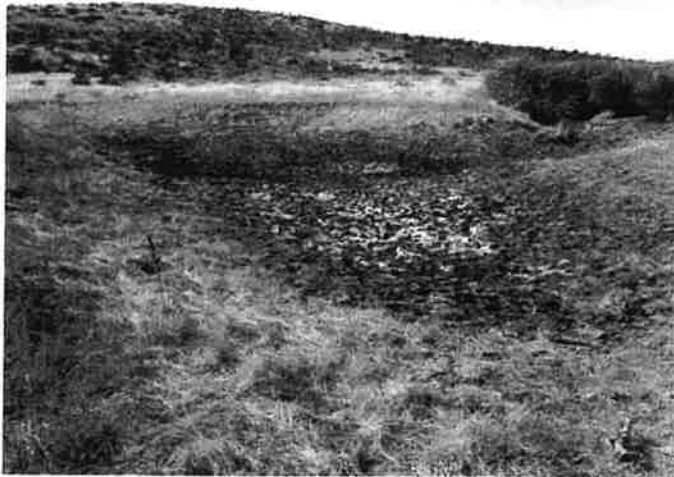
**Picture 1**

| Pond # | Drainage | Water Right Required? | Estimated Depth** | ***Estimated Area | Calculated Size | Inspected | 2017 Inspection Comments |
|---|---|---|---|---|---|---|---|
| 9 | Jenkins | Yes | | 6 | 0.18 | 0.4 | 9/26/2017 Based on review of USGS quadrangle map and on-site visual assessment, the structure impounds water from an natural channel within the basin. |

Pond was dry at time of inspection. Depth from  
base of pond to crest of spillway was  
approximately 6 feet (visual estimate). Pond high  
water mark surface area was approximately 0.18  
acres based on 2015 aerial image.

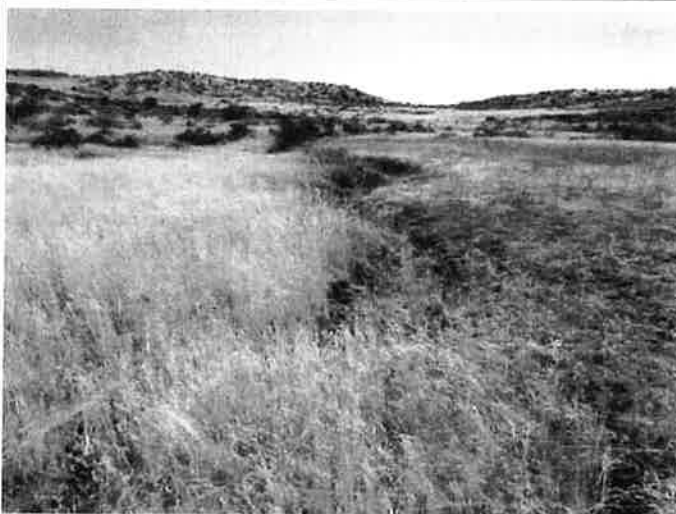
**Picture 2**

The spillway runs along the left abutment of the  
embankment structure.

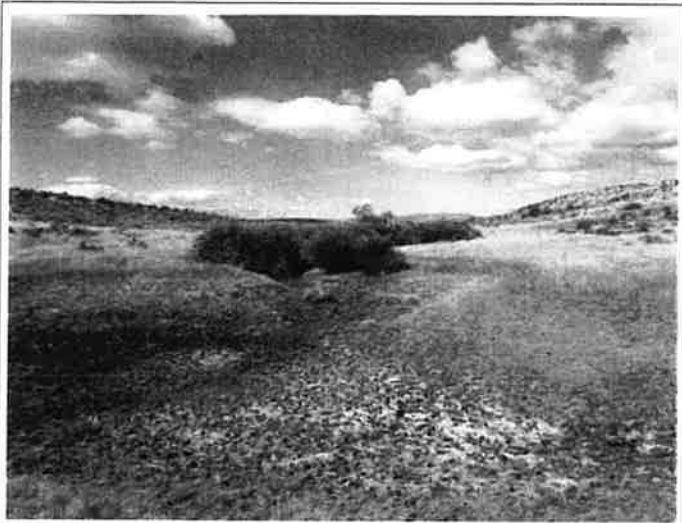
**Picture 3**

Based on review of USGS quadrangle map and on-site visual assessment, the structure impounds water from a natural channel within the basin.

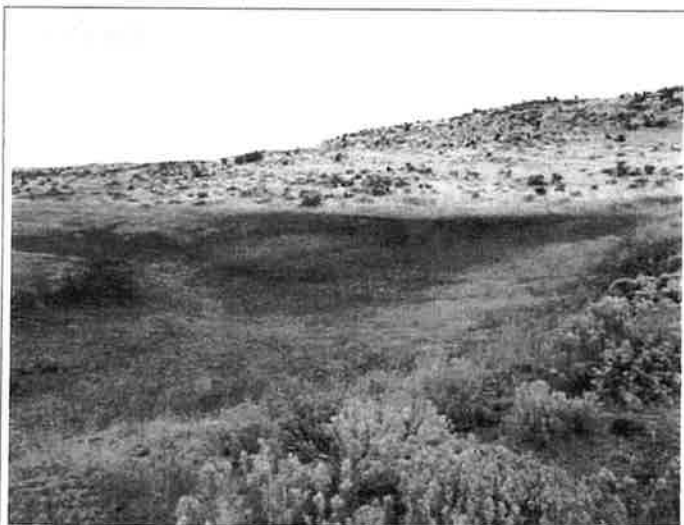
**Picture 4**

| Pond # | Drainage | Water Right Required? | Estimated Depth** | ***Estimated Area | Calculated Size | Inspected | 2017 Inspection Comments |
|---|---|---|---|---|---|---|---|
| 11 | Jenkins | Yes | | 9 | 0.26 | 0.9 | 9/26/2017 Based on review of USGS quadrangle map and on-site visual assessment, the structure impounds water from an natural channel within the basin. |

Pond was dry at time of inspection. Depth from base of pond to crest of spillway was approximately 9 feet (visual estimate). Pond high water mark surface area was approximately 0.26 acres based on 2015 aerial image.

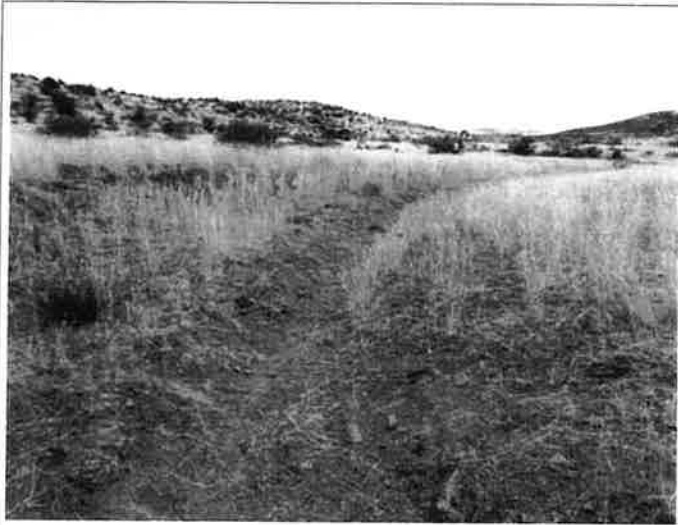
**Picture 5**

The spillway runs along the left abutment of the embankment structure.

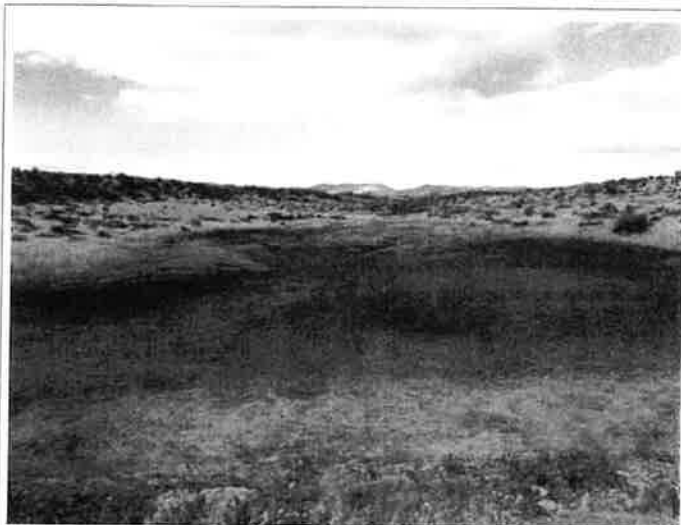
**Picture 6**

Based on review of USGS quadrangle map and on-site visual assessment, the structure impounds water from an natural channel within the basin.

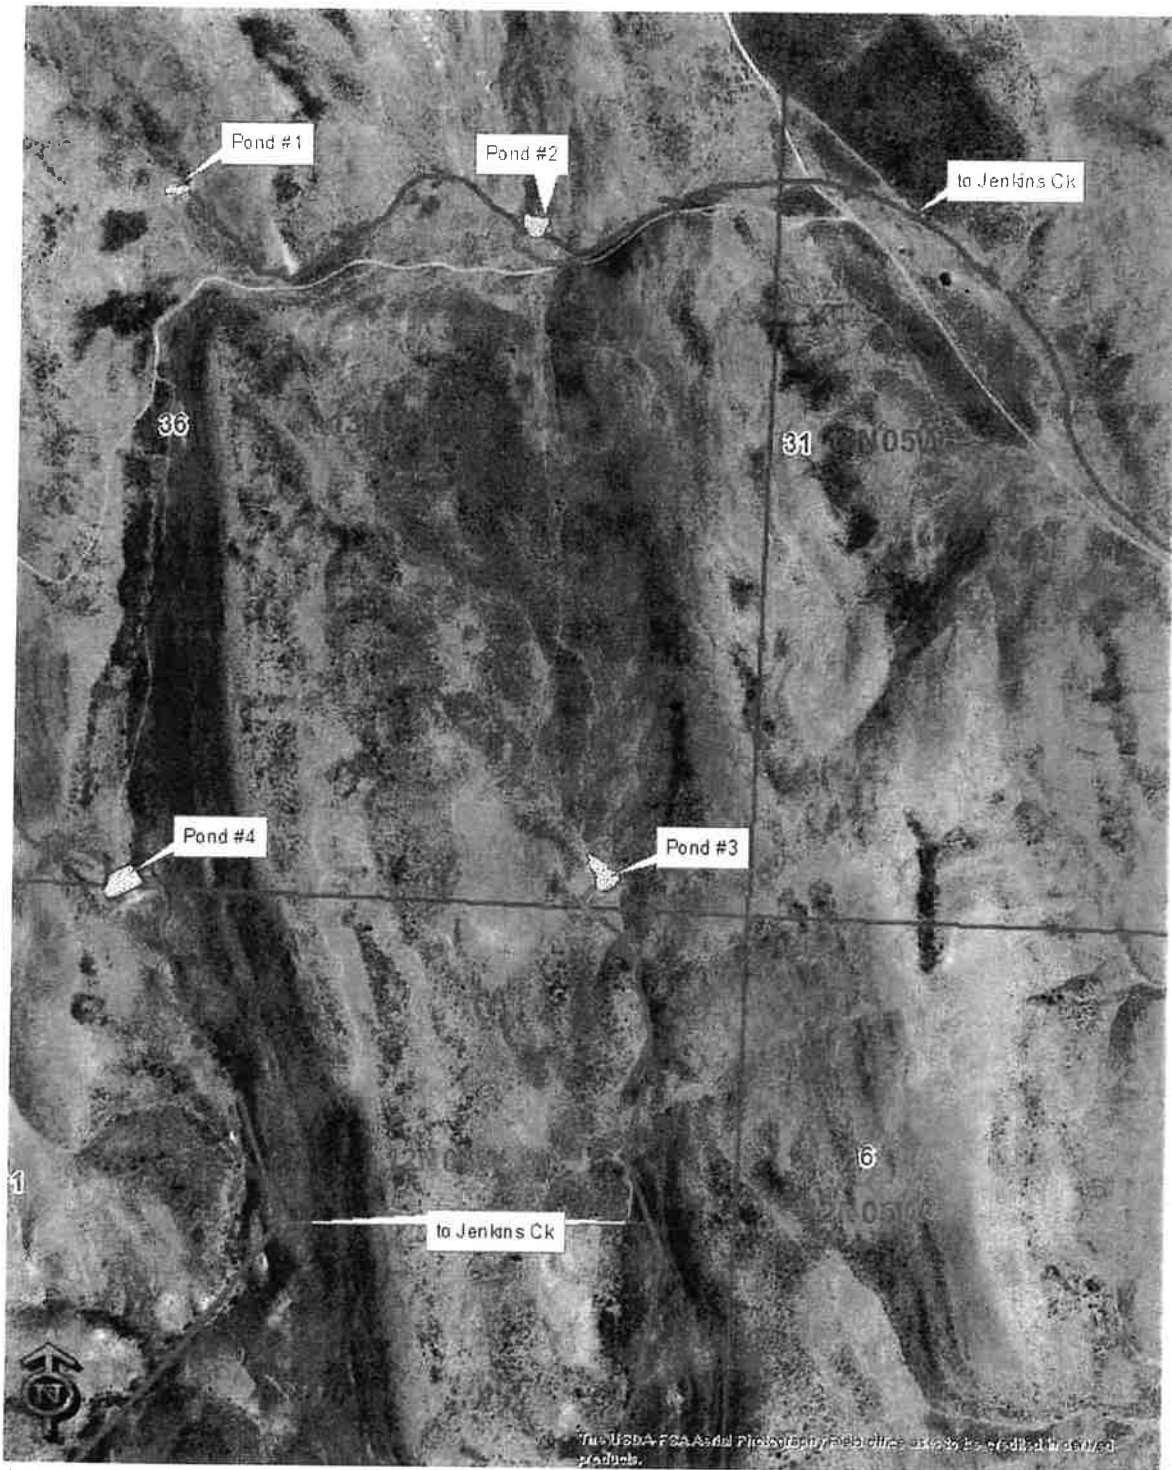
# Eckhardt ponds on Jenkins Ck drainage

The blue line represents sections of a defined channel as depicted on the US Geological Survey topo Digital Raster Graphics (DRG) map. Historic DRG map shows water discharging in the depicted channel into Jenkins Ck.

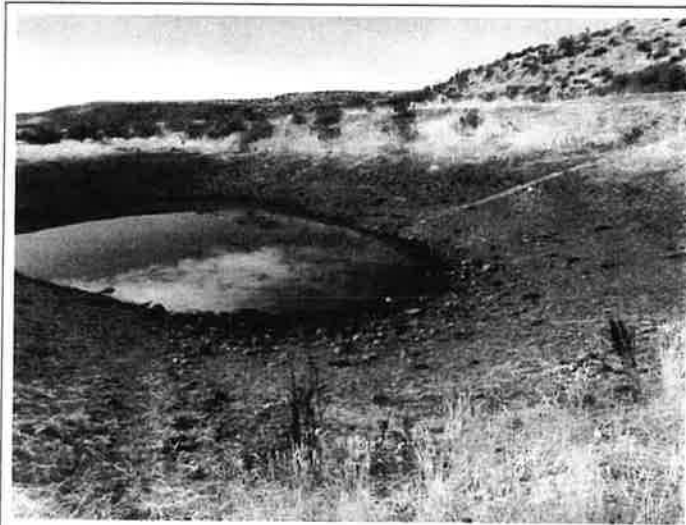
**Picture 1**

This pond is pictured on the DRG maps which  
could indicate that this pond represents a natural  
low spot in the topography. No dam was  
constructed at this site.

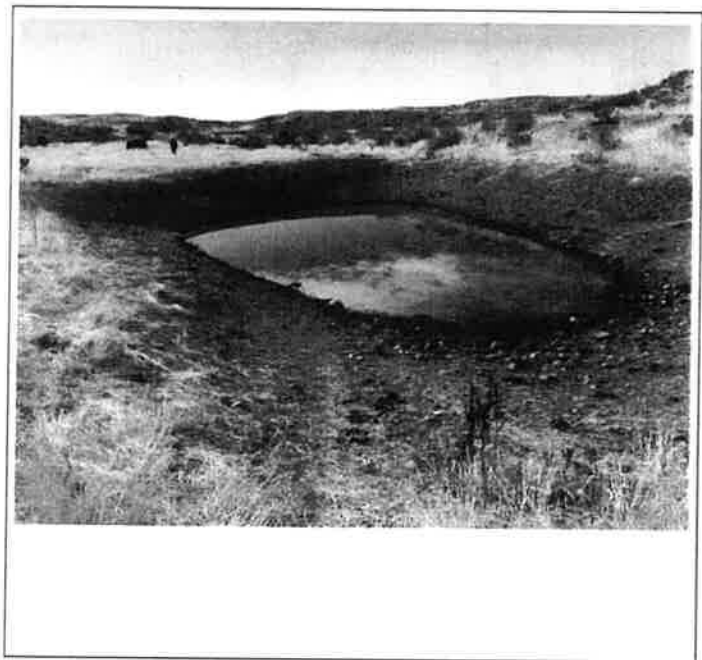
**Picture 2**

Conclusion is this pond appears to be a natural  
feature and does not require a water right filing.

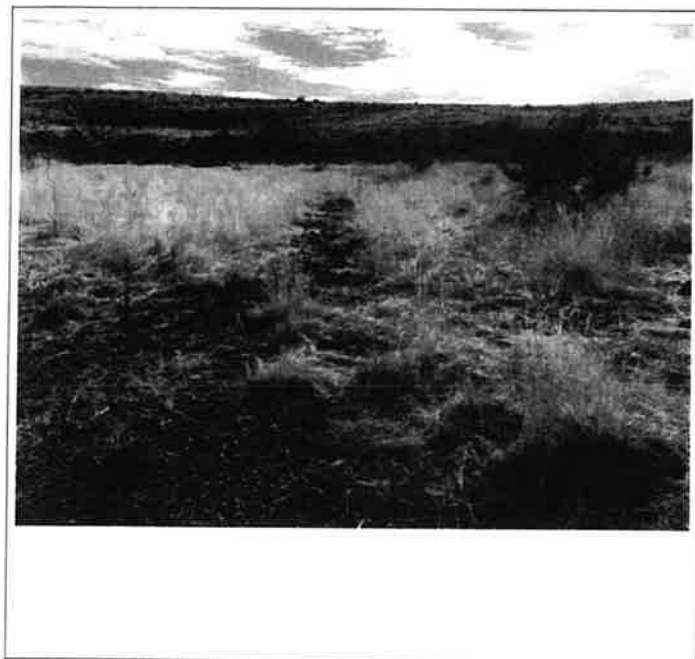
**Picture 3**

This photo shows a channel to the east of the pond.

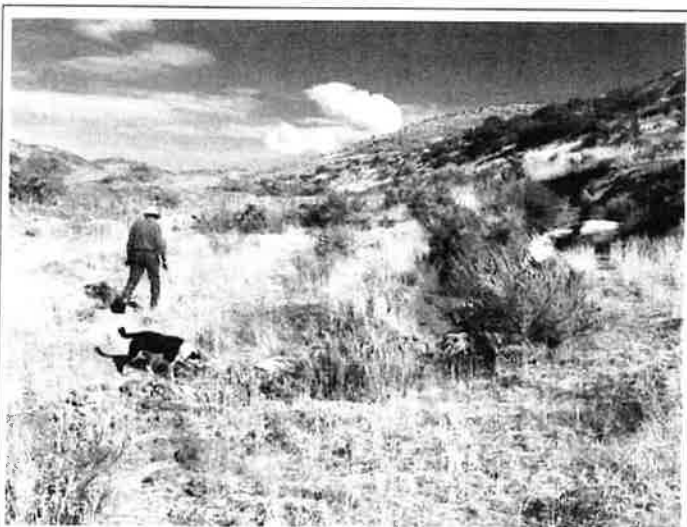
**Picture 4**

This photo is looking to the north. The dam's spillway is to the east. Note the channel downstream of the spillway.

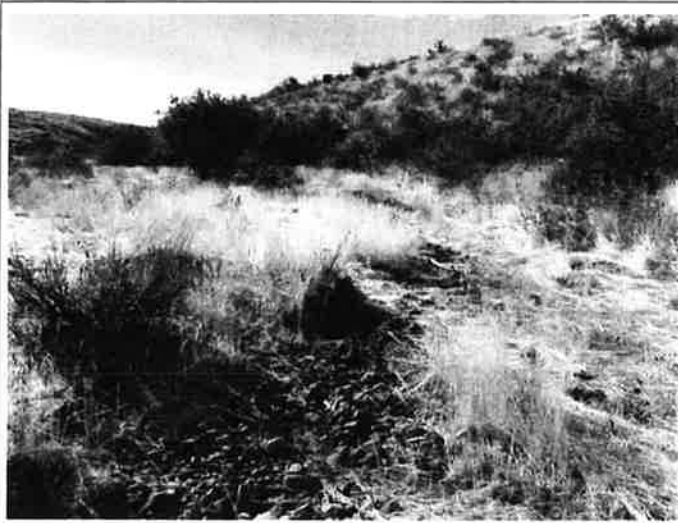
**Picture 5**

Note that the channel discharges into the pond to the south (Pond #15).

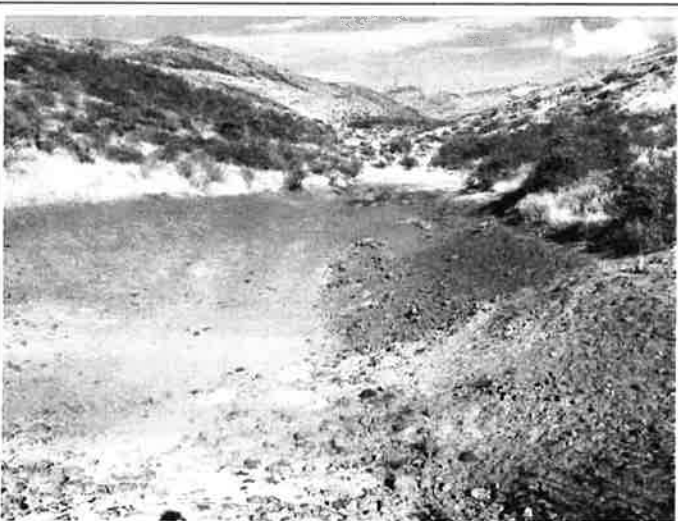
**Picture 6**

| 16 Scott | Yes | 18 | 0.13 | 0.9 | 9/26/2017 | Visibly within a defined channel. This is a constructed pond with a dam. No water in pond upon inspection. |

From the bottom of the pond to the spillway, a measurement of 18' was made. This impoundment appears to require a water right.

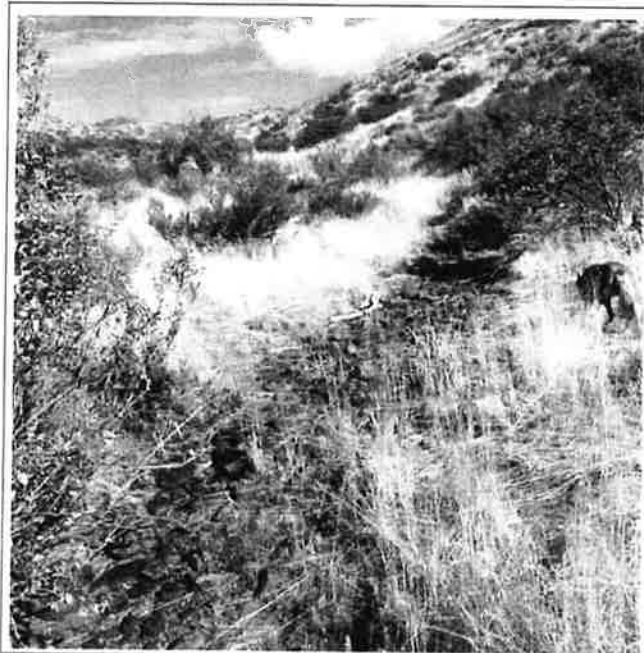
**Picture 7**

Defined channel present.

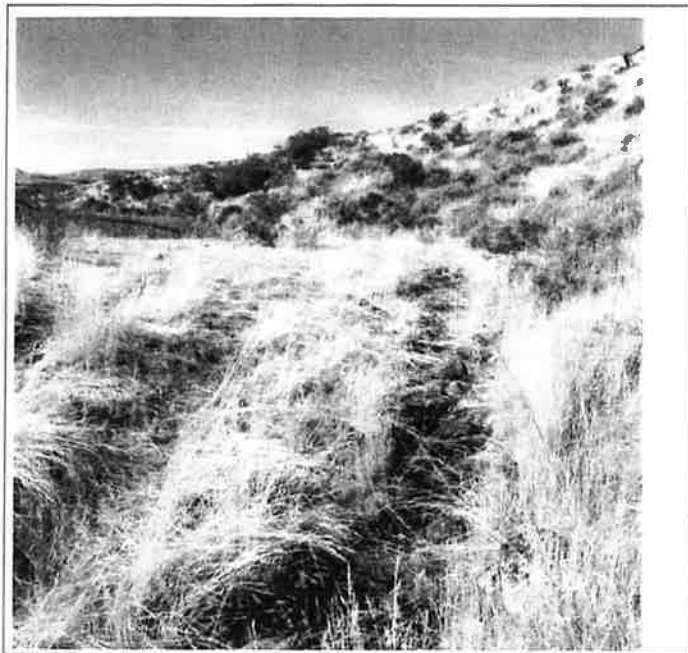
**Picture 9**

Walking the channel from Pond #16 to #15.

There are cobbles in the natural channel in between the two ponds.

According to Eckhardt, when water is flowing, it makes it to Scott Creek.

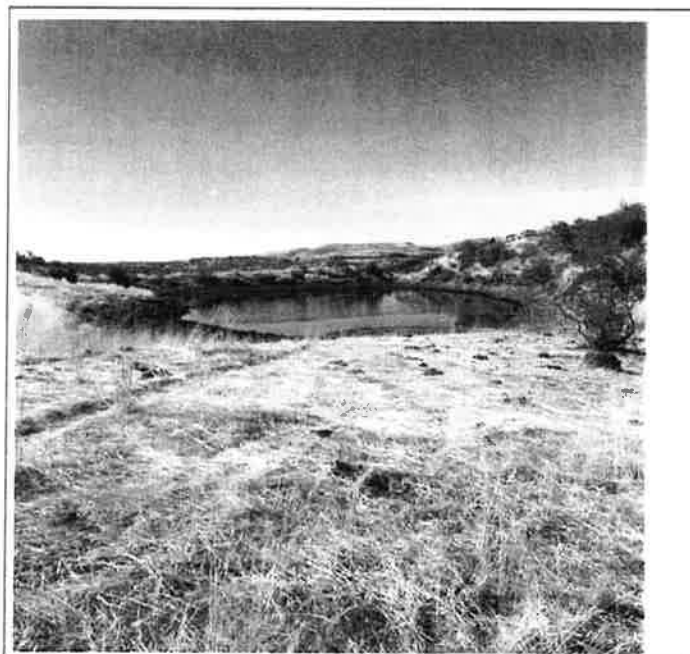
**Picture 10**

Water discharges from this pond from the southwestern corner of the pond. The pond discharges into the unnumbered pond. This pond is nearly full, maybe a foot away from spilling down the channel. This pond is spring fed and is present on the DRG map. It doesn't look like a water right is required for this pond.

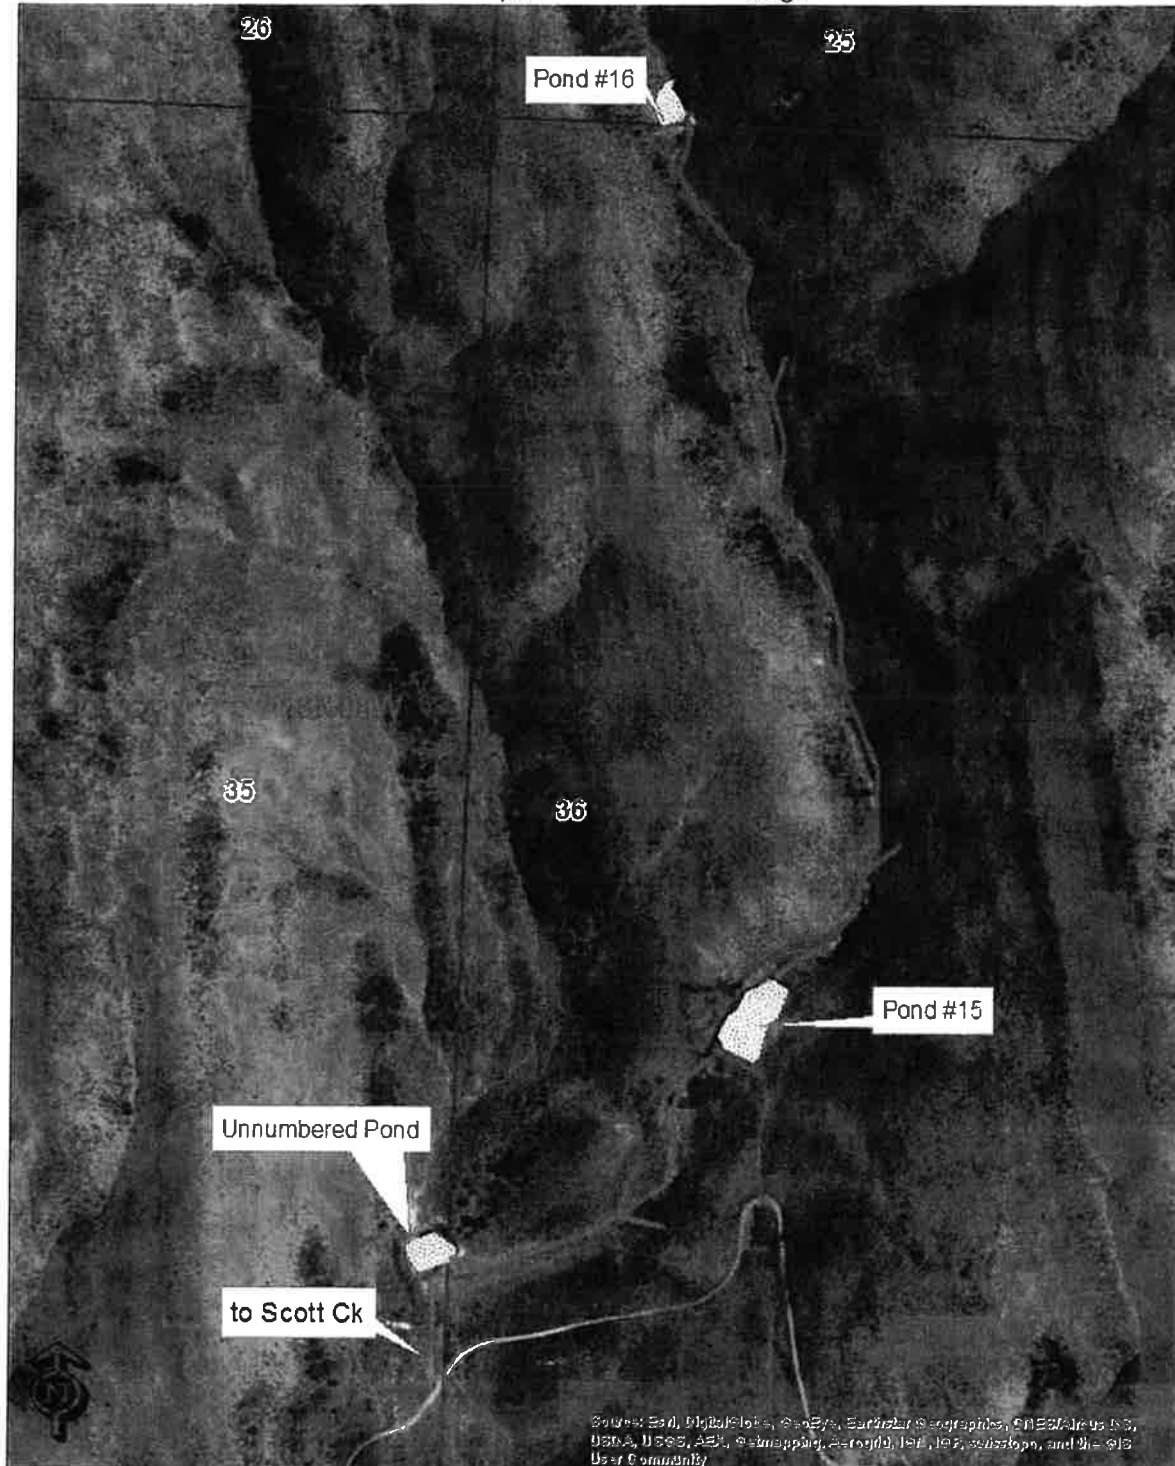
# Eckhardt pond on Scott Ck drainage

The blue line represents sections of a defined channel as depicted on the US Geological Survey topo Digital Raster Graphics (DRG) map. Historic DRG map shows water discharging in the depicted channel into Scott Creek.

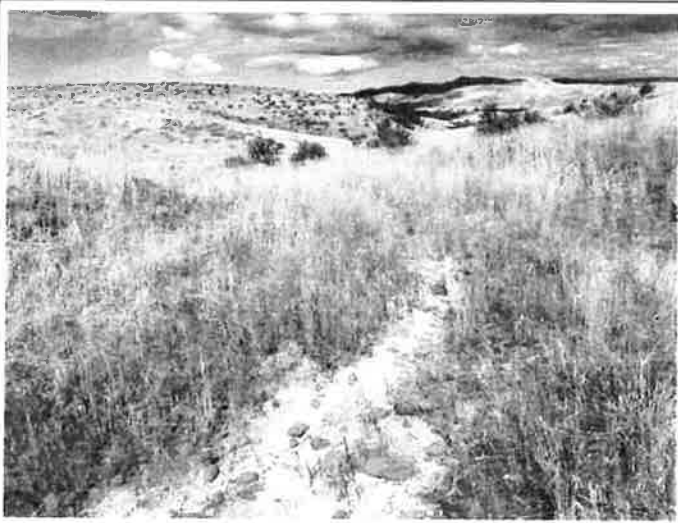
**Picture 3**

Comments:  
This channel goes off Eckhardt's property and  
appears to be part of the Monroe Creek drainage.

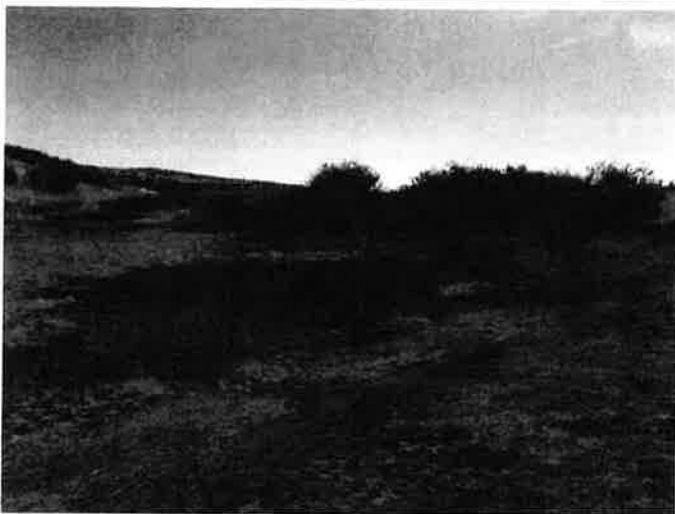
**Picture 4**

Comments:  
This pic shows the dam and a discharge  
standpipe.

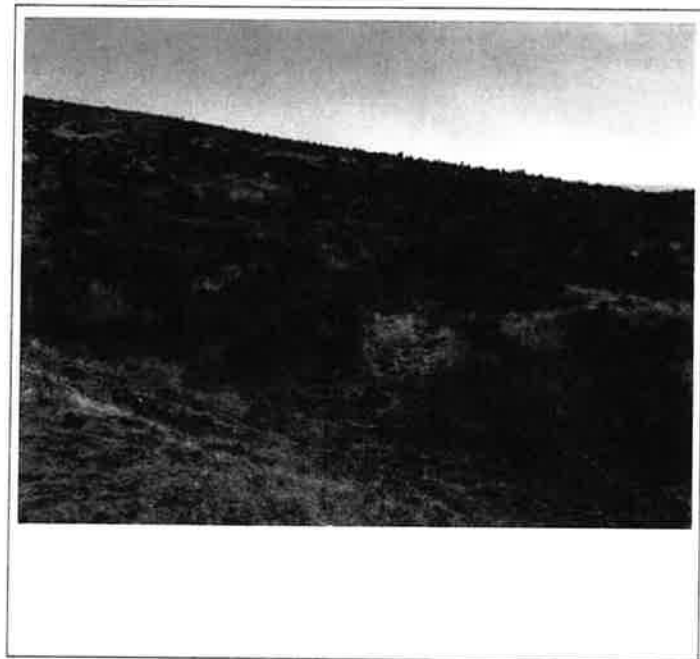
**Picture 9**

Can see evidence of a channel

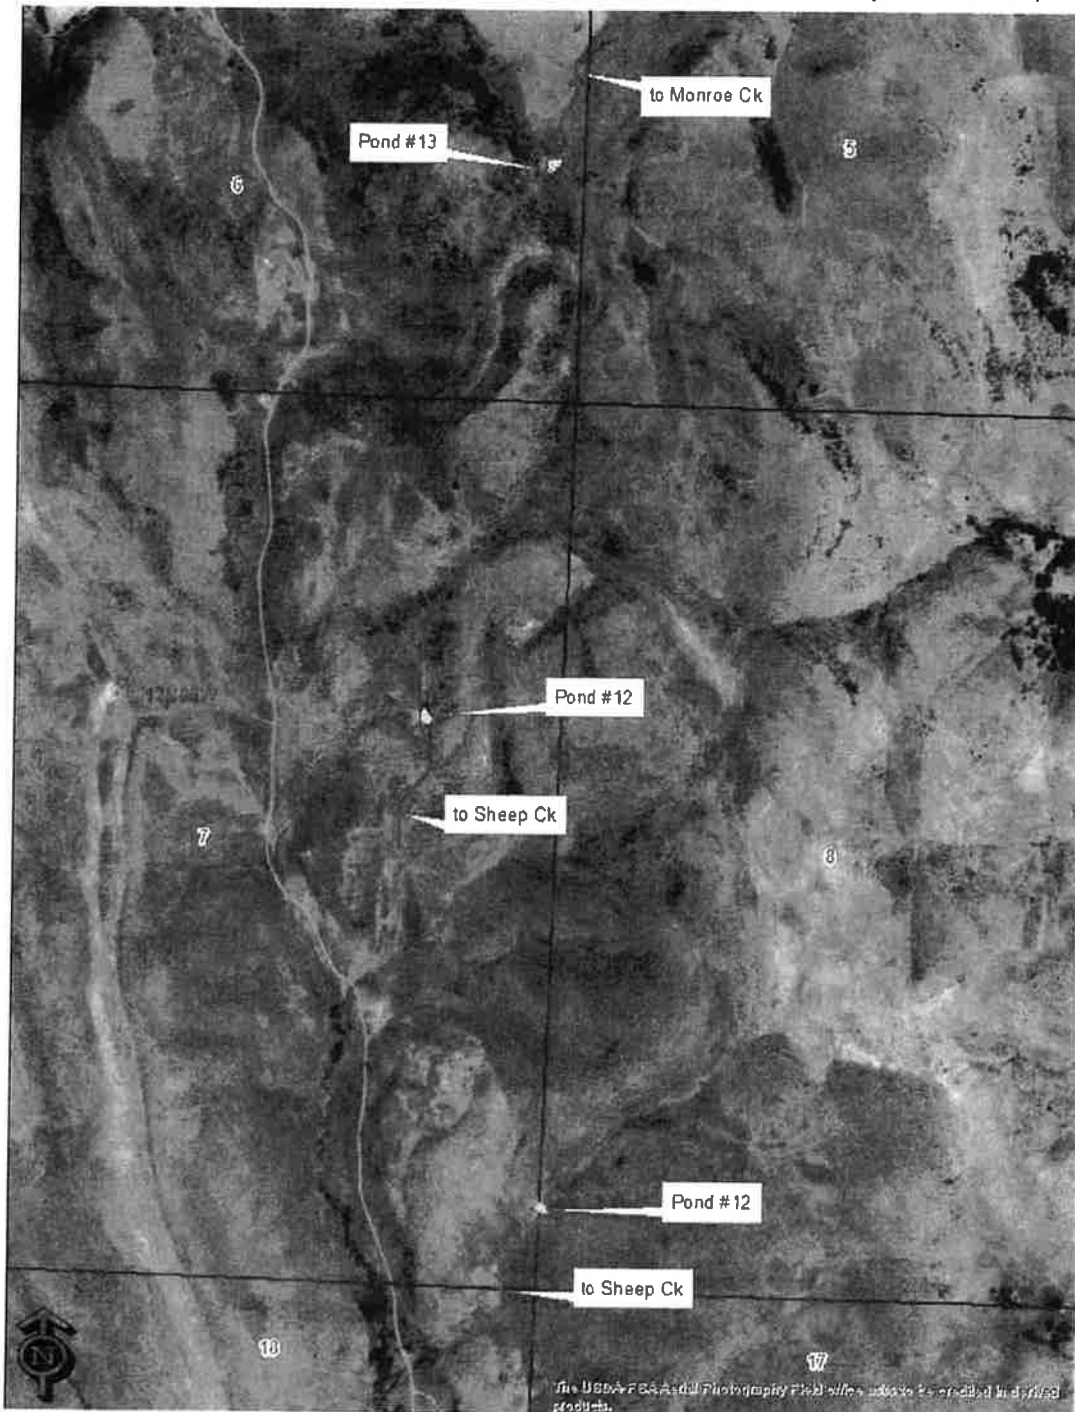
Eckhardt's ponds on Sheep Ck/Monroe Ck drainage (Sheep Ck is tributary to Monroe Ck)

The blue line represents sections of a defined channel as depicted on the US Geological Survey topo Digital Raster Graphics (DRG) map. The pink lines represent channels that appear to be constructed. Drainage from Sheep Ck moves to the south and drainage from Monroe Ck moves to the north.
