# IDAHO DEPARTMENT OF WATER RESOURCES

## --- DAM SAFETY RECORD OF INSPECTION ---

Name of Dam: Jenkins Creek

Date: 9/17/2018

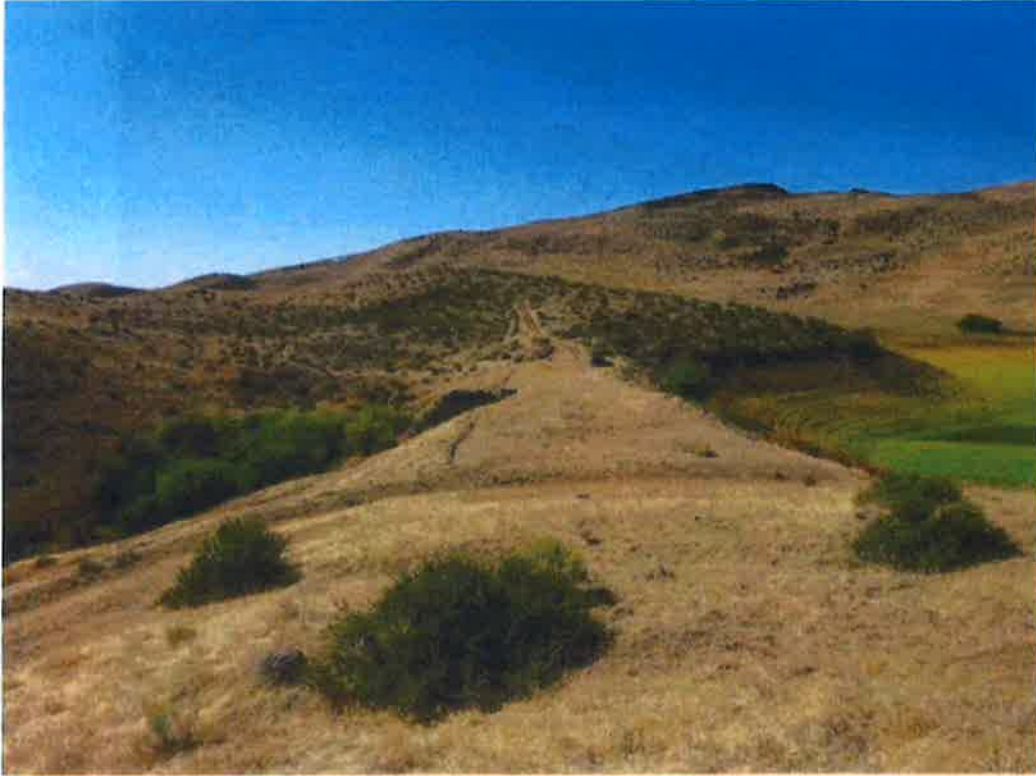
- Crest: Relatively wide; width is approximately 60 feet.
- DS Slope: Covered with dense grass and weeds with woody vegetation in the area above/around the outlet.

**Photo 1: Jenkins Creek dam as viewed from above on the left abutment; note wide crest width.**

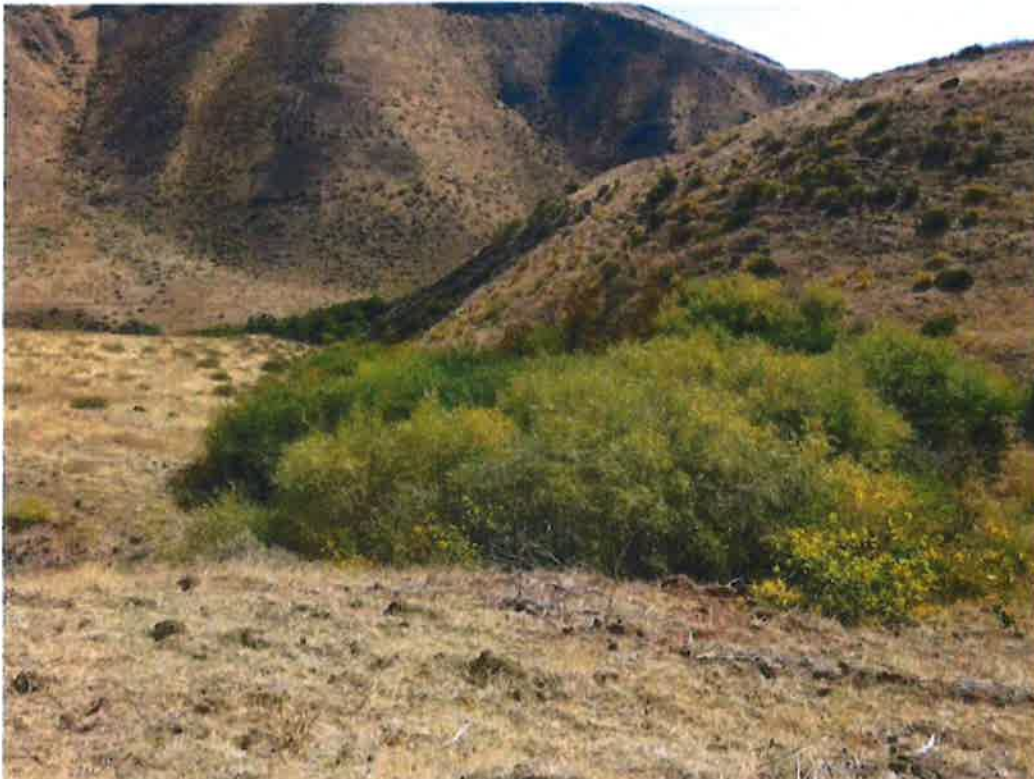
**Photo 2: Downstream drainage as viewed from dam crest.**

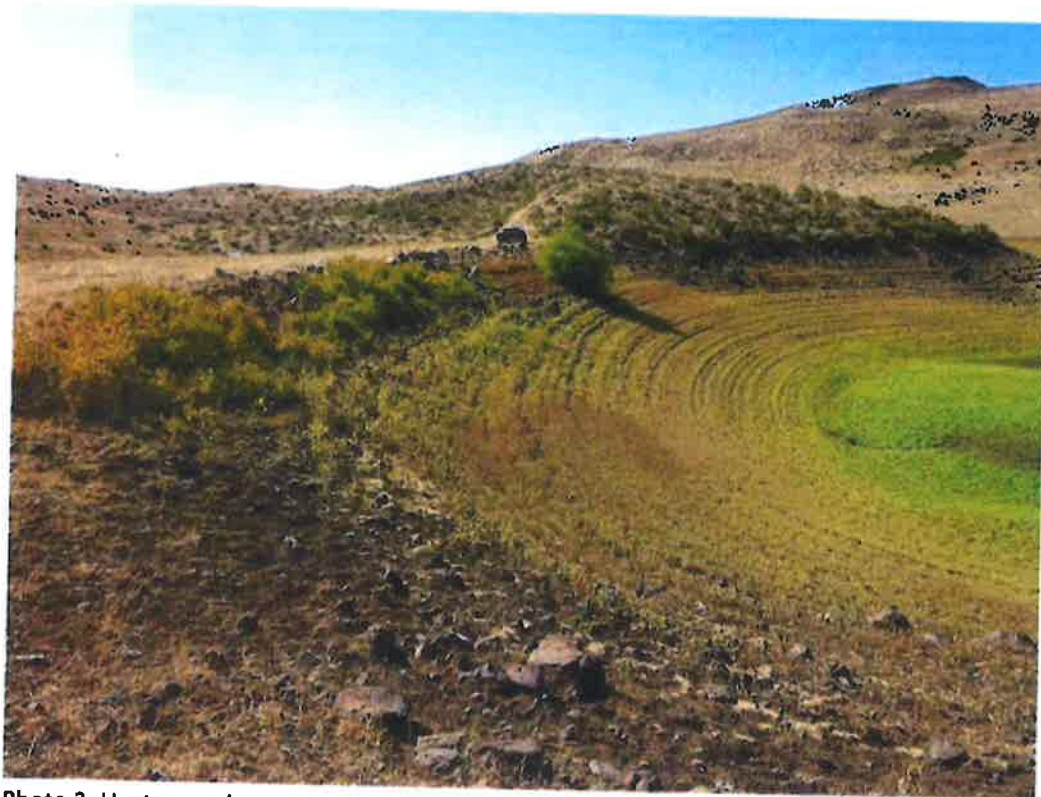
- US Slope: Minor benching erosion at numerous elevations as the pool level dropped over the course of the irrigation season. Dense growth of weeds carpet the slope.

Photo 3: Upstream slope; note minor amount woody vegetation.

Recommend dam owner (1) remove all woody vegetation from the embankment, especially around the outlet at the toe of the dam, (2) eradicate all burrowing animals and repair existing burrows, and (3) monitor the historical leak described above, especially when filling, look for significant changes in flow, color or accumulation of material.

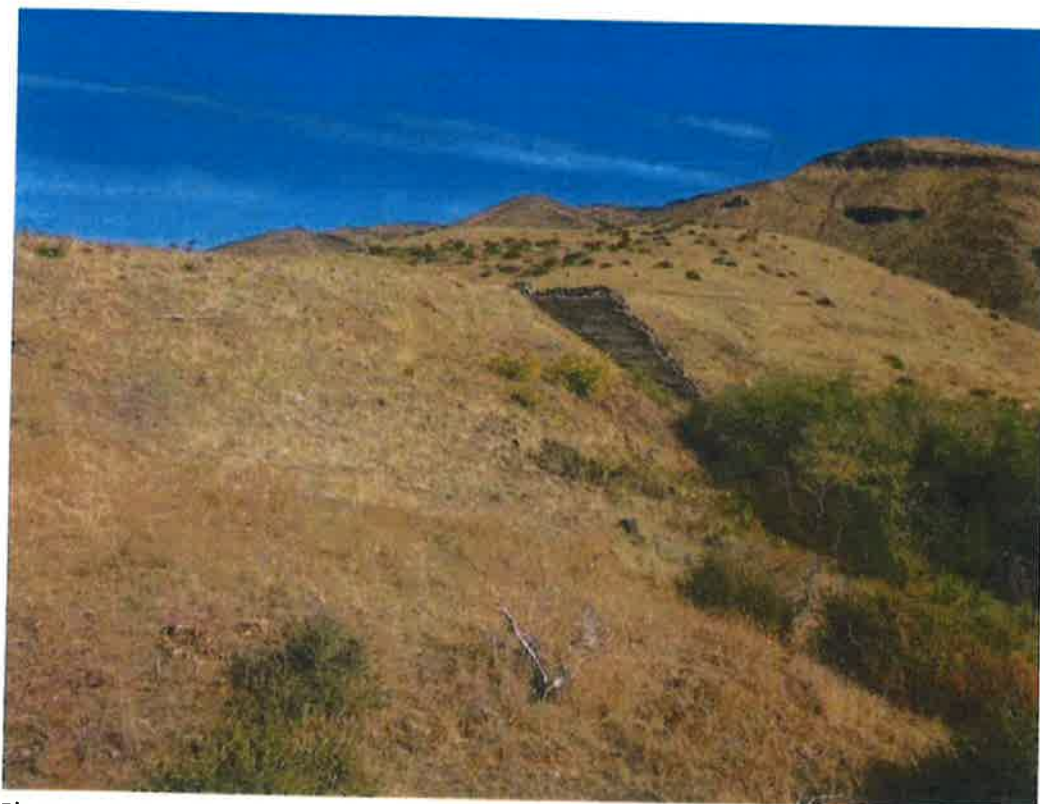
- DS Toe: Dense woody vegetation obscures ability to visually inspect the outlet.
- Leak: the historical leak near the right downstream groin and toe of embankment appeared as a seep (small amount of pooling water) with no flow. Noteworthy since the reservoir was dry. The general consensus from previous inspections going back to when the dam was first constructed is that the leak (1) appears to flow between embankment material and the basalt outcrop it abuts, (2) flows clear, (3) flowrate increases with pool level, up to ~100 gpm.

Photo 4: Downstream slope; note outlet at toe of dam is obscured by the visible woody vegetation.

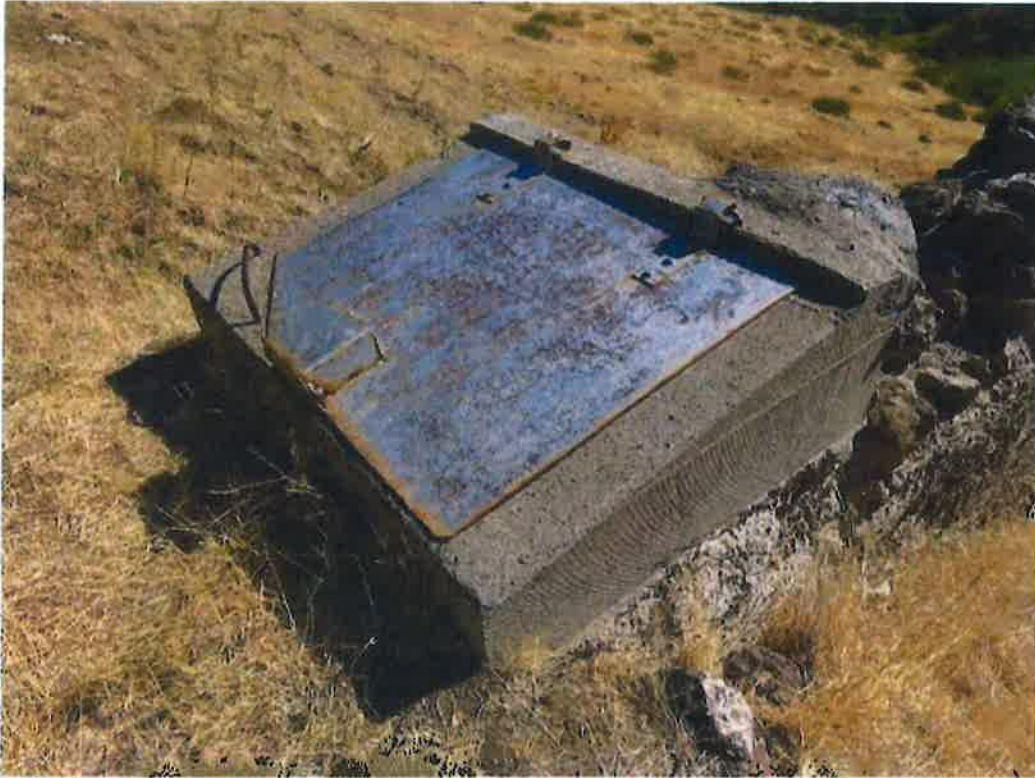
- No flows, reservoir was dry.
- Concrete outlet controls are reportedly functional.
- Inlet structure was free and clear of debris.
- Outlet at toe of dam is obscured by dense growth of woody vegetation; recommend clearing out all of the vegetation to allow for visual inspection.
- Fair condition assessment based on above stated observations.

Photo 5: Outlet controls.

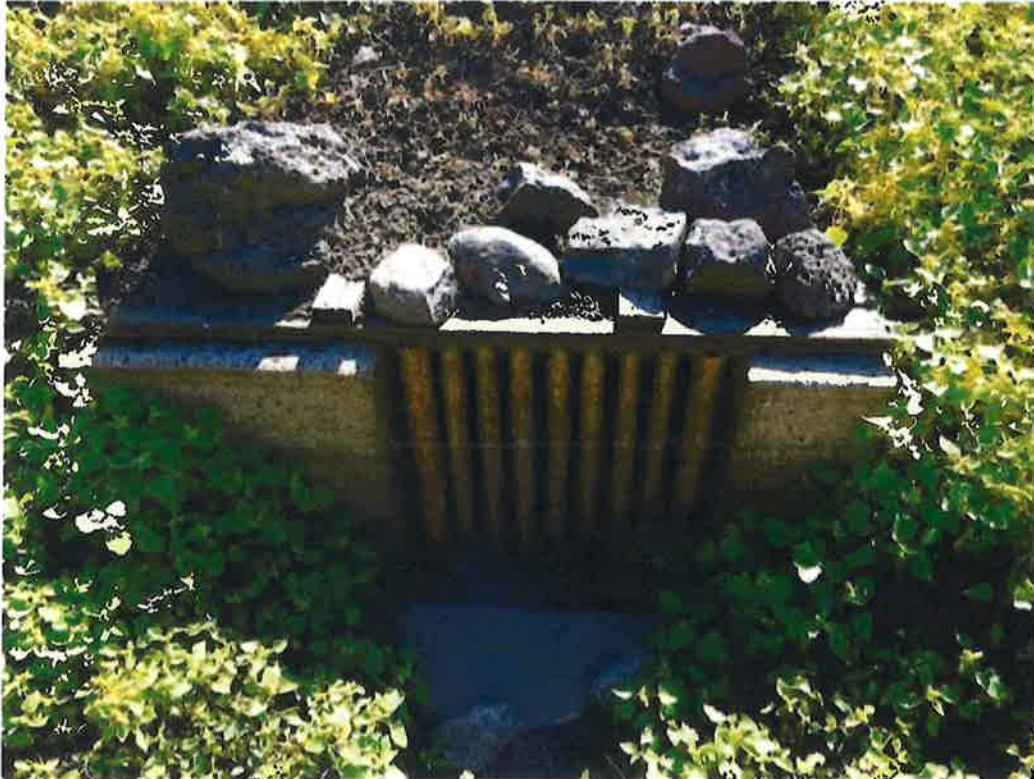
Photo 6: Inlet to outlet works; note free and clear of debris.

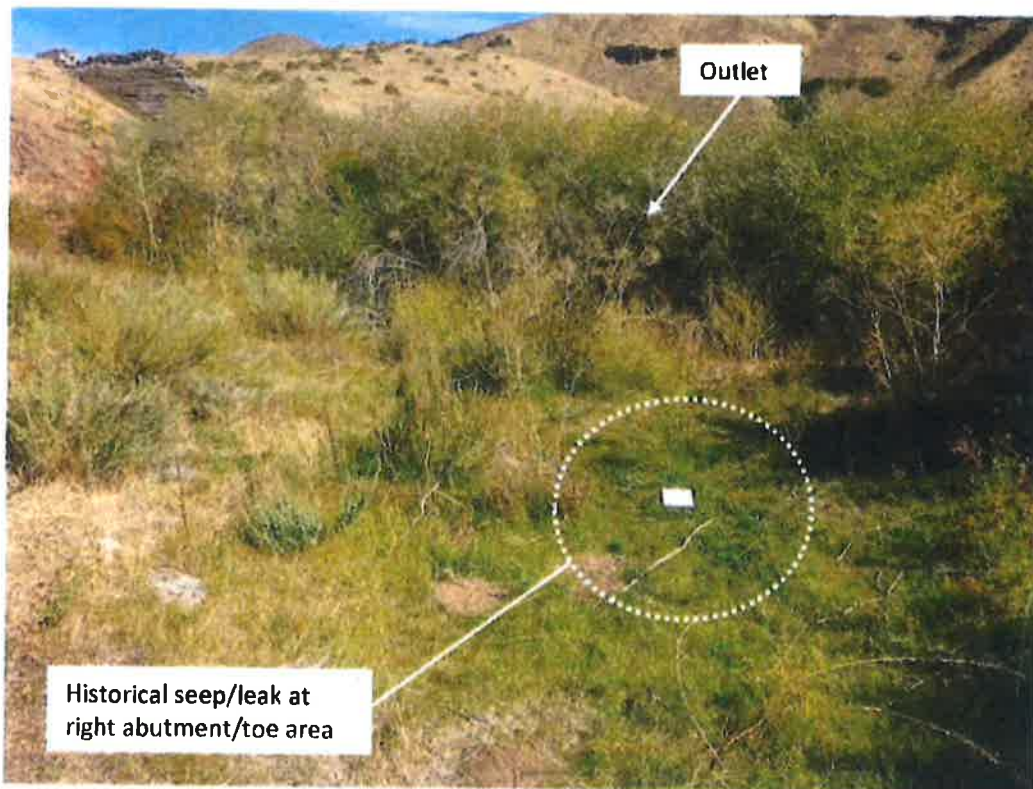
Photo 7: Outlet at toe of dam is obscured by woody vegetation; note location of historical seepage.

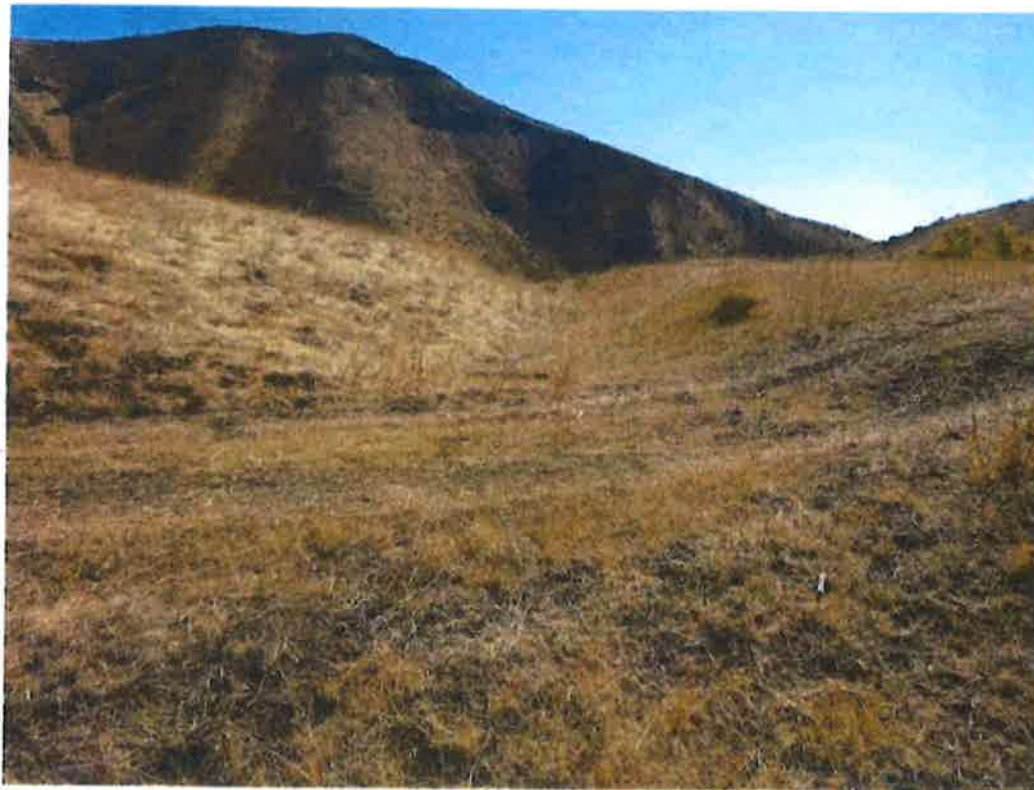
- Spillway is free and clear of debris.
- Spillway channel material appears erodible, but rarely used since the impoundment is situated off the main Jenkins Creek channel and filled via a canal diversion.
- Fair condition assessment based on above stated observations.

Photo 8: Open channel spillway located on left abutment.
