**Dam Safety Section**

**TRIP REPORT**

**TO:** John Falk, Dam Safety Program Manager  
**CC:** Lyle Swank, Eastern Region Office Manager  
**FROM:** Brian Normandeau, Eastern Region EIT  
**DATE:** 11/28/2017  
**SUBJECT:** Geddes Pond Hazard & Size Assessment

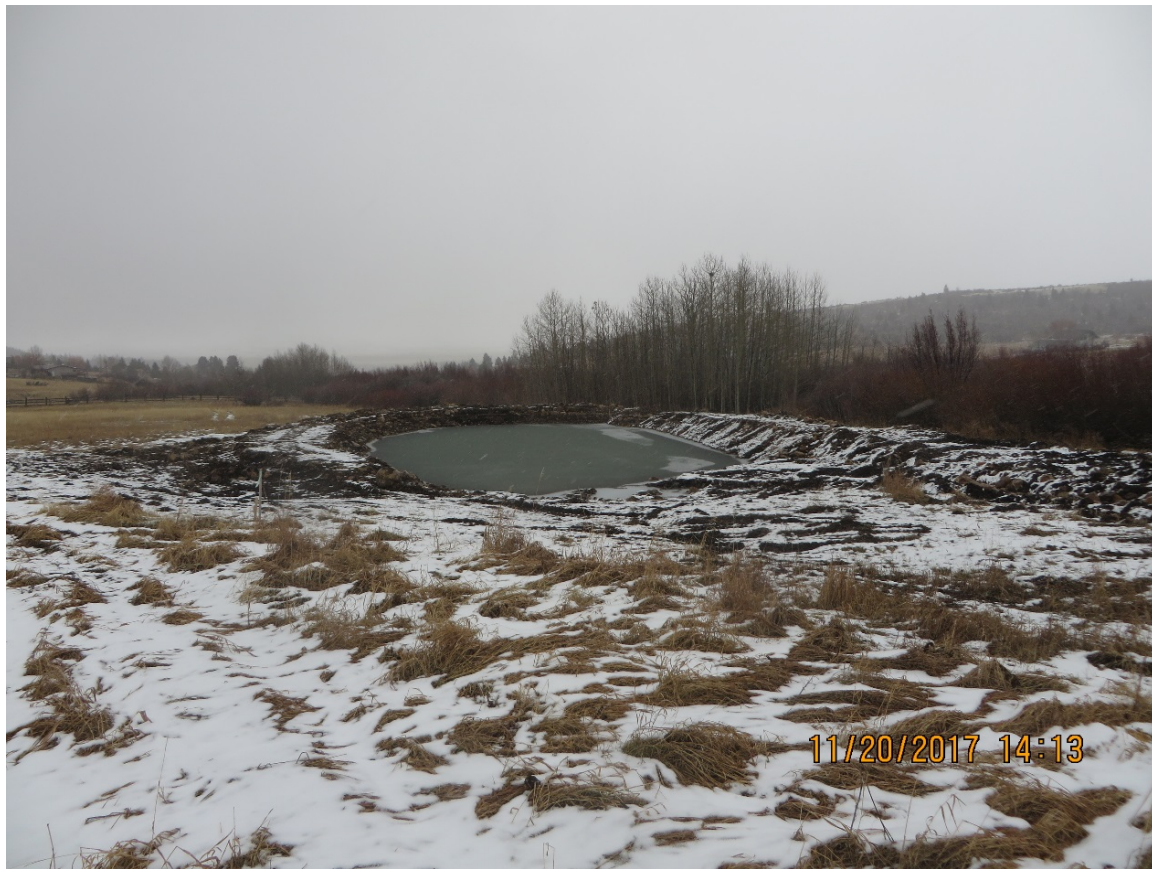
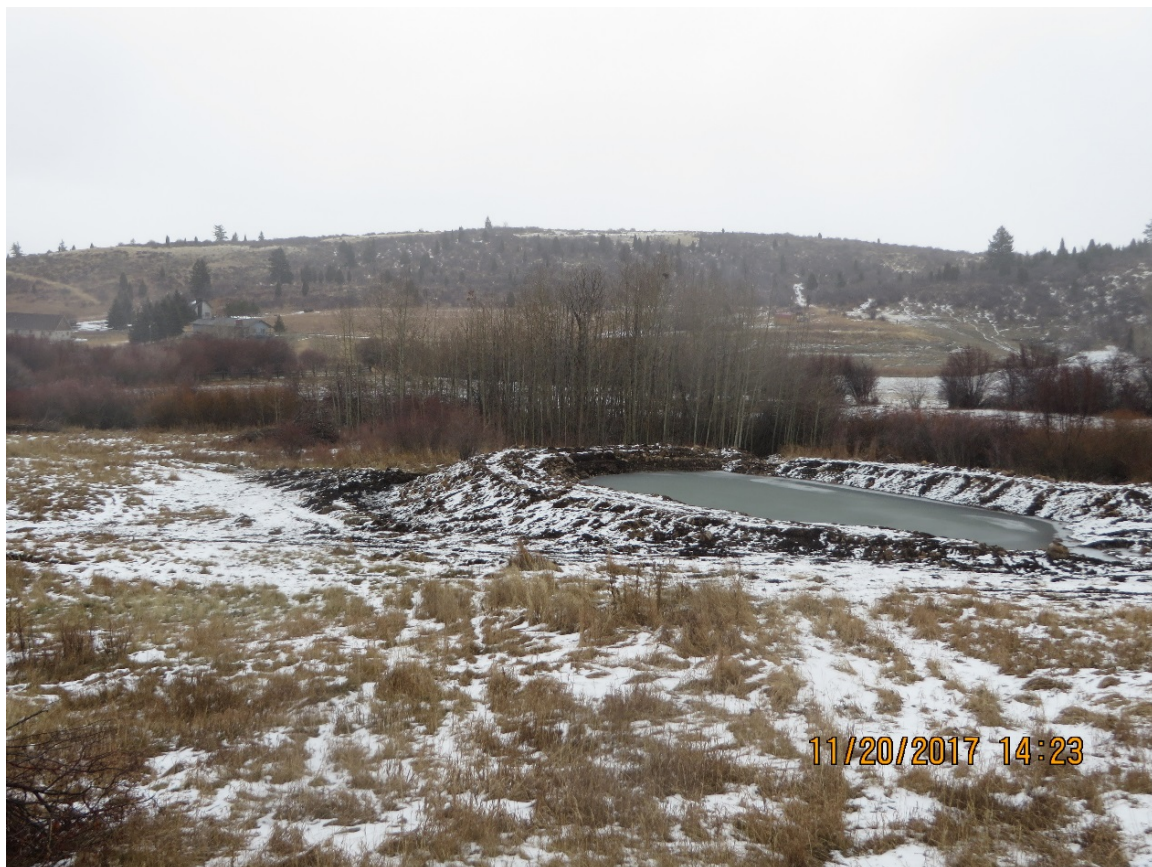
Photo 1a: Pond overview facing in a generally northeast direction.

Photo 1b: Pond overview facing in a generally northeast direction.

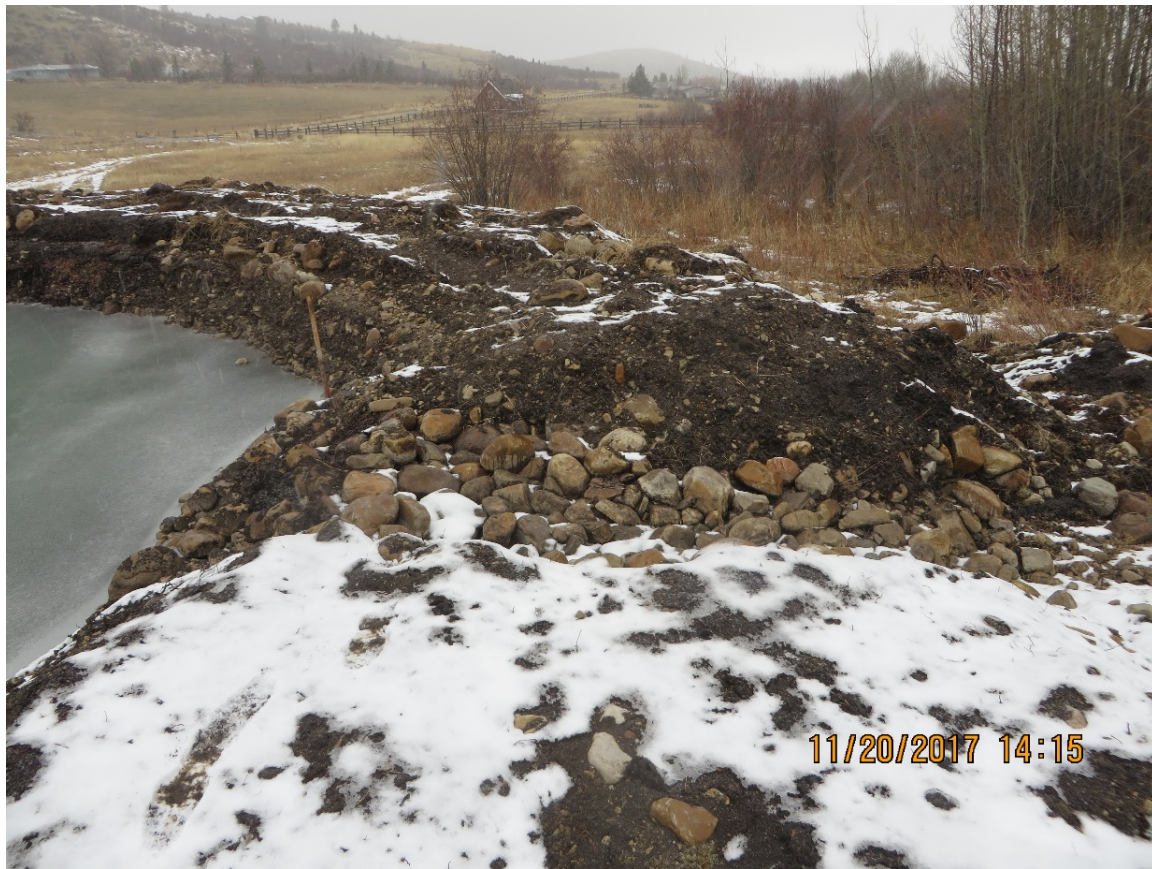
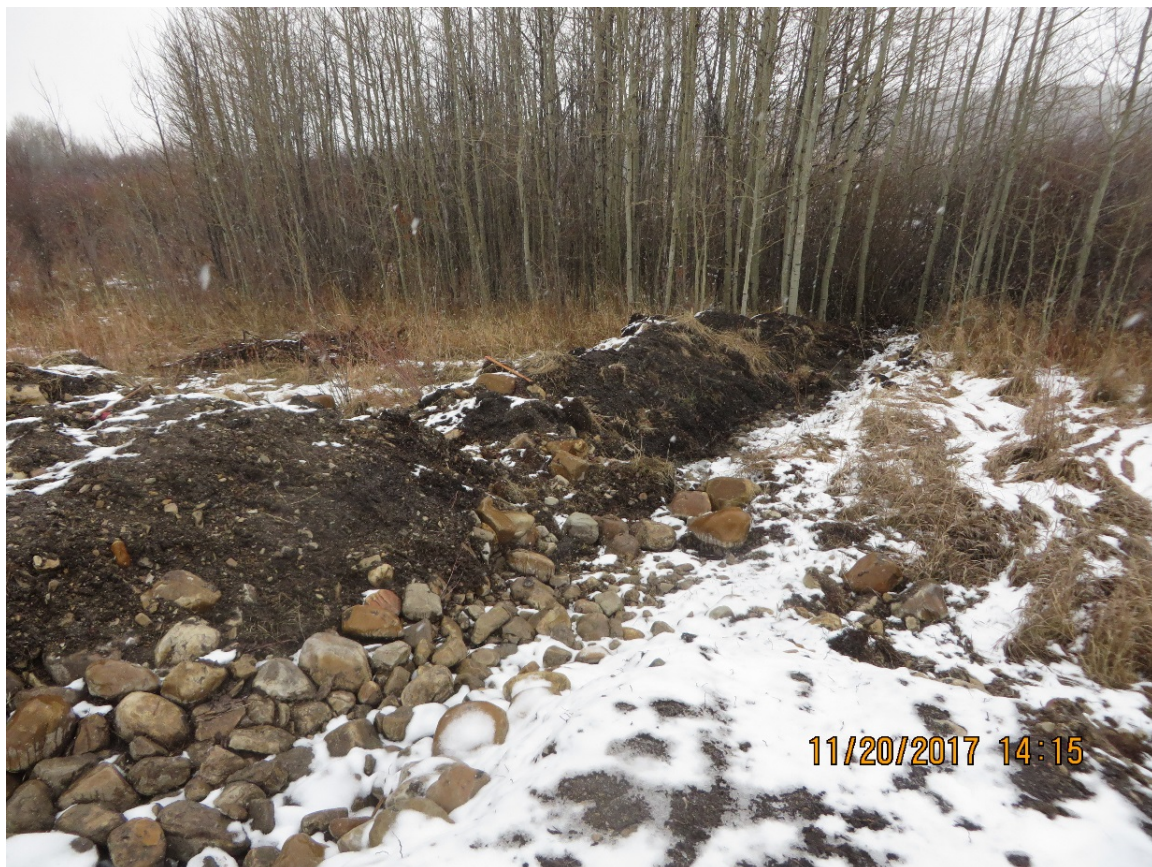
Photo 2a: Spillway channel towards the northeast end of the reservoir.

Photo 2b: Spillway channel towards the northeast end of the reservoir.

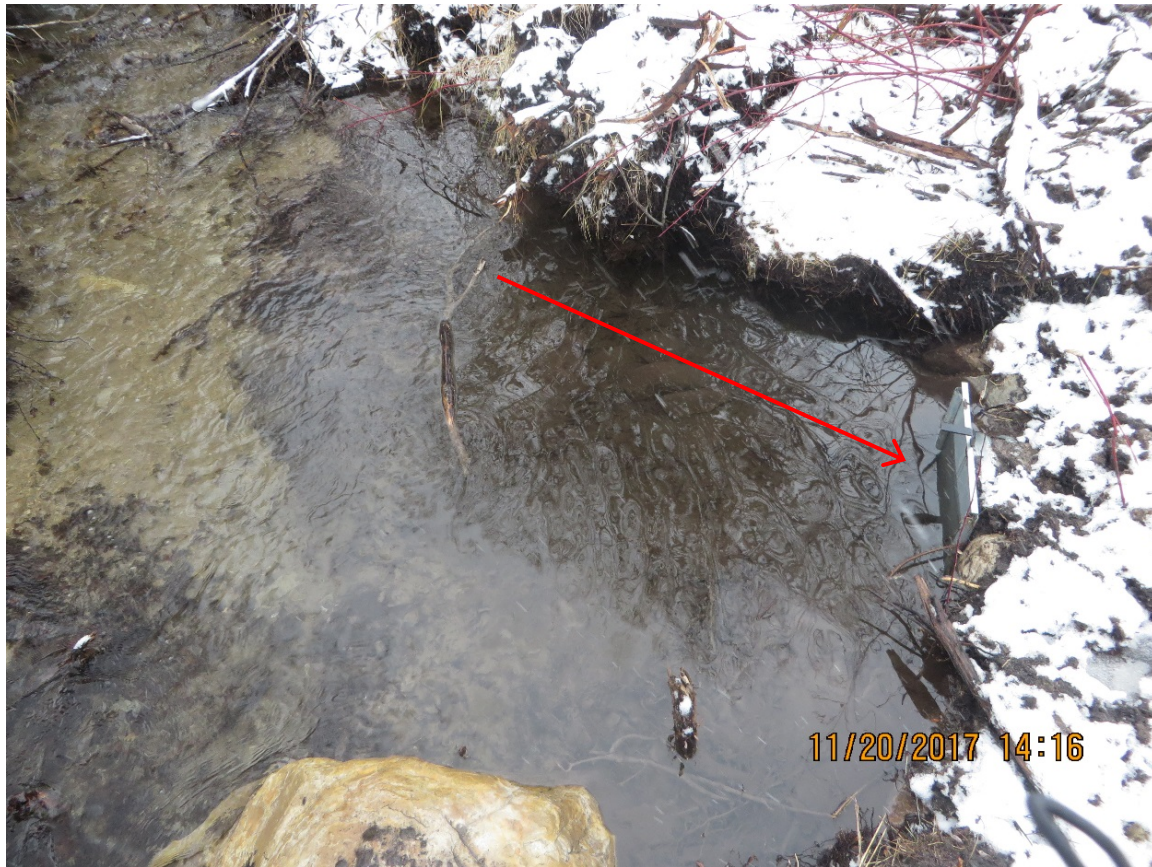
The reservoir is positioned slightly uphill to the west of Bailey Creek at 42.58205N, 111.57938W. The embankment appears to have been constructed using general fill material from the area surrounding it and a small borrow pit. Inflow to the pond is controlled by a 10" CMP culvert with a headgate (Photo 3). The water is diverted down a channel into the south end of the pond (Photo 4). All outflow is routed through an uncontrolled earthen channel spillway located towards the northeast end of the reservoir that returns to Bailey Creek (Photos 2a & 2b). At the time of the visit the inflow headgate was closed, and the water level was approximately 8 inches below the spillway crest. The dam height was estimated at 8 feet, with ~2 feet of freeboard. The size of the reservoir appears consistent with the storage volume allowed by the water right. Seepage was noted at the downstream toe, although the water appeared clear. A small channel had been dug to divert seepage away from the toe.

Photo 3: Inlet at Bailey Creek. Arrow points to inlet headgate.

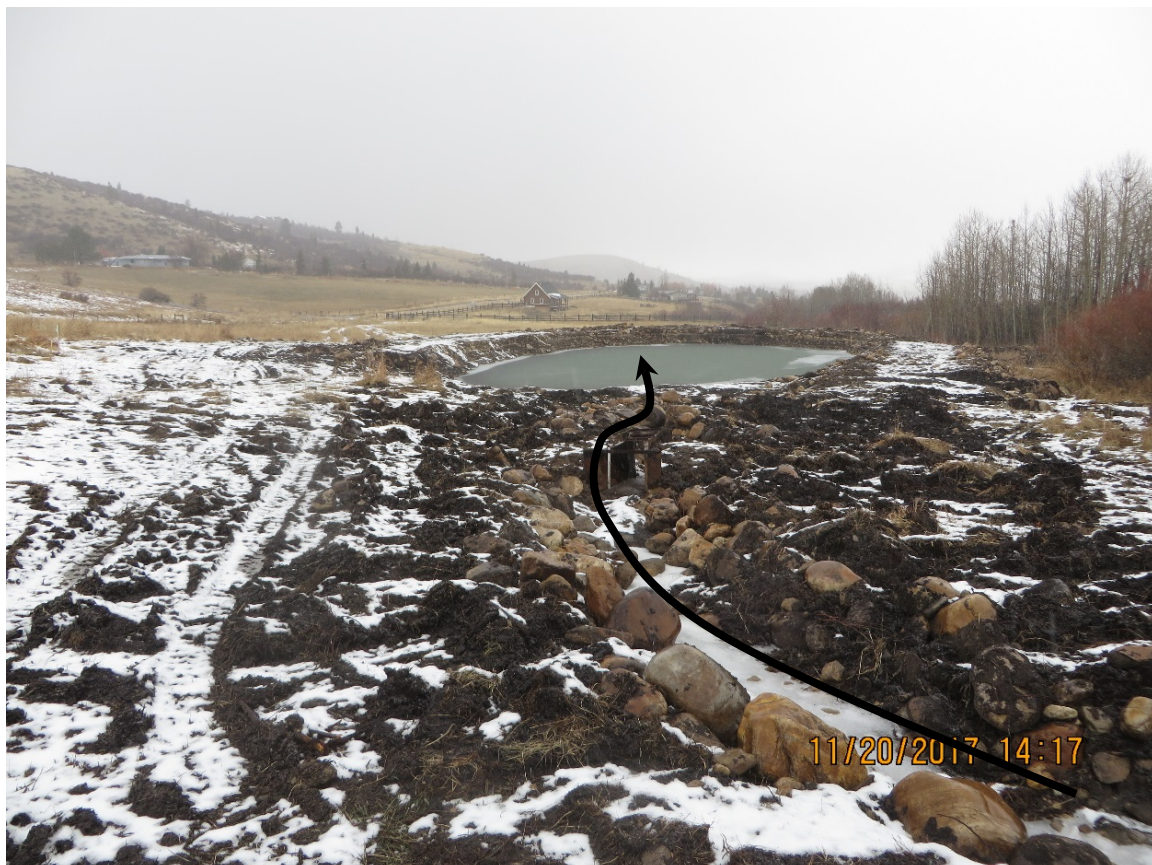
Photo 4: Inlet channel into pond.

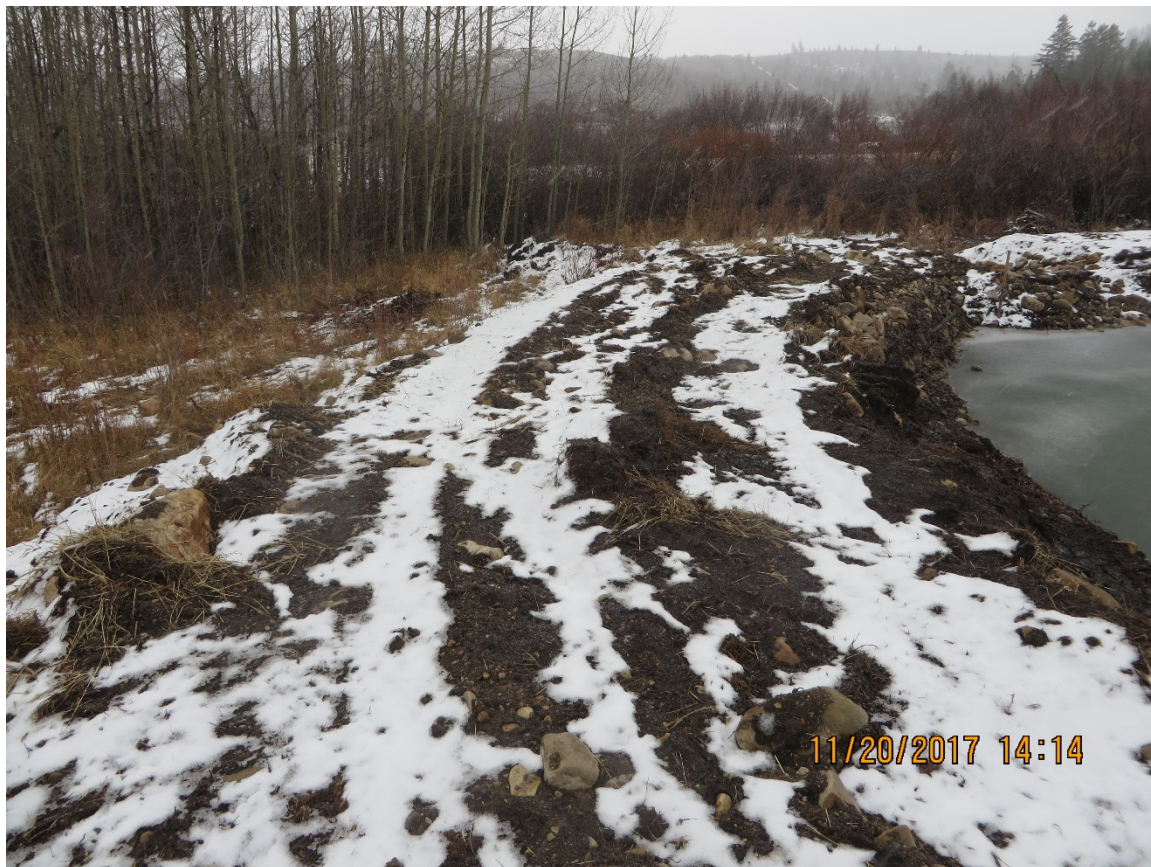
Photo 5: Typical view of the dam crest.

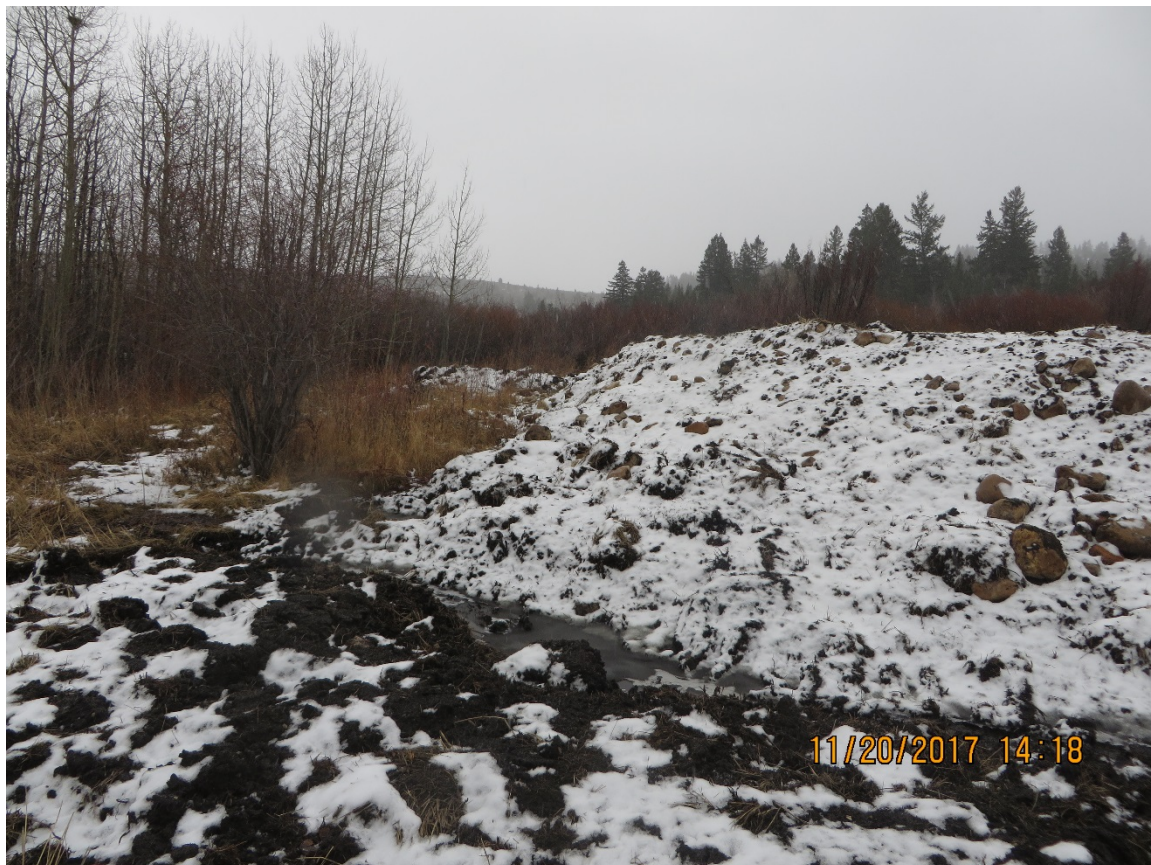
Photo 6: Downstream slope of the main embankment (north end), facing east.
