## DEPARTMENT OF WATER RESOURCES

### Memo to the File: Repair of the Mitchell Sorensen Well

On Friday, September 29, 2017 I witnessed the repair of the Mitchell Sorensen well located in Township 5 North, Range 26 East, Section 21 NE<sup>1/4</sup> NE<sup>1/4</sup>.

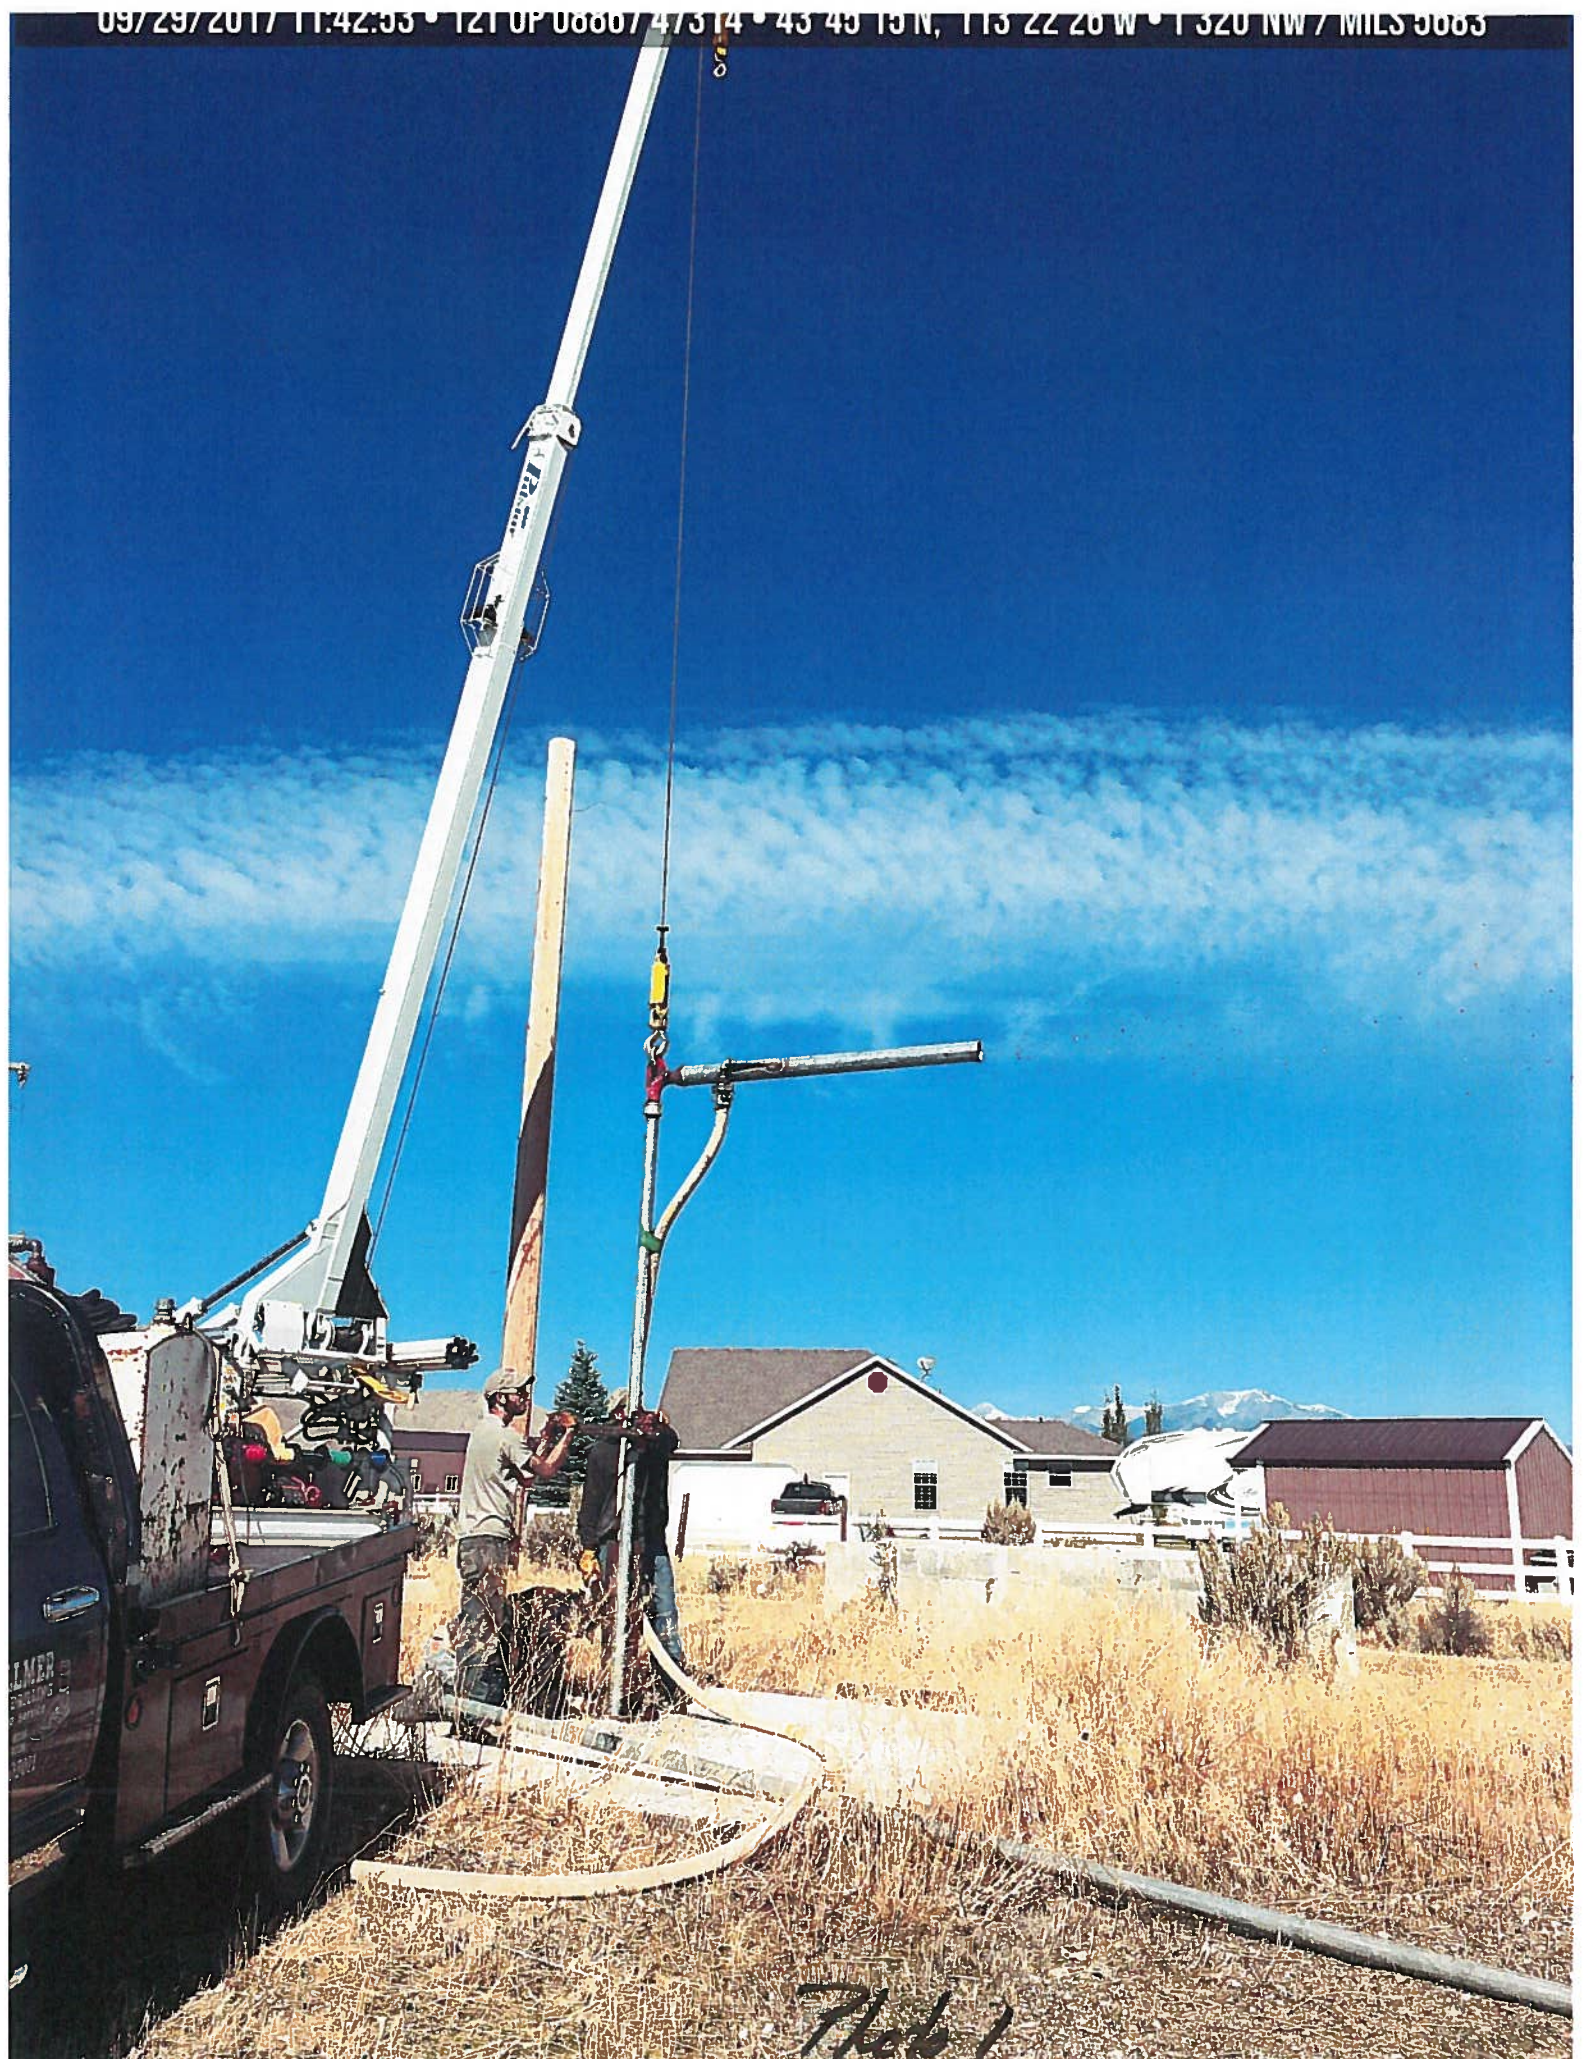
Photo 1

Vollmer Well Drilling designed and fabricated an air lift vacuum that could be inserted between the production string and surface string of casing to remove the crushed limestone aggregate between the two strings of casing. Using 900 cubic feet of air per minute and a 2.5 inch ID drop pipe the calculated up hole velocity is 1384 fps allowing the crushed limestone aggregate to be removed. The measured depth was forty two feet.

Photograph 1 shows the air jet in operation. Note the gravel exiting the pipe.

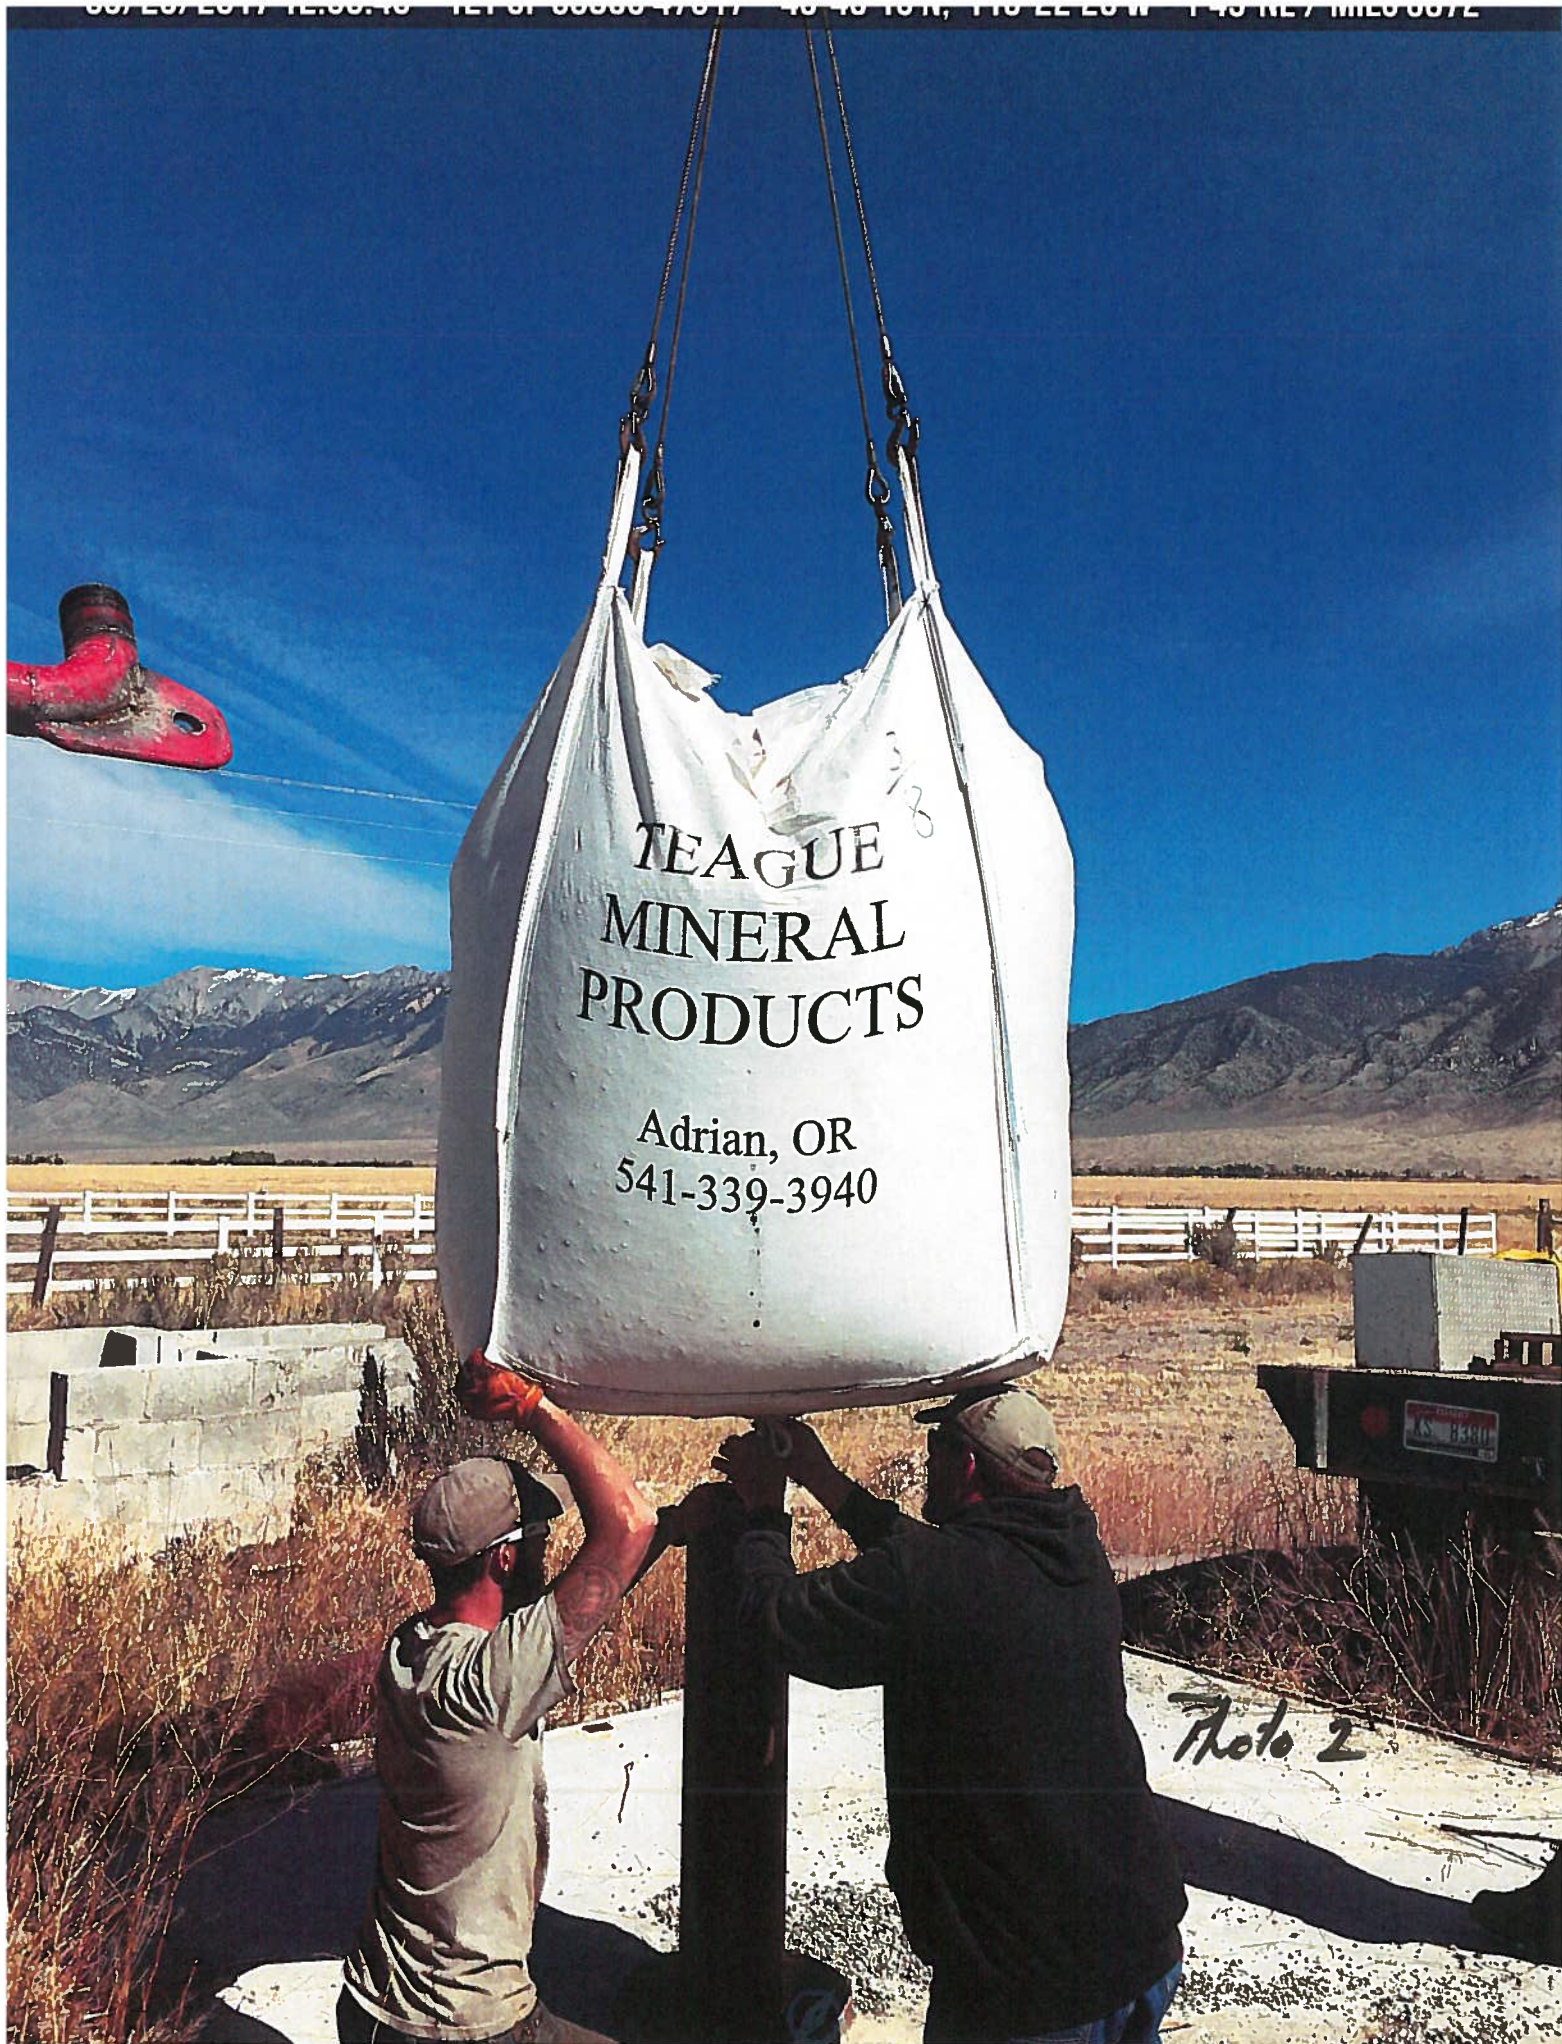
Photo 2

Photograph 2 shows the first yard of bentonite to be placed as a seal.

One and a quarter yards of 3/8 bentonite chips were placed between the surface casing from forty two feet up to a depth of two feet below the top of the surface casing. The top of the bentonite was hydrated with three gallons of water to prevent shocking the cement plug when it was placed. Four bags of cement were mixed with 24 gallons of water and this was placed in the remaining two feet of open hole.

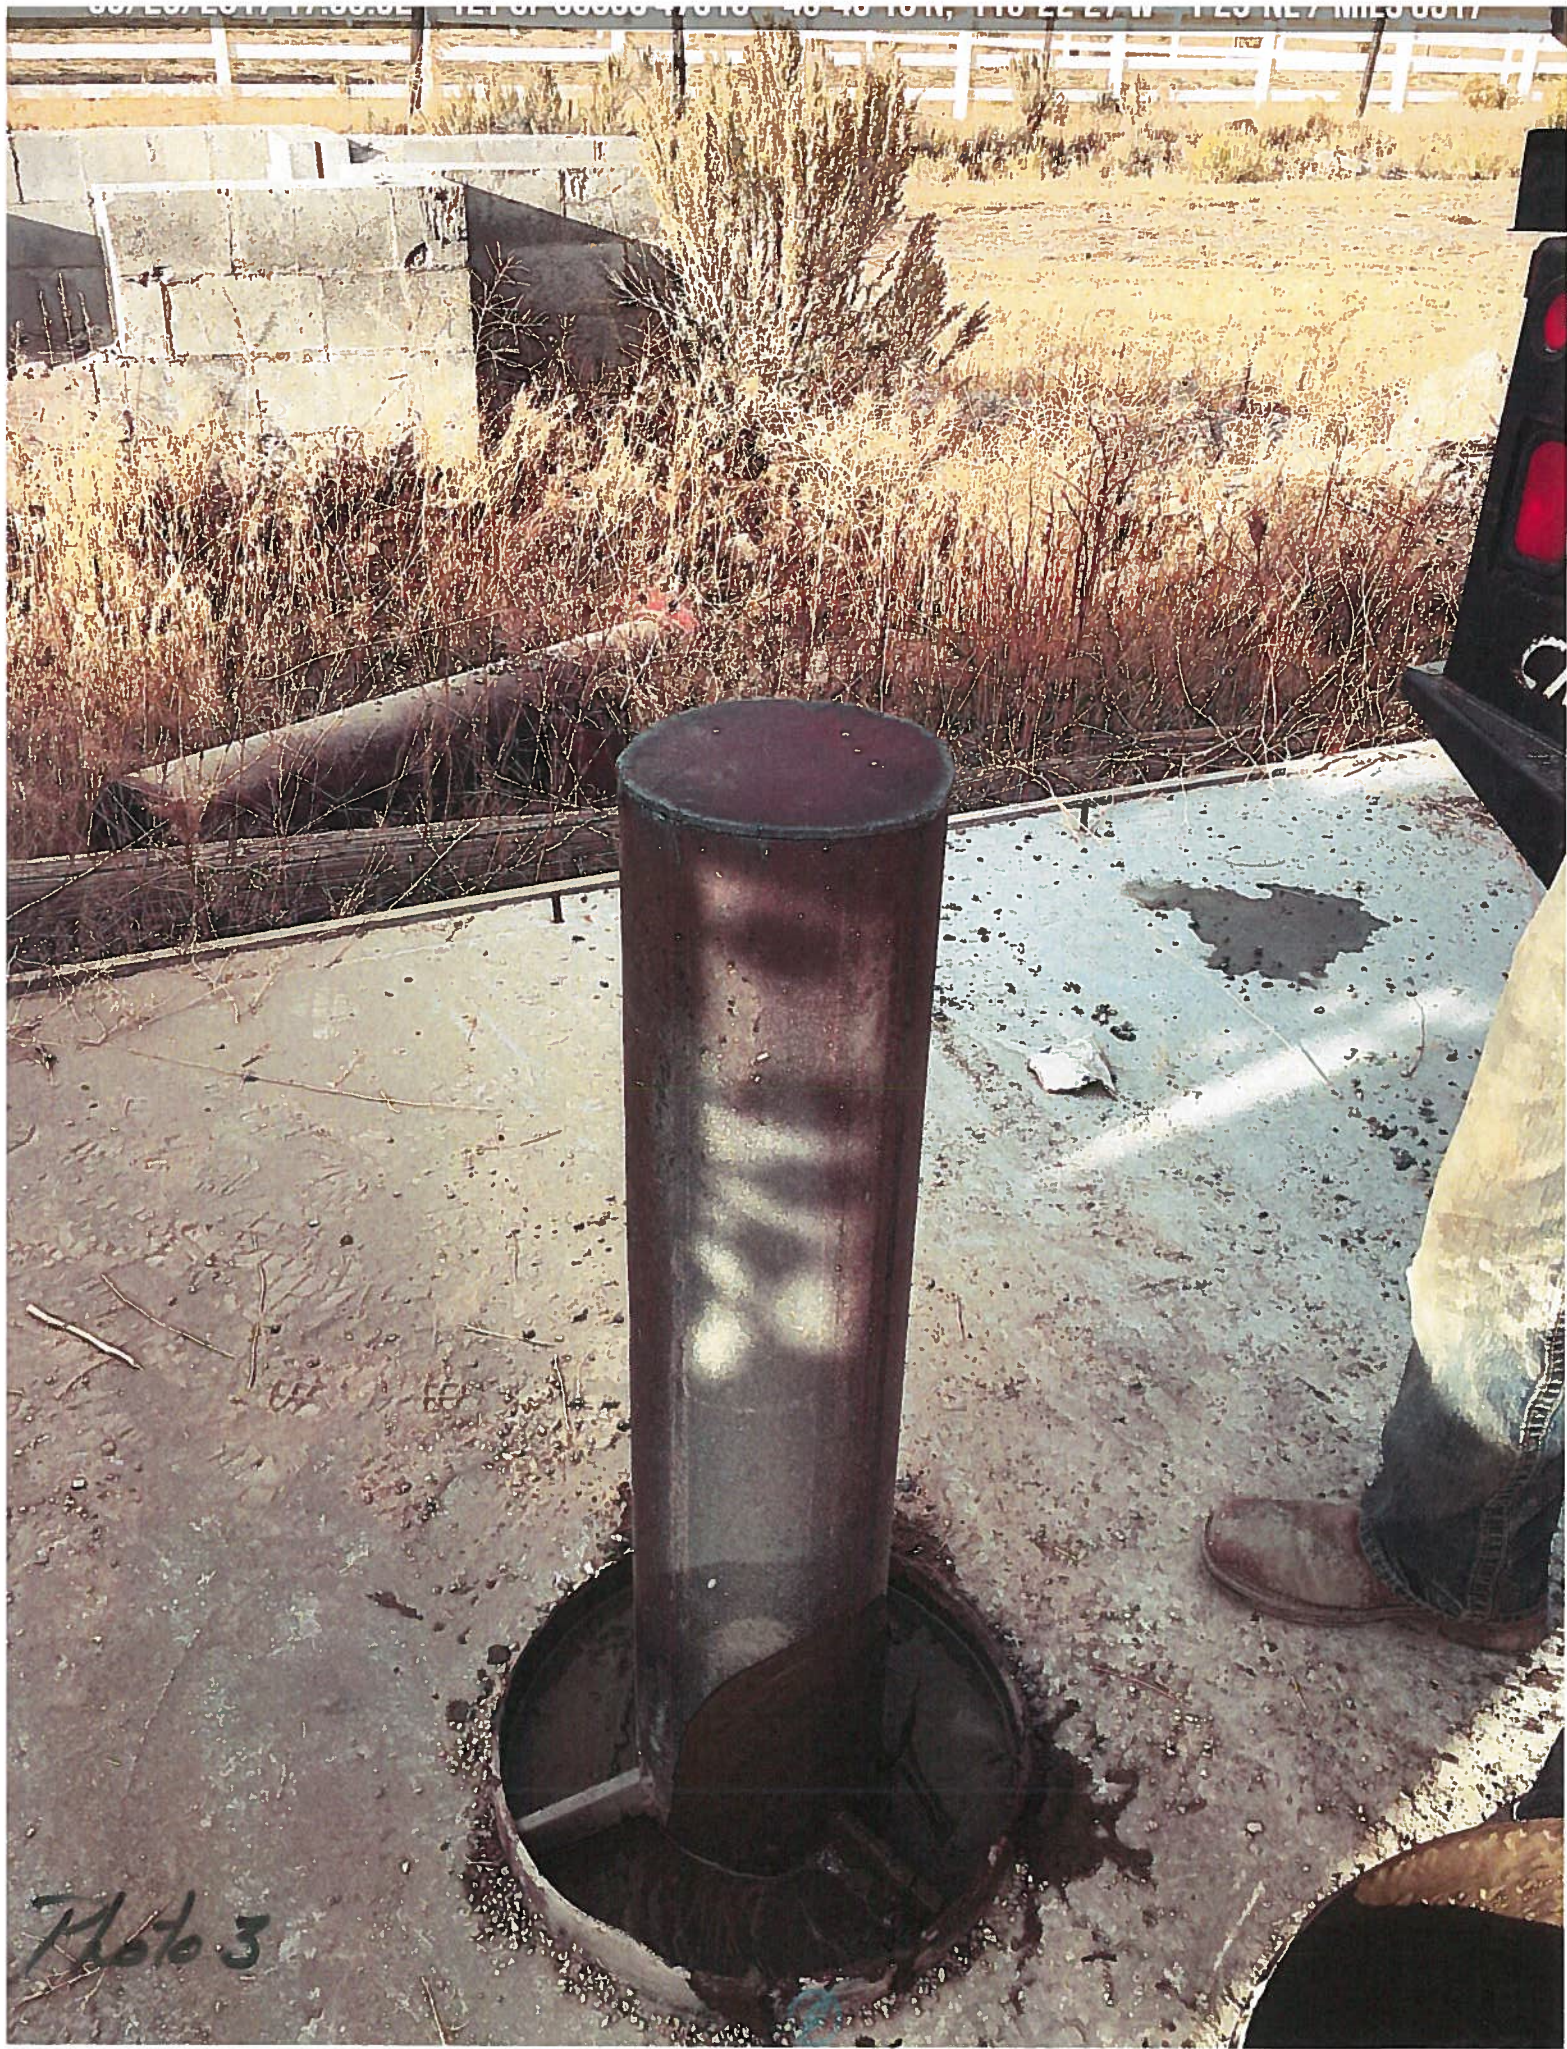
Photo 3

Photograph 3 shows the cement cap between the two strings of casing.
