## Dam Safety Section

### TRIP REPORT

**TO:** Morgan Case, Regional Manager (DWR) Northern Region  
**CC:** Shaun Maxey, IDWR Northern Region Senior Water Resource Agent  
**FROM:** Joe Carlson, PE  
**DATE:** May 9, 2016  
**SUBJECT:** Complaint of an unauthorized pond along Careywood Creek

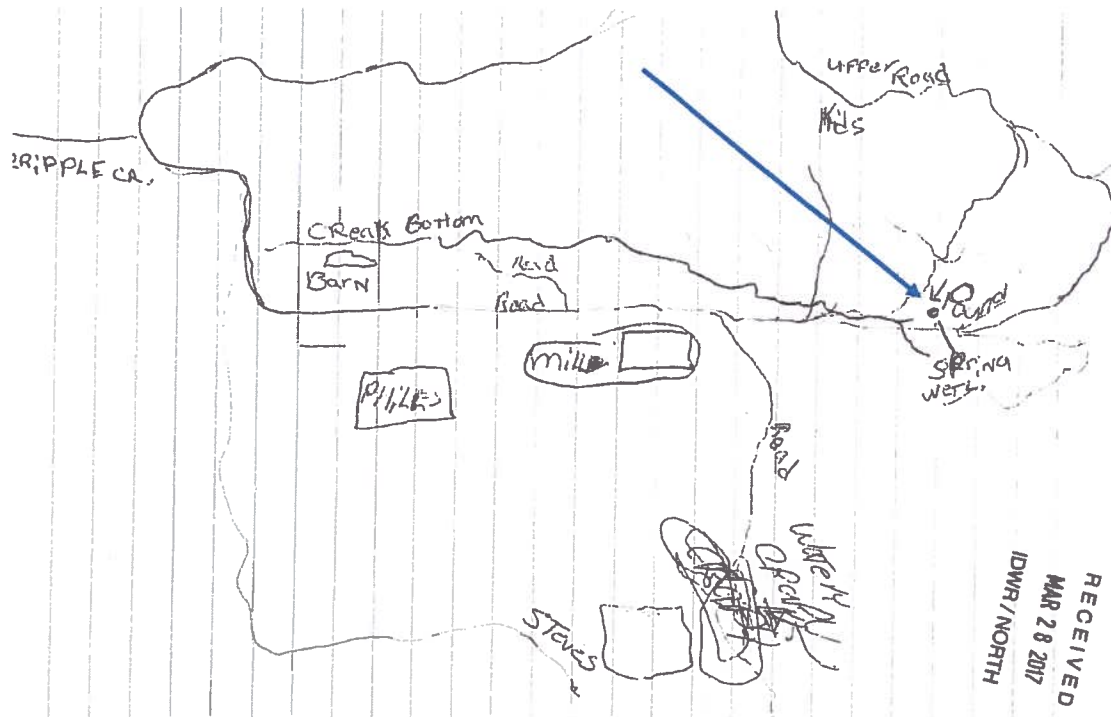
We met with Mr. Shropshire. Mr. Shropshire described for us, using aerial photography, the tentative location of the pond (Photo #1). Mr. Shropshire went on to state that while working for the Barnhardts, he had observed this impoundment to be adjacent to Careywood Creek, and that he recalled seeing piping into, and out of, the pond. In addition, Mr. Shropshire presented the following concerns:

Photo 1 – Charles Shropshire sketch of approximate location of pond (blue arrow)

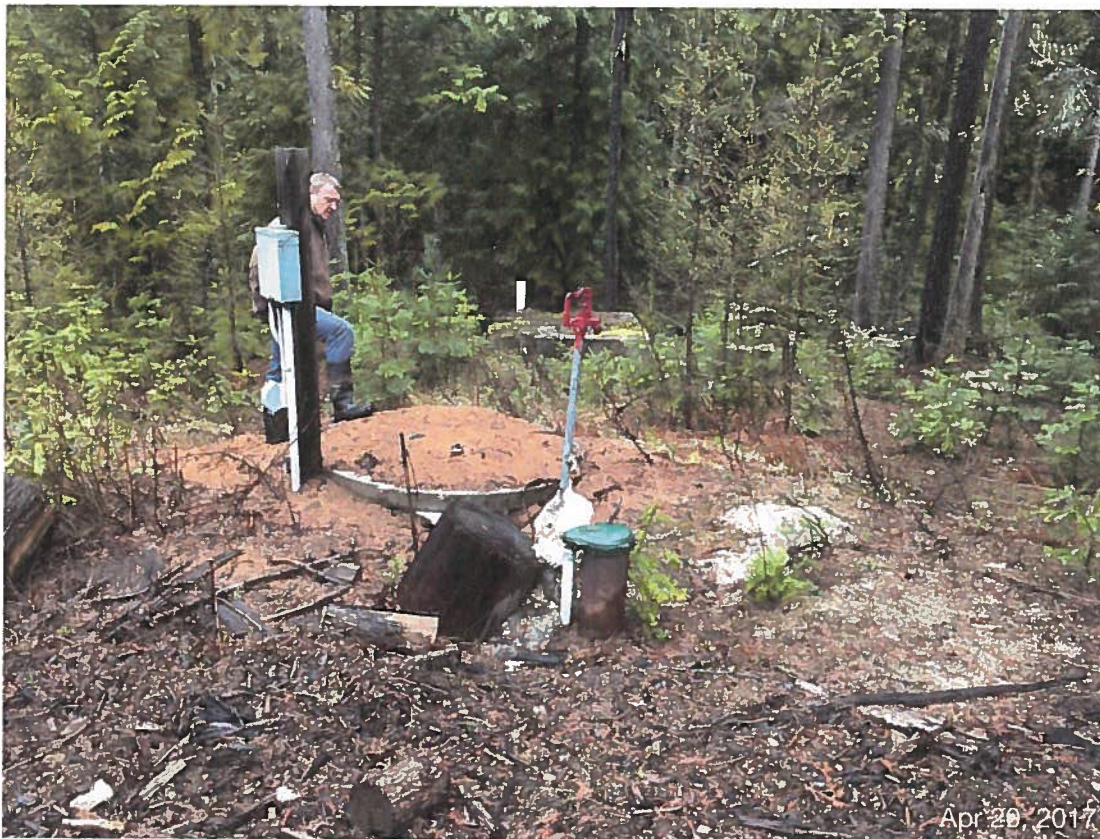
All of the other diversionary structures (wells and cisterns) were either appropriately permitted, or were apparently abandoned.

Photo (April 20 2017) – Phil Barnhardt well (D0040934) and cistern. GPS coordinates (N 48° 01' 36.4, -116° 33' 51.0) as reported to IDWR Groundwater Protection for purpose of record correction. An incorrect Quarter-Quarter shown on Driller's Report.

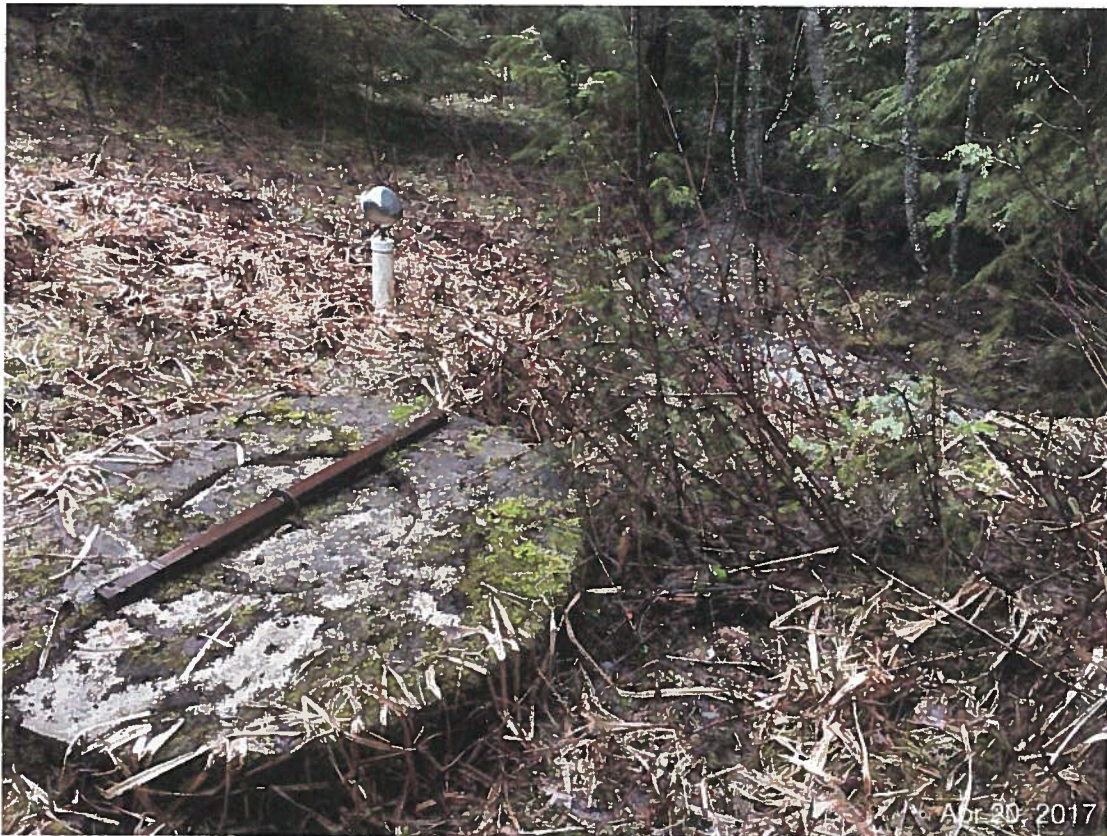
Photo 3 (April 20 2017) – Steve Barnhardt drinking water system; no connection found to empty Pond in Photo 6.

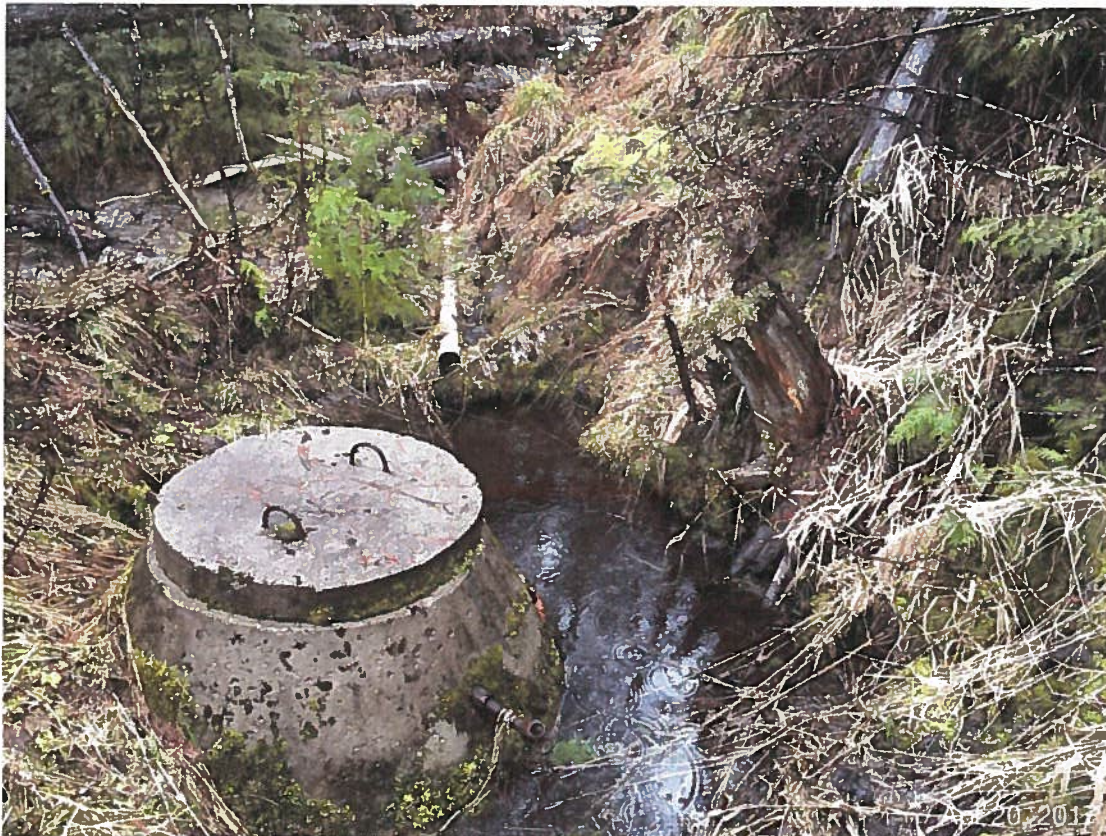
Photo 4 (April 20 2017) – Basin once used for drinking water for abandoned adjacent property; no connection found to empty Pond in Photo 6.

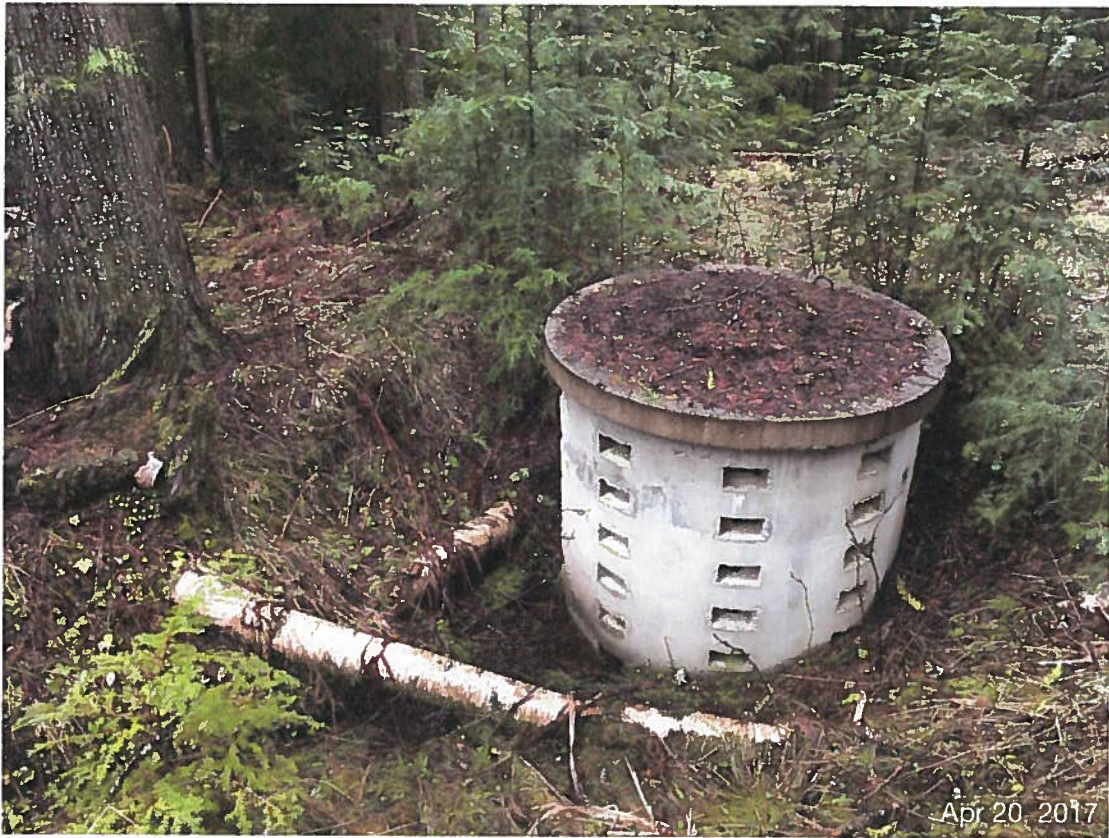
Photo 5 (April 20 2017) – Reportedly abandoned basin; no connection found to empty Pond in Photo 6.

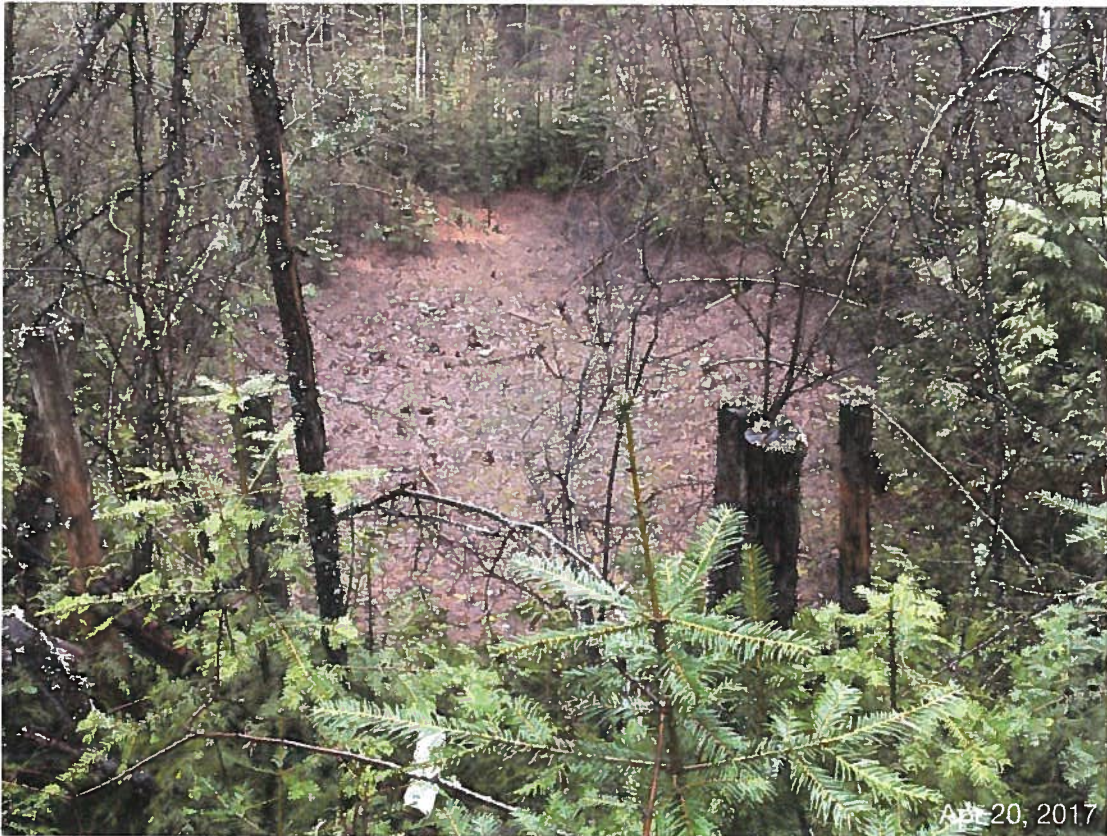
After a thorough walk-through of the site, we were able to confirm the presence of what appears to have been an abandoned pond. This pond did include inflow/outflow piping as described by Mr. Shropshire. There was no apparent pump or piping that would suggest that the pond was being used to divert water to the north (to Mr. P. Barnhardt's daughter's property) or for irrigation.

Photo 6 (April 20 2017) – Apparent pond in question, the pond was not impounding water at the time of our visit. GPS coordinates (N 48' 01" 37.8, -116' 33" 50.9).

Based upon the above meetings and observations, I recommend that no further action be taken.
