## MEMORANDUM

TO: Water Right File 63-34025

DATE: September 20, 2017

SUBJECT: Licensing Review of Water Right 63-34025

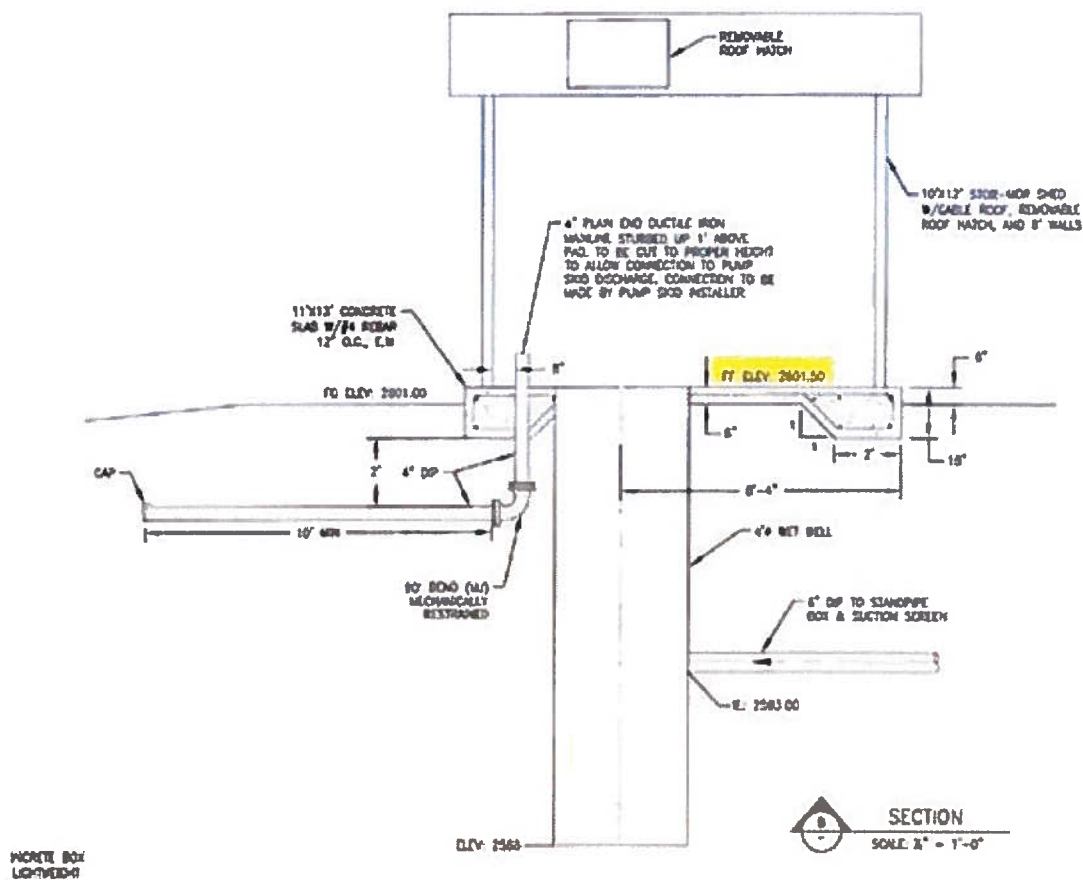
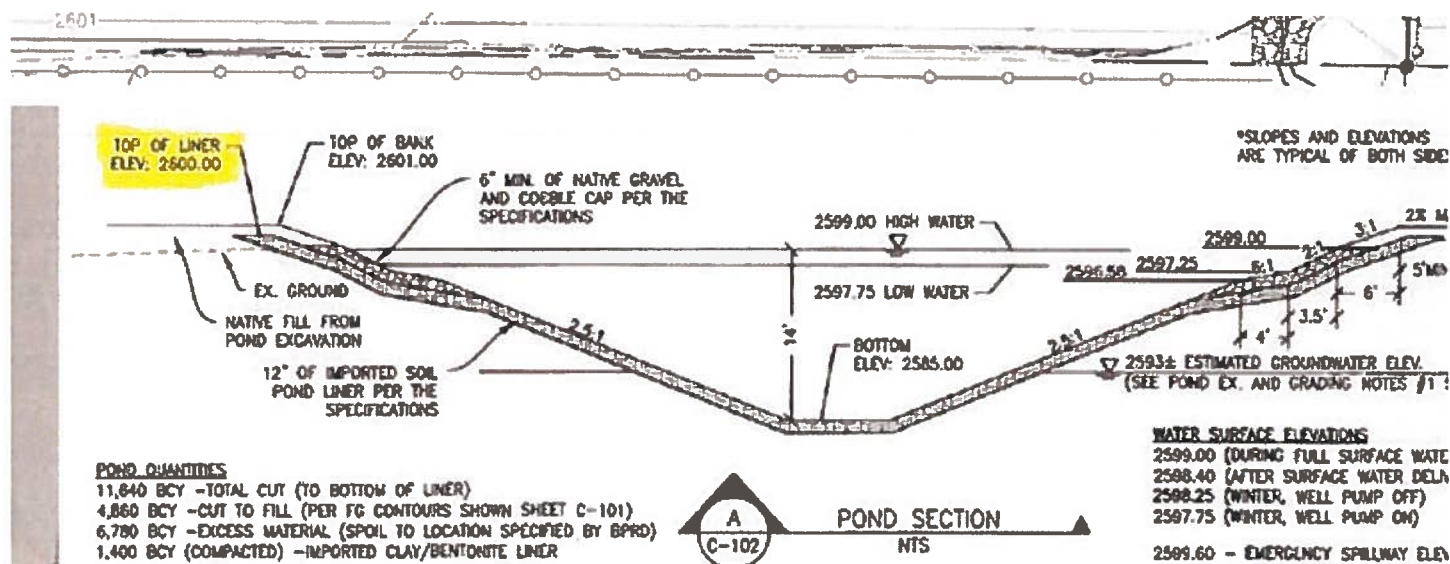
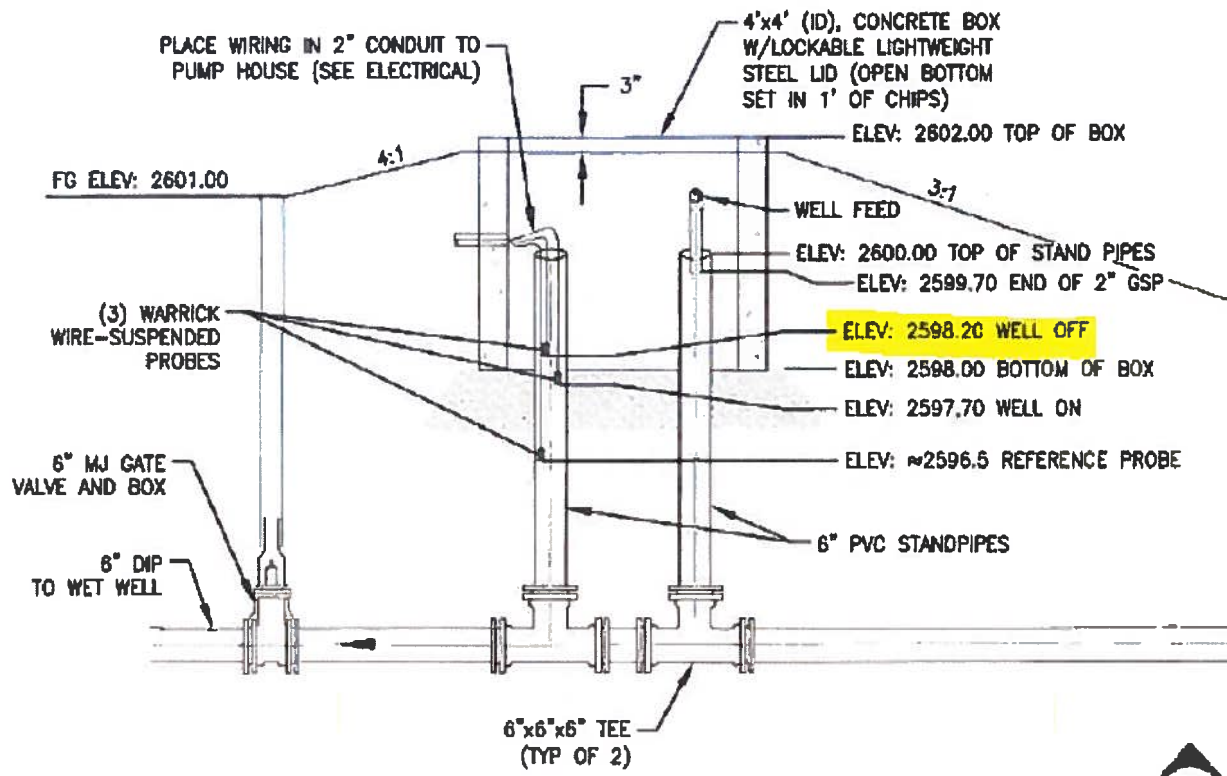
See test information below and attached. It looks like the pond was leaking at more than 1" per day when full last year. When the water level falls far enough, it probably equalizes with groundwater level as you suggested which eliminates seepage.

I understand that bentonite is being added around the banks and will be retested this fall to confirm that it meets the 1/2 " specification. However, at the time of the exam, the pond was full and I assume it was leaking more than 1/2" per day.

It looks like the pond is sealed very well from 45-inches below the wet well slab and down, but the upper banks may not be meeting spec (1/2" per day max). See the first test from 9-13 to 9-16. The first two days the level drops from 42.5" to 45 5/8", which is roughly 1.5" per day. Below that it leaks very little (but could be under the influence of groundwater...) Our plans show that the liner should have been constructed to 2600'. We show the wet well slab at 2601.50 and the pond overflow at 2598.40. So at the very least, the pond should be holding from about 3.1' or 37" from top of slab and lower (assuming slab was constructed to the design elevation). We can discuss more over the phone. But it would probably be a good idea for us to go out and check as-built elevations before you sign off on this. Otherwise, the well pump will be working harder than it should to try to pump up to the winter high (pump off) elevation of 2598.20 (which is 3.3' or 39.6" below the slab).
