## Dam Safety Section

### TRIP REPORT

**TO:** Morgan Case, Regional Manager (DWR) Northern Region  
**CC:** Shaun Maxey, IDWR Northern Region Senior Water Resource Agent  
**FROM:** Joe Carlson, PE  
**DATE:** May 9, 2016  
**SUBJECT:** Complaint of an unauthorized pond along Careywood Creek

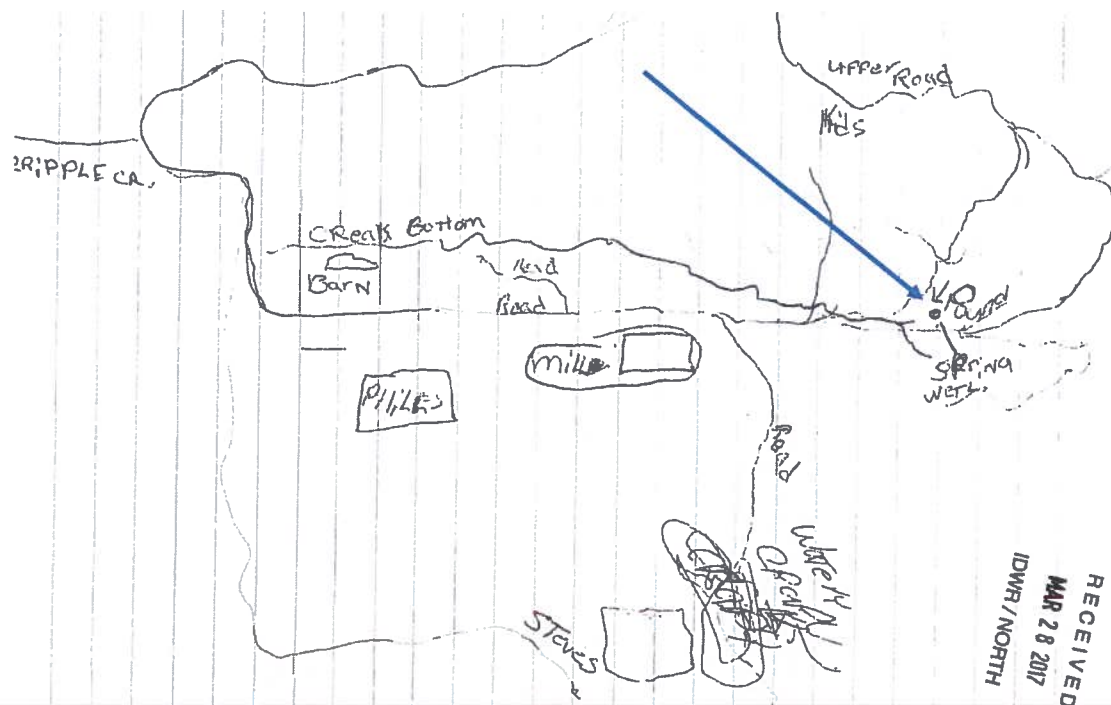
We met with Mr. Shropshire. Mr. Shropshire described for us, using aerial photography, the tentative location of the pond (Photo #1). Mr. Shropshire went on to state that while working for the Barnhardts, he had observed this impoundment to be adjacent to Careywood Creek, and that he recalled seeing piping into, and out of, the pond. In addition, Mr. Shropshire presented the following concerns:

Photo 1 – Charles Shropshire sketch of approximate location of pond (blue arrow)

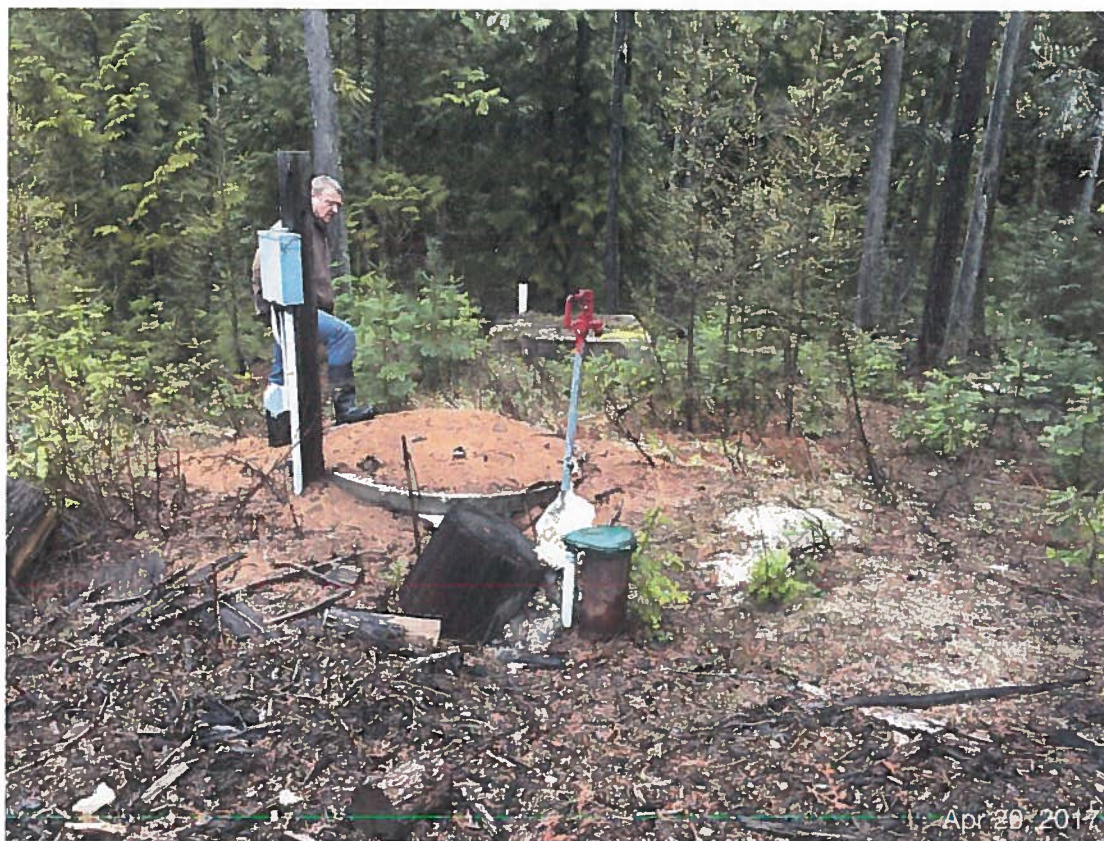
Photo (April 20 2017) – Phil Barnhardt well (D0040934) and cistern. GPS coordinates (N 48° 01' 36.4, -116° 33' 51.0) as reported to IDWR Groundwater Protection for purpose of record correction. An incorrect Quarter-Quarter shown on Driller's Report.

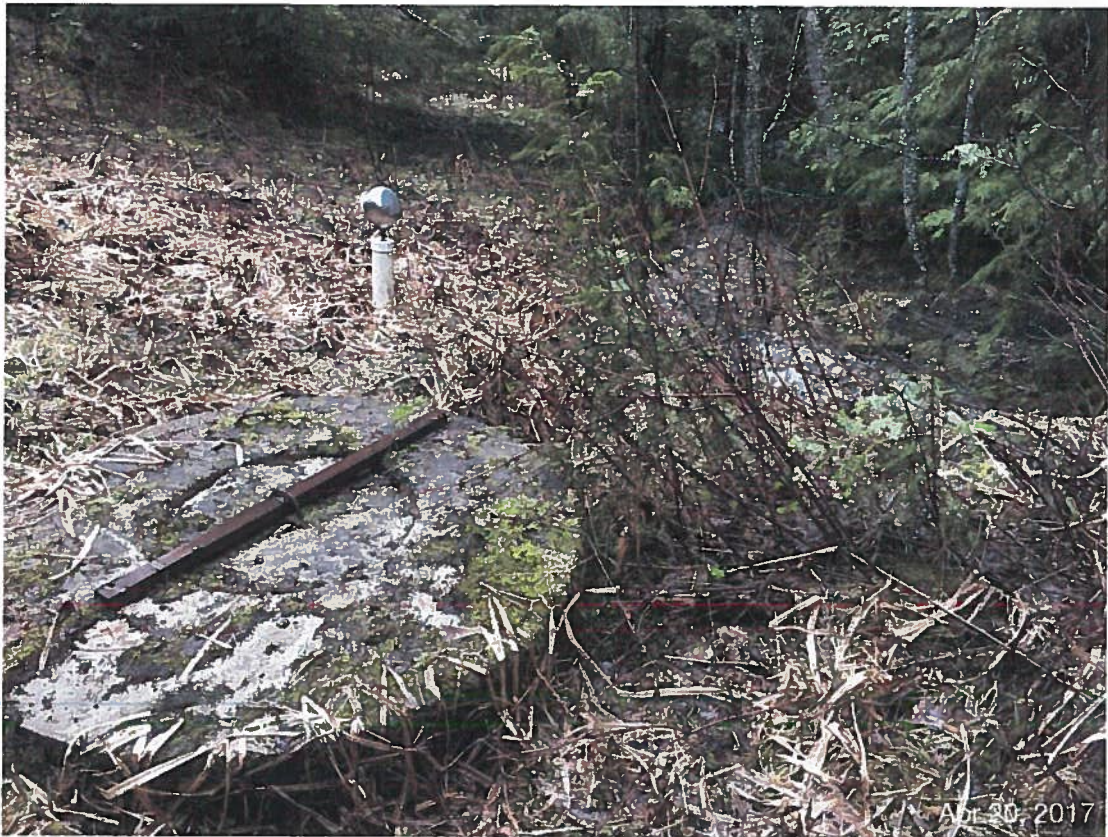
Photo 3 (April 20 2017) – Steve Barnhardt drinking water system; no connection found to empty Pond in Photo 6.

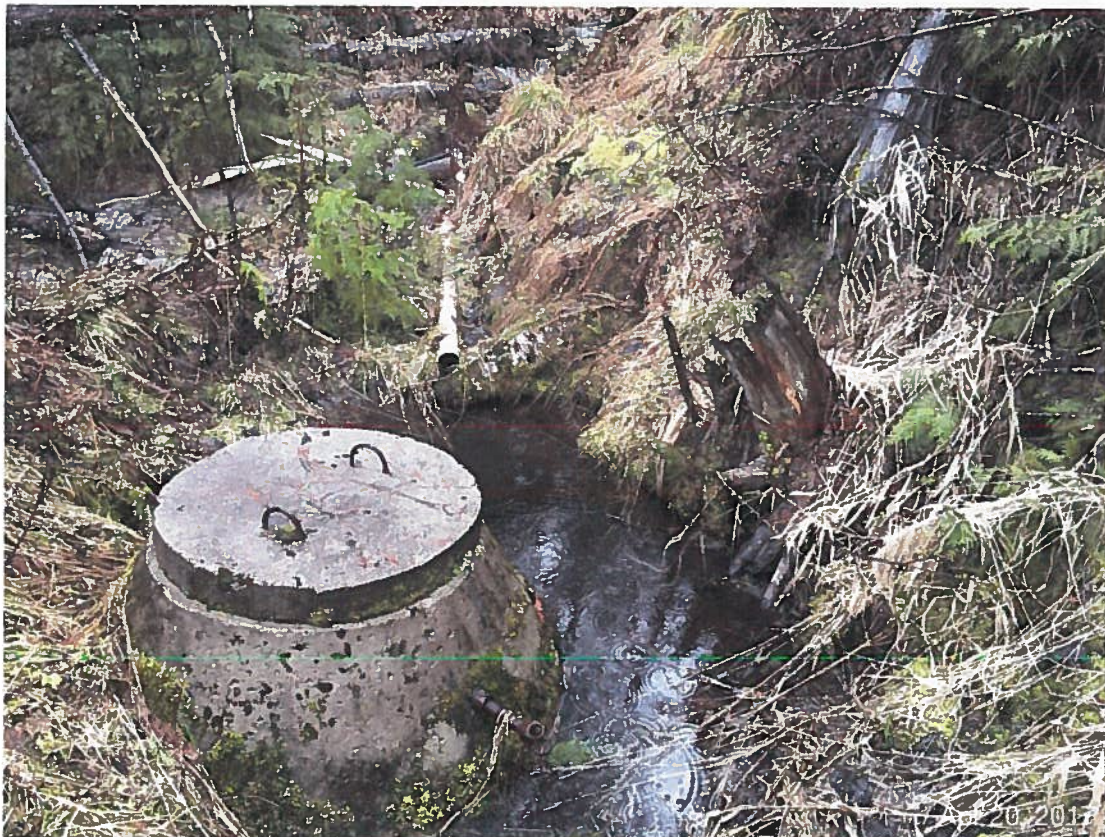
Photo 4 (April 20 2017) – Basin once used for drinking water for abandoned adjacent property; no connection found to empty Pond in Photo 6.

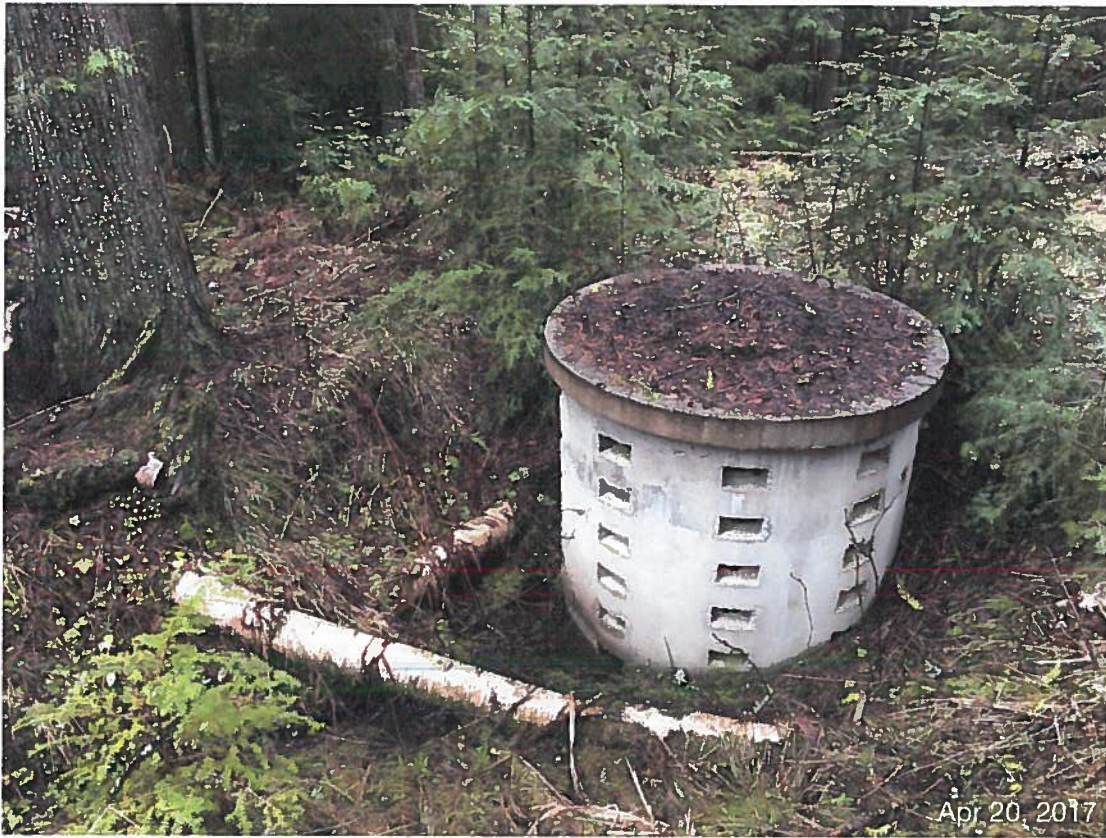
Photo 5 (April 20 2017) – Reportedly abandoned basin; no connection found to empty Pond in Photo 6.

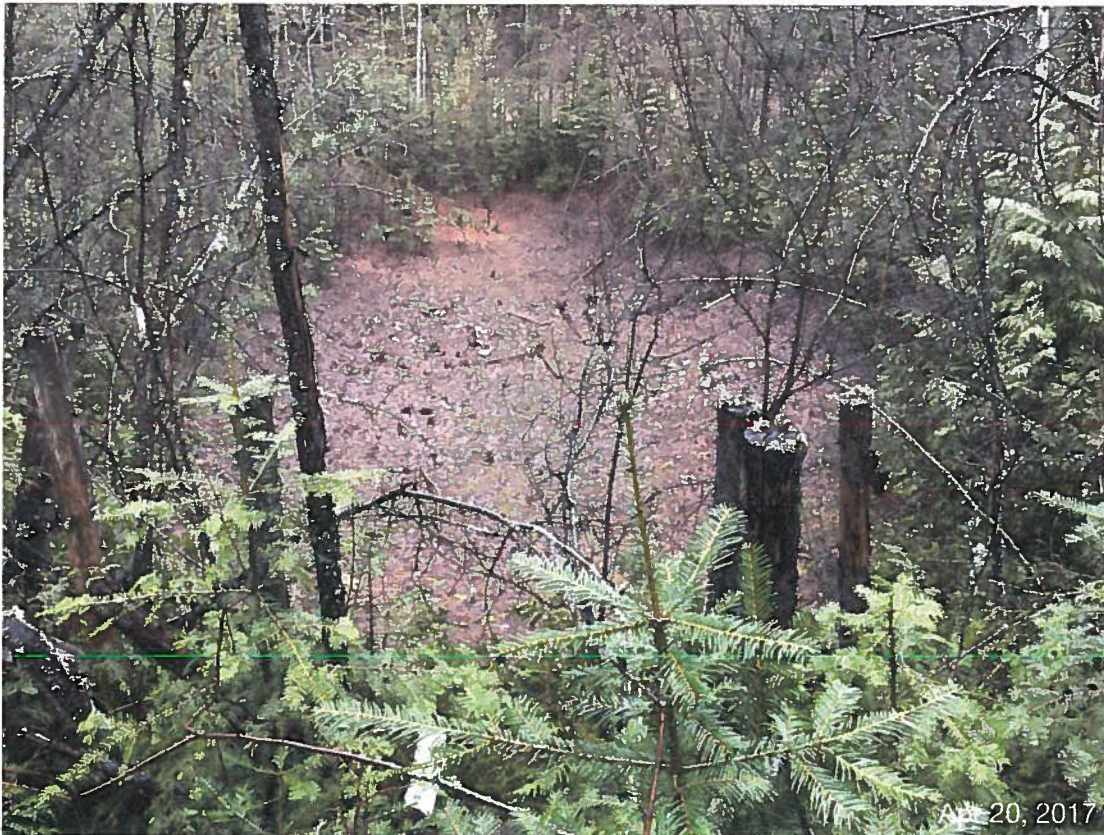
After a thorough walk-through of the site, we were able to confirm the presence of what appears to have been an abandoned pond. This pond did include inflow/outflow piping as described by Mr. Shropshire. There was no apparent pump or piping that would suggest that the pond was being used to divert water to the north (to Mr. P. Barnhardt's daughter's property) or for irrigation.

Photo 6 (April 20 2017) – Apparent pond in question, the pond was not impounding water at the time of our visit. GPS coordinates (N 48° 01' 37.8, -116° 33' 50.9).

Based upon the above meetings and observations, I recommend that no further action be taken.
