STATE OF IDAHO  
DEPARTMENT OF WATER RESOURCES  
BENEFICIAL USE FIELD REPORT

Permit No: 21-13115

Exam Date: 6/19/2012

PERMIT 21-13115 – FIELD EXAM JUNE 19, 2012

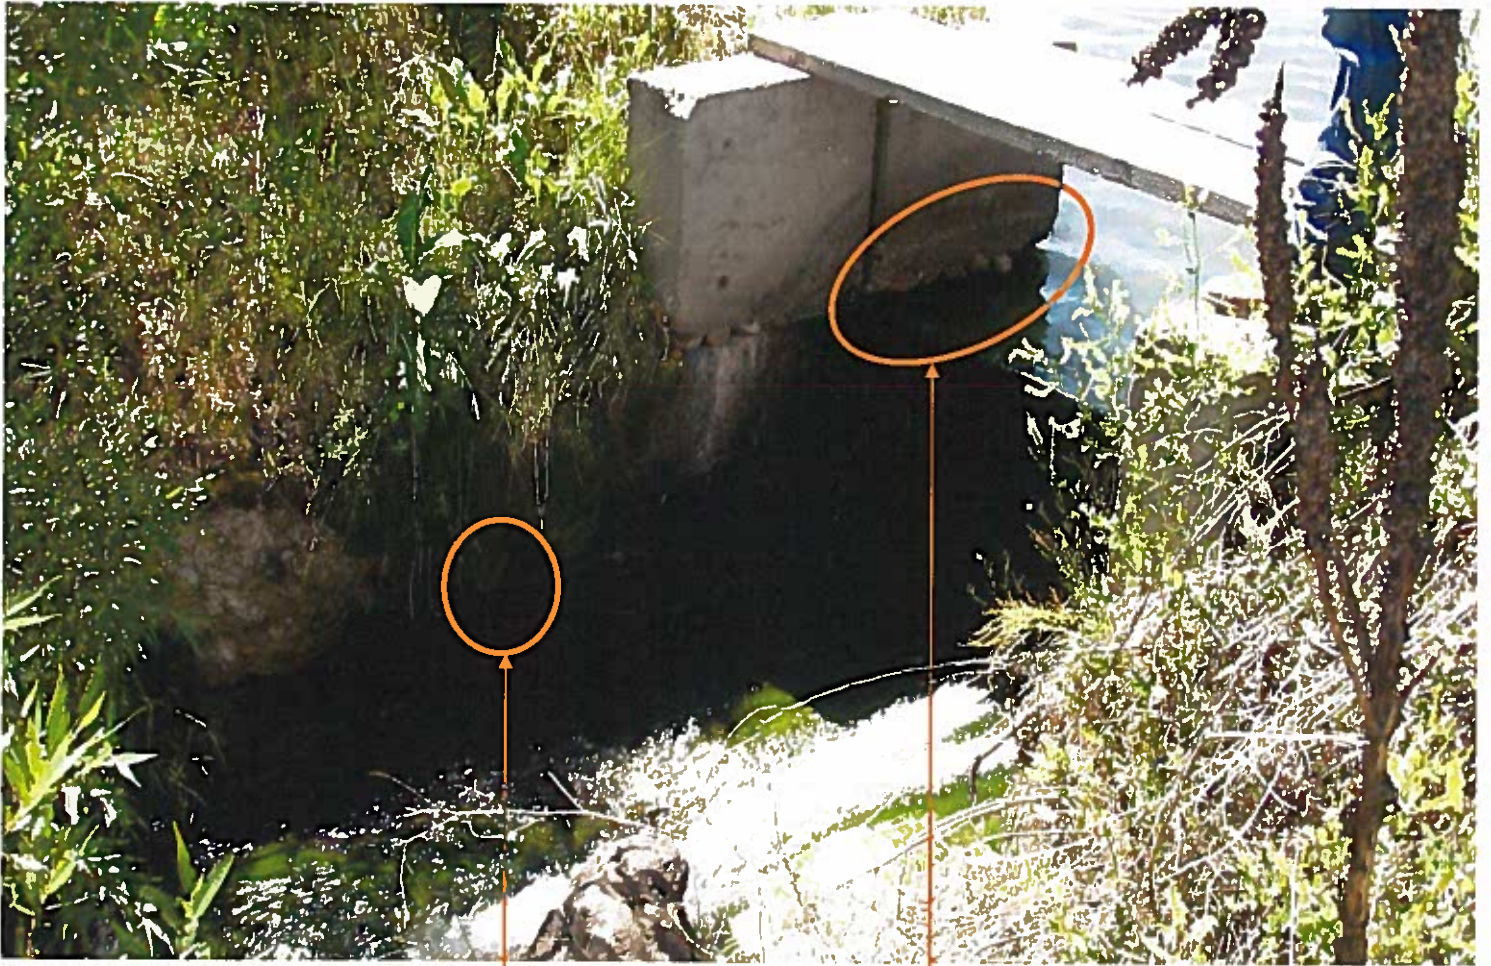
A significant leak appears to have developed since the reconstruction in 2006. As pictured the leak is on the right side of the primary outlet and appears to be water infiltrating the concrete wall at the joint line between the old and new concrete, it then flows along the outside of the wall and discharges into the same channel. There has been some erosion, but currently the leak contained no visible material (estimate 20 gpm) and appears stable. The Dam owner is lowering the reservoir pool to below the suspect joint and is planning immediate repair. Required draw down is approximately 0.5 ft.

Above: Primary spillway: est 20 gpm leak discharging from right side. Suspected infiltration point at concrete joint.

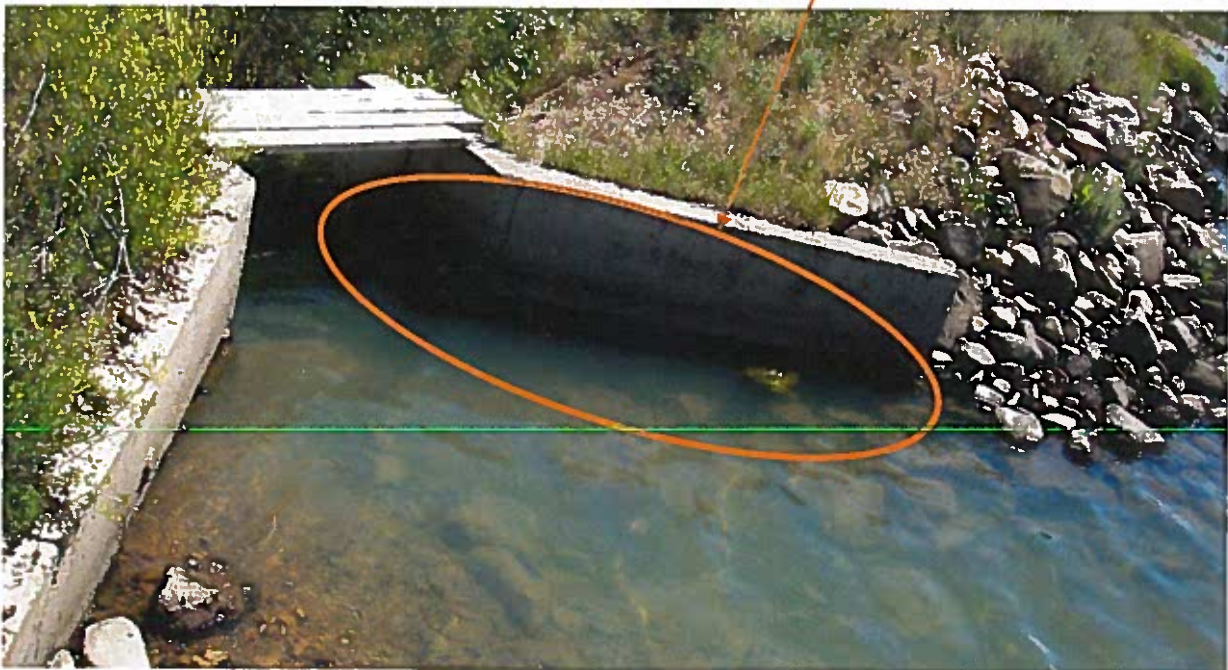
Below : Upstream view of Primary spillway.

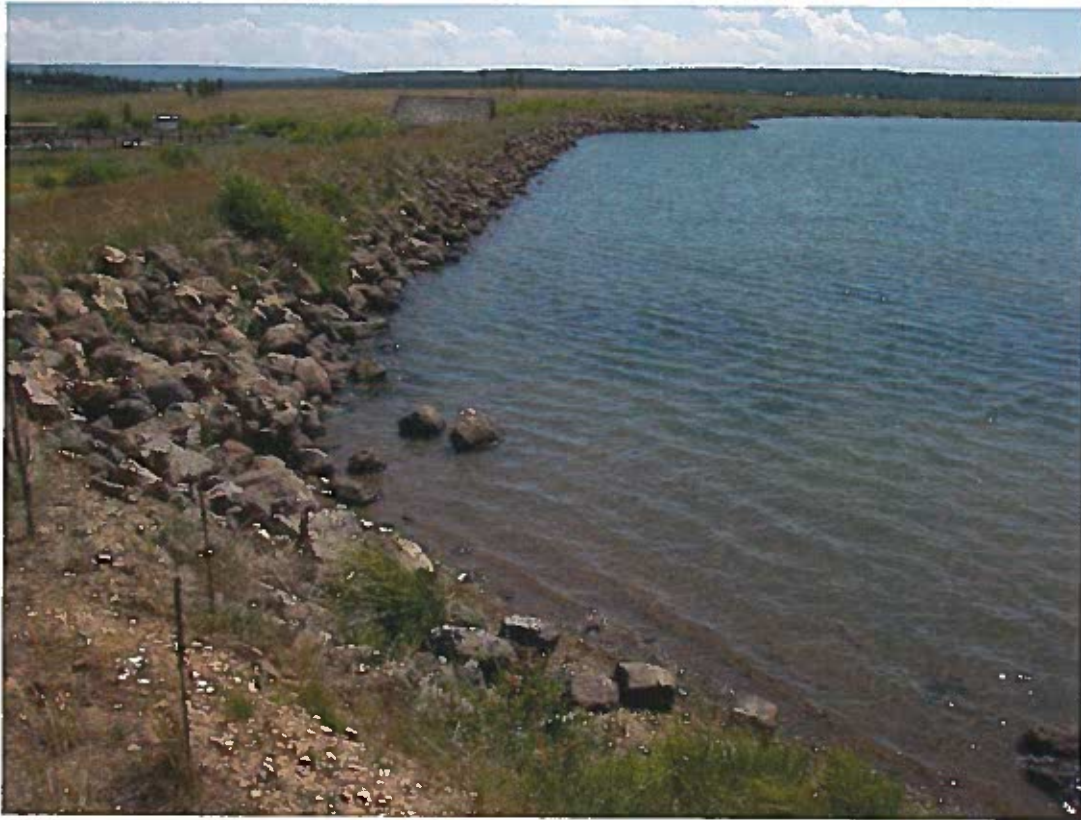
Embankment was rebuilt in 2006. Since the last inspection rip rap has been placed on the upstream slope.

Above: Upstream slope of Dam with new rip rap from left abutment.

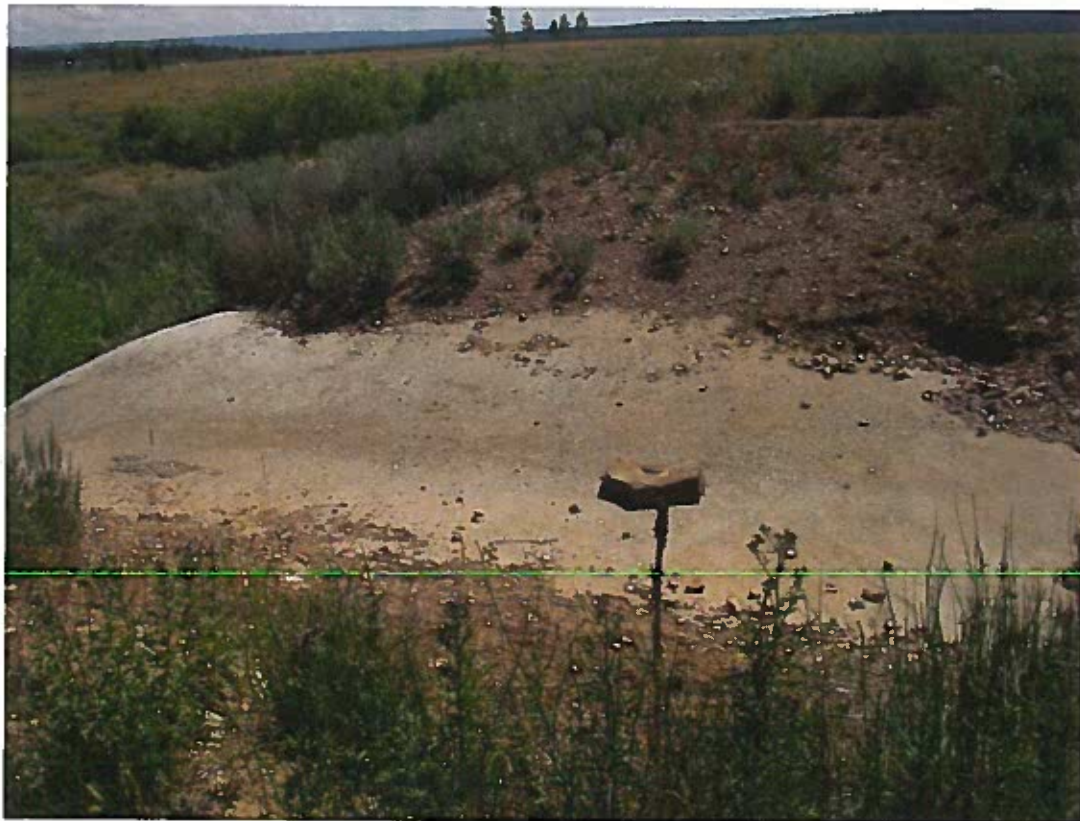
Below: Emergency spillway at center of Dam.

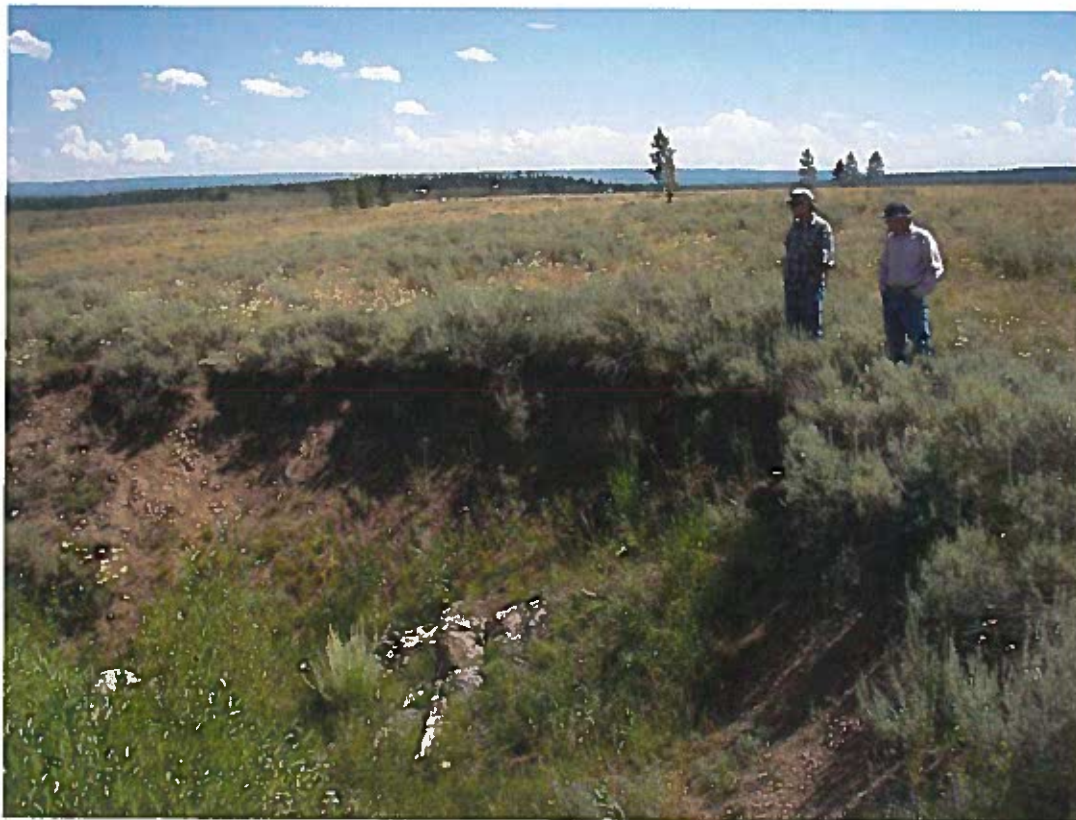
\*Erosion on Right Abutment : Appears to be historic head cut from old spillway approaching the right abutment. New concrete emergency spillway likely to prevent further erosion that might make its way to the embankment. Historic spillway is still lower than the Dam crest and will likely run water if current outlet works are overwhelmed.

Above: Historic headcut on right abutment. Right abutment is lower than the crest of the dam.

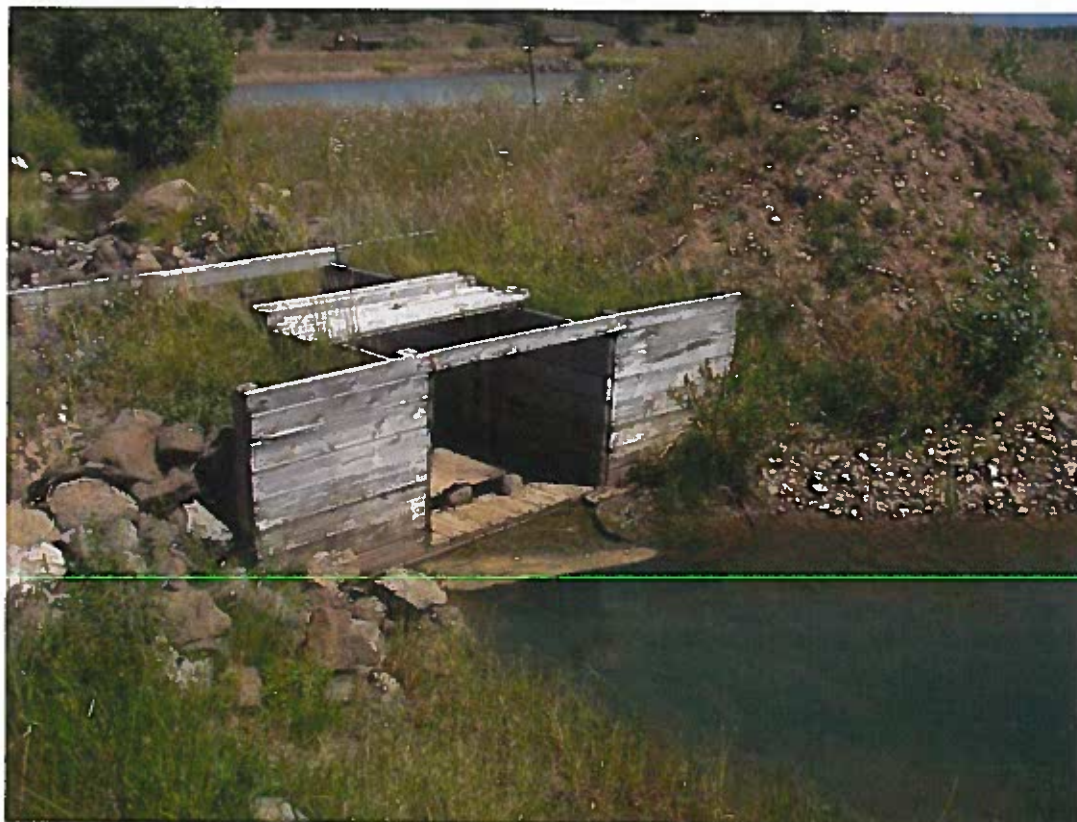
Below: Outlet at left side of Dam.
