## MEMORANDUM

**Date:** February 26, 2016  
**To:** Water Right File 65-22979 and 65-23479  
**From:** A. Newbry  
**Re:** Dam Safety Site Visit

### TRIP REPORT

**TO:** Nick Miller, Western Region Manager  
**CC:** Erik Boe, Ashley Newbry, Jeff Peppersack  
**FROM:** John Falk, PE  
**DATE:** February 26, 2016  
**SUBJECT:** Dry Creek Diversion Dam  
IDWR File: 65-7603 (65-23479 enlargement)

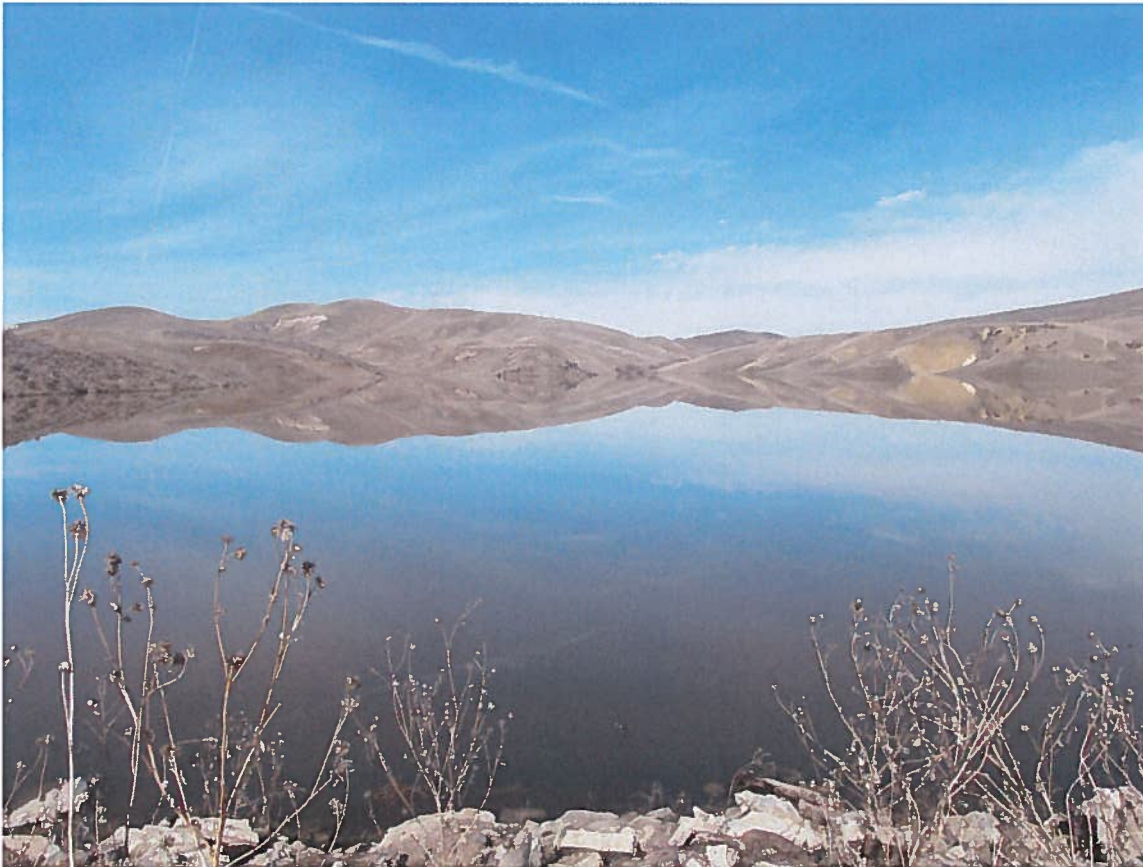
*Dry Creek Reservoir was full at the time of the site visit. This was the reservoir view from the Main Dam.*

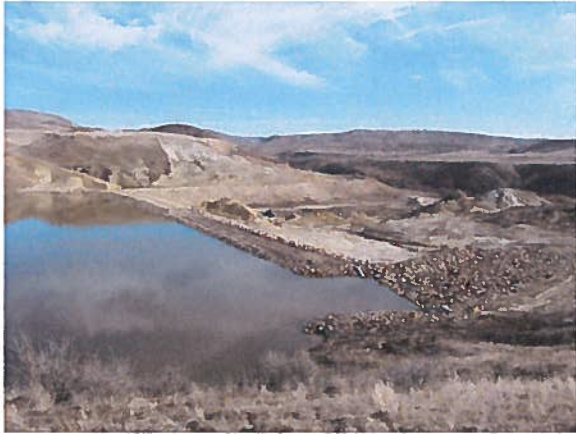
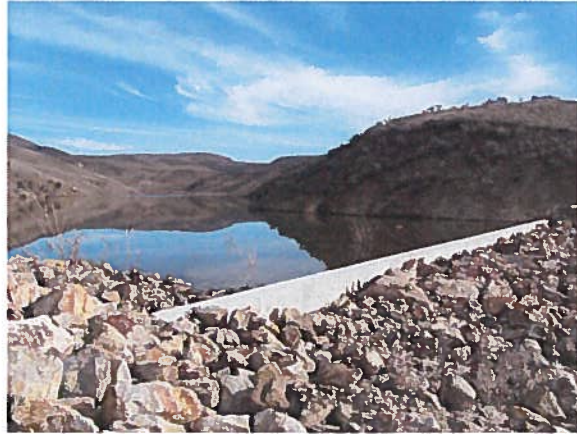
*(Left) Dry Creek Reservoir was full and spilling at the spillway near the Dike. (Right) The Diversion Dam storage was nearly full, 10.5 inches from the spillway crest.*

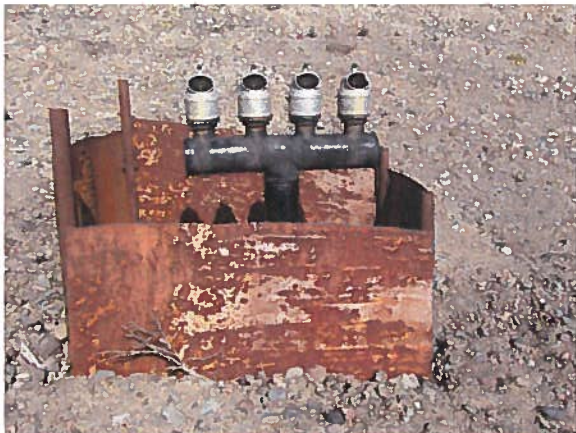
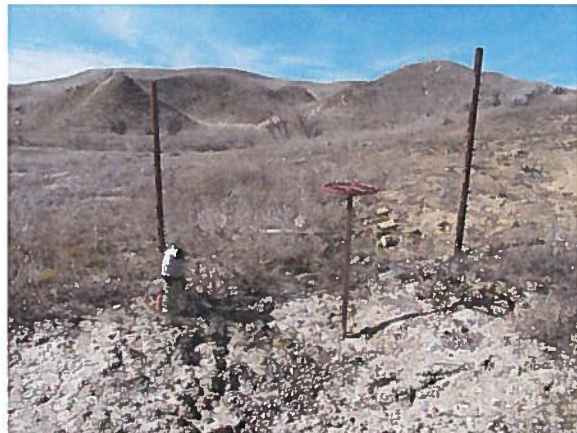
*(Left) We observed the four large vents at the toe of the Main Dam. (Right) Farther down the access road, we stopped to look at the outlet valve and vent.*

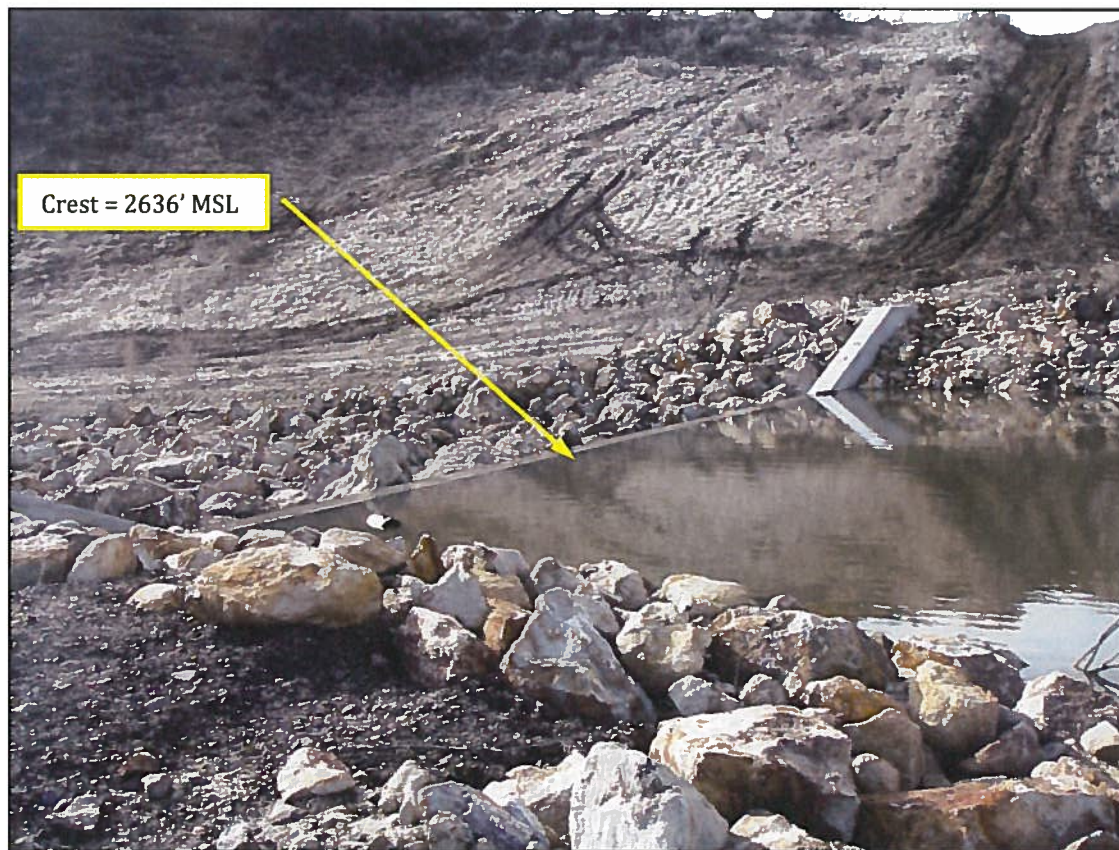
Photo 1 – Primary overflow spillway located on the south (right) side of the Auxiliary Dike. This feature regulates the pool level associated with the larger reservoir impounded by the Main Dam and the Auxiliary Dike. Water to fill the 1859 AF reservoir is diverted from Dry Creek via a canal. As shown, the crest of the concrete weir at the Auxiliary Dike defines the maximum pool.

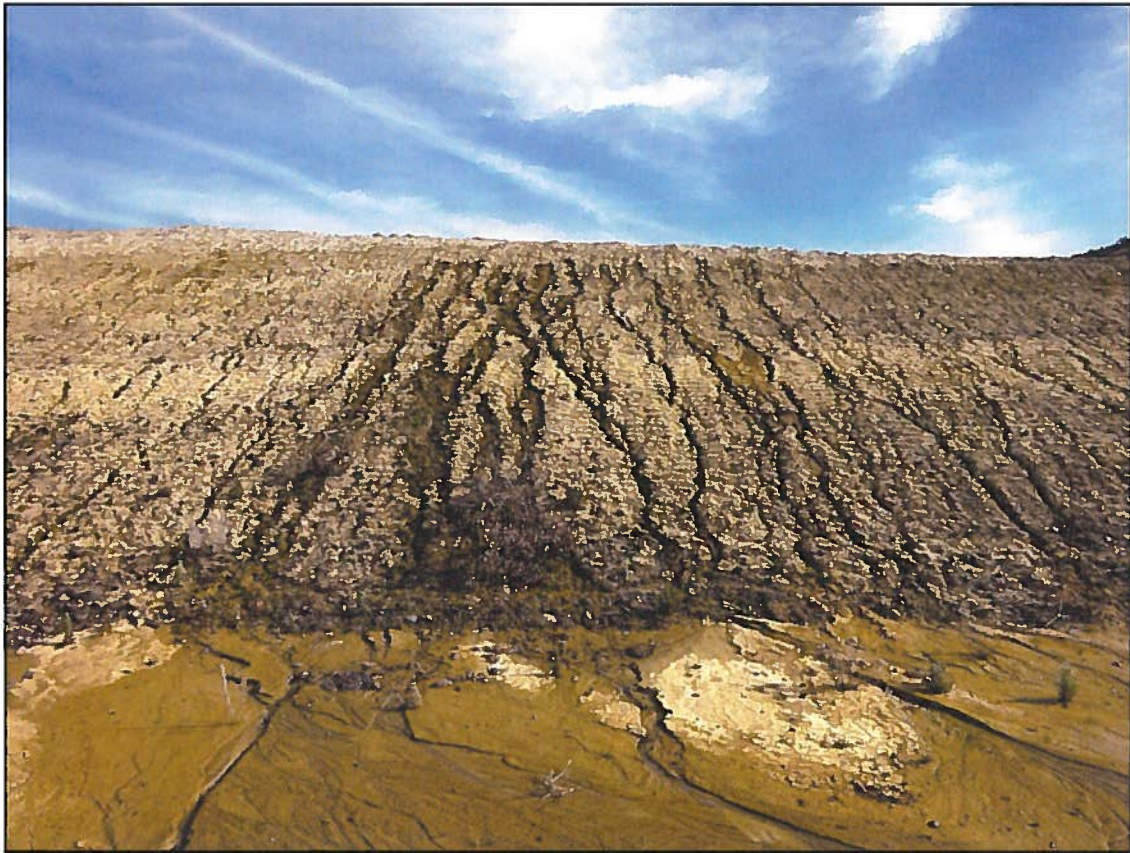
Upon arrival, all three of the earthen embankments were inspected, in keeping with IDWR Dam Safety program schedule. At the time of our visit the weather was clear, warm and dry. The reservoir impounded by the Main Dam and Auxiliary Dike was full, with approximately one-half inch (0.5") depth of flow passing over the crest of the primary emergency spillway (Photo 1). The pool level behind the Diversion Dam was measured 10½ inches below the concrete spillway crest (design elevation 2637.0'). Inspection reports and accompanying photographs for each dam are being finalized; however, they are not included with this summary report which was deemed necessary to describe our unexpected observations of leaking waters flowing in multiple rivulets down the exposed slope of the Diversion Dam (Photo 2-4).

At the Diversion Dam, we observed multiple rivulets at randomly spaced locations across the downstream slopes of the earthen embankment; including several that were flowing measureable quantities of water. The larger source of the water supplying the rivulets likely originates from the reservoir impounded behind the diversion dam. The flow of water was confined to narrow rills which appeared to have been eroded into the earthen soils by the force /velocity /duration of the flow. Of all dozen or so flowing rivulets observed, the greatest flow was estimated to be 2 gallons per minute (Photo 5).

Photo 2 - Downstream, south-facing slope of the Diversion Dam located on Dry Creek. Flowing water was observed in some of the larger features; many of the smaller rills exhibited moisture.

Regardless the causes for the multiple leaks witnessed on the exposed slope of the Diversion Dam any appearance of seepage, and especially that of *flowing water*, located anywhere on the downstream face of an earthen dam is reason for concern. Without undue delay, the owner must begin lowering the level of the reservoir to an elevation that results in stoppage of all observed leakage. In the interim, the dam owner and his engineer should begin making necessary arrangements to investigate and positively identify the source of the leak(s). Once identified, the embankment must be repaired in a manner that results in satisfactory resolution of this observed deficiency. Failure to make adequate repair and/or to lower the pool level in a timely manner may result in catastrophic breach of the embankment. The storage certificate for the Diversion Dam expires at the end of the year, 12/31/2016; its existing status and future renewal should be dependent on whether or not this problem is resolved.

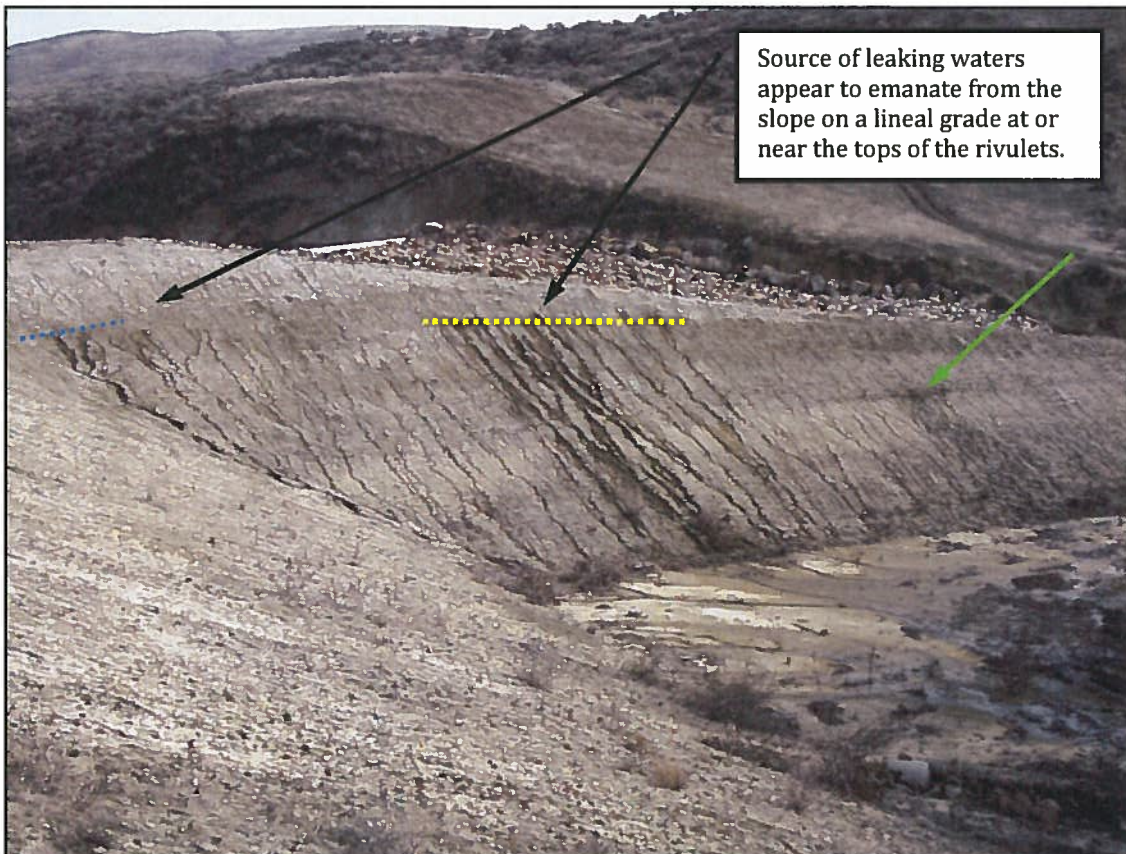
Further, the uppermost elevation of the rivulets appeared to have a common upper lineal boundary; i.e. the appearance of flow was associated with a horizontal feature, band or layer within the mass of the embankment (Photo 3). The lower portions of the exposed embankment slope were dry except in, or immediately adjacent to, the channels (rills) created by the rivulets. Discharge from the toe drain was significantly less than the sum of the leakage flowing from the rivulets. Such observations suggest that the embankment is not saturated, and that the phreatic line does not daylight high on the slope. An explanation for the numerous rivulets may be the result of a permeable layer of material that was introduced during construction of the embankment, or perhaps due to improperly compacted layers of fill materials in the dam.

Photo 3 – Similar view illustrating the source of rivulets and deposited soil at the toe of the slope.  
Dry Creek Diversion Dam

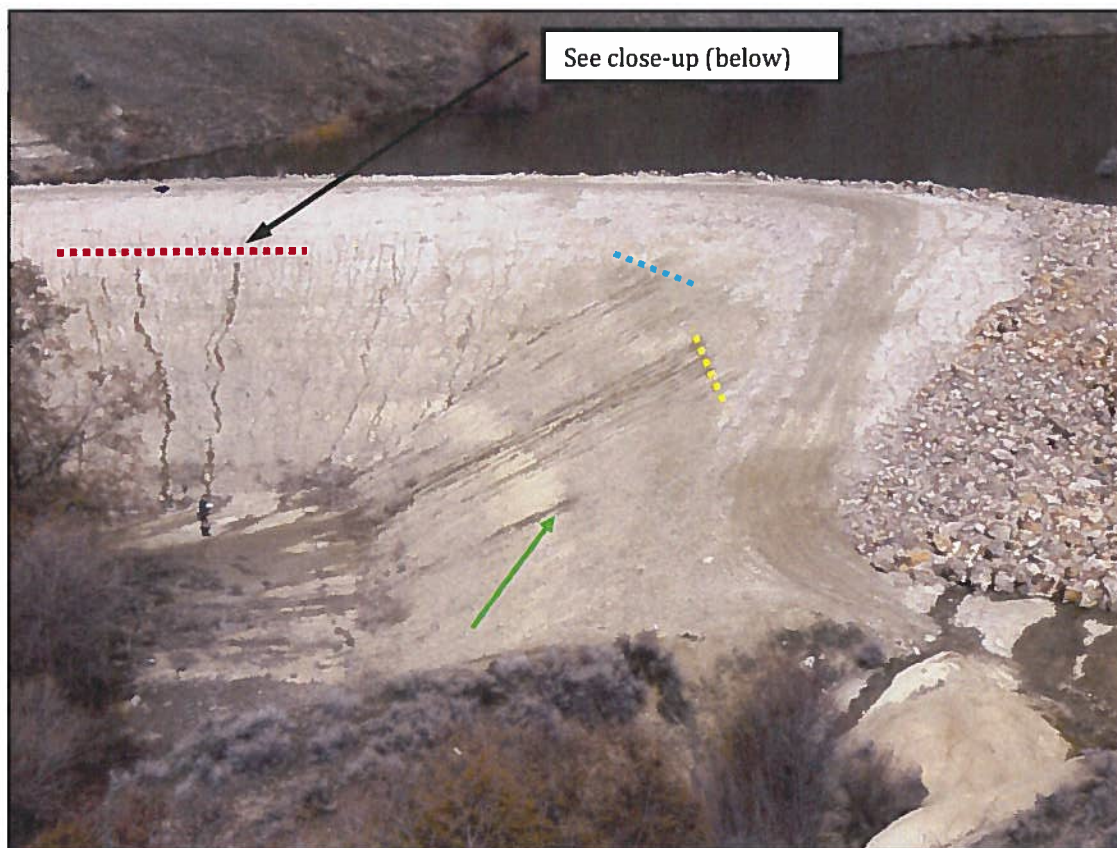
All features exhibited evidence of erosion; however the rate-of-flow was generally too small in most of these to be measured, and instead might well be considered to resemble more of a seep versus a leak. Nonetheless, all of these features were easily viewed due to the depth of the eroded channels (2-5 inches) that had been eroded into the exposed slope, and the distinct dark color associated with the accompanying moisture. Other smaller rills were observed, but all of those which were not wet may have been created by surface runoff and not from water leaking /seeping from out of the slope. Leaking water appeared to be emanating at or near the tops of the rivulets, as a point source, instead of being dispersed equally along the length of the rill.

Photo 4 – Reverse view looking westerly at other deeply incised rills on the downstream slope of the Diversion Dam. Note the person at the toe of the slope for scale.

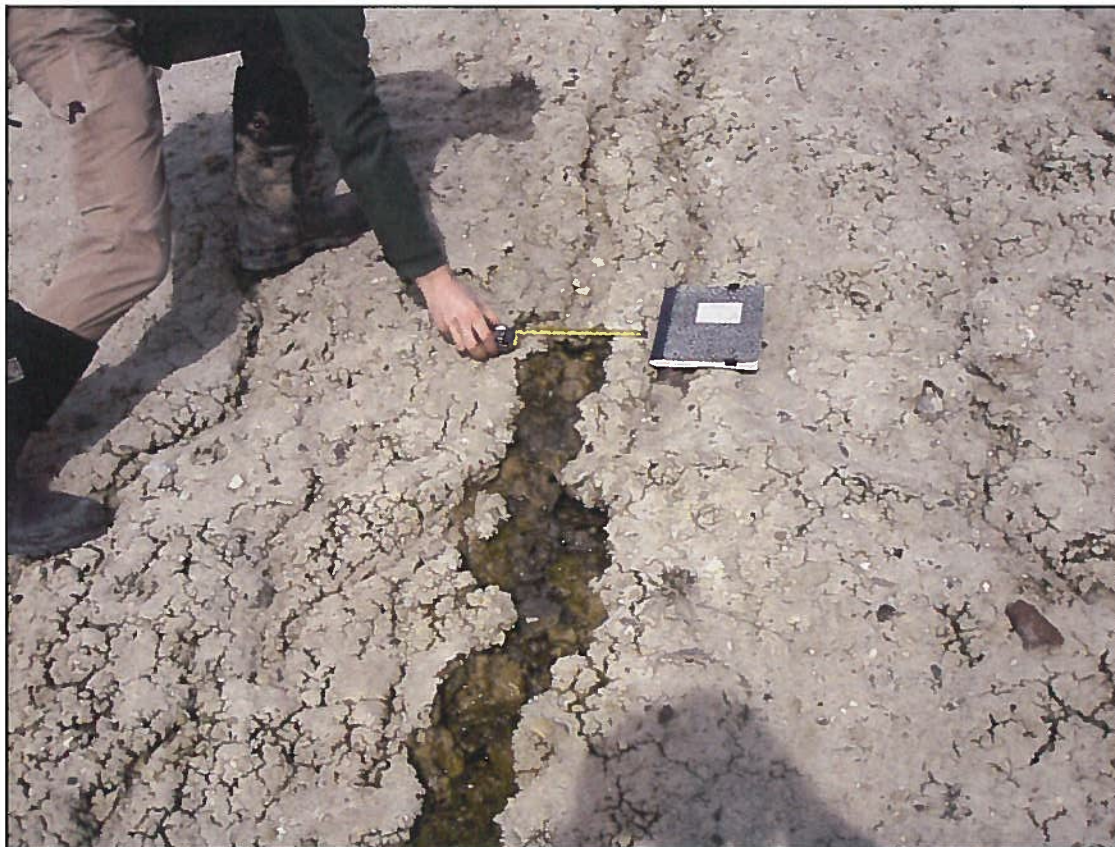
Photo 5 – Close-up showing the origin of one of the larger flowing leaks, estimated @ 2 gpm.

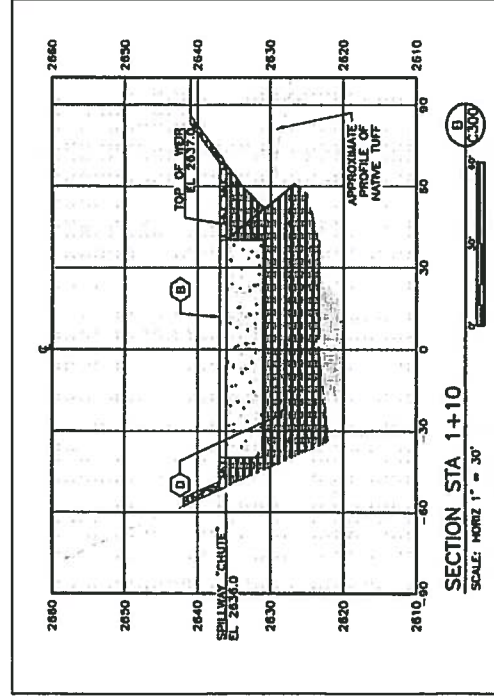
Figure 1 (left) – Reprint from Record Drawings, Sheet C301 illustrating the cross-section of the concrete overflow spillway along the center-line axis. Note the view is in the direction of flow, downstream convention (left = east).

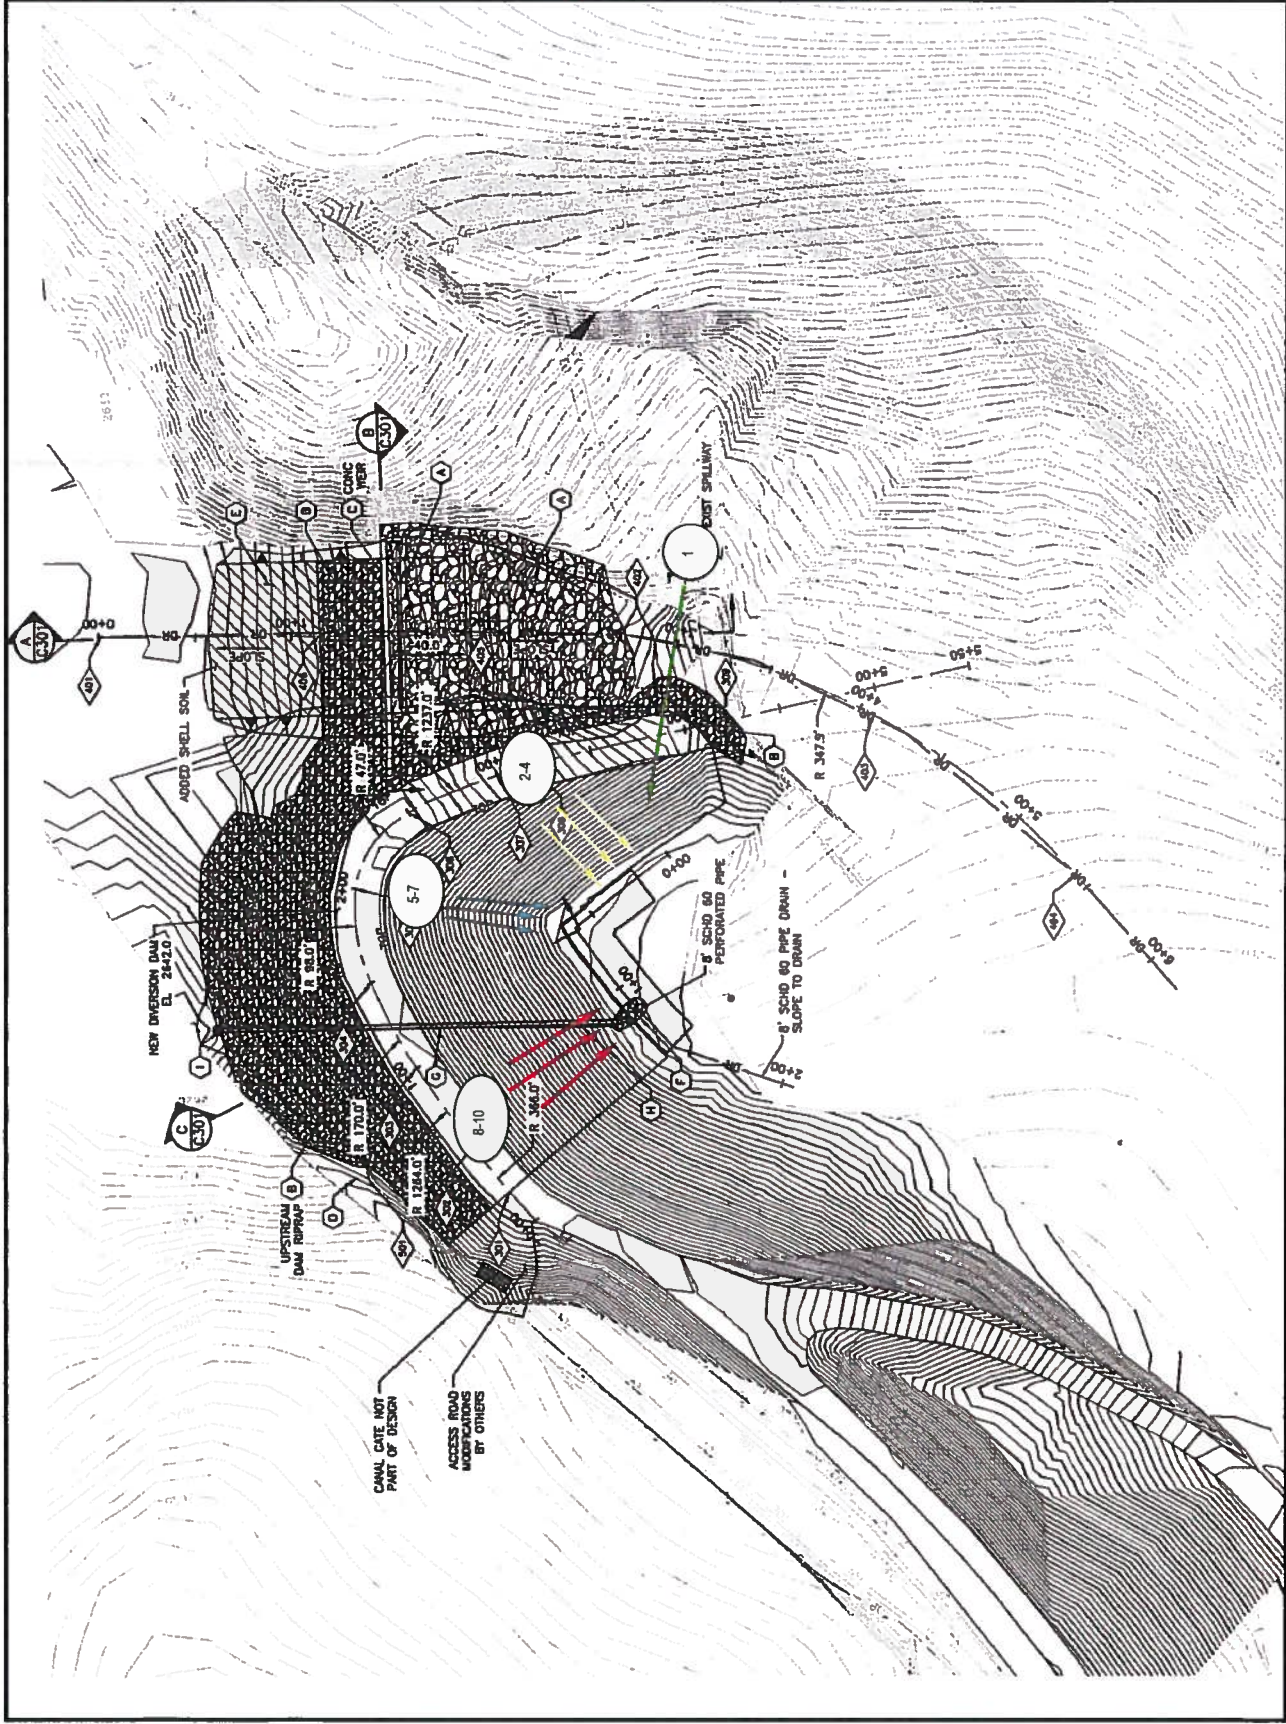
Figure 2 - Copy from Record Drawings-Sheet C300, showing approximate locations of rivulets; identified per Stationing in Table 1 (see photos 2-4).
