Permit Nos. 21-13033 and 21-13034  
Thompson Addition Homeowners Association Inc.  
(same subdivision, combined field exam)

**STATE OF IDAHO  
DEPARTMENT OF WATER RESOURCES  
In-Office Beneficial Use Examination**

18 June 2012  
Thompson Well  
7220074

RE: Enhanced Sanitary Survey conducted on 13 June 2012

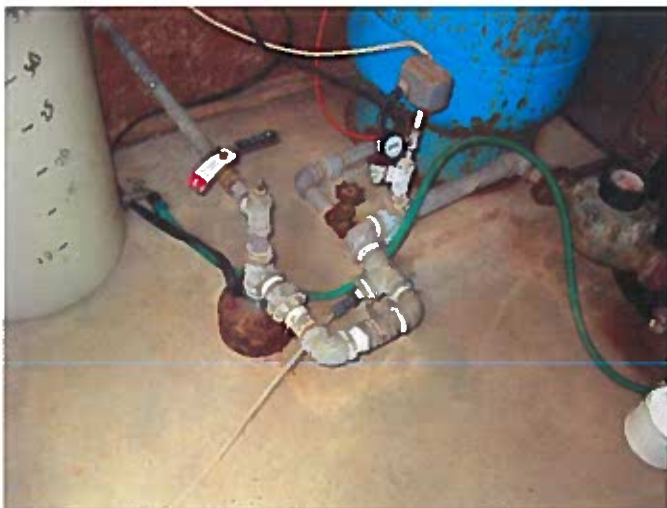
**Groundwater Source:** 1. The well casing for well #1, North Well or Main Well, does not extend 18 inches above the final ground surface and/or 12 inches above the pump house floor, as required by IDAPA 58.01.08.511.06.a. There is a low potential for the casing to be covered by water during a flooding event. The casing height requirement will be reevaluated every time an ESS is conducted. **(No action required at this time)**

1. Well #1, distribution lines, and check valve.

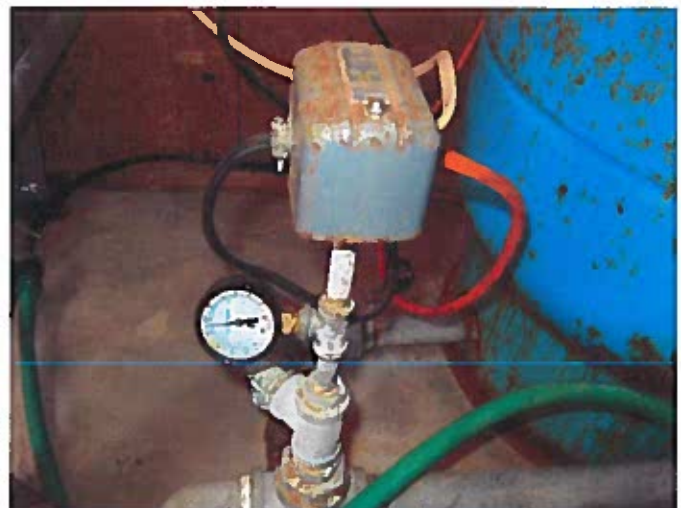
2. Pressure switch and gauge reading about 45 psi.

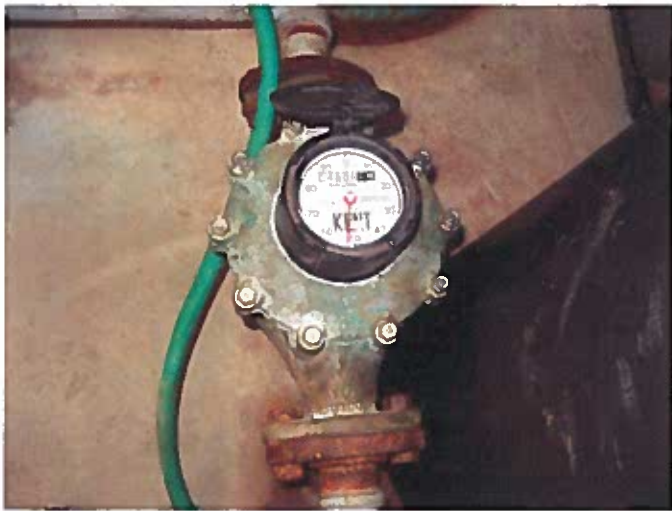
Diversion Rate: Graph used by IDWR to determine domestic demand shows that 24 homes would require an instantaneous diversion rate of 0.22 cfs (or 0.11 cfs for each permit). There is a flowmeter installed on the primary well (NWSW Sec 36). On June 13, 2012, the day IDEQ conducted its sanitary survey, the system was pumping at a rate of 51 gpm (0.11 cfs).

3. Flow meter in the pump house.

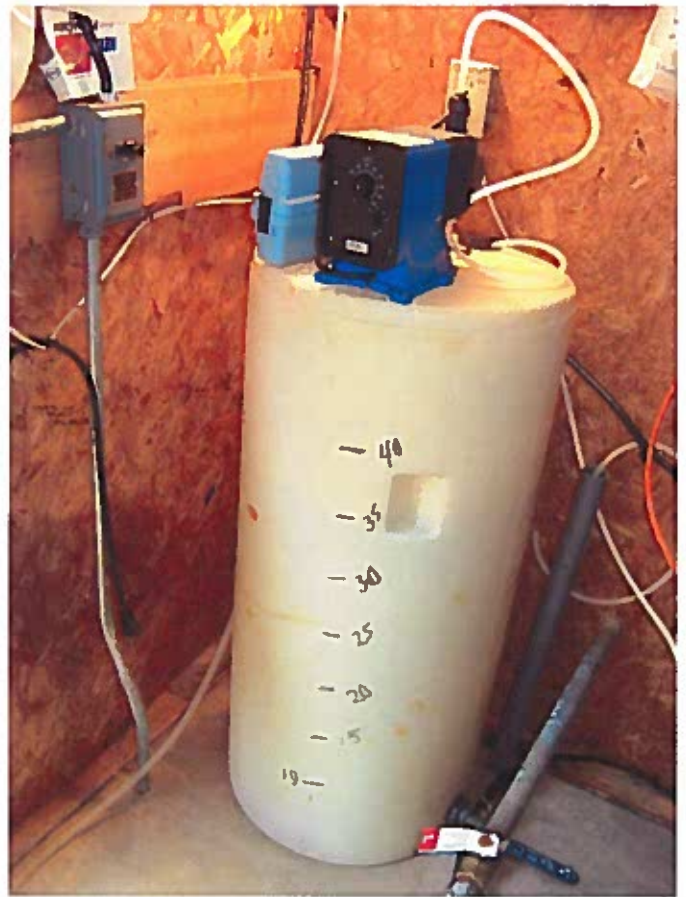
4. Chlorination system to the Main Well.

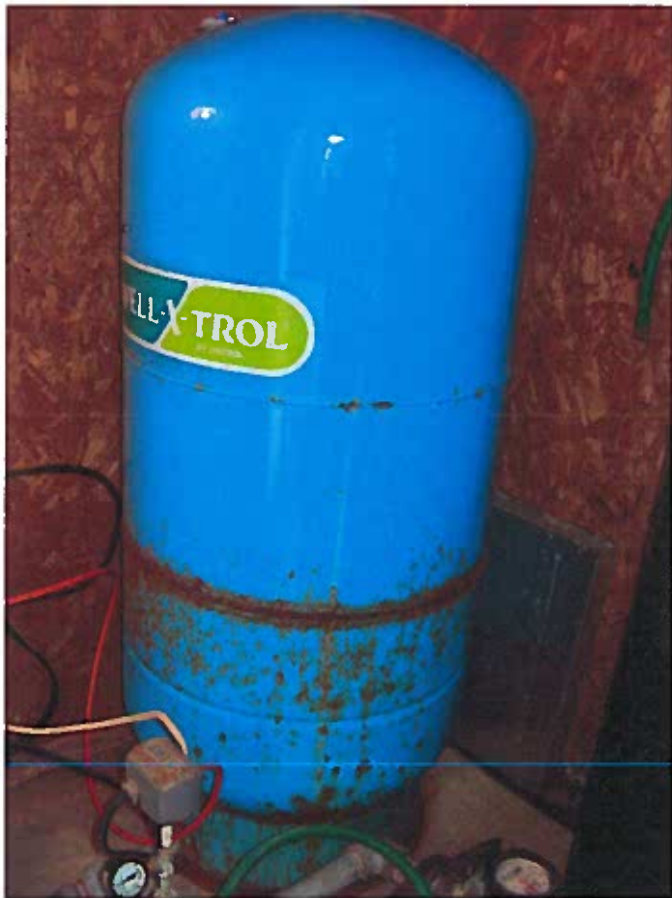
5. Pressure tank in the Main Well pump house.

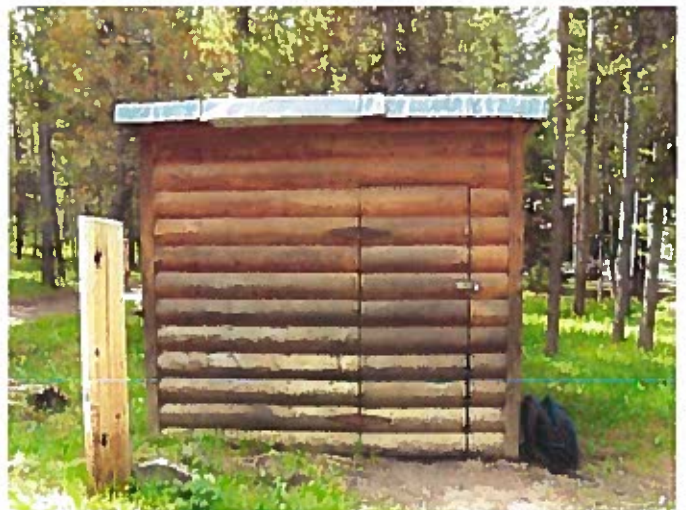
6. Pump house for the Main Well.

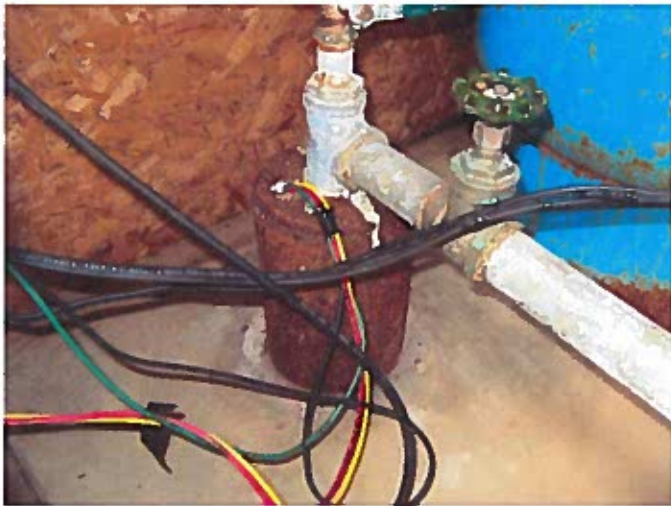
**Managerial:** 1. Inadequately protected electrical wiring is producing a safety concern, per IDAPA 58.01.08.501.6, IDAPA 58.01.08.501.14, and IDAPA 58.01.08.501.16.

7. Well head for Well #2, shutoff and concern with the electrical wiring.

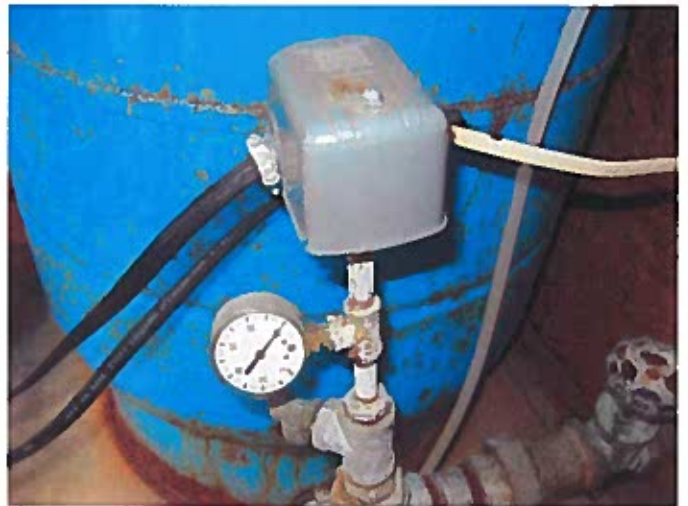
2. A pressure gauge is not provided at all installations for well #2, South Well or Back-up Well, or the existing pressure gauge is not properly working, as required by IDAPA 58.01.08.511.03.

8. Pressure switch and broken pressure gauge for Well #2.

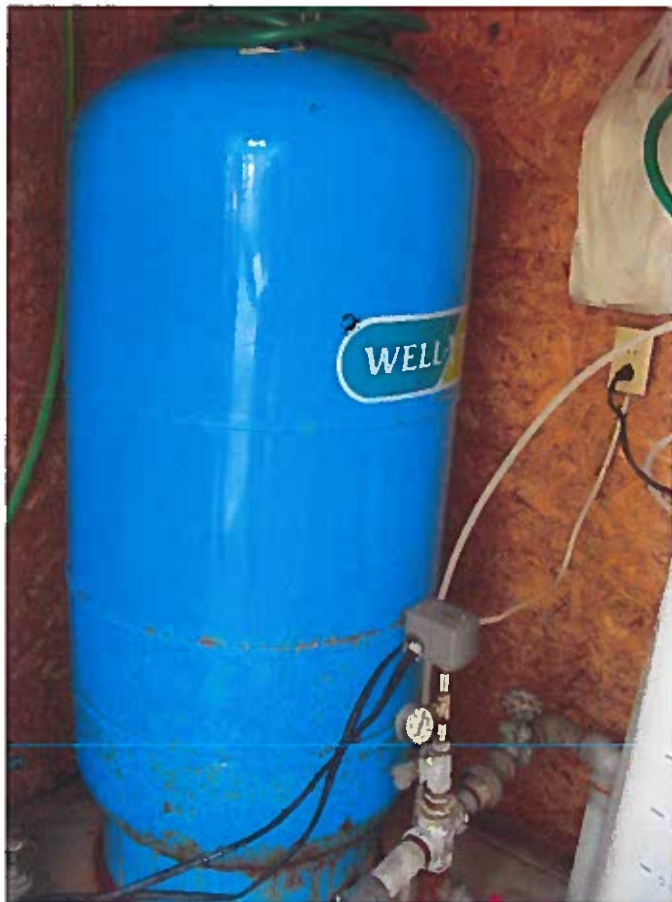
9. Pressure tank for Well #2.

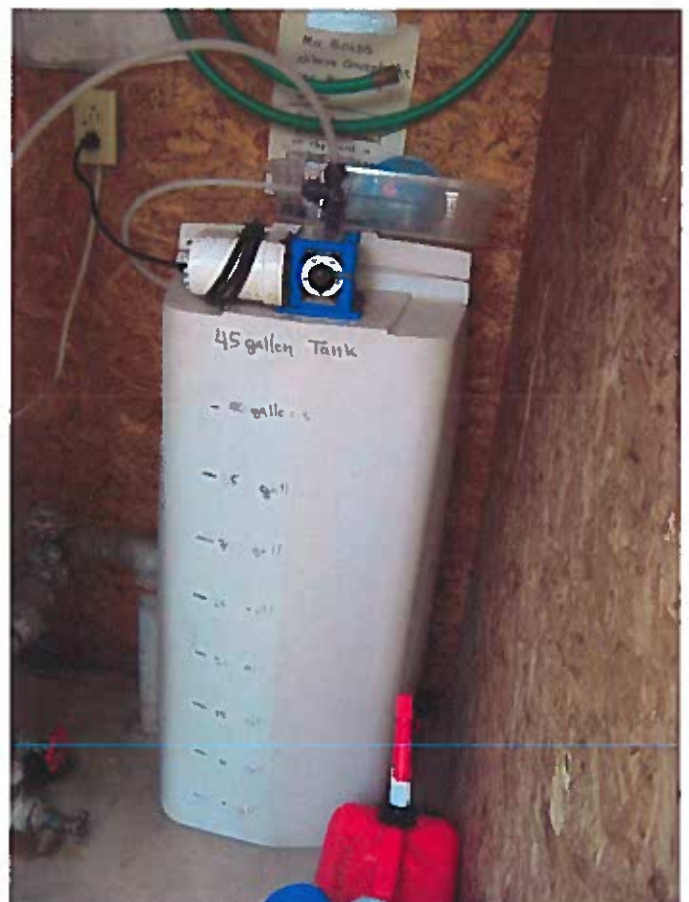
10. Chlorination system for the Back-up well.

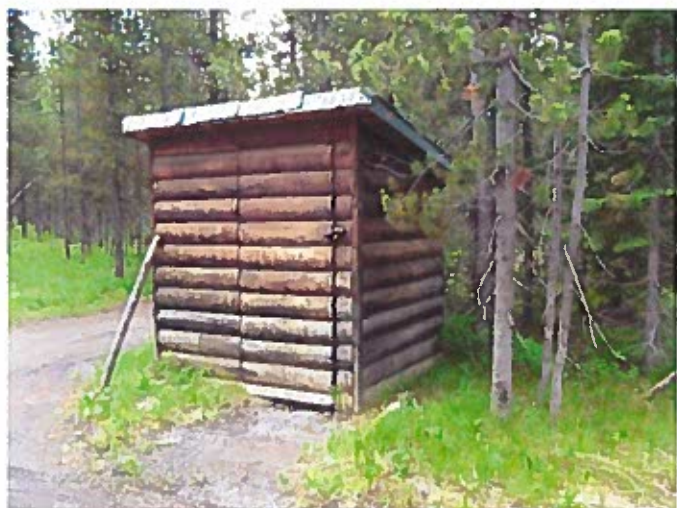
11. Pump house for the Back-up Well.

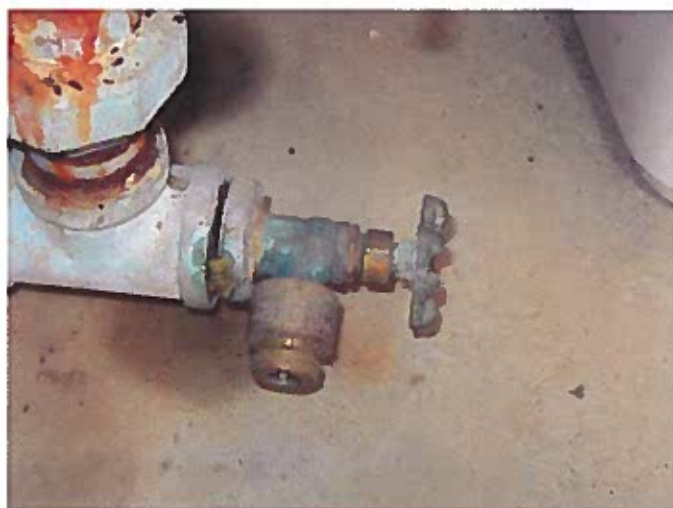
12. Corrected item from the previous survey.
