## MEMORANDUM

**To:** Permit 63-33698

**Re:** Second field exam and use of available surface water

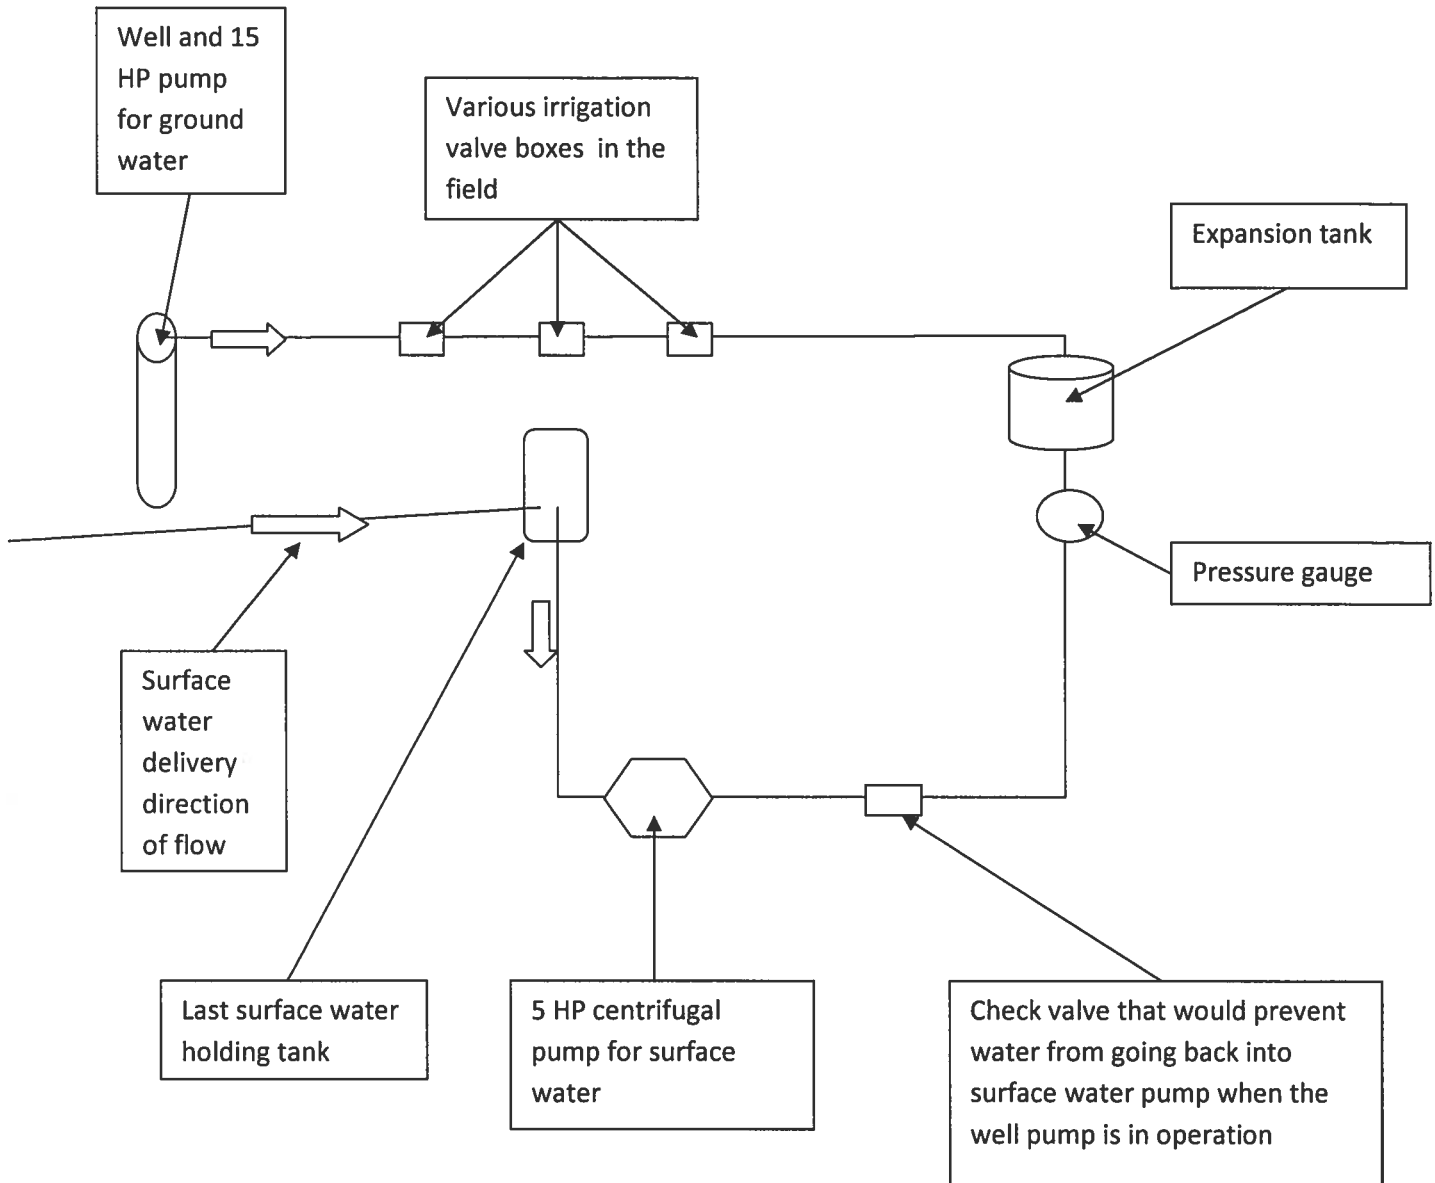
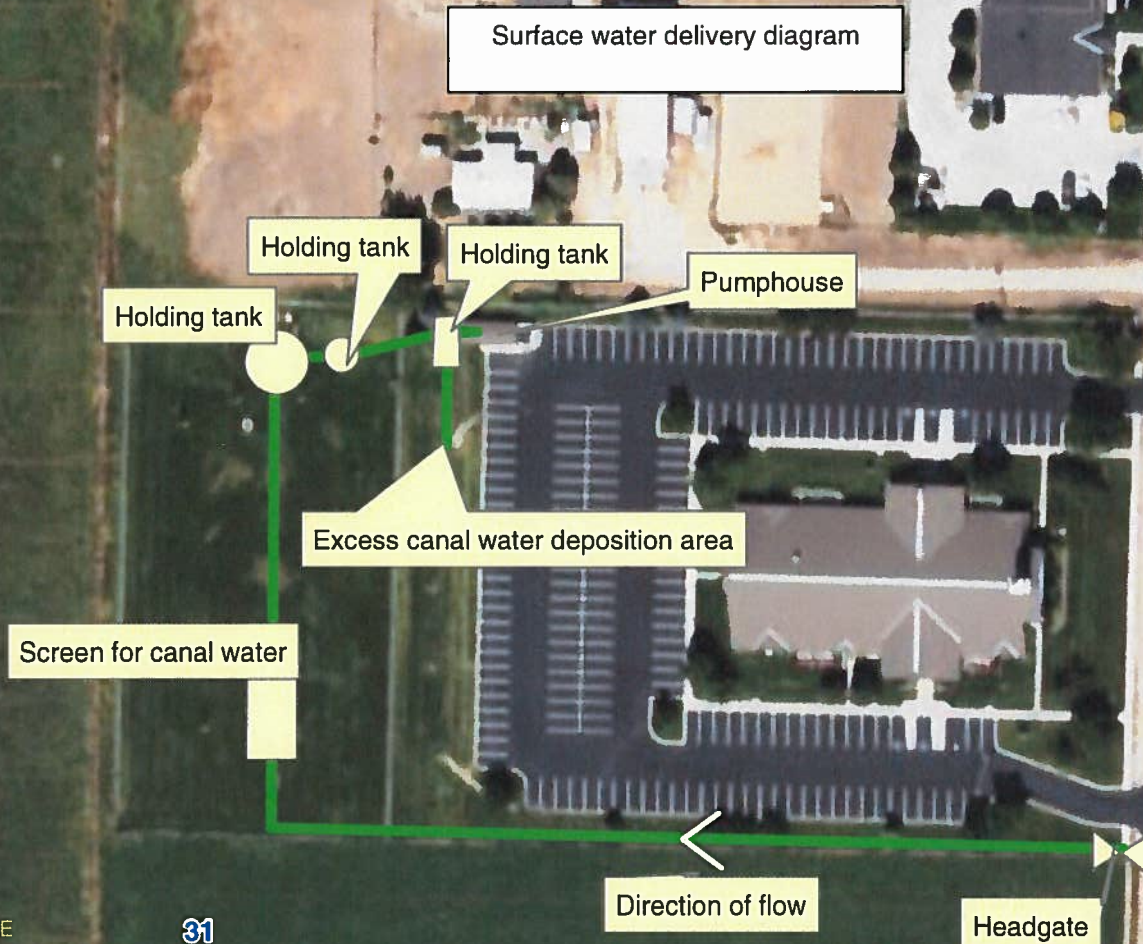
# Irrigation System Diagram

Green Line is location of the canal delivery line that is burried.

Rob Buchanan described the surface water delivery system. When surface water is delivered, it first comes into a diversion box along N. Locust Drive. The water then travels to a screen box on the west side of the property that has a series of screens for filtering the canal water. The canal water then travels to the north side of the property and into two 1000 gallon holding tanks. Water then travels towards the pumphouse and is discharged into another holding tank. It is from this third holding tank that the water is drawn from for pumping into the irrigation system. The supply line from the holding tank to the pumphouse is a 2" metal pipe. Water is pumped through a 5HP pump and into a 2" metal pipe that is tied into the mainline of the irrigation system. There is a check valve on the 2" metal pipe that prevents water from being pumped backwards into the 5HP pump when the groundwater pump is in operation. Any excess water in the last holding tank that is not used for the irrigation system overflows into a pipe in the last holding tank and is diverted into a large depression area on the west side of the parking lot . Currently the large depression area was being maintained as manicured lawn.

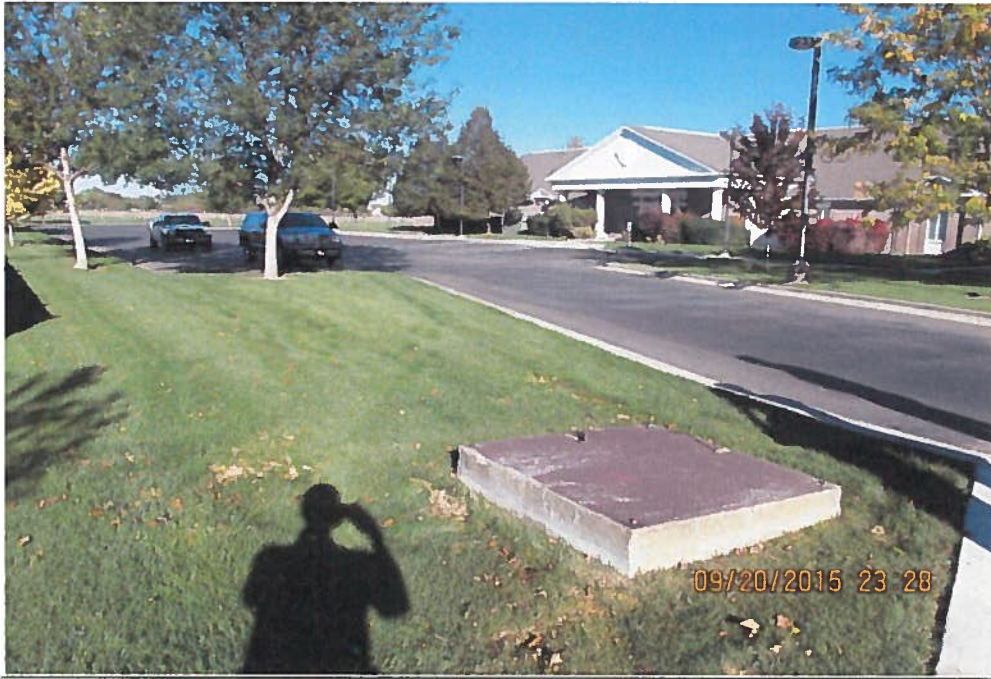
Headgate box that diverts surface water to the church property. This is the south east corner of the property.

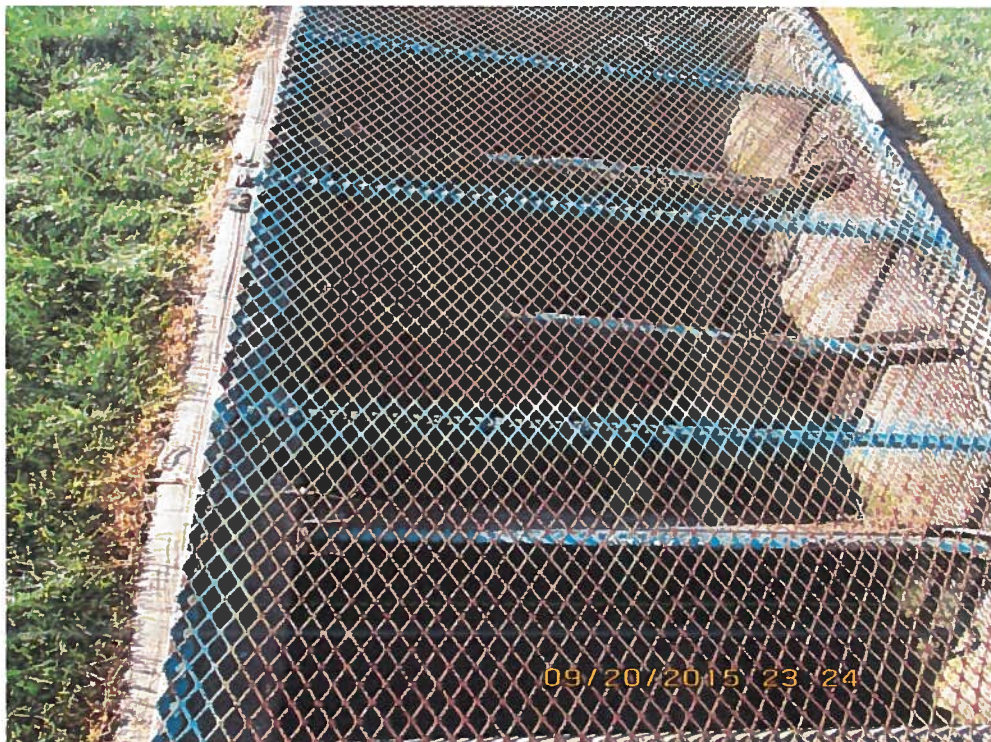
The filter box that filters the canal surface water before it goes into the holding tanks.

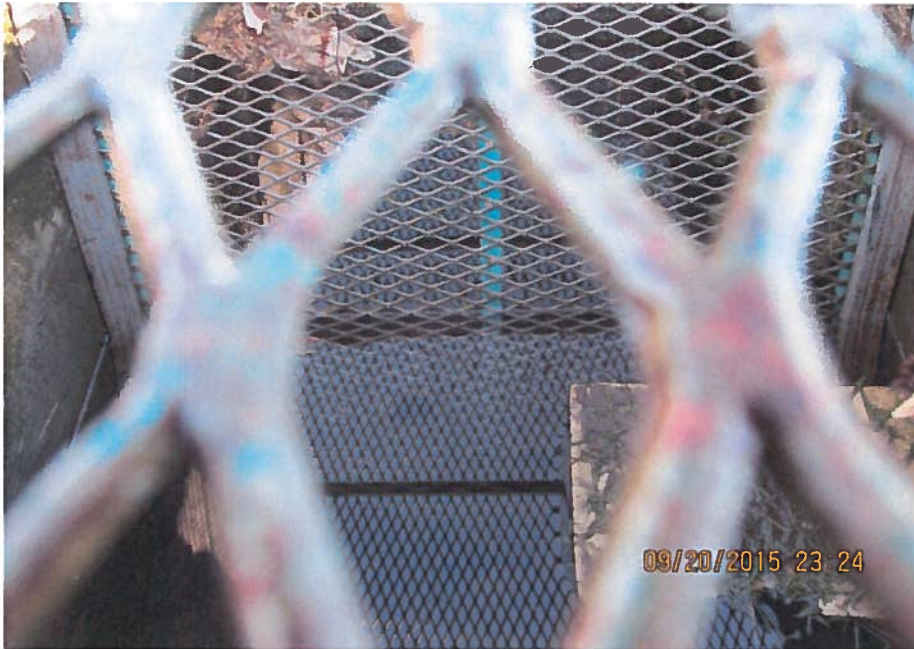
Looking in the filter box where water passes through a series of screens. Water was flowing through the screen box at the time of our field exam

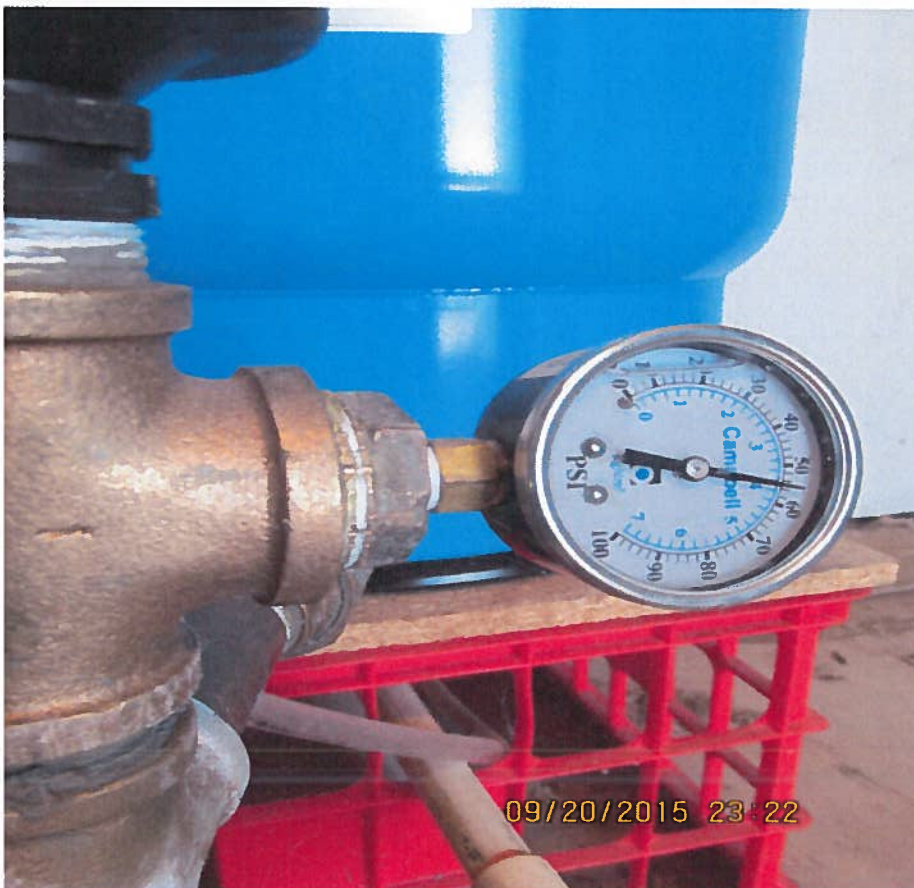
Pressure during the exam using the surface water with the above ground pump was 55PSI according to the gauge on the system.

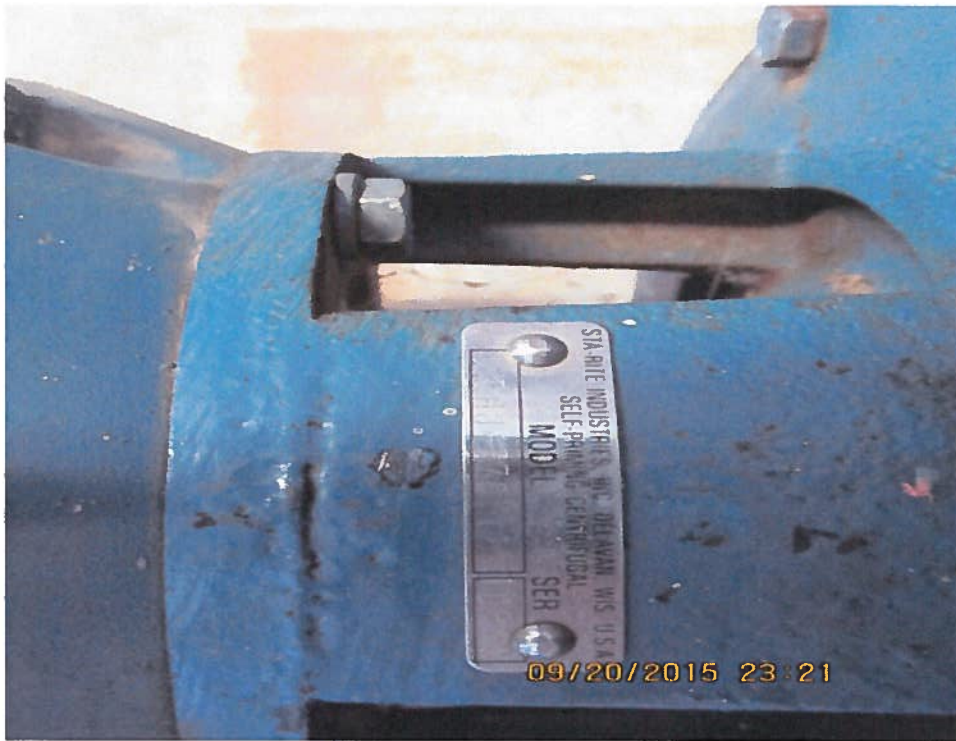
The pump  
information;  
STA-RITE  
Industries – self  
priming  
centrifugal  
Model DHJ-170  
Serial 1D99J

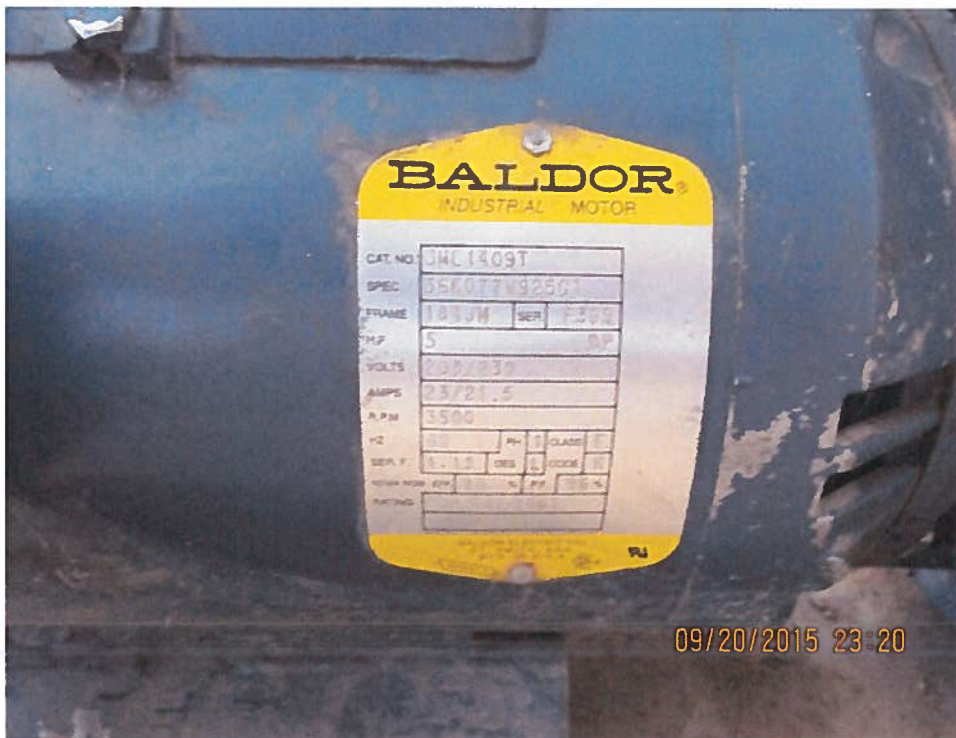
Pump motor  
info; Baldor  
Industrial  
Motor 5HP Cat  
No. JWL1409T  
Serial # F399

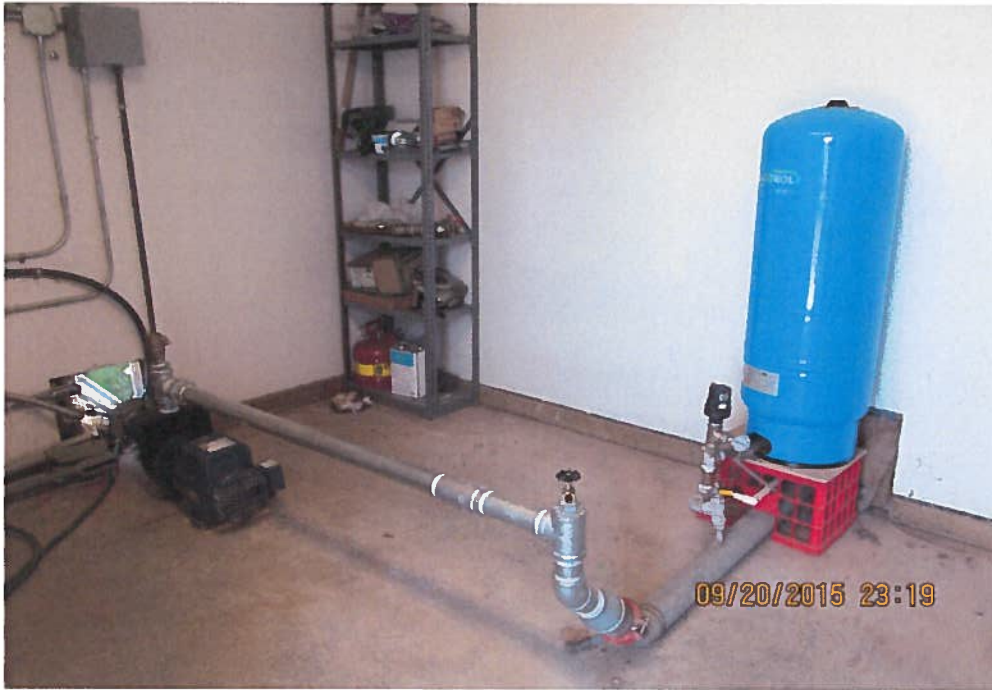
A view from inside the pump house. Water is pumped in from the holding tank outside the pumphouse, into the above ground pump, and is tied to the mainline with the pressure tank and pressure gauge.

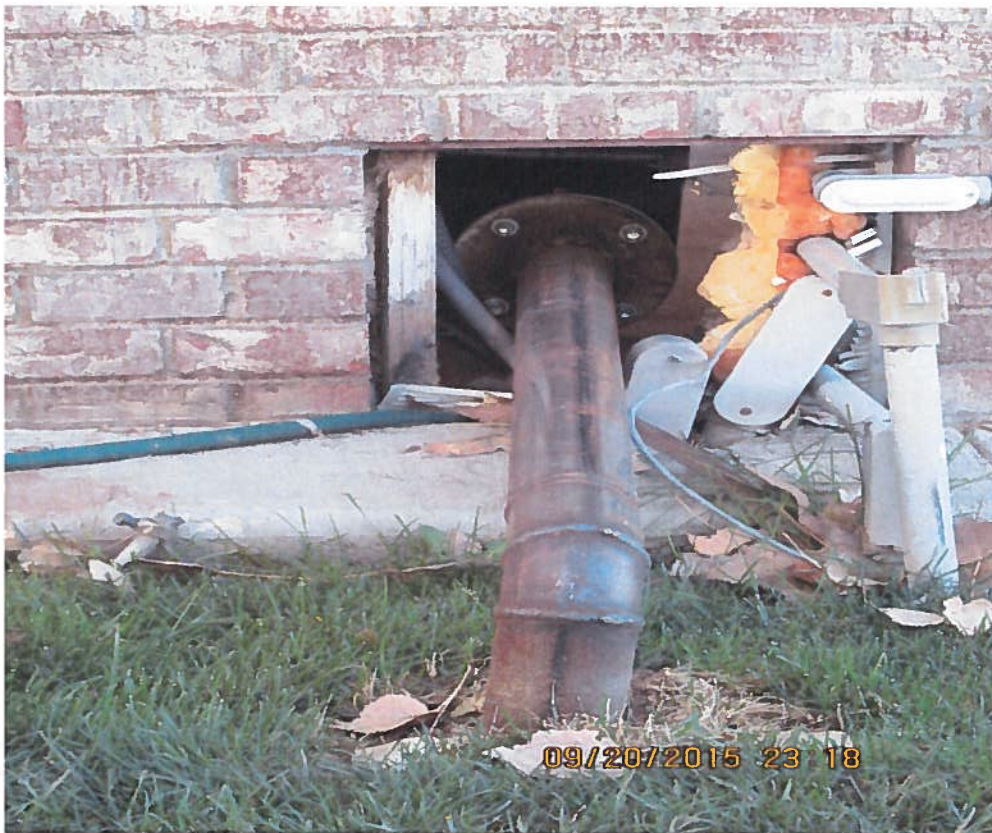
A view of the intake line from the holding tank going into the pump inside the pumphouse.

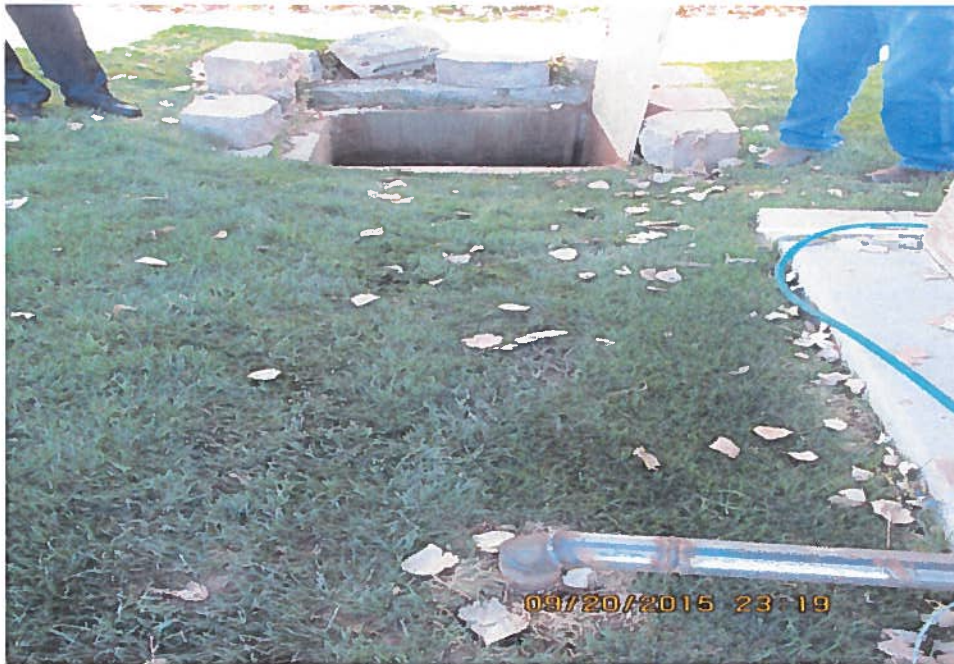
The holding tank where canal water is stored and diverted into the intake line for the above ground pump. Any excess water flowing into this holding tank overflows into a large depression area behind the parking lot.
