STATE OF IDAHO  
DEPARTMENT OF WATER RESOURCES  
**BENEFICIAL USE FIELD REPORT**

Permit No: 75-14215

Exam Date: 6/18/2014

**TO:** Dam File 75-14465  
**FROM:** John Falk, PE  
**DATE:** July 13, 2009  
**SUBJECT:** Chipps Creek Reservoir

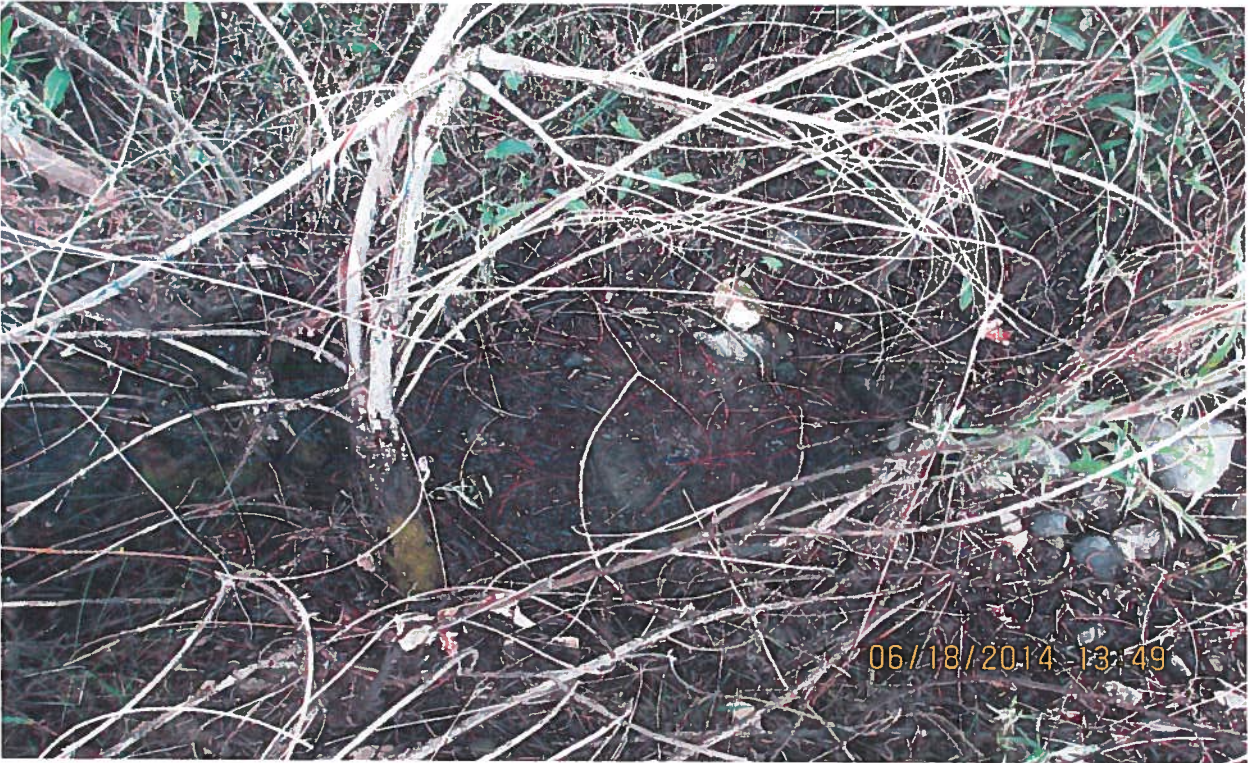
There is minimal seepage at the bottom of Chipps Creek Reservoir that appears to be the source indicated on the permit application. The application indicated that a point of diversion was located in T21N, R21E, Sec 02 in the SWSE.

Beginning of Seepage from Chipps Creek Reservoir (-113.939892, 45.172995)

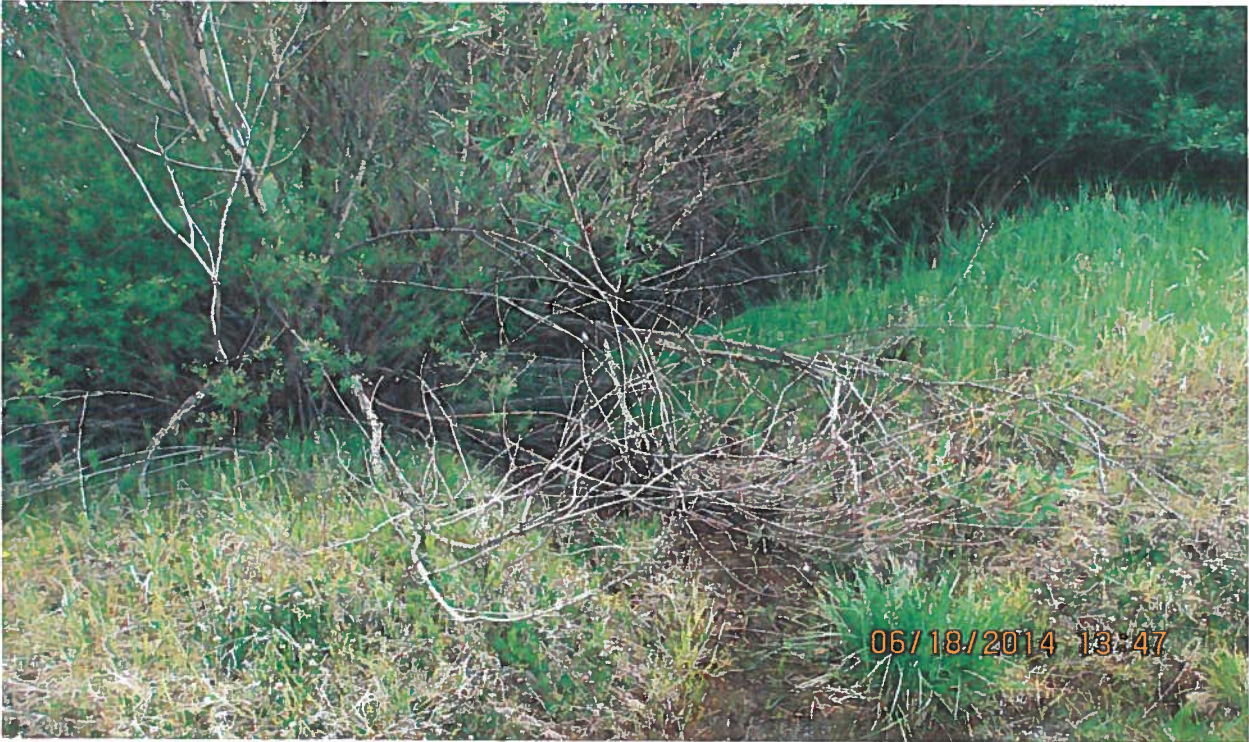
There is a small channel that connects to a diversion ditch for an irrigation company with a listed source of Pole Canyon Creek. The irrigation ditch runs through the applicants property, near the pond there is an uncontrolled secondary ditch that diverts water into the pond. It was noted during the site visit that the discharge from small channel below Chipps Creek Reservoir is significantly smaller than the inflows into the applicant's pond.

Confluence with Irrigation (Ditch?) looking East (-113.939124, 45.173282)

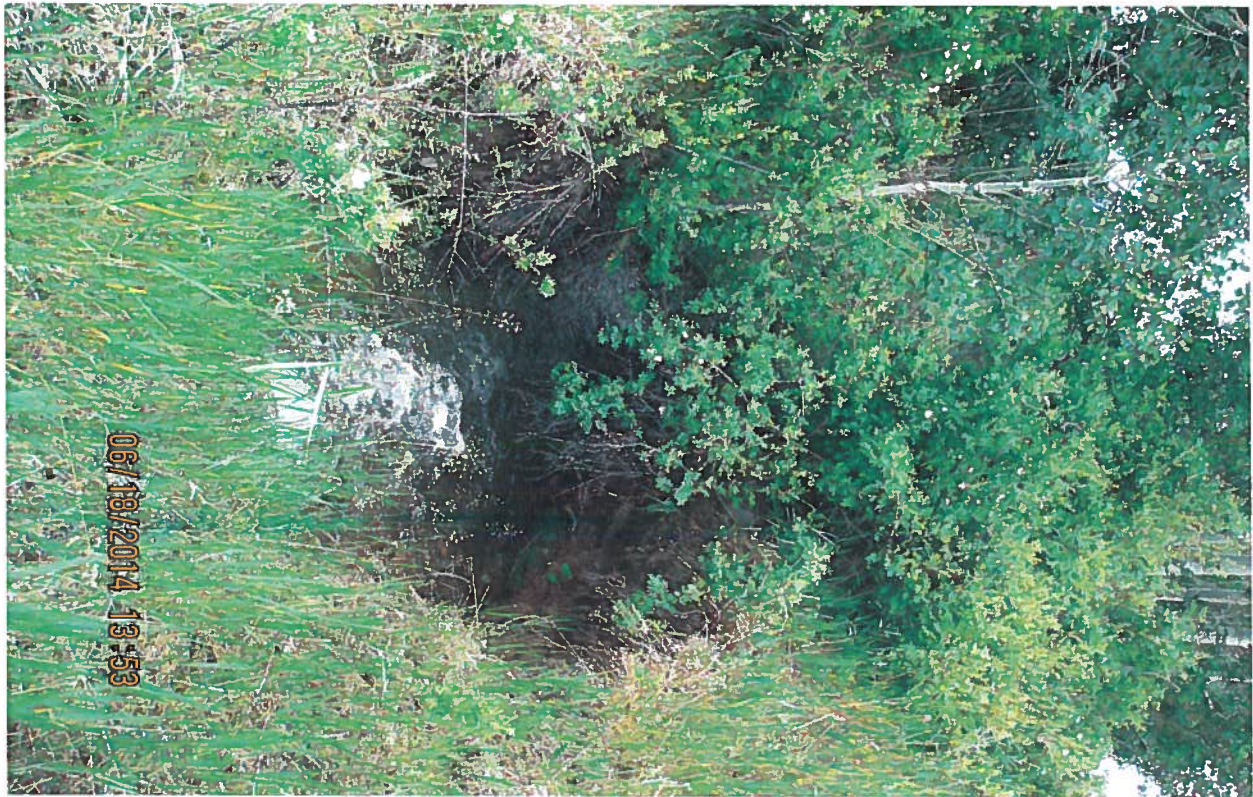
Flow below Sacajewa Road, looking East (-113.93829, 45.172575)

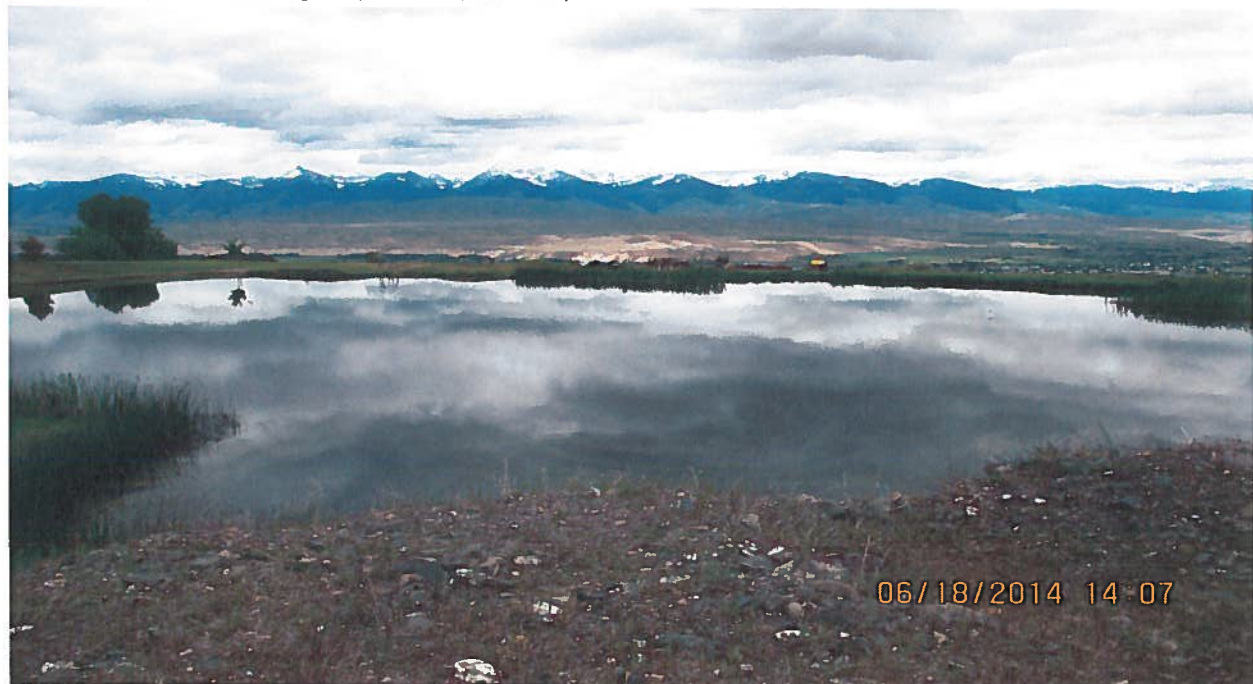
★ Pond is much larger than the volume authorized by the water right.

Pond, Looking North East

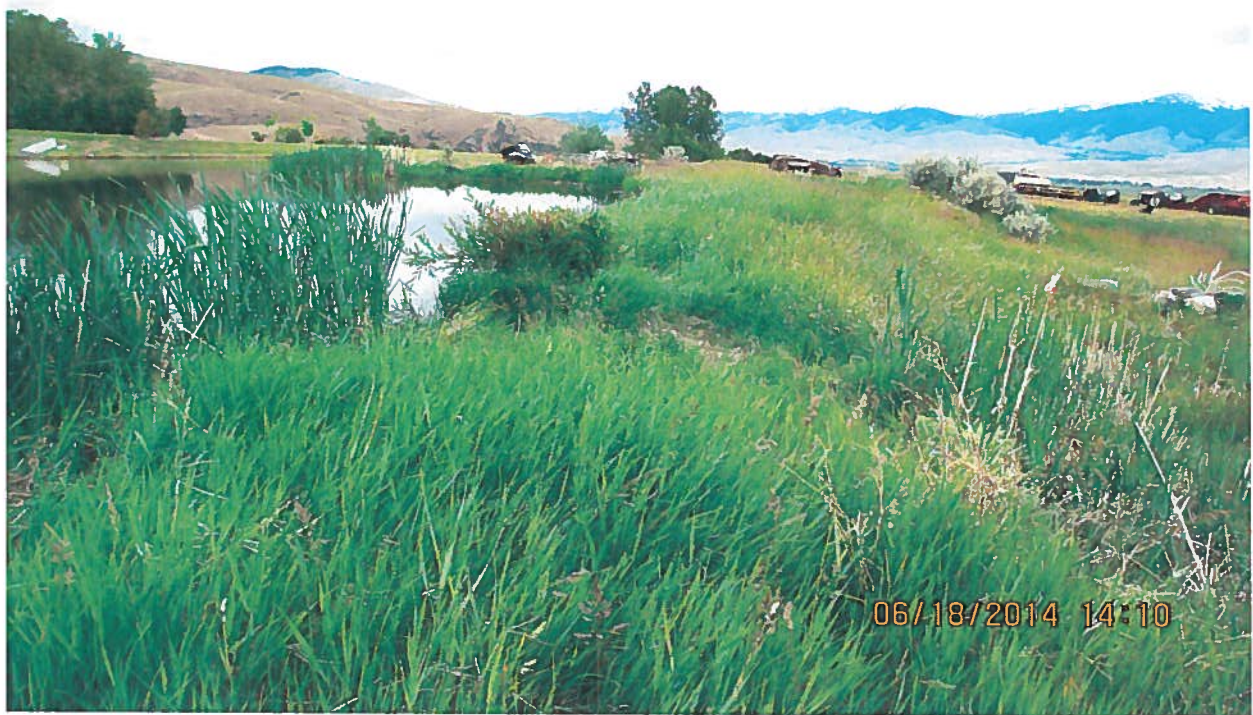
Dam, looking North

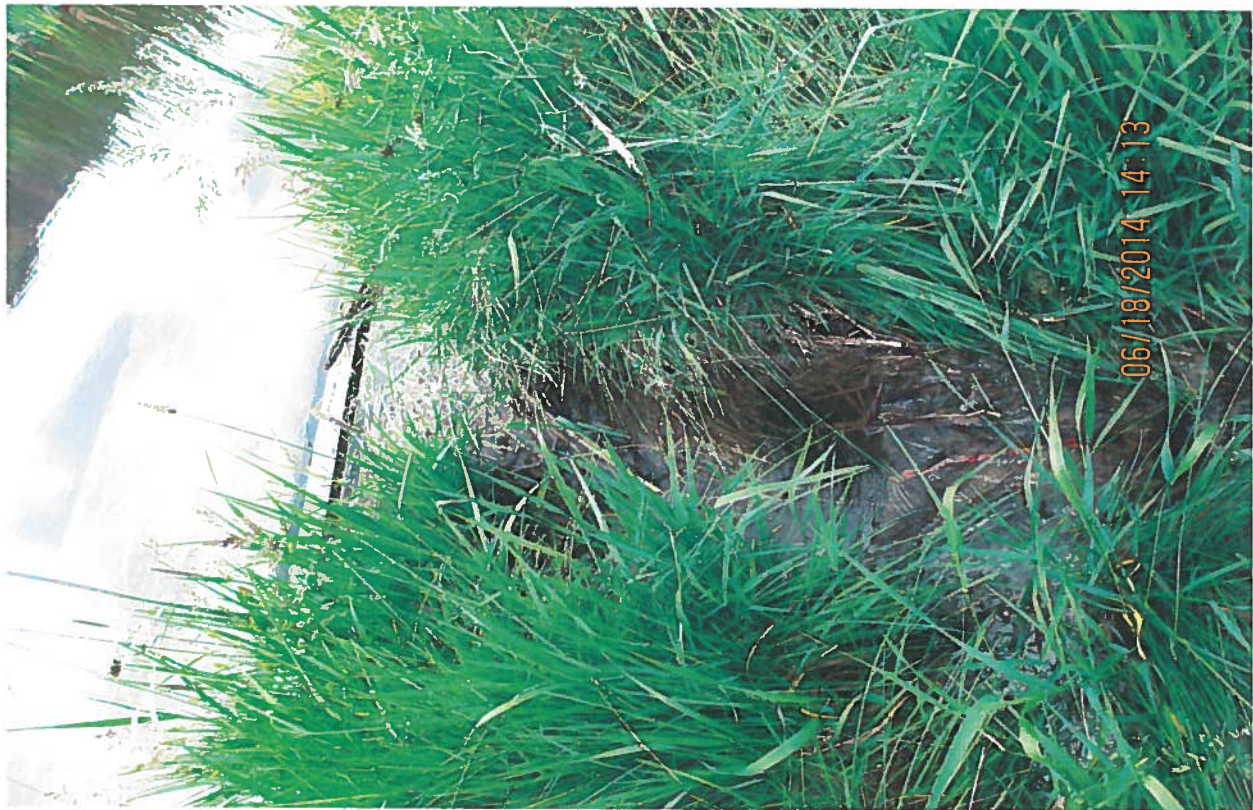
Outflow

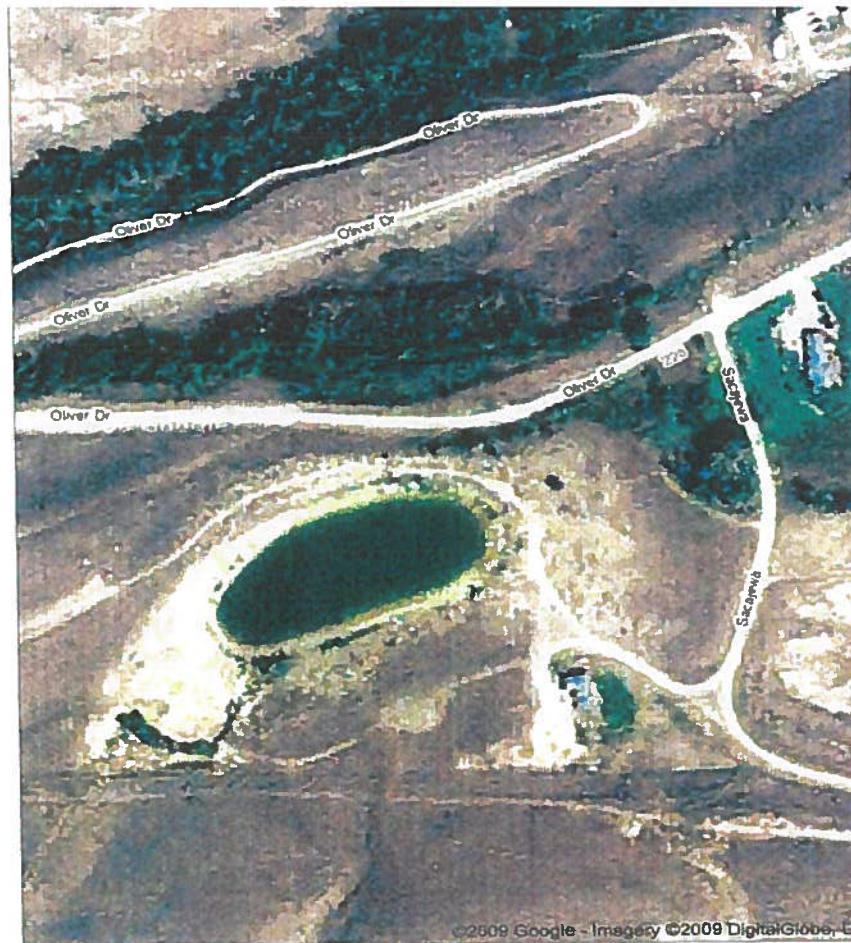
On Thursday 6/25/09, I visited the referenced off-channel impoundment located ~100 feet south of Oliver Drive in Salmon, ID (Photo 1). The weather was mostly sunny, warm, and dry. Based on my site observations, the dam consists of an earthen structure constructed near the base of a long, northeast sloping hill in Section 2, T21N, 21E, Lemhi County. The structure appears to have been built by the "cut and fill" method using native soils excavated from the reservoir and placed in a perimeter berm against the hillside. The exposed fill materials are composed predominately of reworked glacial outwash (clay/ silt → rounded cobbles up to 20" diameter). The age of the structure is unknown, but the size of trees growing on the north downstream slope suggest at least 15-20 years.

I also investigated the drainage path below the dam. A single residence on Oliver Drive exists in close proximity to the dam. In the event of a catastrophic dam failure and sudden release of reservoir contents, this property likely would experience significant flooding damages. A smaller, more shallow, and younger reservoir is located about one-quarter mile downstream. It appears that flood water from a catastrophic failure of the upper dam likely would overtop this pond, resulting in its failure. For these two reasons, the existing upper structure is rated a Significant-hazard dam.

Photo 1 – Aerial view showing reservoir and its relationship to Oliver Drive. Note the location of the residence near the intersection of Oliver Drive and Sacajawea Road.

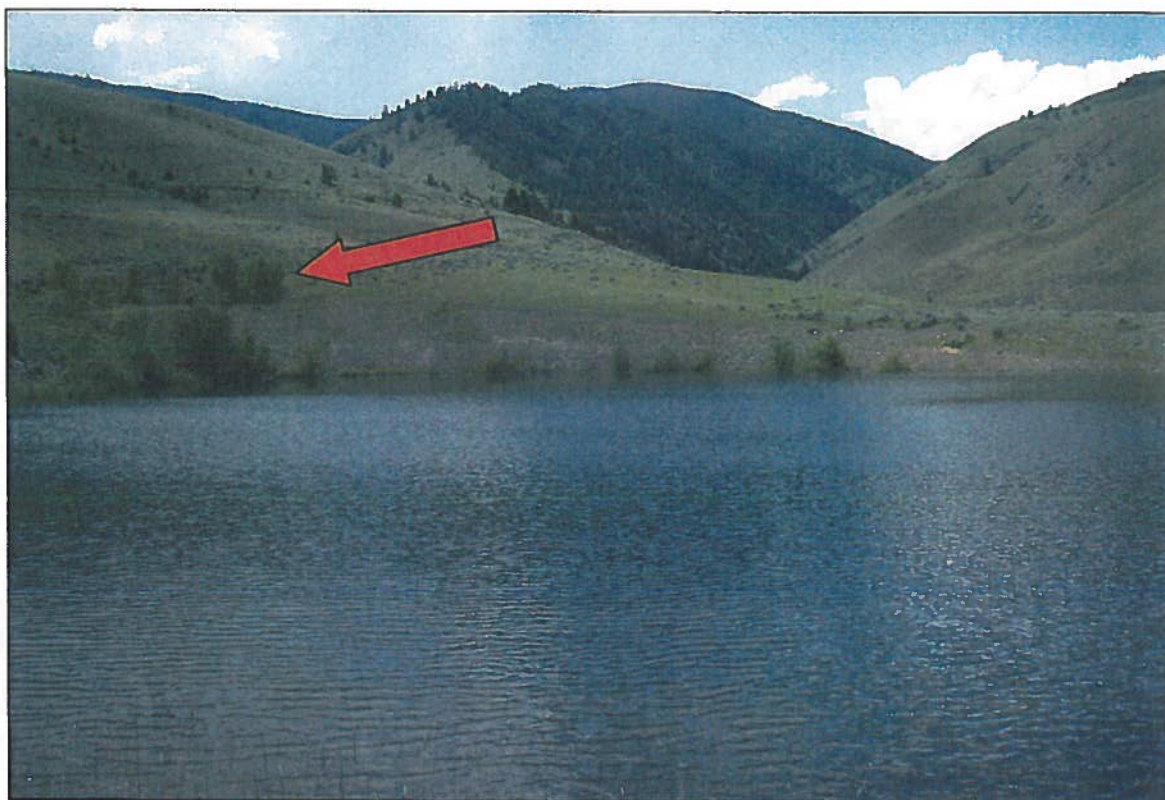
The reservoir apparently is filled by a combination of surface runoff from hillside drainage and water from a developed artesian spring (Photo 2). Flow into the reservoir at the time of the site visit was 30 gpm, or less. An emergency spillway did not appear to exist; neither could I locate a low level outlet conduit. Seepage was evident along the north and east, downstream toe of the embankment. Discharge rates were difficult to estimate due to a long strip of rounded river-rock that had been placed adjacent to Oliver Drive. This coarse gravel appears to function as a "French Drain" for the express purpose of diverting leakage from the reservoir away from the roadway (Photo 3). All seepage from the dam appeared to flow toward a common point at the downstream toe where it was routed into a small drainage ditch, presumably for irrigation purposes (Photo 4).

**Photo 2 (6/25/09) - Upstream view from dam crest looking across the reservoir to the primary source of water, supplied by a developed, artesian spring (shown by arrow).**

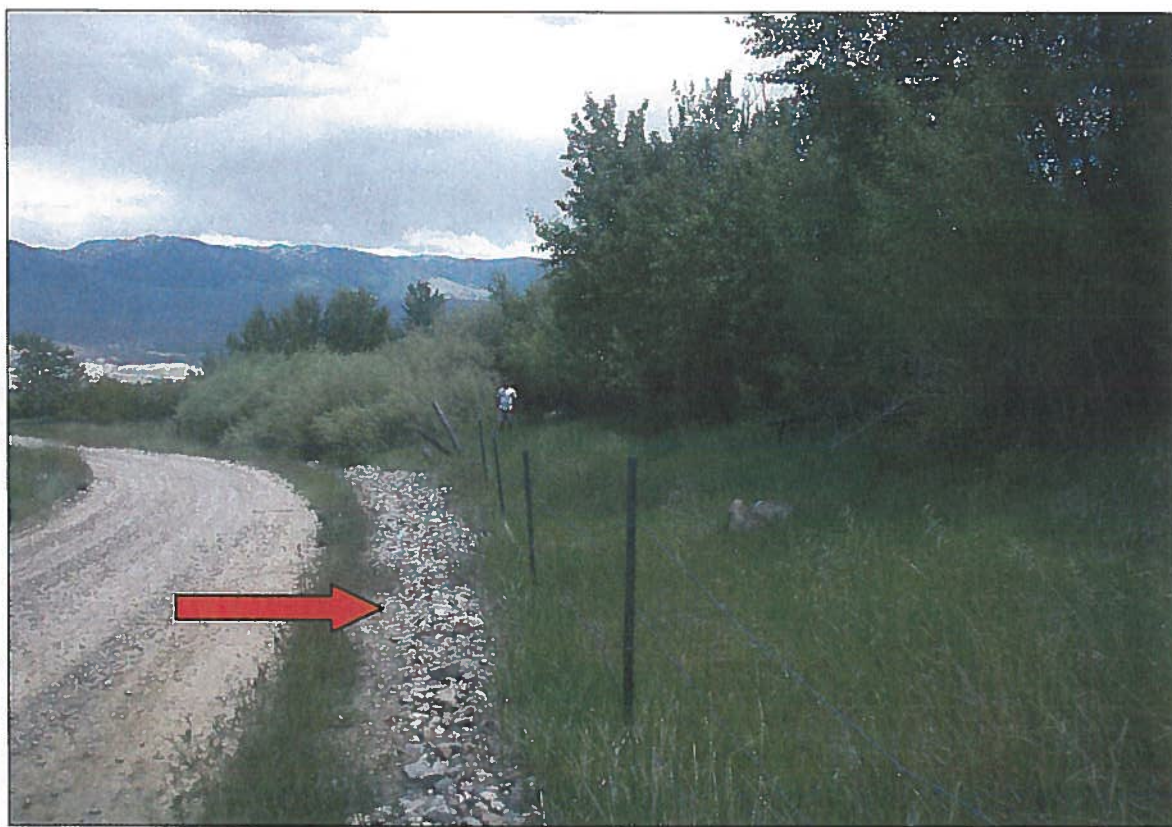
This project exists at an elevated risk for failure due to 1) the lack of an emergency overflow spillway to prevent overtopping of the embankment and 2) the absence of a low-level outlet conduit that could be used to lower or to drain the reservoir in the event of an emergency. Lastly, the lack of design drawings or construction details, together with the seepage along the toe of the slope contributes to my concern regarding the integrity of the embankment.

**Photo 3 (6/25/09) - Oliver Road, looking east along the north side of the existing embankment. Seepage from the toe of the slope is collected in the gravel drain material (shown by arrow). Note the heavy growth of trees and brush on the downstream slope of the dam.**

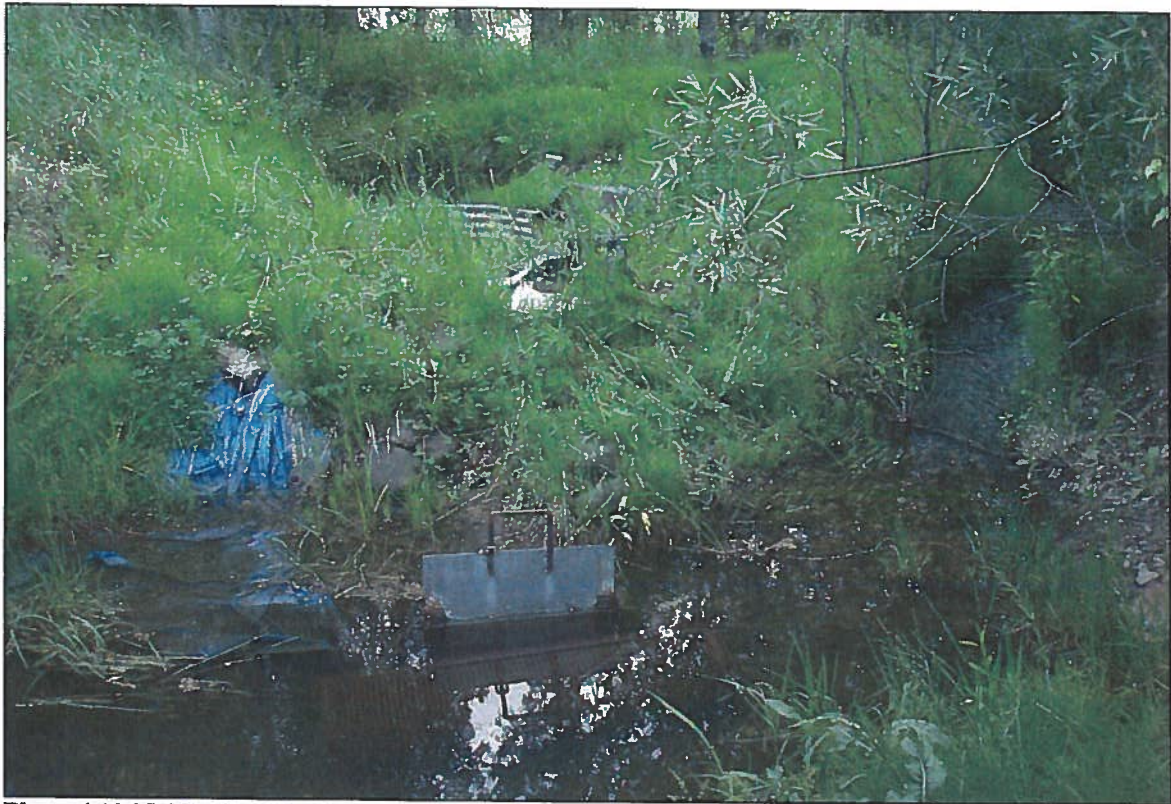
**Photo 4 (6-25-09) - Facility for collection of seepage from the dam. This feature exists on the east side of the embankment. At the time, the rate of flow in the ditch (right) was estimated ~20-25 gpm.**

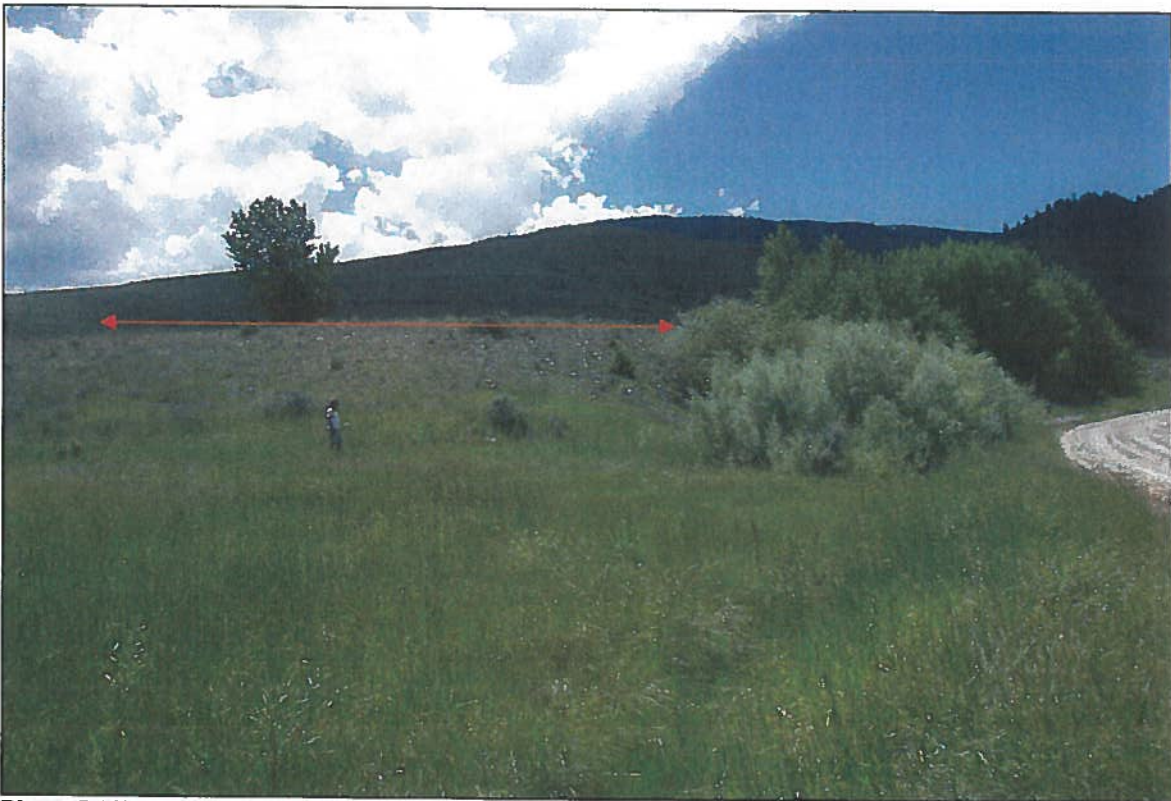
| • Embankment Height * | 15 feet (est) | Photo 5 |

**Photo 5 (6/25/09) - View looking at the downstream slope of the dam near maximum section. Note the location of Oliver Road (right), and the heavy growth of vegetation on north side of the embankment.**

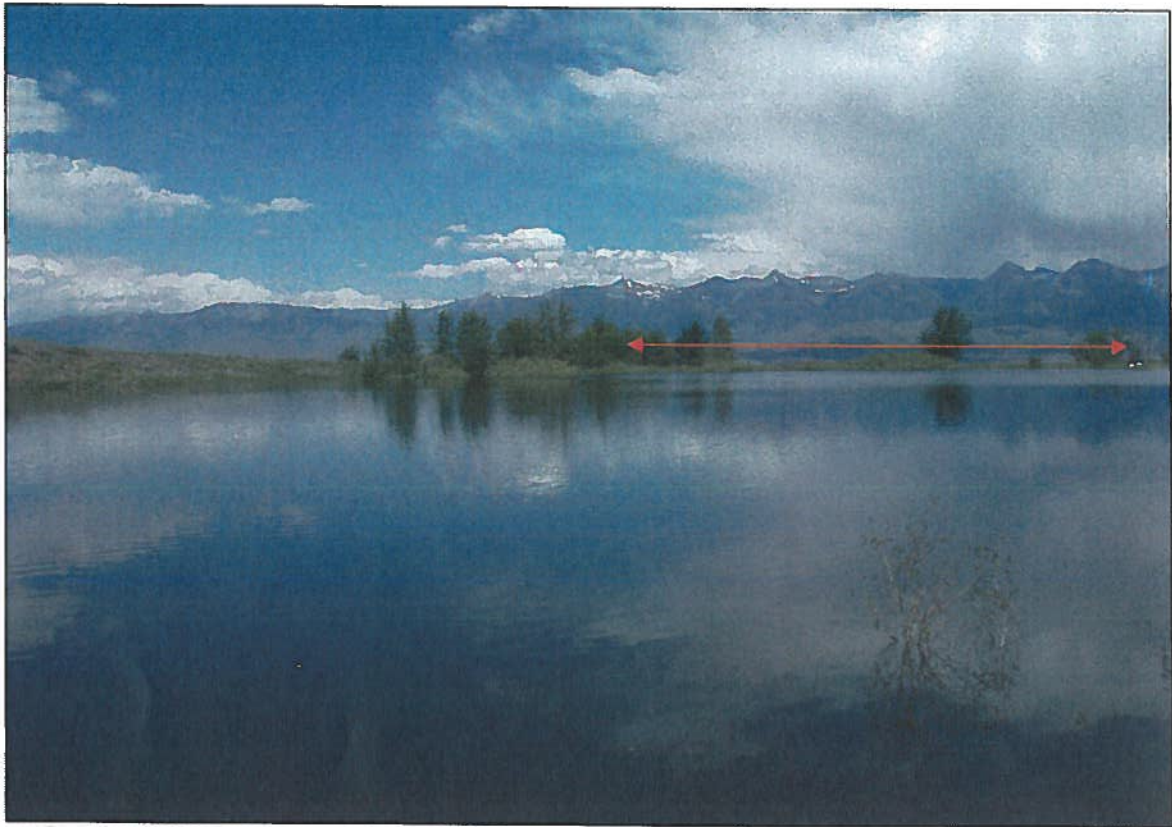
| • Freeboard | 1 foot (est) | Photo 6 |

**Photo 6 (6/25/09) - View from the back of the reservoir looking east, toward the crest of the embankment. Note the elevated water level referenced by the submerged vegetation.**

I recommend this dam be modified to include the installation of an emergency overflow spillway. Issuance of a formal Water Right to the owner(s) of this dam should not be approved until such repair is implemented to the satisfaction of IDWR Dam Safety. In the interim, this structure will be added to the state inventory of dams for regular inspection.

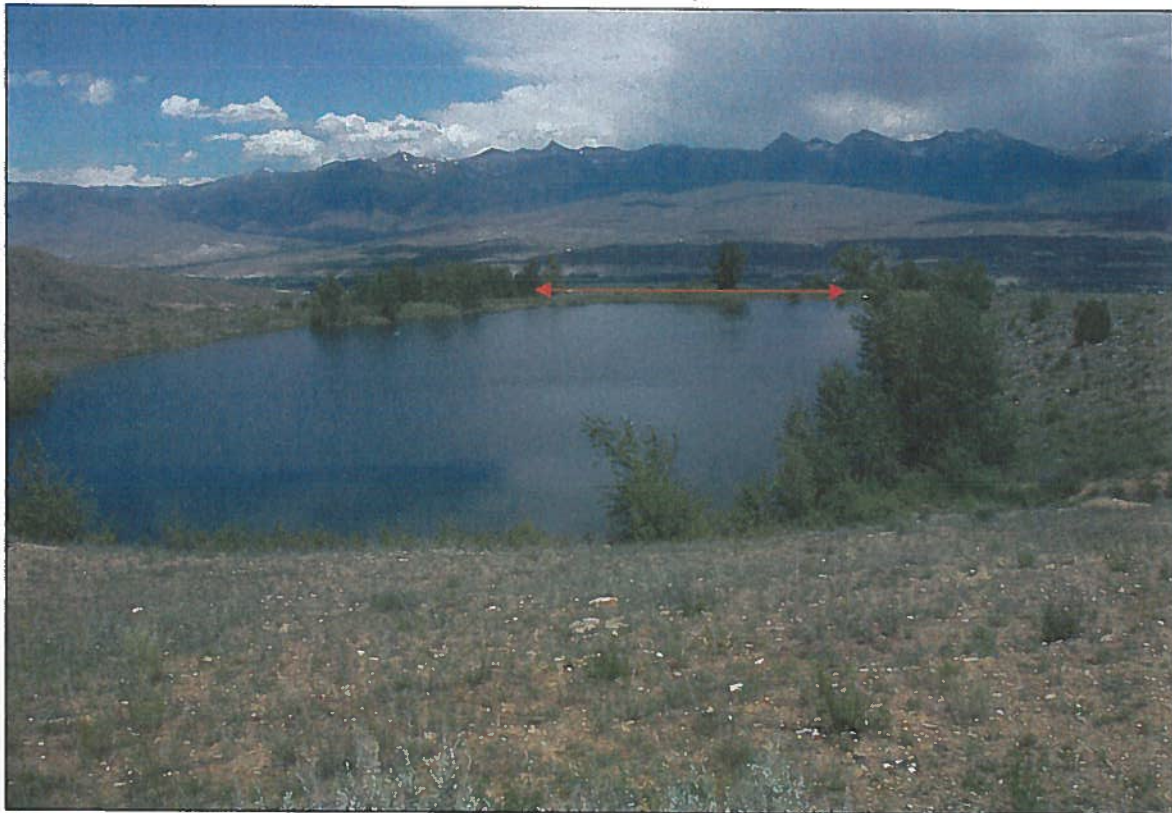
| • Pool Surface Area | 4 acres (est) | Photo 7 |

**Figure 7 (6/25/09) - Overview of existing dam (background) and reservoir. The treed area in the photograph right-front corner is the channel carrying water from the spring to the reservoir.**

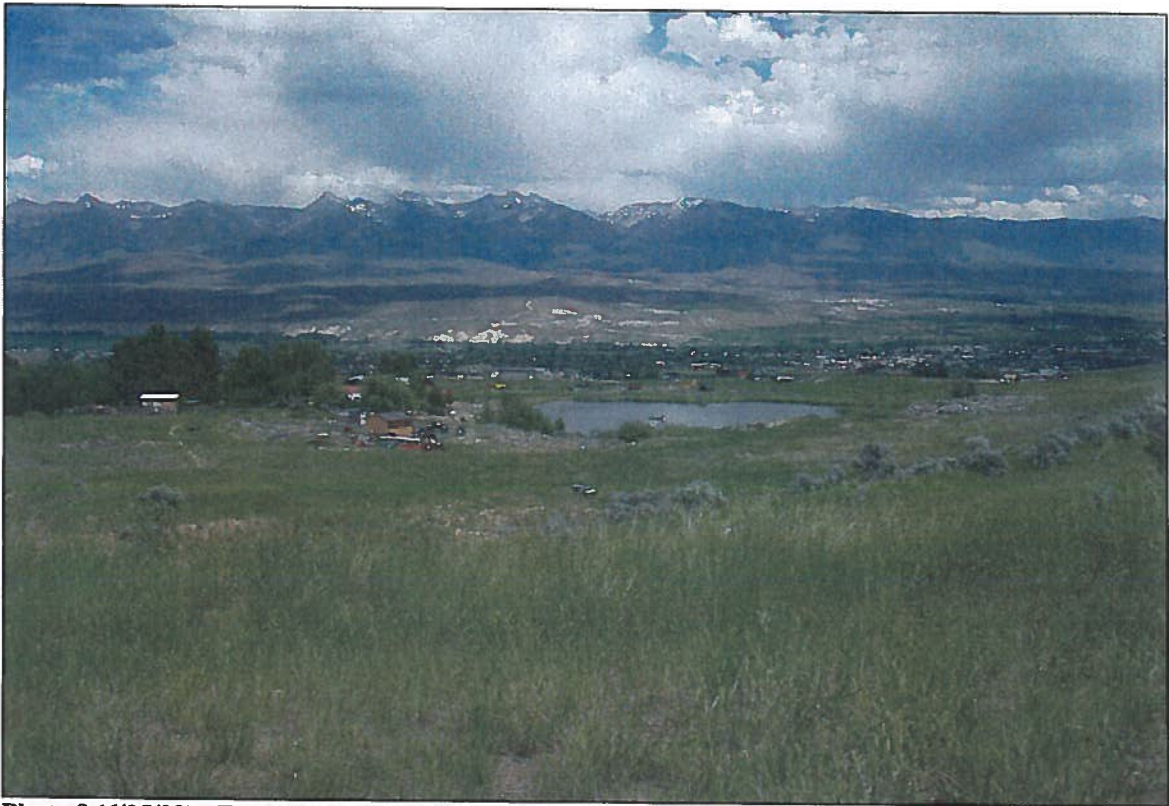
**Photo 8 (6/25/09) - Eastward view from Sacajawea Road, located near downstream toe of existing (Chipps) dam. The small pond in the foreground lies within the inundation zone of the existing dam.**

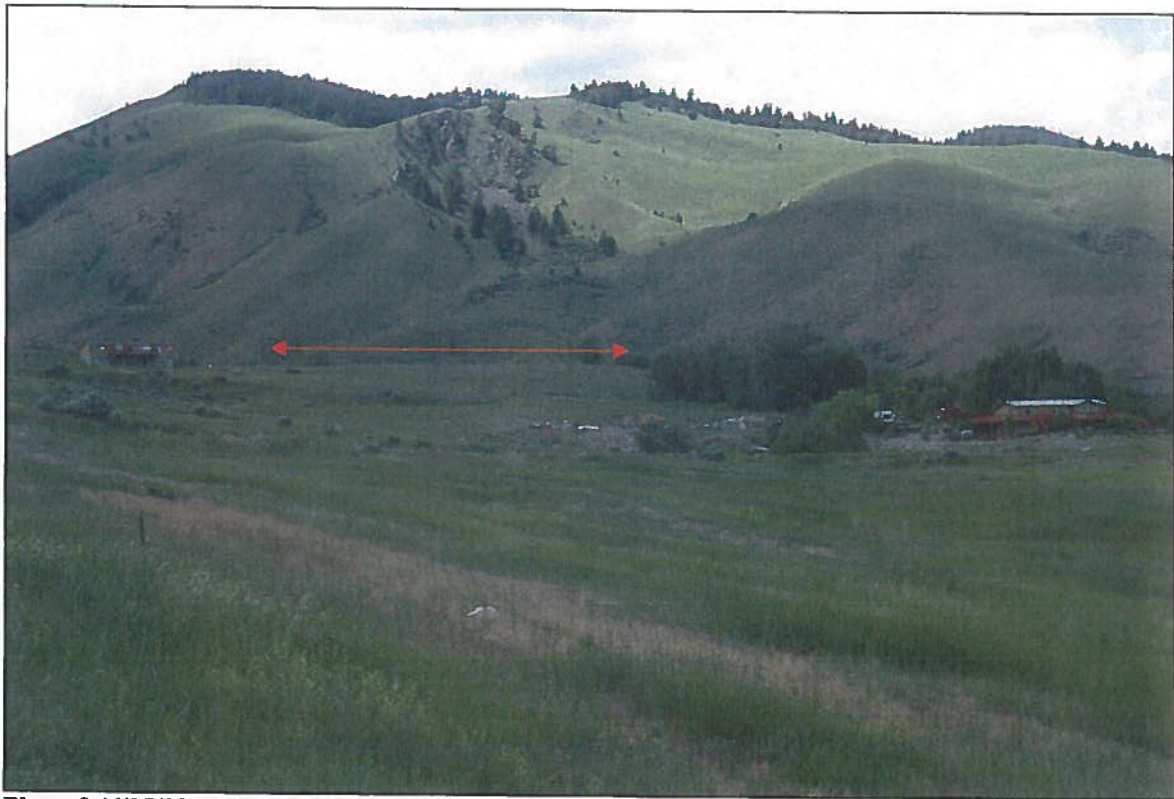
**Photo 9 (6/25/09) - Embankment from a downstream vantage point. The crest is highlighted with a colored line stretched above its length. In foreground is the small pond (shown above).**
