STATE OF IDAHO  
DEPARTMENT OF WATER RESOURCES  
**IN-OFFICE REVIEW/BENEFICIAL USE FIELD REPORT**

**A. GENERAL INFORMATION**Permit No: 75-14088

SUBJECT: Review of System for Licensing

# Cabin Creek Pipeline 75-14088

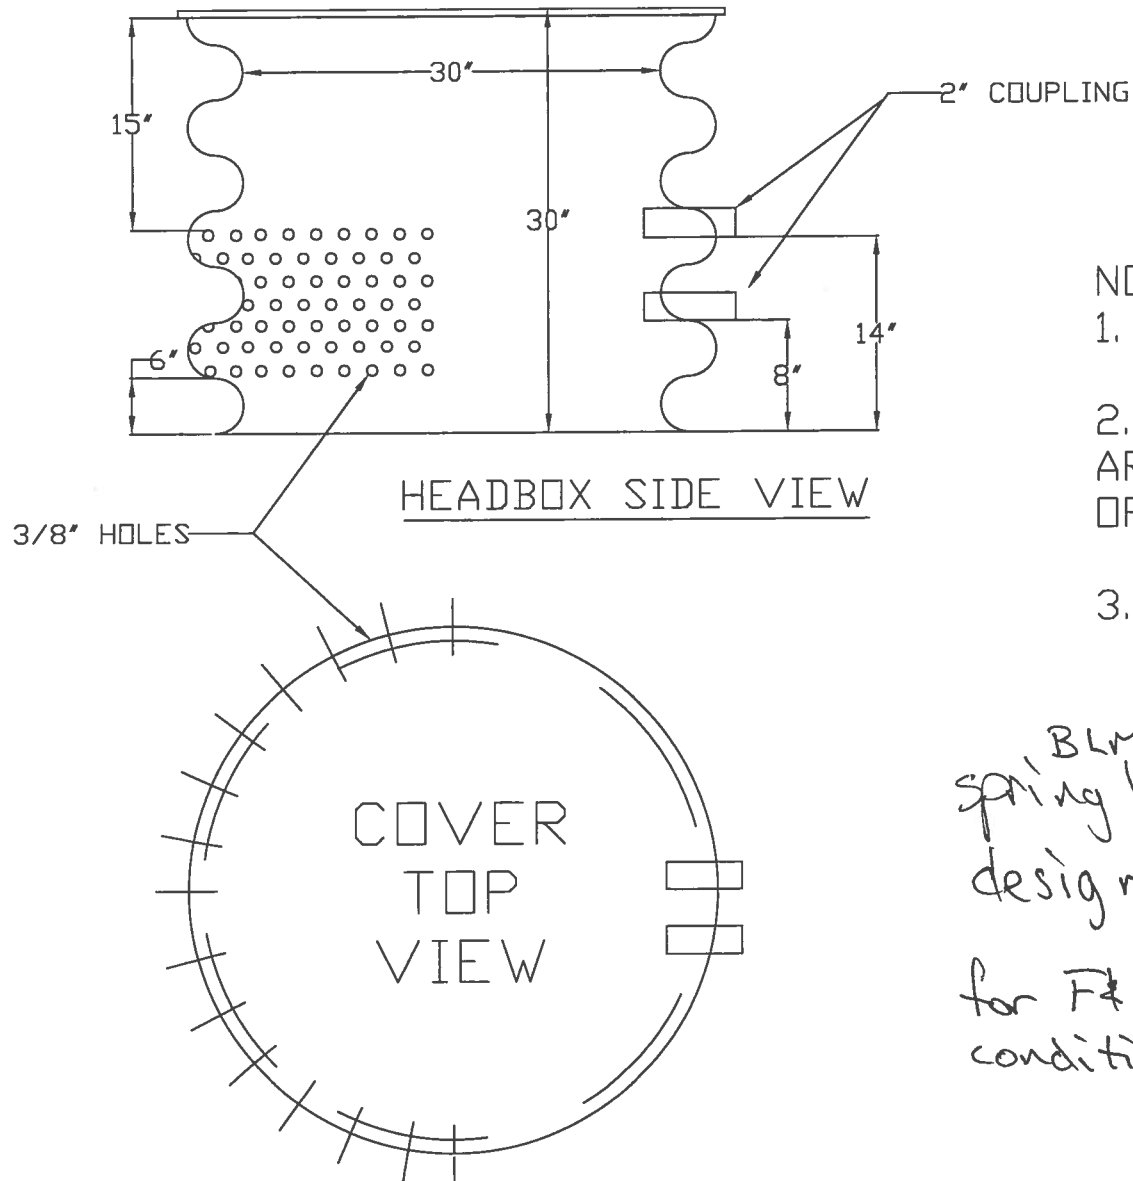
# SPRING HEADBOX & COVER DIAGRAM

Fish Screen condition – Diagram supplied by BLM indicating 3/8 in screen.

BLM  
spring box  
design  
for F&G  
condition

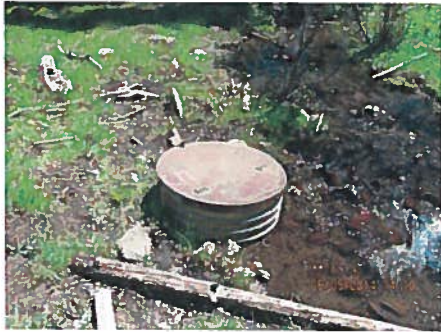
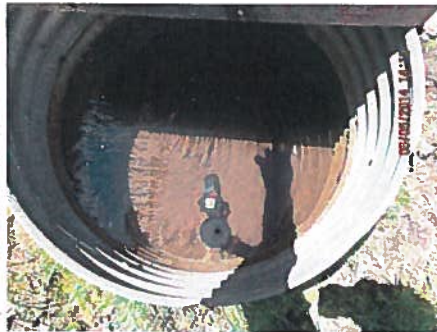
These first two photos show the headbox and the turnoff valve.

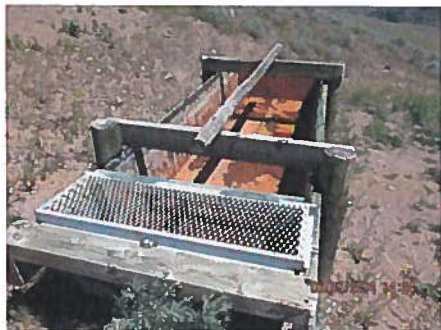
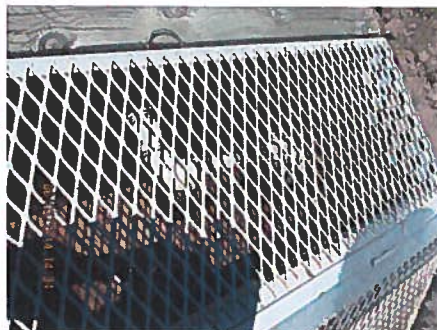
This second set of photos show the first water trough and the float valve in the tank.

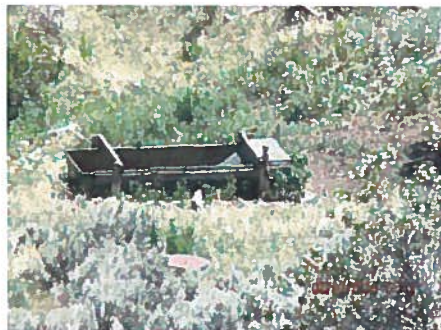
This photo shows the second trough and you can see it is set up exactly like the other two troughs.

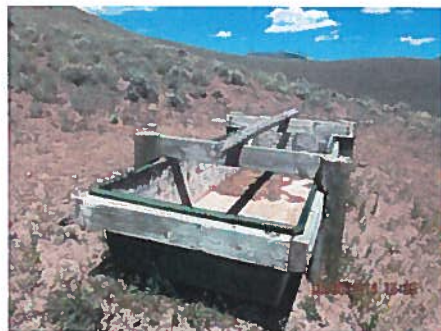
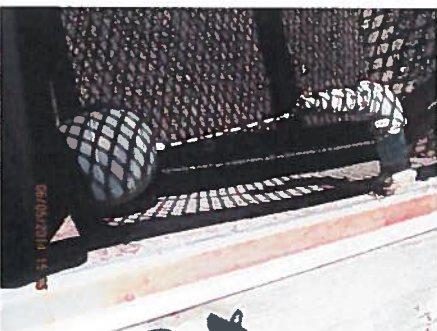
This is the third trough, and float valve.

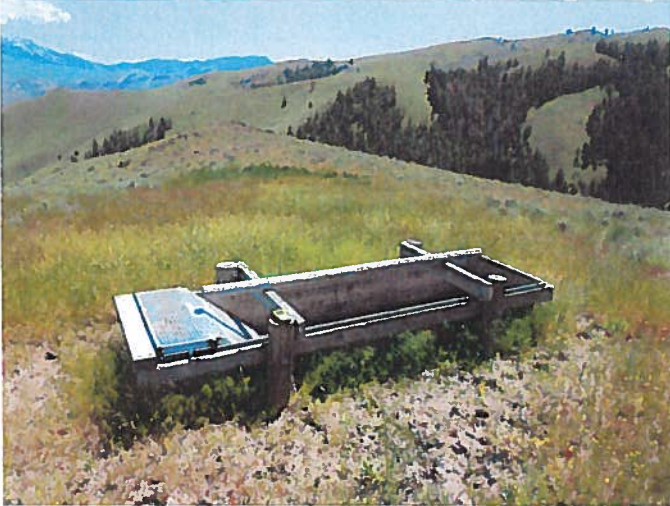
~~Fork R~~  
Trough  
# 3

| 7a. Last Inspection (Date)<br>New improvement 2004 | | b. Condition or success of improvement<br><input checked="" type="checkbox"/> good <input type="checkbox"/> fair <input type="checkbox"/> poor <input type="checkbox"/> failure | |

b. Describe needed repairs or treatment  
Drain was repaired in July by Operations Crew. Trough working.

8a. Recommended Action  
☒ Normal Maintenance ☐ Reconstruction ☐ Salvage or other use  
☐ Abandon ☐ Other ☐ Notify user/cooperator responsible for maintenance
