STATE OF IDAHO  
DEPARTMENT OF WATER RESOURCES  
**IN-OFFICE REVIEW/BENEFICIAL USE FIELD REPORT**

**A. GENERAL INFORMATION**Permit No: 74-7366

## MEMORANDUM

SUBJECT: Review of System for Licensing

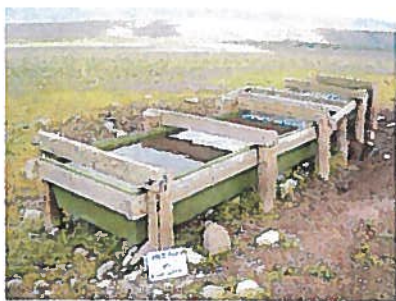
Existing Trough

| c. Document existing noxious weed species and extent of infestation (if none, state "none observed")<br>Some mustard observed around trough | | | |

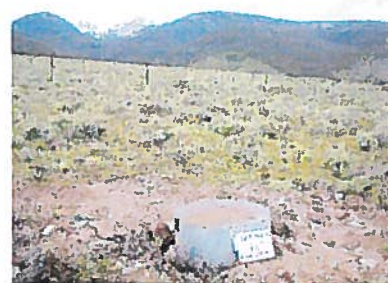
Pressure Break 2

| b. Describe needed repairs or treatment<br>Vince, the hired man, wants to move one of the pressure boxes closer down the line to a trough; it doesn't have good pressure. | | | |

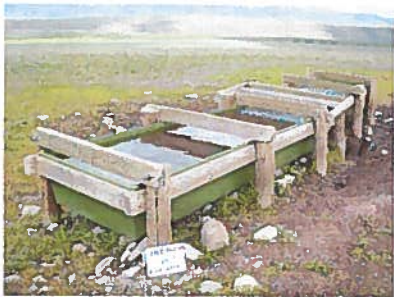
Existing Trough

| c. Document existing noxious weed species and extent of infestation (if none, state "none observed")<br>Some mustard observed around trough | | | |

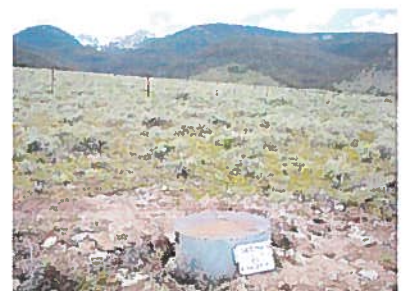
Pressure Break 2

| b. Describe needed repairs or treatment<br>Vince, the hired man, wants to move one of the pressure boxes closer down the line to a trough; it doesn't have good pressure. | | | |
