**Date:** December 31, 2013  
**To:** Water Right File 95-9502  
**From:** shemenway  
**Re:** Field Exam Narrative and Licensing Review

Subject: Sanitary Survey of PWS #1280030 conducted on June 16, 2009

**Panhandle Health District  
Drinking Water Supply Report**

**System:** Camp Mivoden

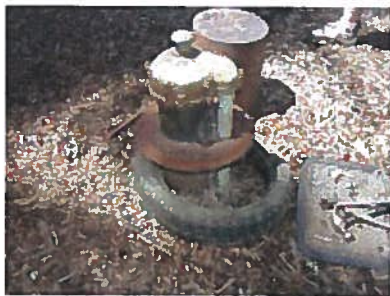
Well #3: Well #3 is a 6-inch cased well drilled 11/29/1989 to a depth of 350 feet. It is located south of the parking lot, approximately 30 feet east of the road. The well casing extends 24 inches above ground, fitted with a watertight vented well cap, to 39 feet below with a bentonite surface seal to 39 feet. The current capacity of the well is 6 gallons per minute (gpm). The flow meter and smooth-nosed sample tap are located in a vault adjacent to the well. A pressure gage and means to flow the well to waste must be installed on the discharge line.

Due to the close proximity of well #3 to a shallow creek, within 50 feet, a microscopic particulate analysis (MPA) must be conducted on the well during peak flow in the spring.

1. A pressure gage must be provided on the discharge line from each well.
2. Well #3 must have a means to pump the well to waste at the design capacity of the well via an approved air gap.

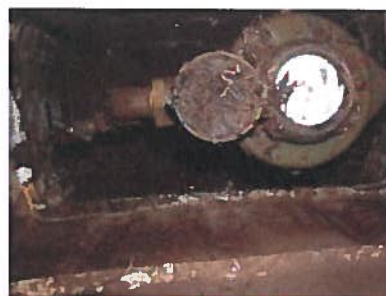
Vault with sample tap and flow meter

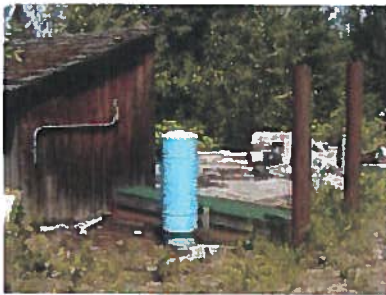
The reservoir does not have an overflow pipe or a vent. A properly screened overflow pipe must be provided where it drains to daylight in a way that will prevent backflow to the reservoir. A vent must also be provided with the open end at least 24 inches above the roof of the reservoir and screened with 24 mesh non-corrodible screen. This may be accomplished by adding a vent to the reservoir hatch inside the pump house. Currently the reservoir is probably vented through the access lids; however, these lids need to be fitted with gaskets to make them water tight and eliminate insects from getting in the reservoir. Spider webs were observed to be accumulating inside the reservoir hatch as a result of the hatch not being sealed.

Pump house and main reservoir

3. An overflow that discharges to daylight must be provided on both reservoirs in a way that will prevent backflow to the reservoir.
4. The main reservoir access lids must be provided with gaskets to make them water tight and eliminate insects from entering the reservoir.

5. The used paint buckets must be removed from the top of the main reservoir.
6. A vent must be provided on the main reservoir with the open end of the vent screened and turned downward at least 24 inches above the roof of the reservoir.

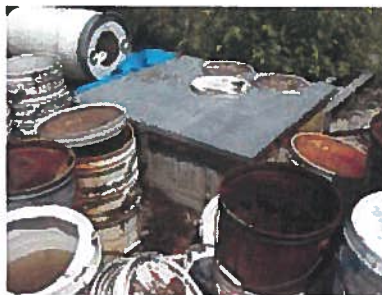
Paint cans stored on top of reservoir

At the time of the survey many used paint buckets were being stored on top of the reservoir and are considered a potential source of contamination. The buckets must be removed and stored elsewhere. The reservoir roof must be kept clear of any potential sources of contamination and should be inspected regularly for any cracks or defects. Also, it is recommended the reservoir be inspected annually for integrity and silt build up, and cleaned at least every five years.

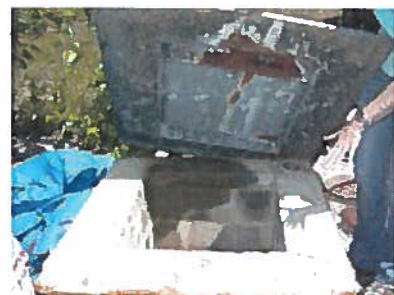
Access hatch – needs gasket

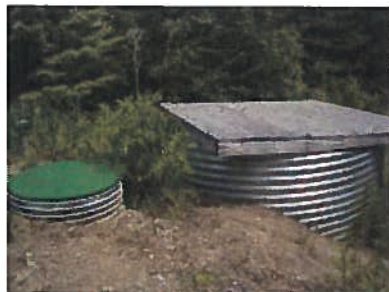
Reservoir lid and valve pit

The reservoir does not have an overflow. A properly screened overflow must be provided where it drains to daylight in a way that will prevent backflow to the reservoir. One hydrant has been installed off of the reservoir and is controlled by a pump and pressure tank located in the valve pit.

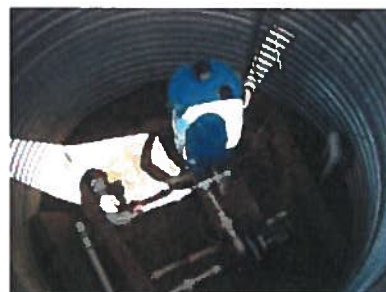
Valve pit

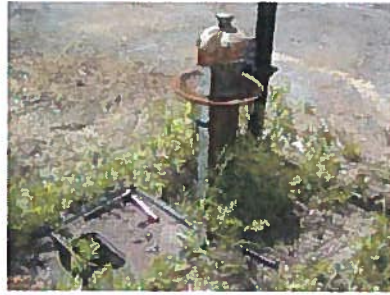
Well #4: Well #4 is a 6-inch cased well drilled 11/30/1989 to a depth of 50 feet. It is located at the edge of the parking lot, behind the basketball hoop. The well was hydrofractured and deepened on 1/12/1990 to a depth of 100 feet and again on 2/12/2002 to 400 feet. The 6-inch casing extends 19 feet below the surface and is sealed with bentonite to 19 feet. A 4-inch PVC casing extends to 100 feet below the surface. The well casing extends 30 inches above ground and is fitted with a water tight vented well cap. The current capacity of the well is 15 gpm. The flow meter is located in a vault adjacent to the well and a flow to waste is located at the end of the vault. A pressure gage must be installed on the discharge line.

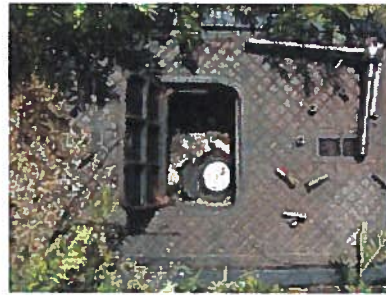
Vault with flow meter

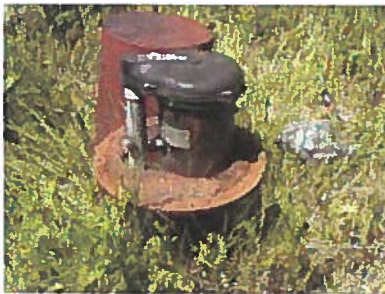
Well #5: Well #5 is a 6-inch cased well drilled 2/14/2002 to a depth of 280 feet. It is located approximately 200 feet east of Hayden Lake Road in a grassy area. The well casing extends 24 inches above the ground; fitted with a watertight vented well cap, to 37 feet below with a bentonite surface seal also to 37 feet. A 4-inch PVC liner extends to 280 feet below the surface. The well is equipped with a 1-horsepower submersible pump and the current capacity is 12 gpm. Located adjacent to the well is the pump controls, flow to waste line, frost free hydrant, and a vault containing the flow meter and smooth-nosed sample tap. A pressure gage must be installed on the discharge line.

At the time of the survey, the pump was making an unusual sound and shiny particles were present in the water from the hydrant. It is important the water system have the well and pump examined to ensure it is operating properly.

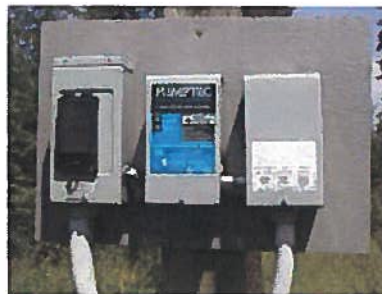
Pump controls

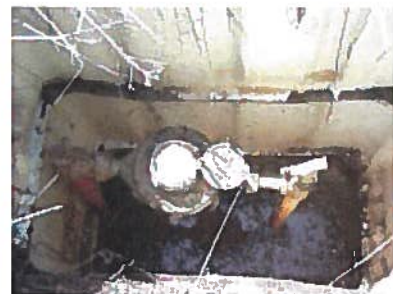
Vault with flow meter and sample tap

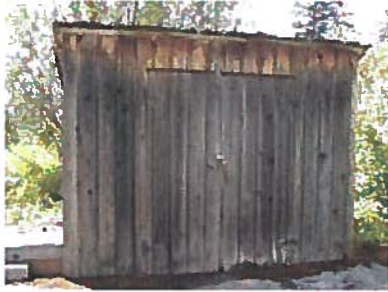
Pump House

The pump house is a wood framed house that sits atop the main reservoir and contains the main reservoir access and the chlorinator. The pump house can be locked and has adequate light, heat and ventilation. A properly screened floor drain must be provided where it drains to daylight.

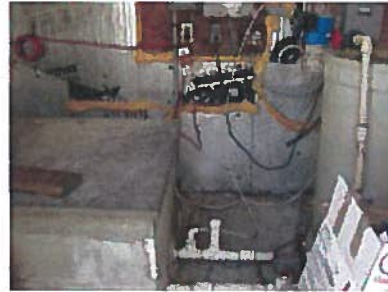
Reservoir access and chlorinator

The sodium hypochlorite is mixed in a solution tank, using 2 gallons of sodium hypochlorite and filled with water. In order to prevent the tank from collapsing and corrosion of water system components, a vent (which may consist of tubing material) must be installed from the solution tank to the outside atmosphere.

8. A vent must be provided from the sodium hypochlorite solution tank to the outside atmosphere.
