## **Memorandum**

To: Water Right Permit File 74-15613, Shelley Keen, Dan Nelson

RE: Whittaker Permit Field Visit – May 22, 2013

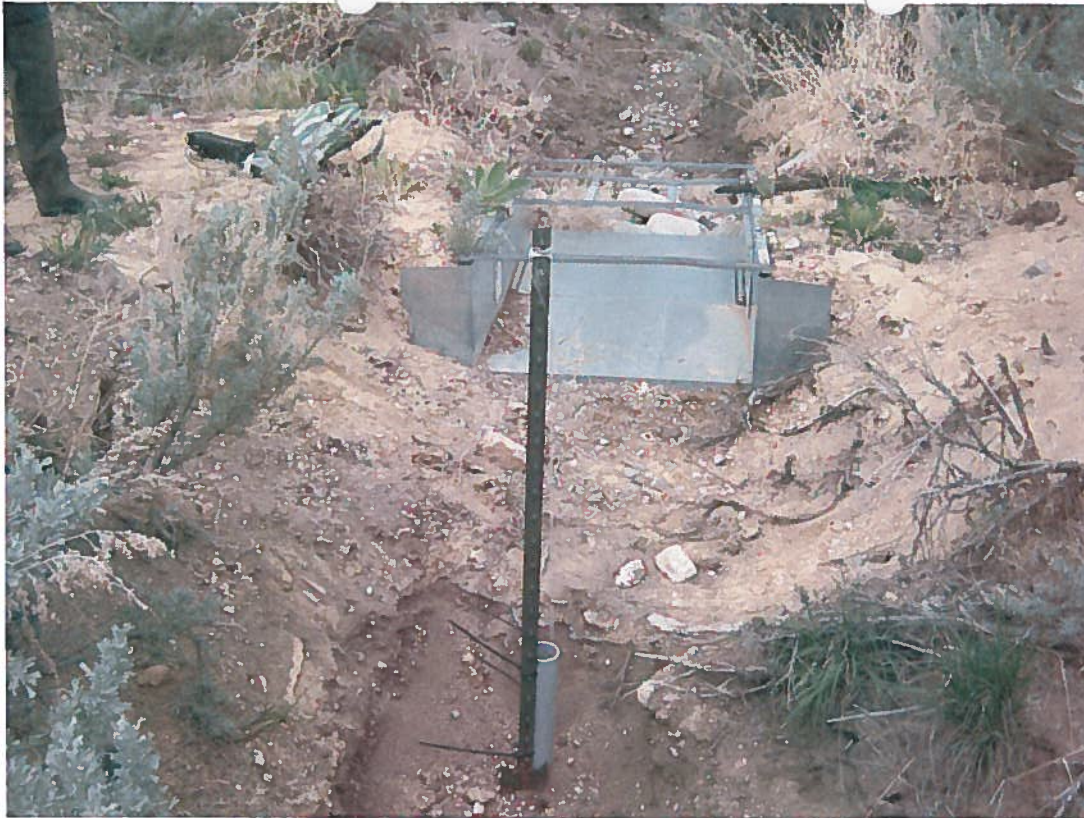
- There was no stilling well installed with the flume to house the transducer and data logger in order to measure a proper water level in the flume to correspond with the staff gage installed in the flume.
- Water delivered down the ditch and filling the hole might undermine and dislodge the fence pole and data logger, or sediment may wash into the hole and potentially bury the transducer and data logger and cause at least faulty readings or no readings at all, thereby rendering the instrument useless and potentially damaged.

1. Data logger and transducer installed in plastic pipe mounted to metal fence pole in a dug hole about 4 to 5 feet in front/upstream of ramped flume.

Based on the above concerns, I removed the data logger from the metal fence pole, programmed it to record water levels every 30 or 60 minutes<sup>1</sup>, and left the logger at the convenience store/post office in Leadore for James to pick up along with a hand written note suggesting that he re-install the logger inside the plastic pipe and attach the pipe securely along the inside wall of the flume and near the upstream entrance of the flume. I discussed this idea with him on site as well. I also instructed him to drill several holes in the plastic pipe so that water level in the pipe fills to the same level in the flume. I explained that the logger will not record the correct height of water above the flume sill but it should at least record water levels inside the measuring device which can be adjusted later knowing the exact location of the transducer/logger relative to the sill and bottom of the staff gage. This is not necessarily the most ideal installation set-up but it seemed like the most practical for him to follow.

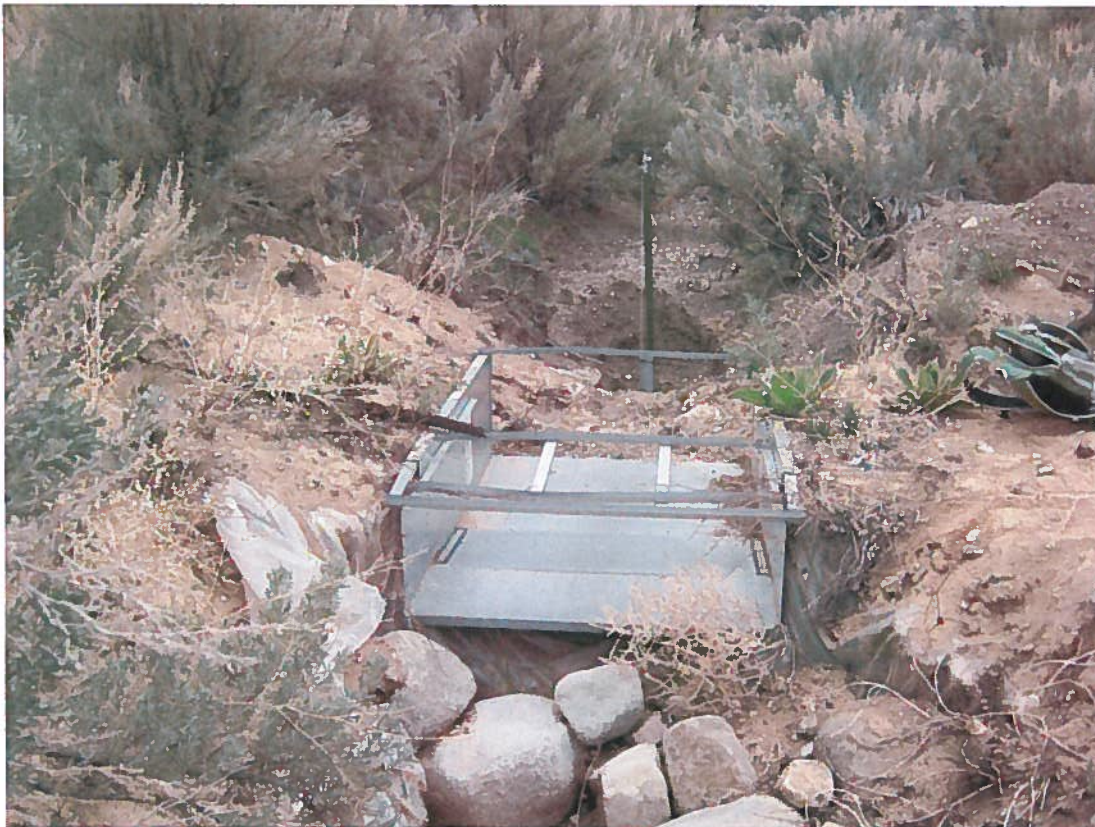
Note: I apparently misplaced the few field notes that I took relative to the dimensions of the flume and several details on the head gate. I did not have a level to check the level of the flume. The sill height may not be properly set to accurately measure water relative to ditch conditions. A current meter measurement should be taken of the ditch near the flume at the time of the field exam to check the accuracy of the flume. See also comments on photo no. 2 concerning the flume installation where flow exits the device – there is a concern regarding some potential for the device to wash out.

2. View of flume from downstream location. Metal fence pole with data logger/transducer in background. Note the significant size hole dug in the ditch where the logger is located inside the plastic pipe. Note potential for flume to wash out where water exits flume where boulders are located.

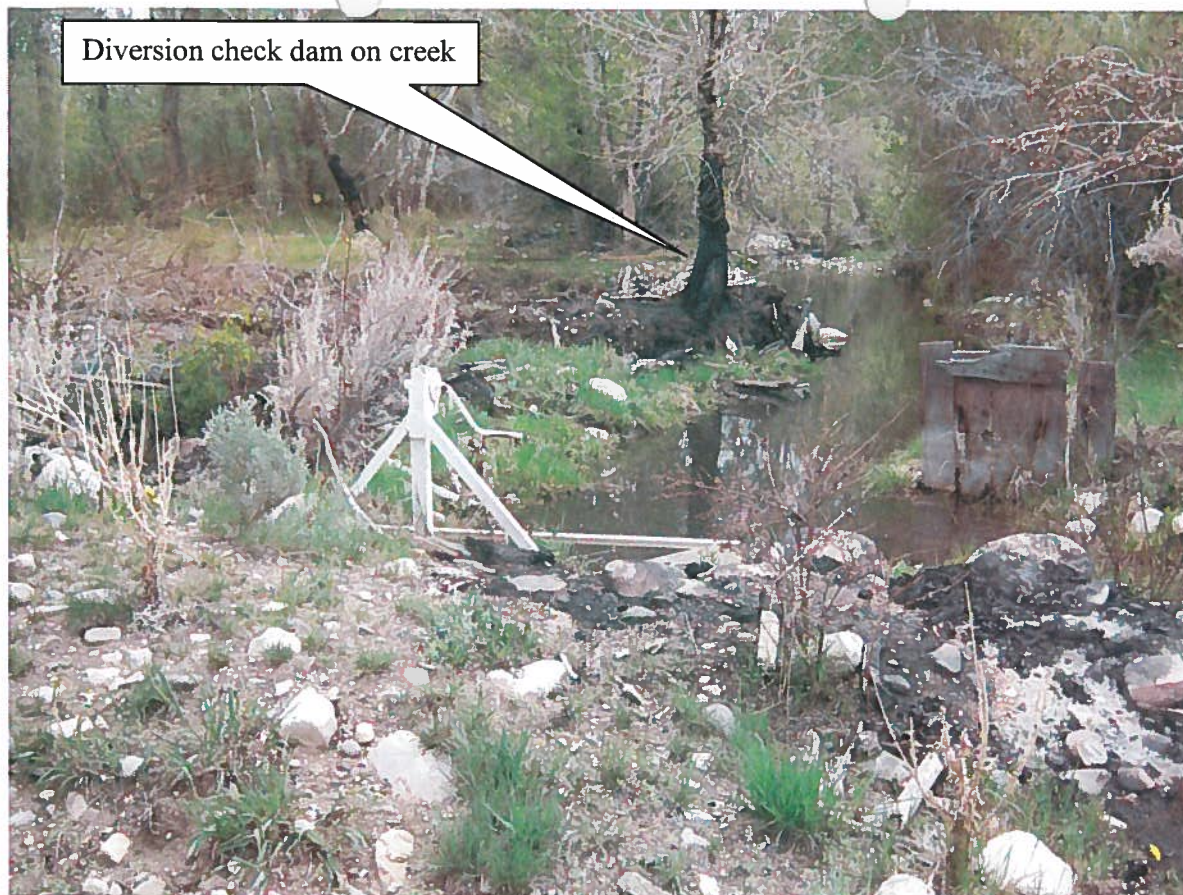
Before leaving the site, I also took a location of the diversion ditch head gate from Big Timber Creek. The head gate is located on the ditch near the ditch heading and about 500 feet above (upstream) of the flume. My GPS location was at the physical control steel head gate (see attached photos) which was located about 130 to 150 feet from the creek where the water can be checked or diverted into the ditch by a rock/dirt berm and plastic tarps. Some water was backed up to the steel head gate but water was flowing freely down the creek as the rock/dirt berm was not maintained to check water down the head of the ditch and past the control head gate. The location of the earthen dam and plastic tarp can be seen in the background of photo no. 3.

3. Control head gate to Whittaker's Ditch – permit 74-15613.

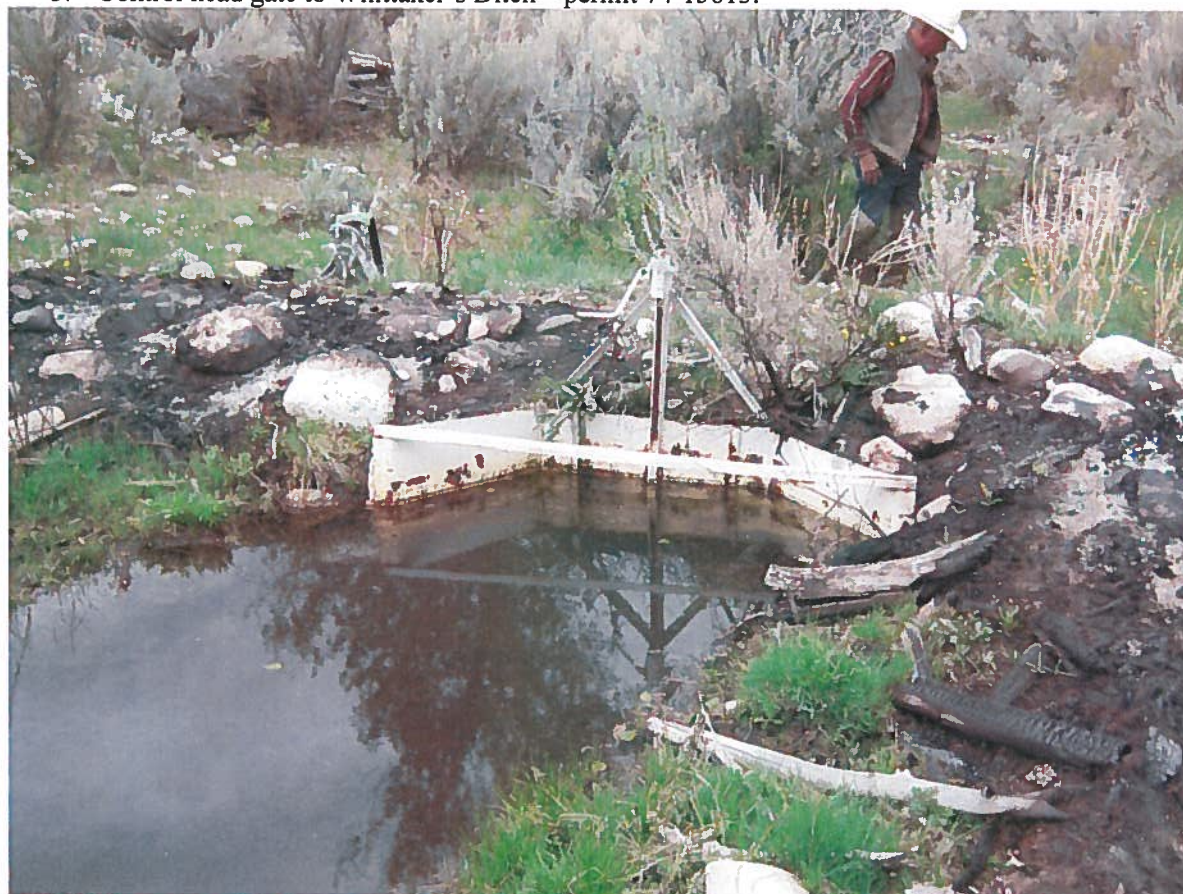
4. Control head gate with ditch in background behind Mr. Whittaker.
